Our Ref: B25239-JNP-XX-XX-RP-S-0001      Chkd: VW

Re: Bell Farm Avenue

The purpose of this report is to inspect and report on the existing structural arrangement, size of members and any visual defects. It also includes the findings from the CCTV survey and the Damp and Timber survey which can be found in the appendices.

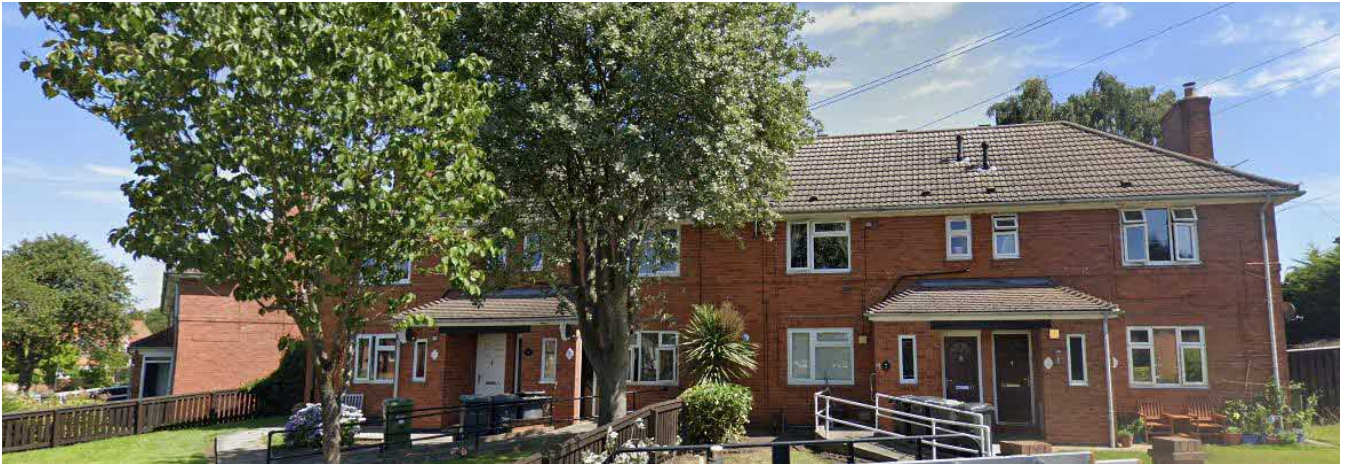
Photograph 1. Front elevation (showing 2 No. trees)

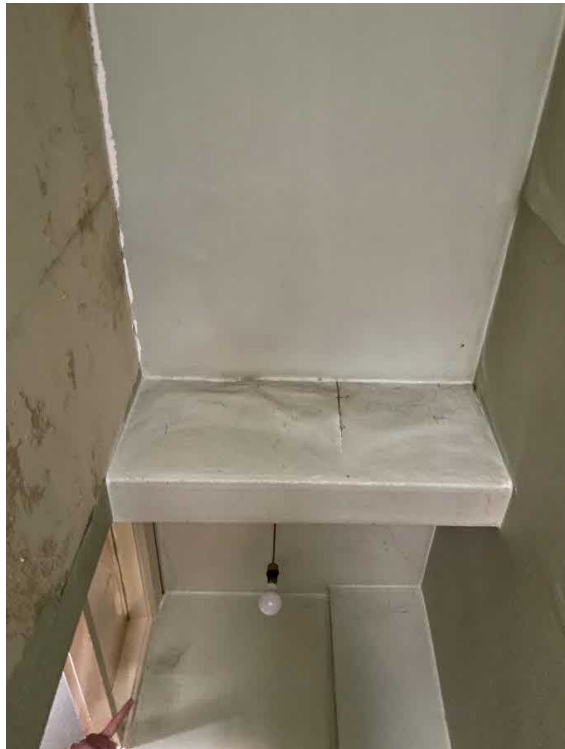
Photograph 12. Timber Lintel Supporting Wall Above Top of Stairs

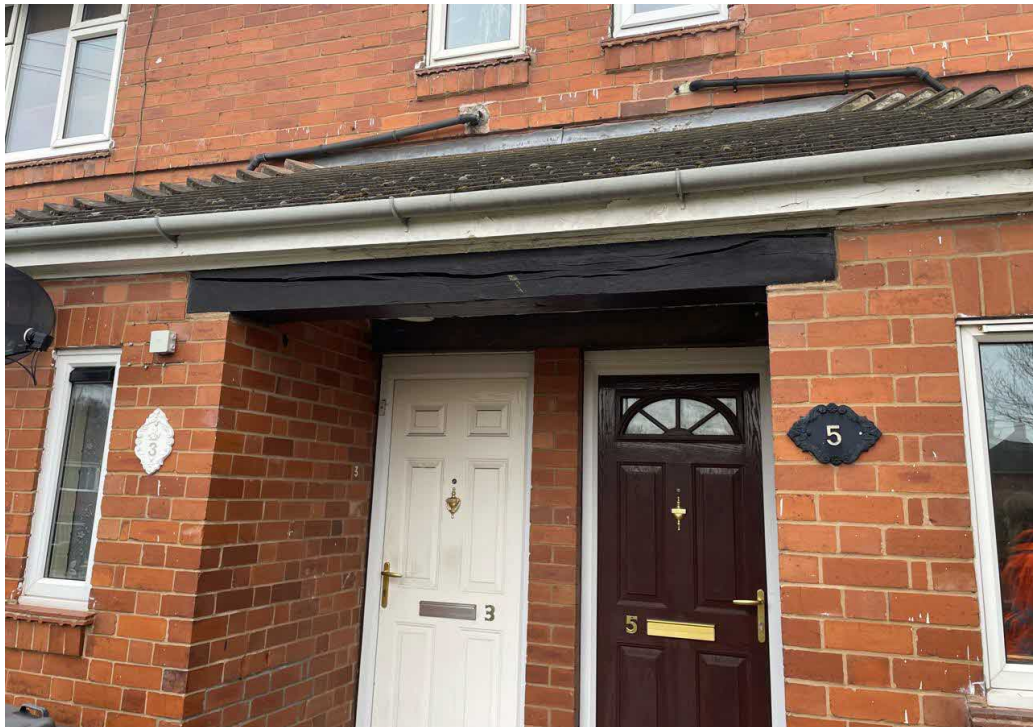
Photograph 14. Timber Lintel Deflecting and Shrinkage Apparent

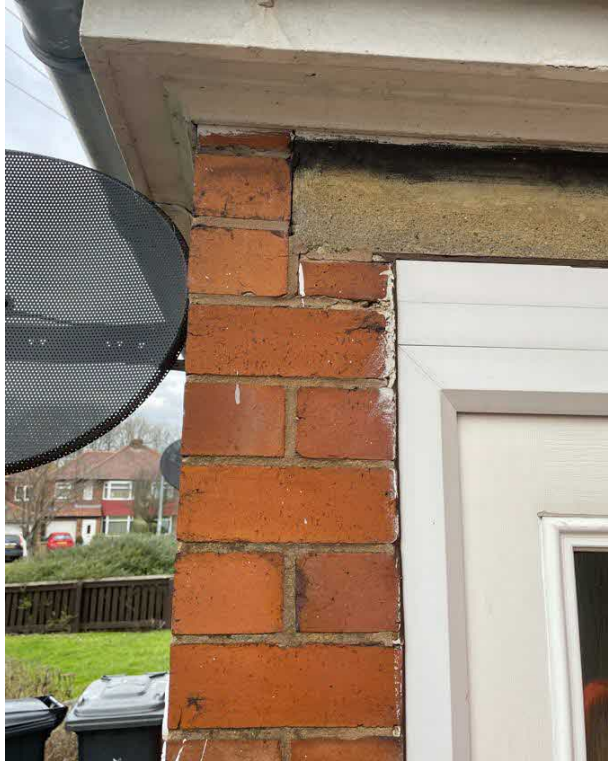
It was noted that the external wall of the porch to the front door was leaning out at the top slightly.

Photograph 15. External Wall to Porch Leaning Out

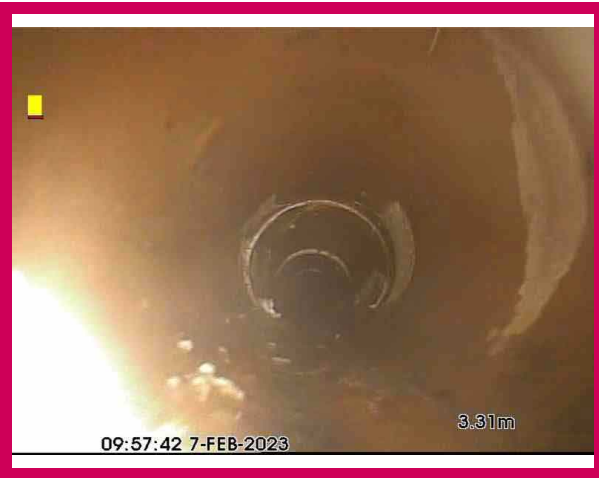
1, 00:00:15, 3.31 m  
Crack, circumferential at joint from 12 o'clock to 12 o'clock

Section 5. MH02- LINE X. Dia-100mm. Defect- Crack at 3.31m & 7.45m. Fracture at 4.53m. Repair- 3x 600 CIPP Liner.

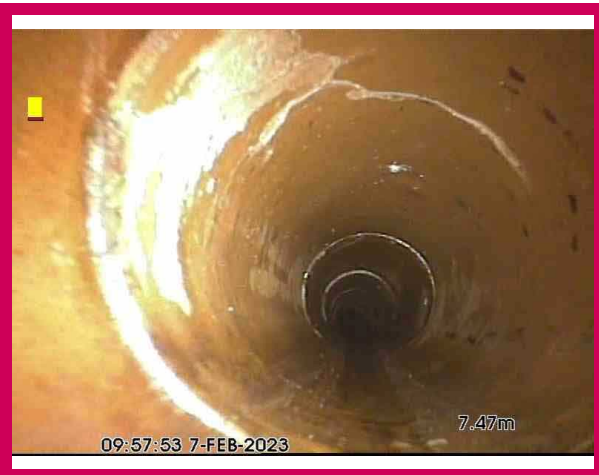
3, 00:00:27, 7.45 m  
Crack, circumferential at joint from 12 o'clock to 12 o'clock

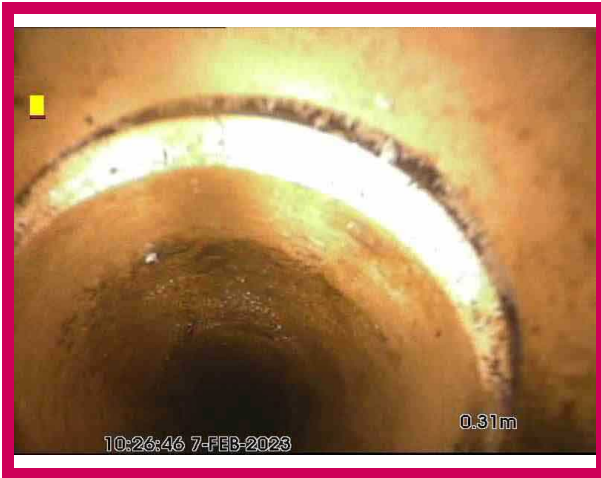
1, 00:00:13, 0.40 m  
Joint displaced, medium

Section 8. MH07- LINE A. Dia-150mm. Defect- JDM at 0.40m. Repair- 1x 600 CIPP Liner.

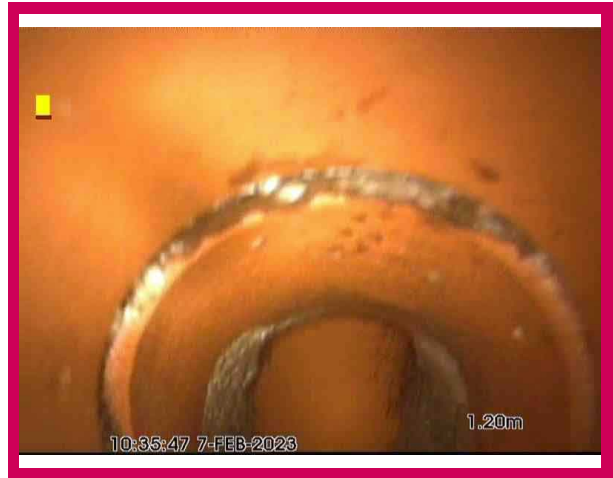
2, 00:00:11, 1.24 m  
Crack, circumferential at joint from 12 o'clock to 12 o'clock

Section 11. MH05- LINE A. Dia-100mm. Defect- JDM at 0.10m & crack at 1.24m. Repair- 2x 600 CIPP Liner.

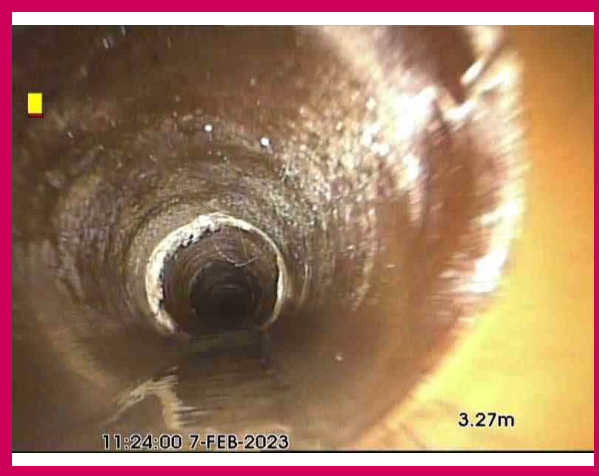
1, 00:00:15, 3.37 m  
Crack, circumferential at joint from 12 o'clock to 12 o'clock

Section 17. MH08- LINE X. Dia-150mm. Defect- Crack at 3.37m. Repair- 1x 600 CIPP Liner.

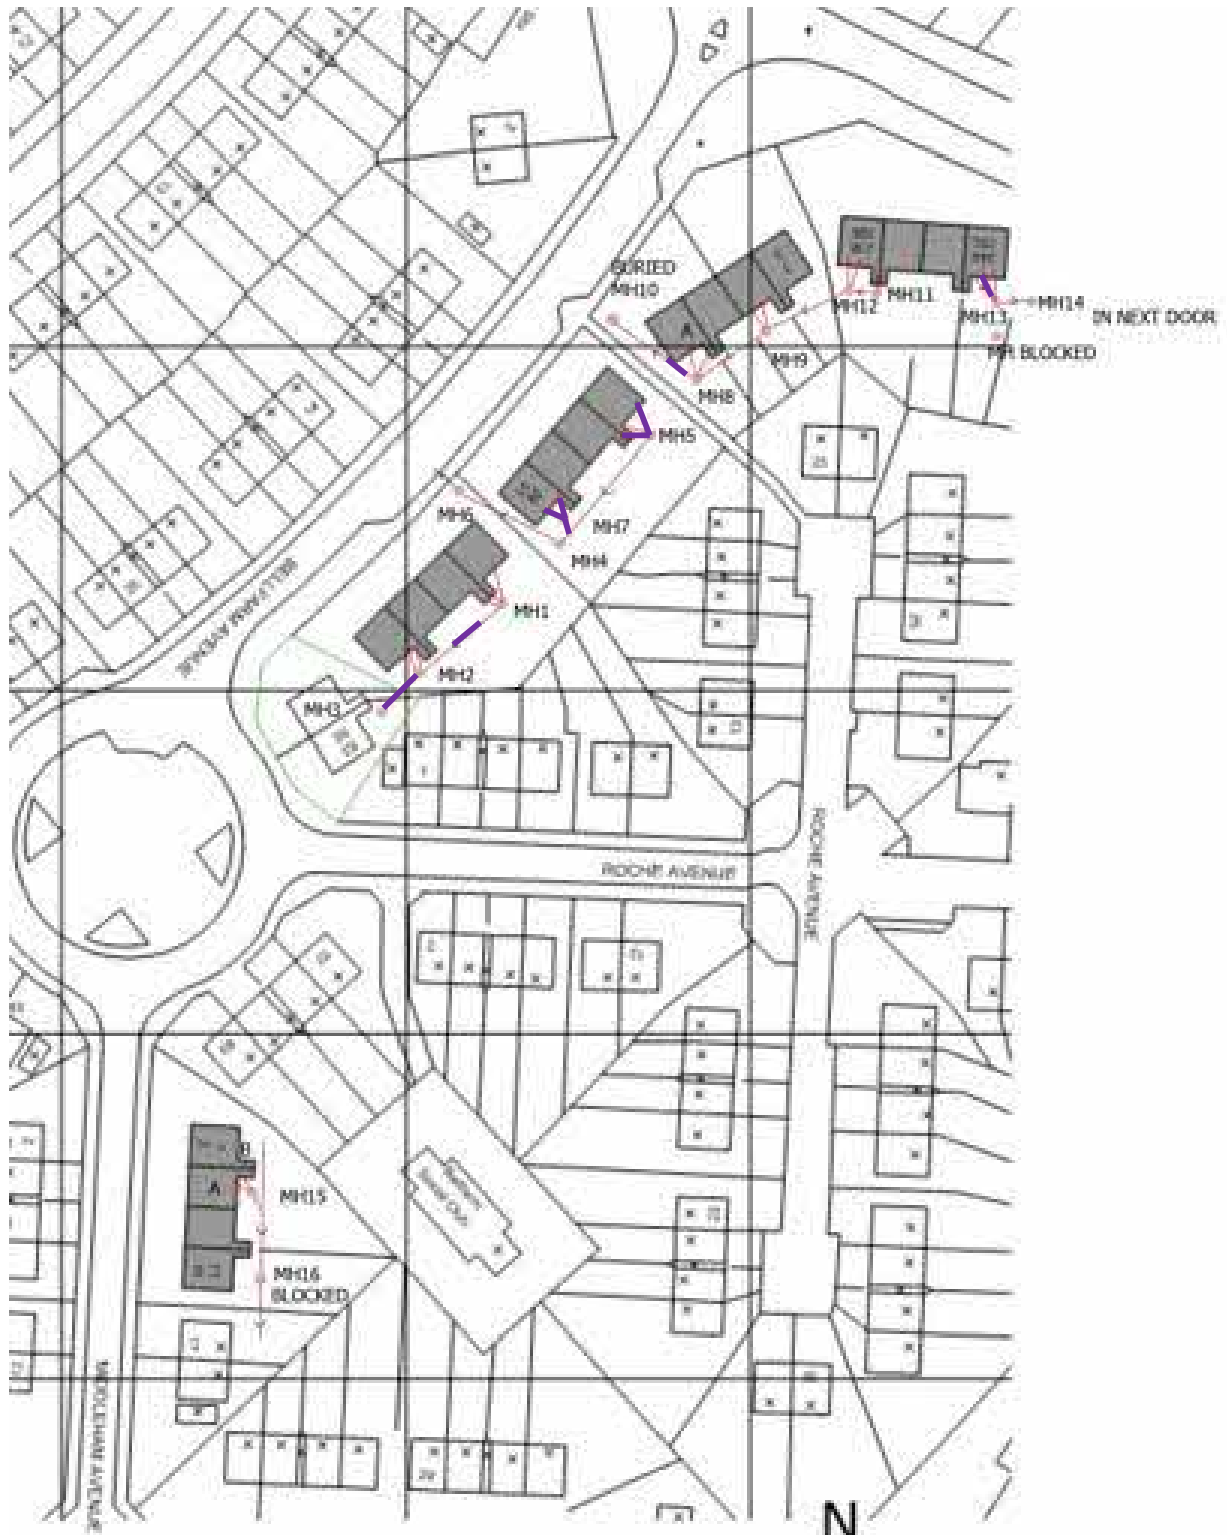
— Length of drain identified as needing repair
