**LBC
Survey**

Address:
97/3 Portland Street,
Edinburgh, EH6 4AY

Grade C Listed Property

Client requests the installation of double glazing by replacement of existing sashes with new custom fitted with 14mm IGU's. All historic detail to be matched like-for-like. The original existing cases are to be retained and refurbished in situ.

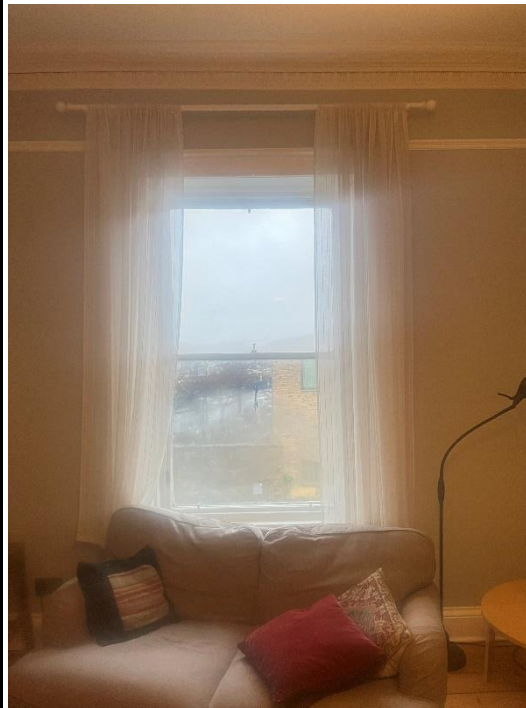
W1 – Front Room

Currently 1 over 1 style

1900h x 1070w

- Cracking along glue lines of mortise and tenon joinery indicative of excessive movement
- External paint and putty has been breached
- Condensation damage to horizontal rails
- Window heavily overpainted

Replacement 1 over 1 style sashes with 14mm
IGU's

Replacement of existing 1/1 style sashes on a like-for-like basis with new custom fitted 14mm IGU's.

Existing casement to be retained and refurbished.

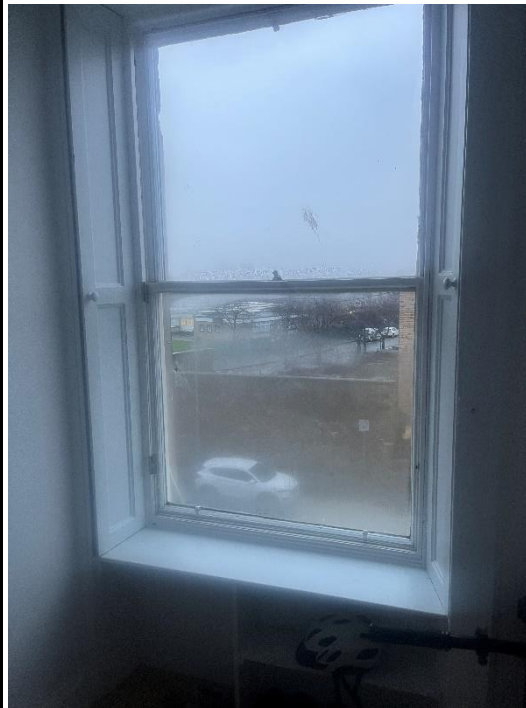
W2 – Front Middle

Currently 1 over 1 style

1910h x 1070w

- Cracking along glue lines of mortise and tenon joinery indicative of excessive movement
- External paint and putty has been breached
- Condensation damage to horizontal rails
- Window heavily overpainted

Replacement 1 over 1 style sashes with 14mm IGU's

Replacement of existing 1/1 style sashes on a like-for-like basis with new custom fitted 14mm IGU's.

Existing casement to be retained and refurbished.

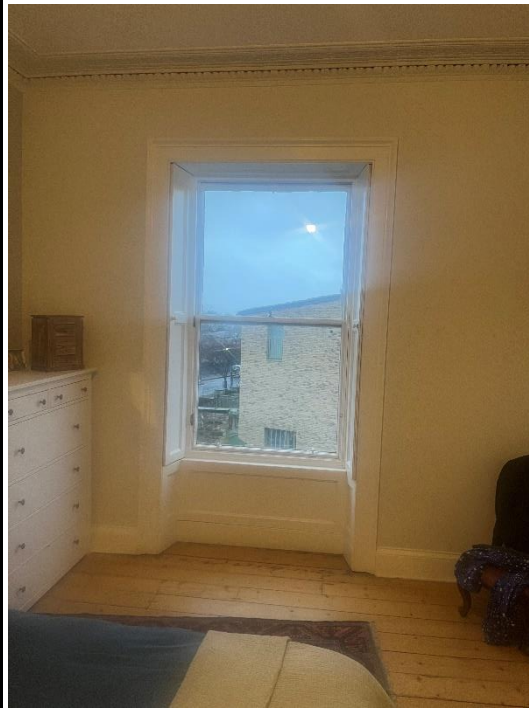
W3 – Front Bedroom

Currently 1 over 1 style

1900h x 1070w

- Cracking along glue lines of mortise and tenon joinery indicative of excessive movement
- External paint and putty has been breached
- Condensation damage to horizontal rails
- Window heavily overpainted

**Replacement 1 over 1 style sashes with 14mm
IGU's**

Replacement of existing 1/1 style sashes on a like-for-like basis with new custom fitted 14mm IGU's.

Existing casement to be retained and refurbished.
