PROJECT
9 FORRES ST,
EDINBURGH

STATUS
LBC

DRAWING TITLE
EXISTING & PROPOSED W1&W2
DRAWINGS

DATE
FEB 24'
DWG. NO.
(31)100

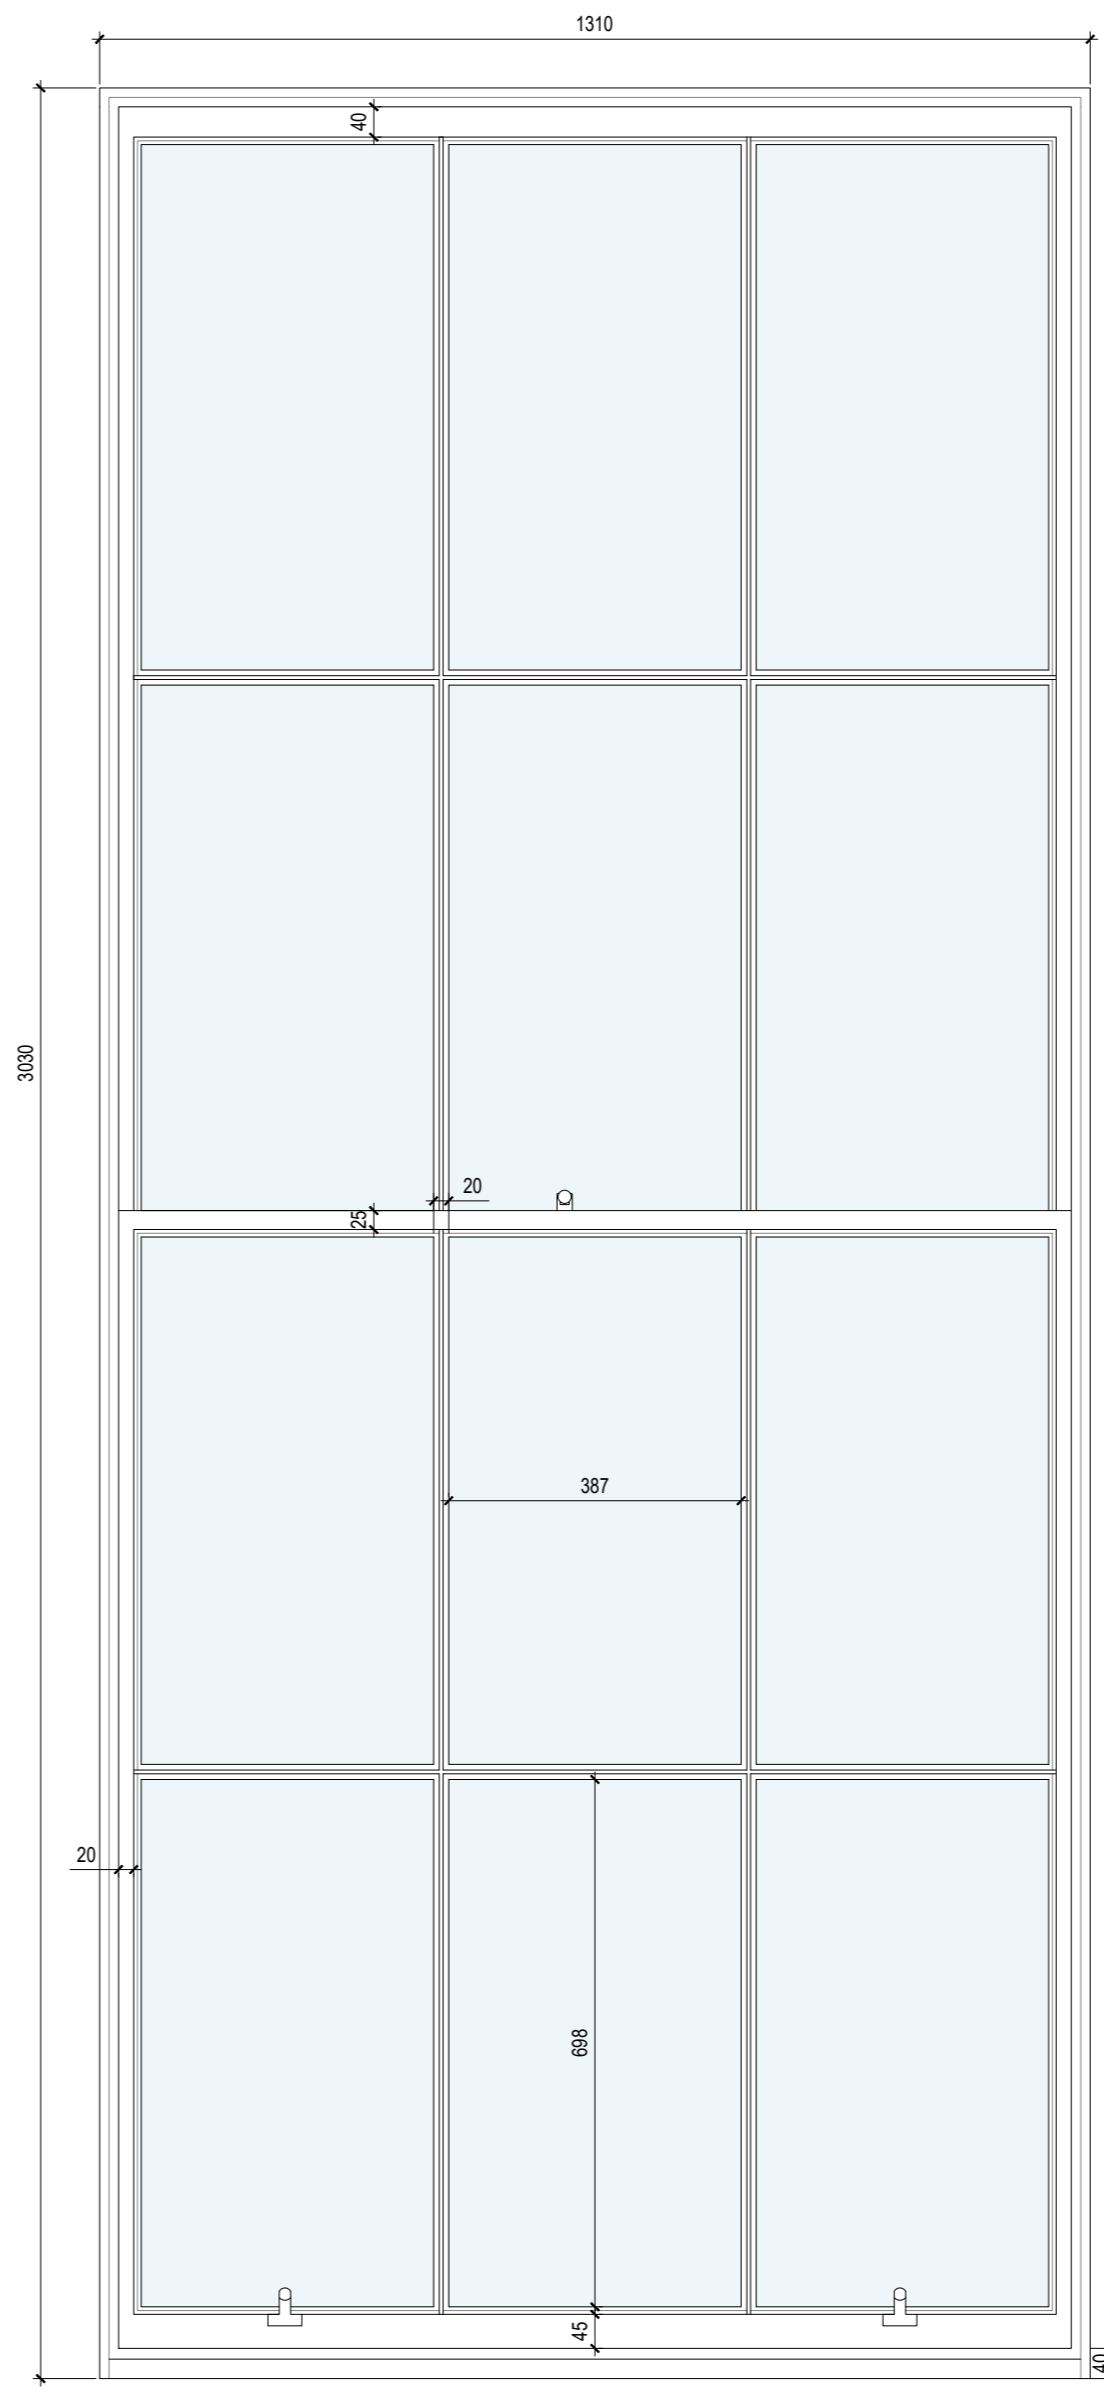
W1 - EXISTING LIVING ROOM INTERNAL WINDOW ELEVATION
scale 1:10

EXISTING WINDOW CONDITION NOTES:

W1& W2 both sashes are in working condition and can open, pulleys, ropes and weights would benefit from refurbishment to better ease of opening. No evidence of existing draught brushes installed to face of inner frame, there is a trickle vent to the underside of the outer sash mid transom. Windows would benefit from the install of draught brushes within the frame.

6 over 6 configuration, suggests window arrangements are as per the original design. Existing ironmongery in working condition but would benefit from refurbishment.

Both windows are identical in dimension and profile. Astragals appear to be original in profile and dimension.

Glazing Type: Single Glazing
GLASS MAKE UP: 6-7mm
