PROJECT
9 FORRES ST,
EDINBURGH
STATUS
LBC

DRAWING TITLE
EXISTING & PROPOSED W3
WINDOW DRAWINGS

DATE
FEB 24'
DWG. NO.
(31)101

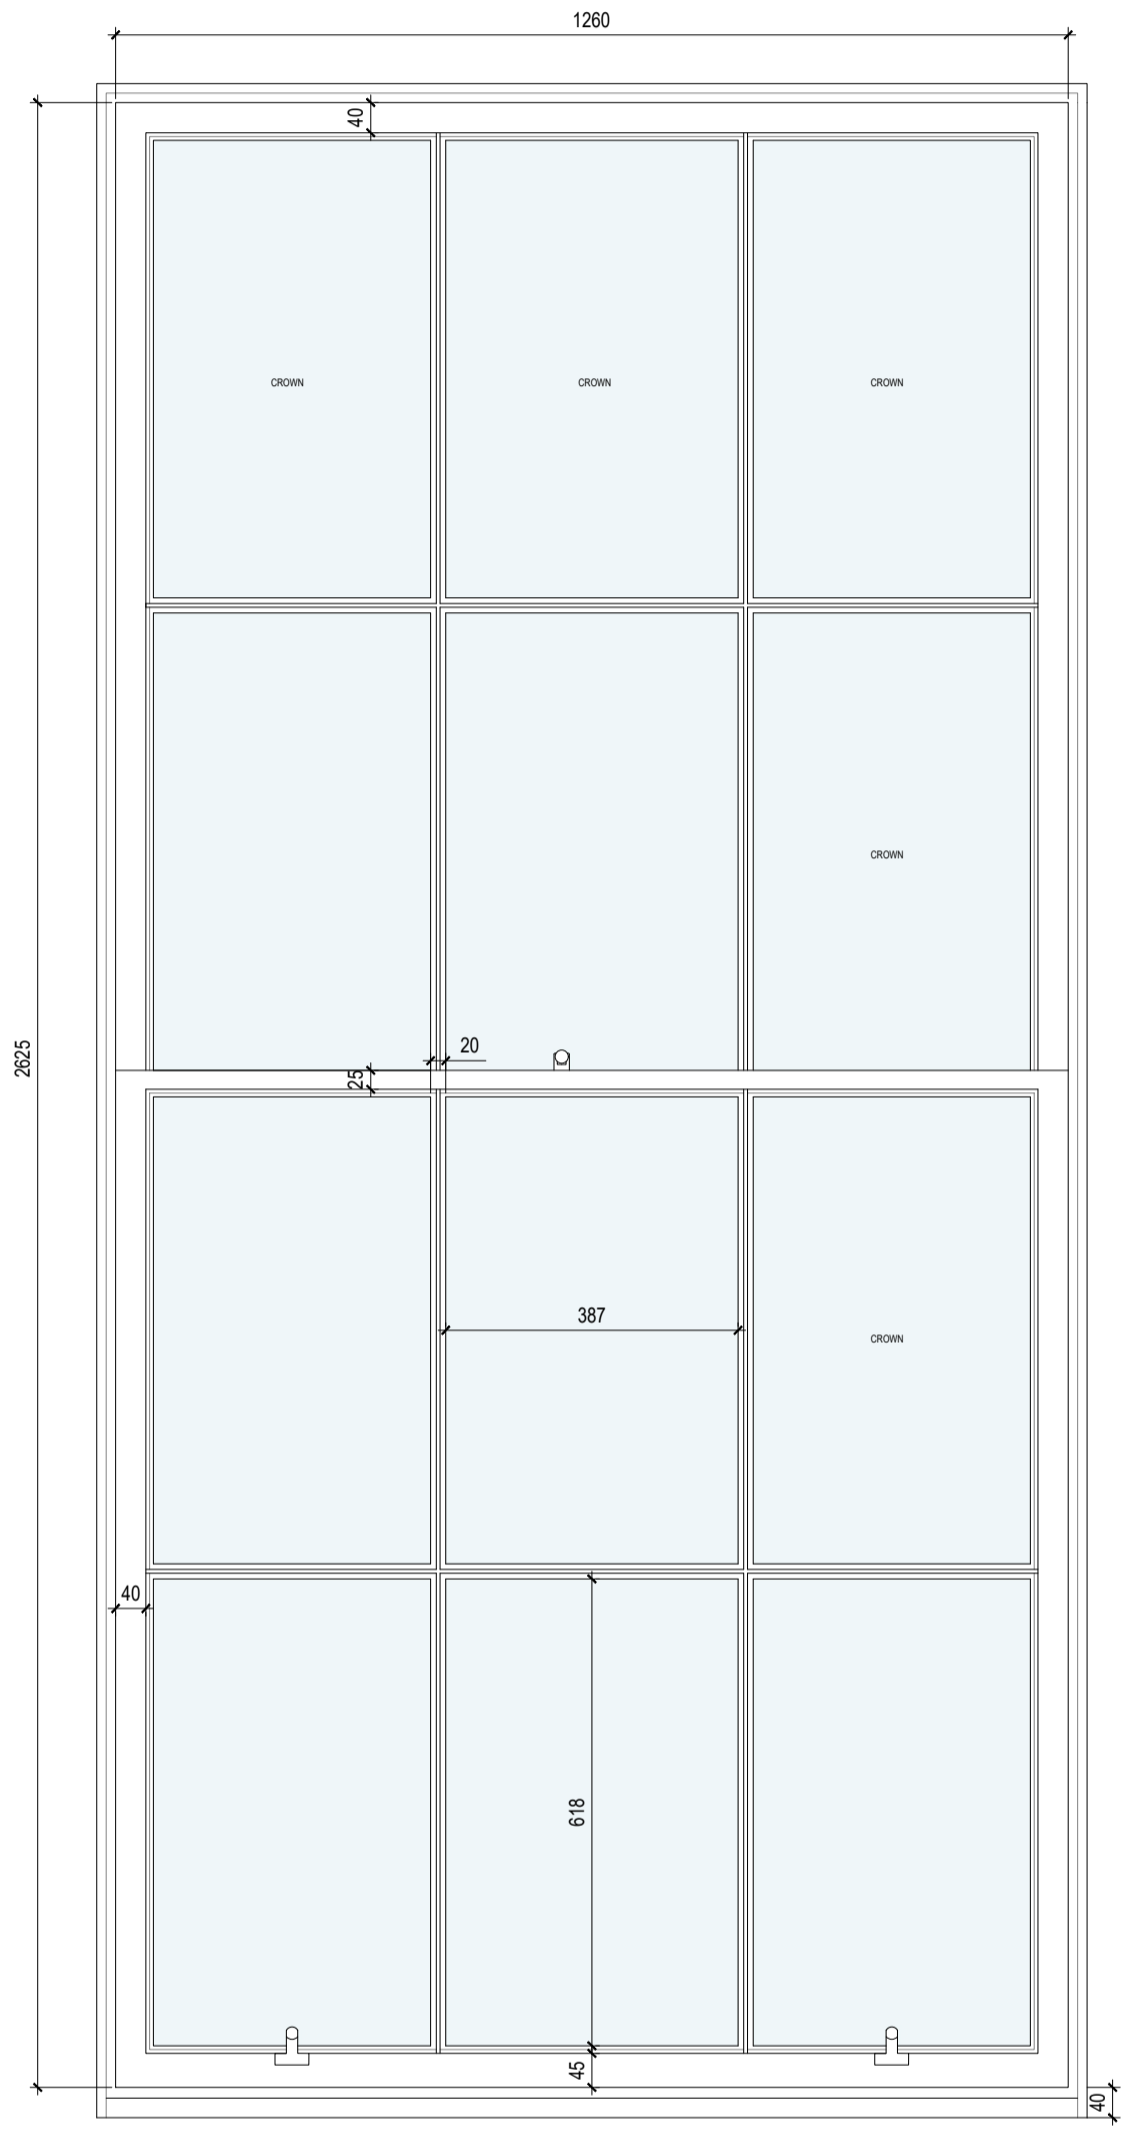
W3 - EXISTING BEDROOM 01 INTERNAL WINDOW ELEVATION
scale 1:10

EXISTING WINDOW CONDITION NOTES:

W3 both sashes are in working condition and can open, pulleys, ropes and weights would benefit from refurbishment to better ease of opening, as they are currently very stiff. Modern draught brushes have been applied to the face of the frame at the sides and mid transform recommended that the existing draught brushes are to be replaced with new draught brushes installed within the frame.

6 over 6 configuration, W3 has evidence of crown glazing, as shown, suggests window arrangements are as per the original design. Existing ironmongery in working condition but would benefit from refurbishment.

Astragals appear to be original in profile and dimension.
