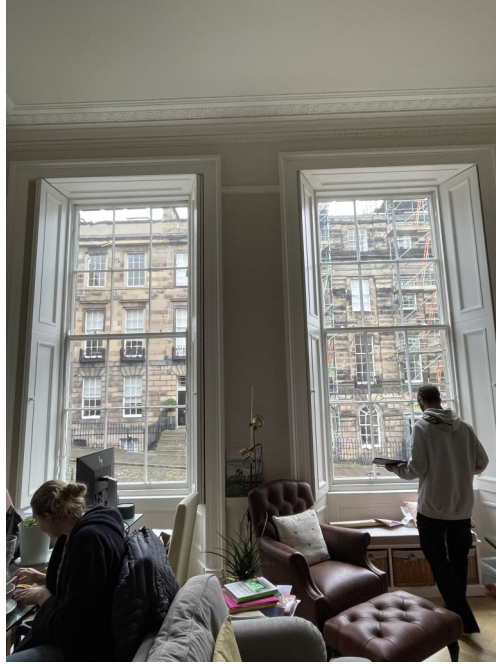
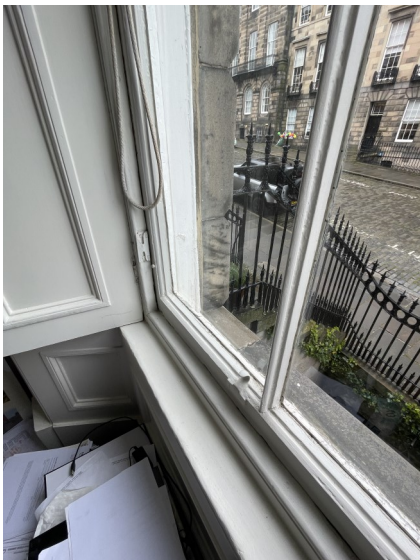
Window 01.  
Living Room

Ironmongery is non-existent in areas and requires to be installed. Gaps to window frame and sash are allowing draughts to enter property.

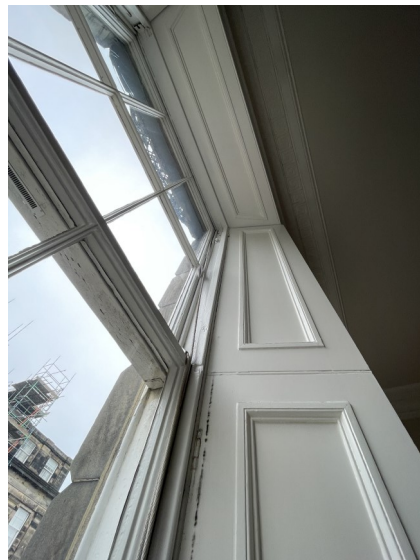
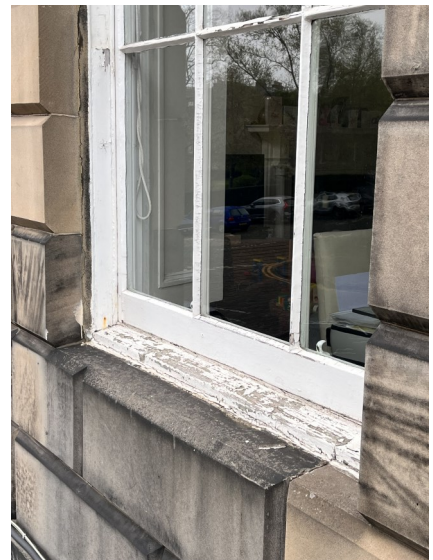
Window 02.  
Living Room

Defective cill requires to be replaced/ repaired.

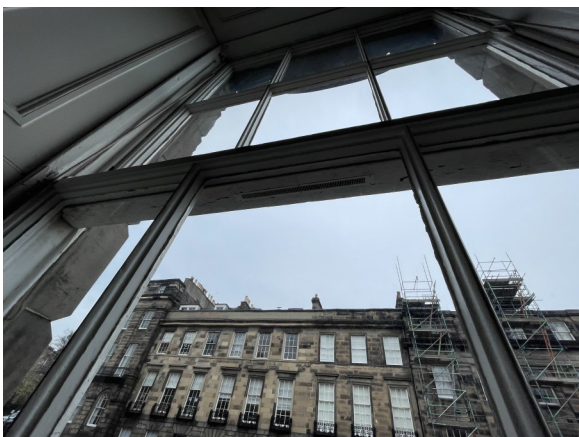
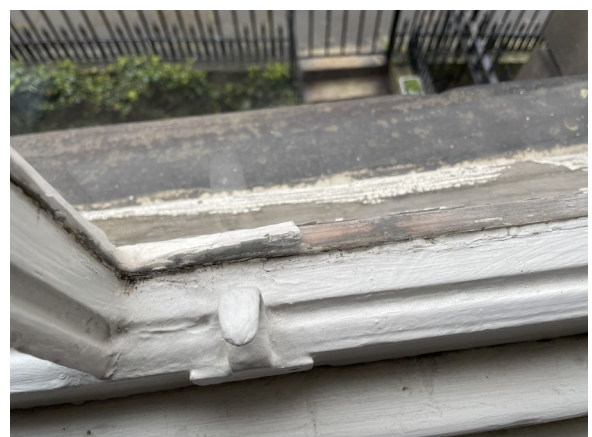
Defective sections of timbers require to be replaced.

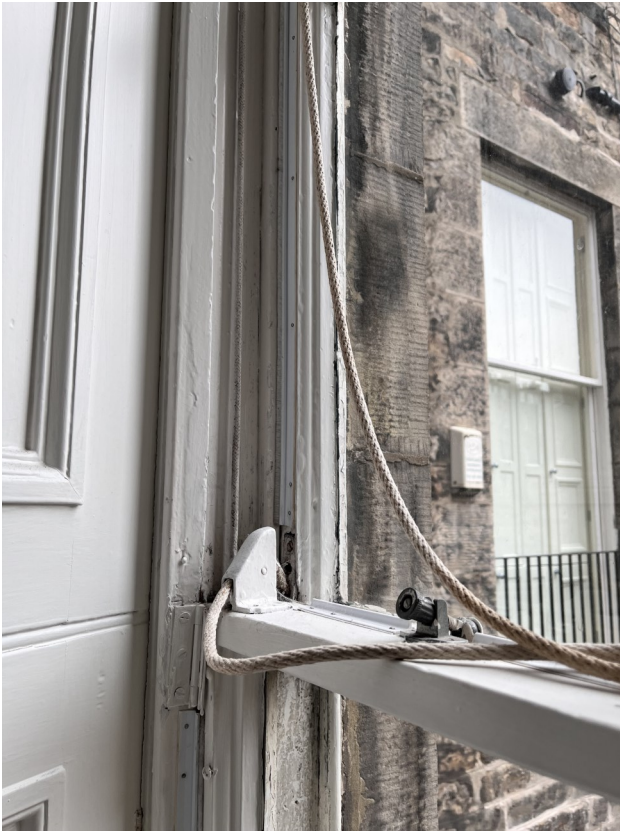
Window 03. Bedroom 01

Defective rope cords do not allow for ease of opening for the user

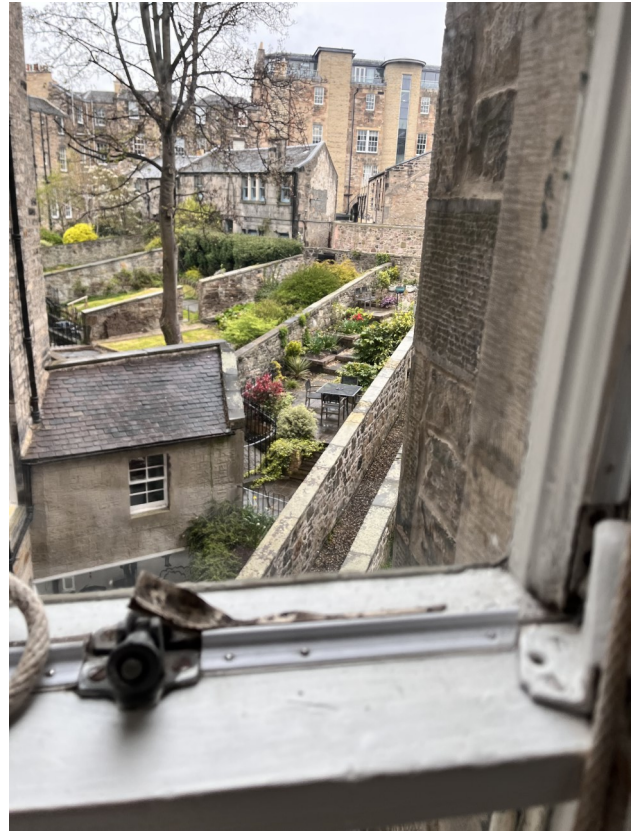
Window sash out of alignment causing weak contact points at mid transom, top sash and bottom sash, allowing major draughts to enter the property. Has been retrofitted with inadequate face fixed brushes.

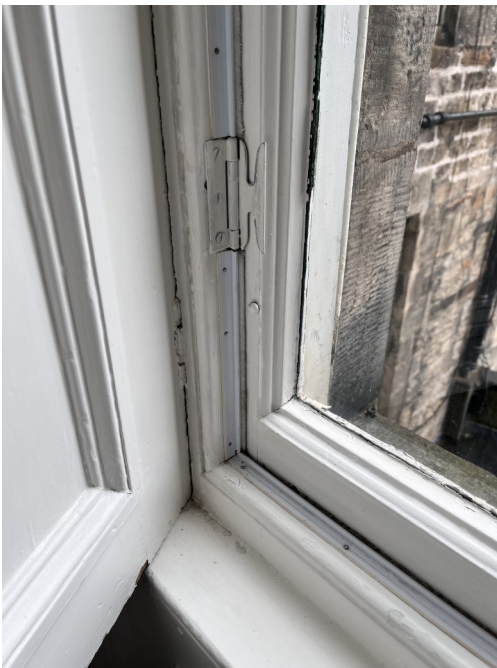
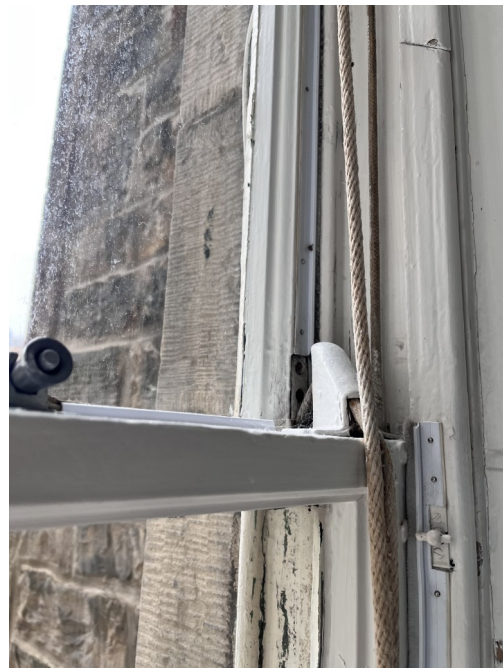
Defective easy clean battens and ironmongery requires replacement.
