Minmore Mill, Minmore House, Glenlivet, Ballindalloch, AB37 9DB  
CONDITION REPORT  
JULY 2022

The purpose of this report is to record the existing condition of the former Mil building on the site, with the intention of informing the buildings future use and restoration.

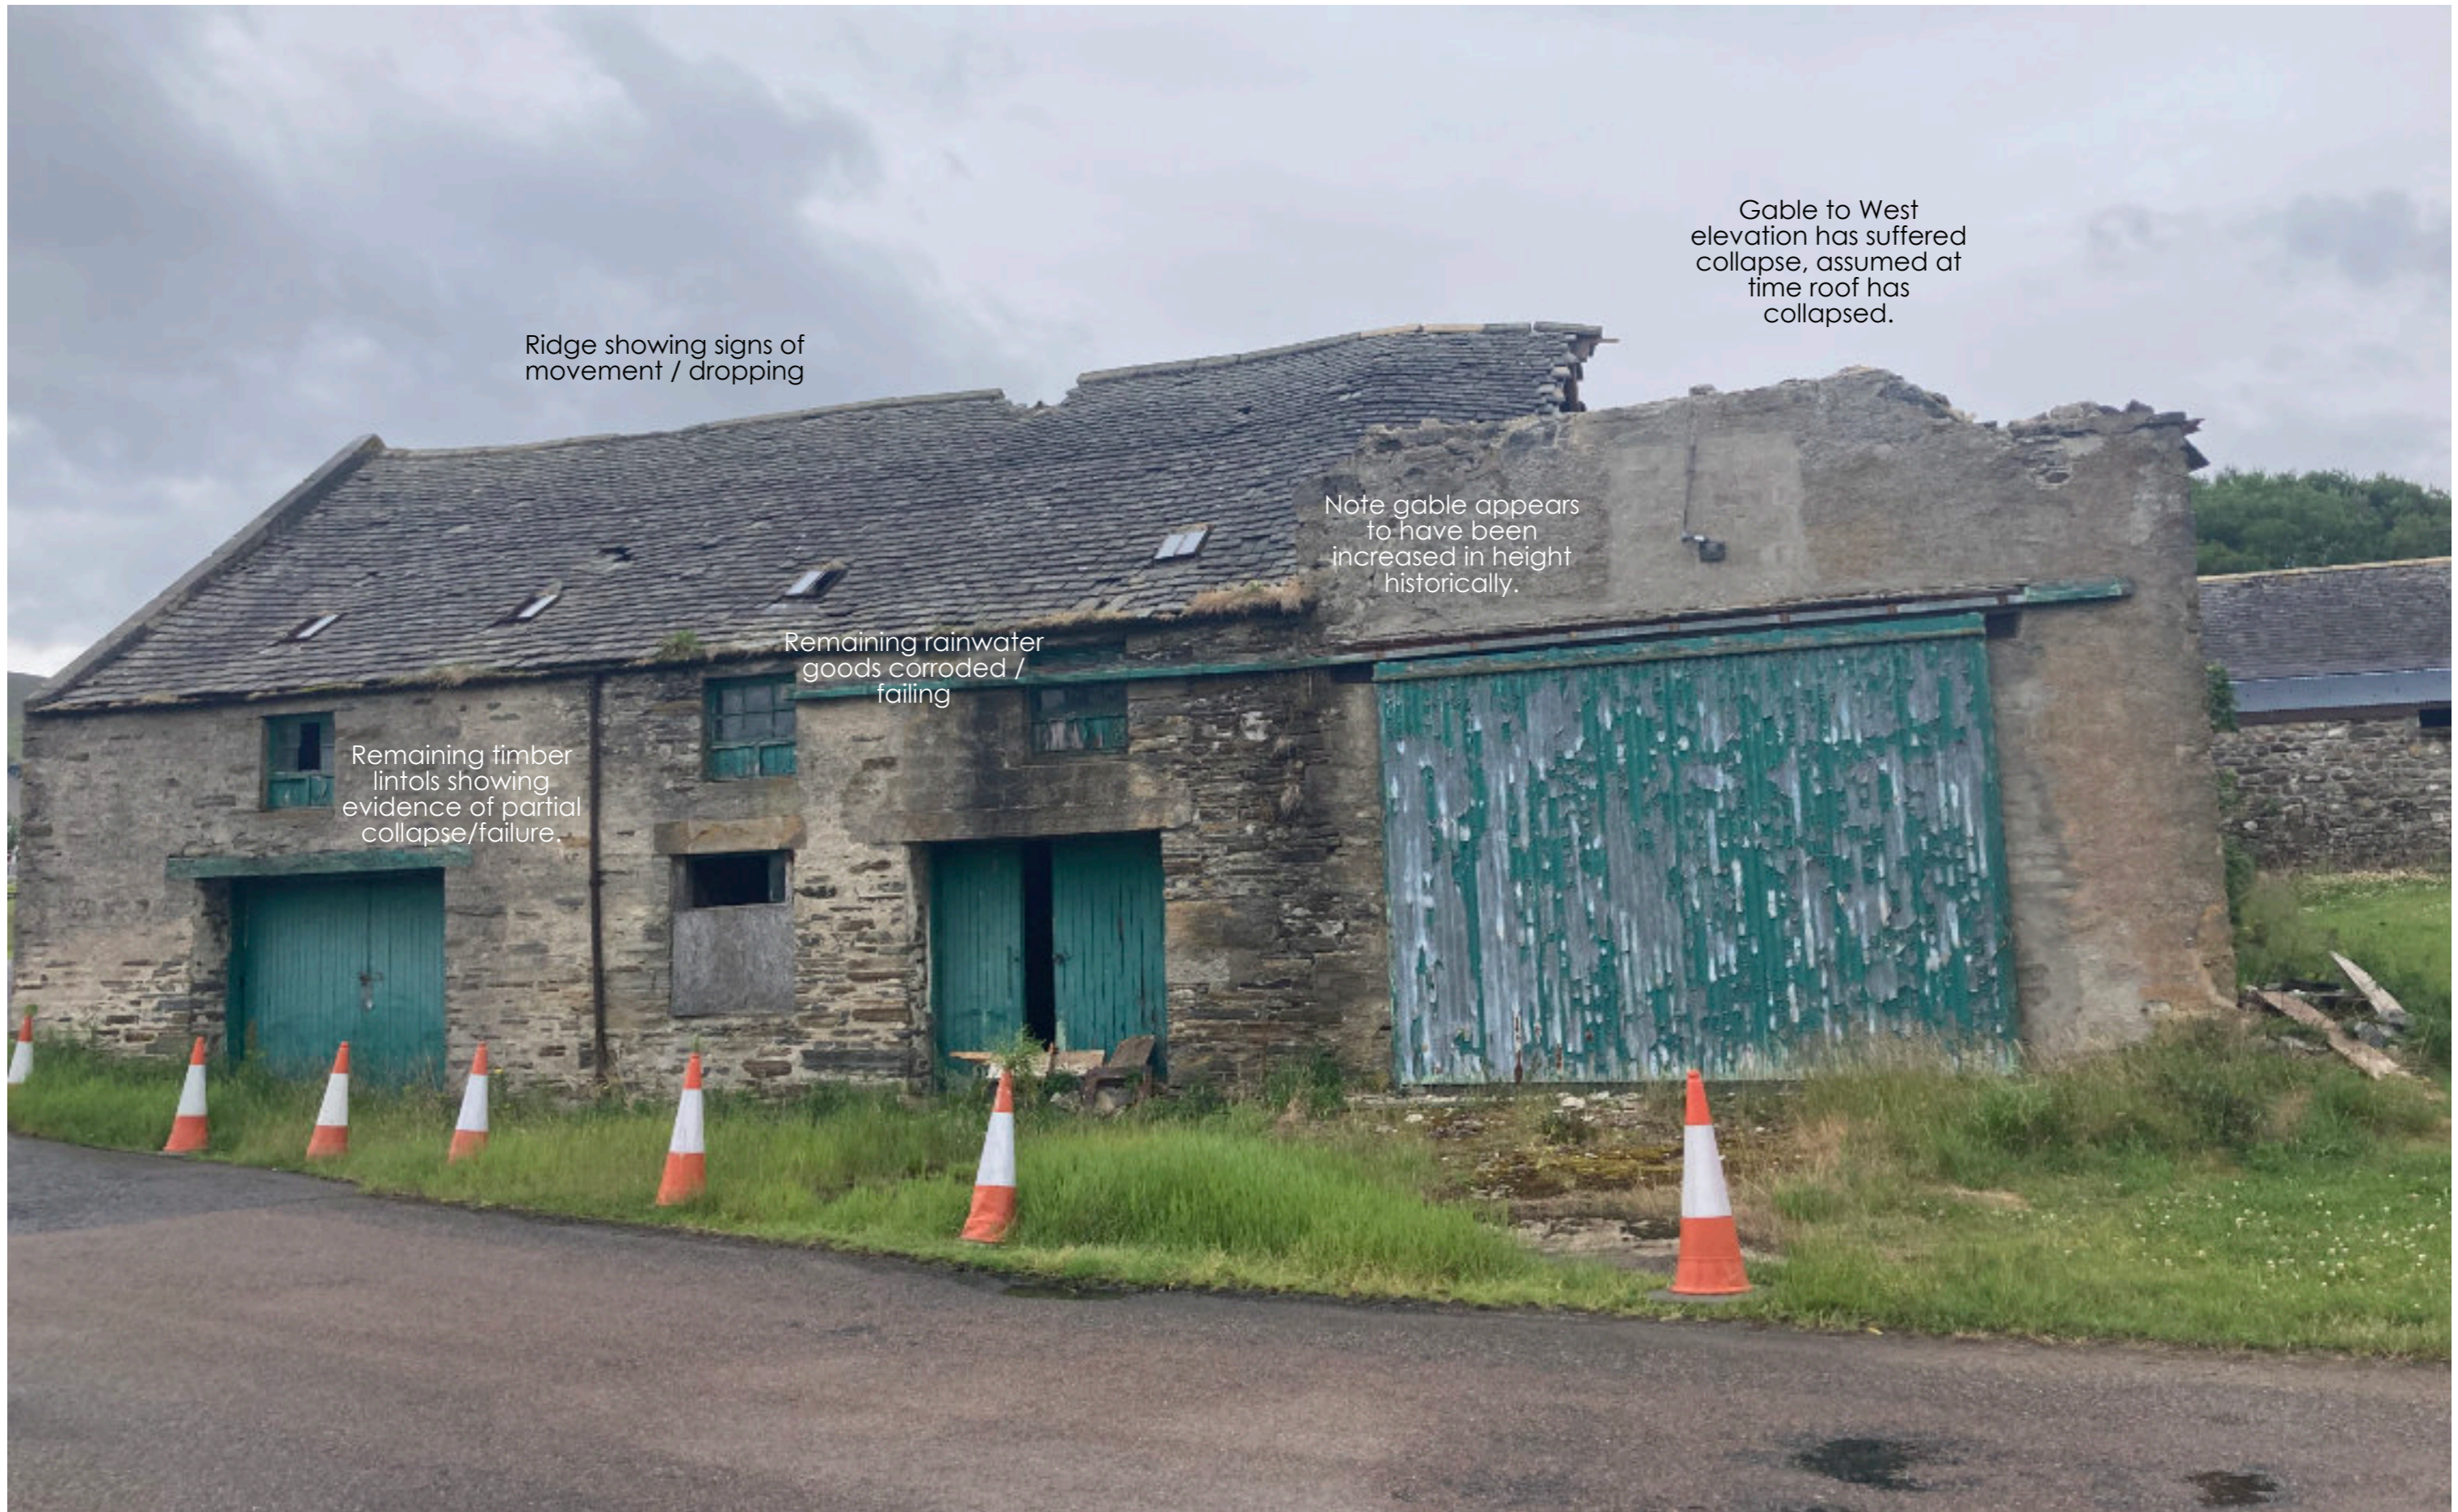
Existing West Elevation - Annotated

Ridge showing signs of movement / dropping

Gable to West elevation has suffered collapse, assumed at time roof has collapsed.

Note gable appears to have been increased in height historically.

Remaining rainwater goods corroded / failing

Remaining timber lintols showing evidence of partial collapse/failure.

Initial priority is to remove what remains of the existing roof structure and slating. As a section of the roof has suffered partial collapse and effectively 'filled' the interior of the lower section of the building with timber and rubble it is advised works to demolish the roof are undertaken externally only. It may be possible that the upper levels of the roof can be accessed by a scaffold/mobile platform where slates can be removed manually and retained for future use, the extent of this would require to be determined by a specialist contractor.

Once safely removing the roof it would be advised to remove the large door to the West Gable and carefully removing the remains of the lintol and gable above this opening. This would then provide a clear and safe access to the property to remove the debris from within the building, directly to the roadside for safe disposal.

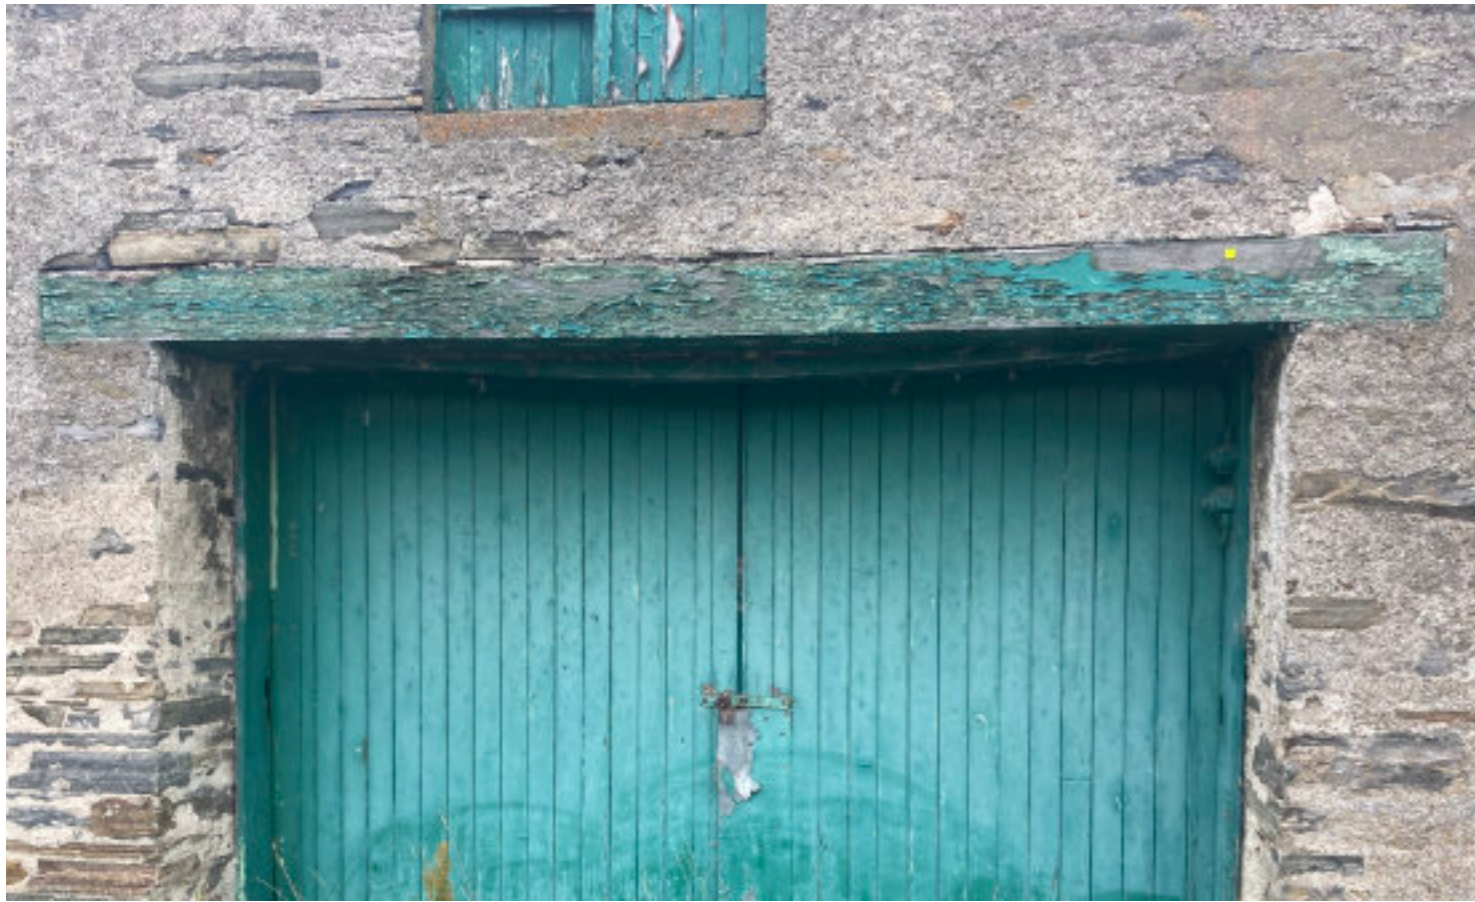
A number of the existing timber lintols have failed and are in varying levels of collapse.

Timber lintol to East elevation showing signs of failure. Internal lintols have completely failed.

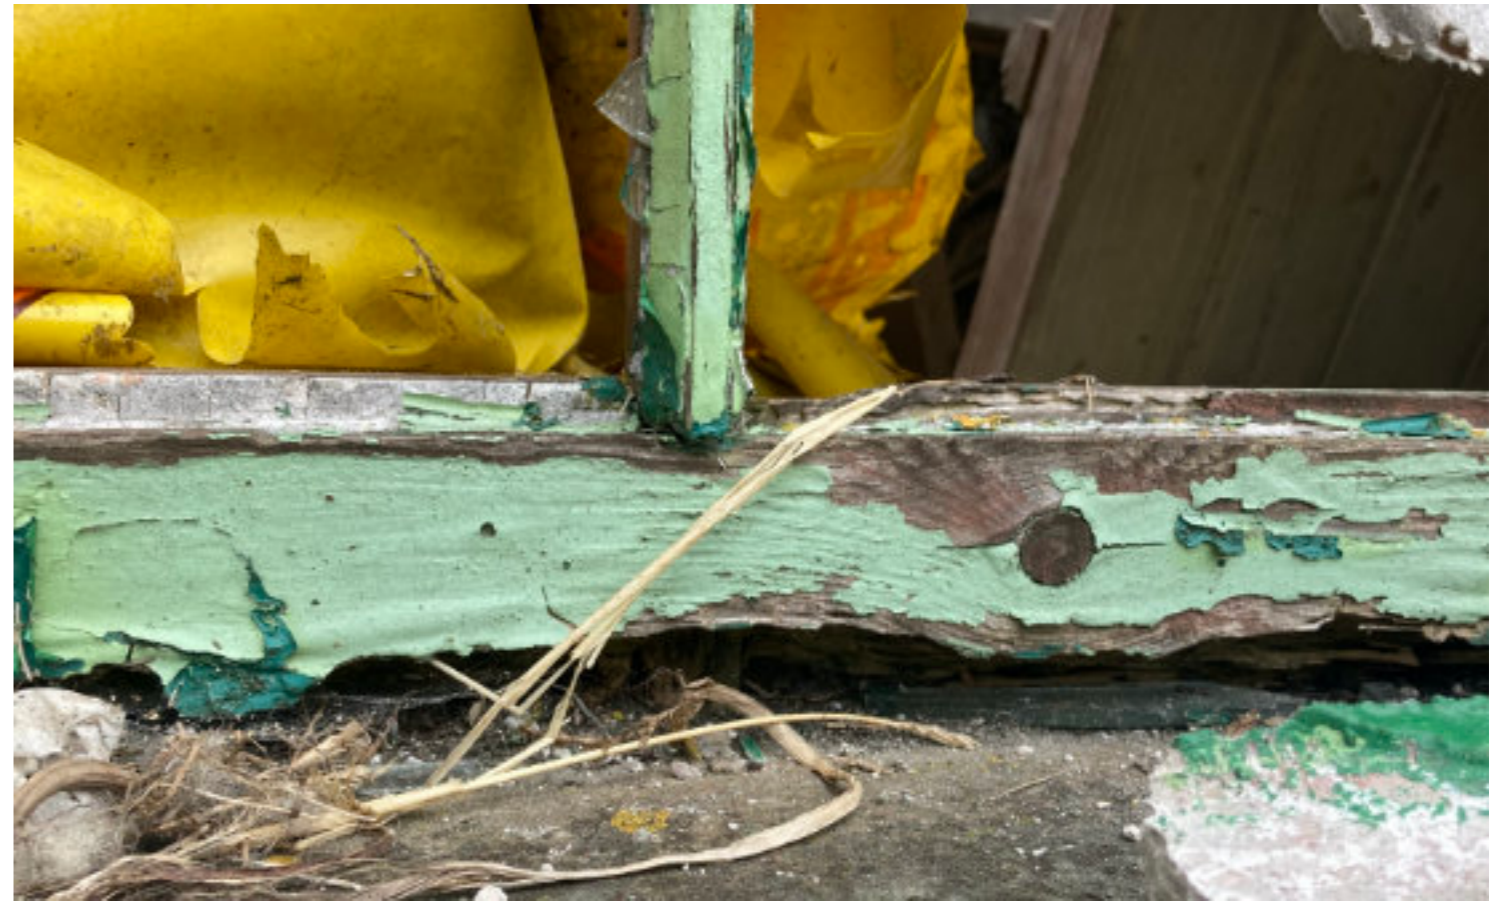
All windows and doors to the buildings appear to have been timber, with multiple panes of single glazing. There are a number of openings where windows have been removed completely and, in some instances, blocked up with concrete blockwork. The remaining timber windows have all suffered considerable damage and rot to their framing and cills and are in all cases considered beyond viable repair.

Timber framing to windows have widespread rot damage

All internal timber from the building should be removed and disposed, as the extent of woodworm and rot is significant and widespread and there would be limited value in attempting to retain any of these timbers. This applies also to the existing doors and windows.

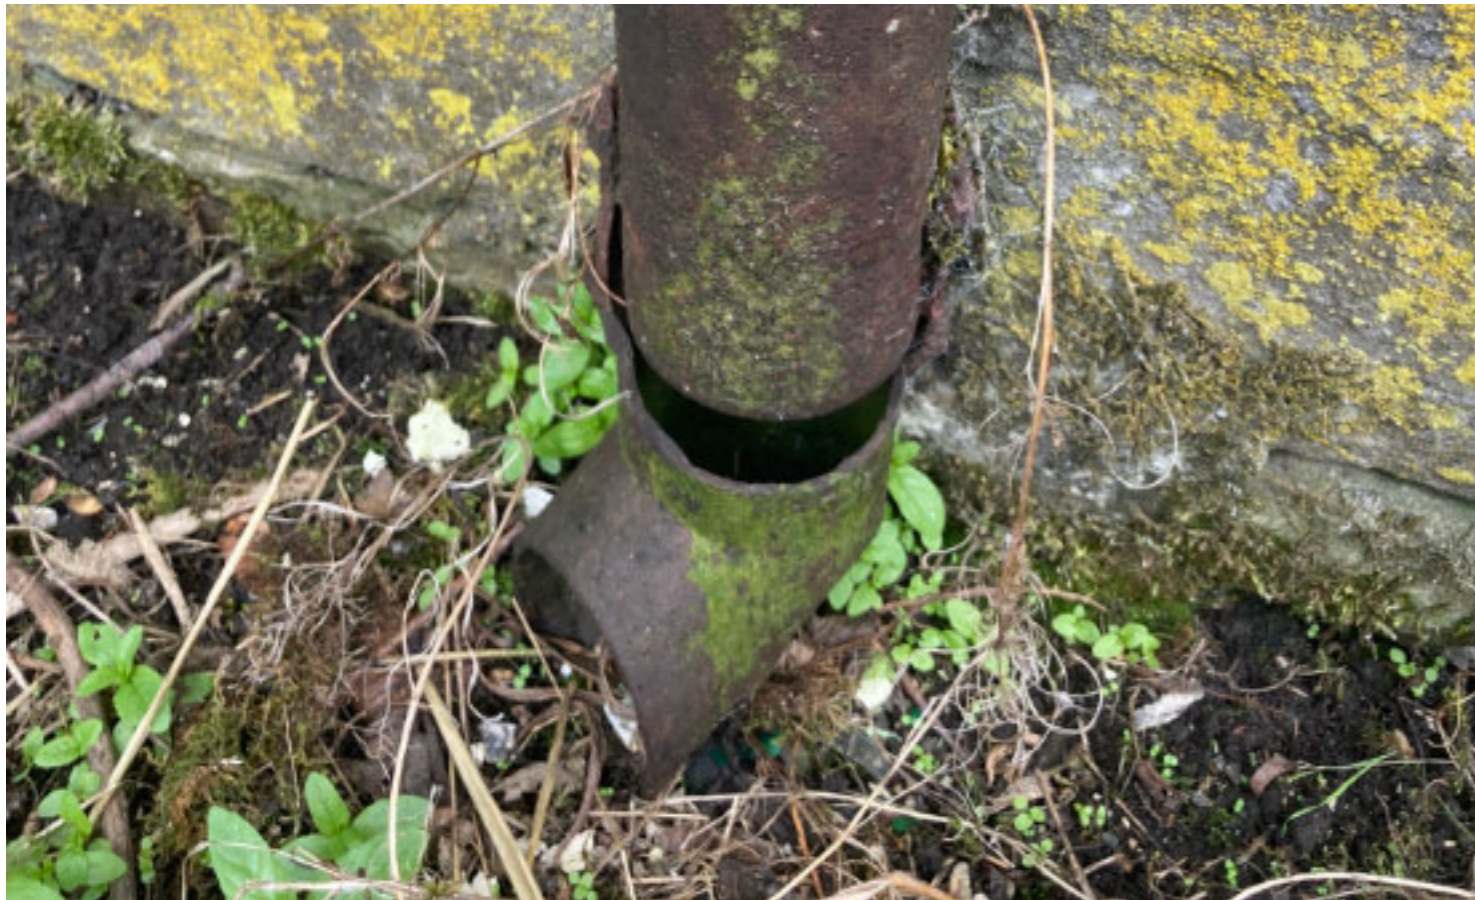
All buildings appear to have had cast iron rainwater goods, the majority of which have fallen from the building or been removed completely.

Existing cast iron rainwater goods appear to have corroded beyond repair

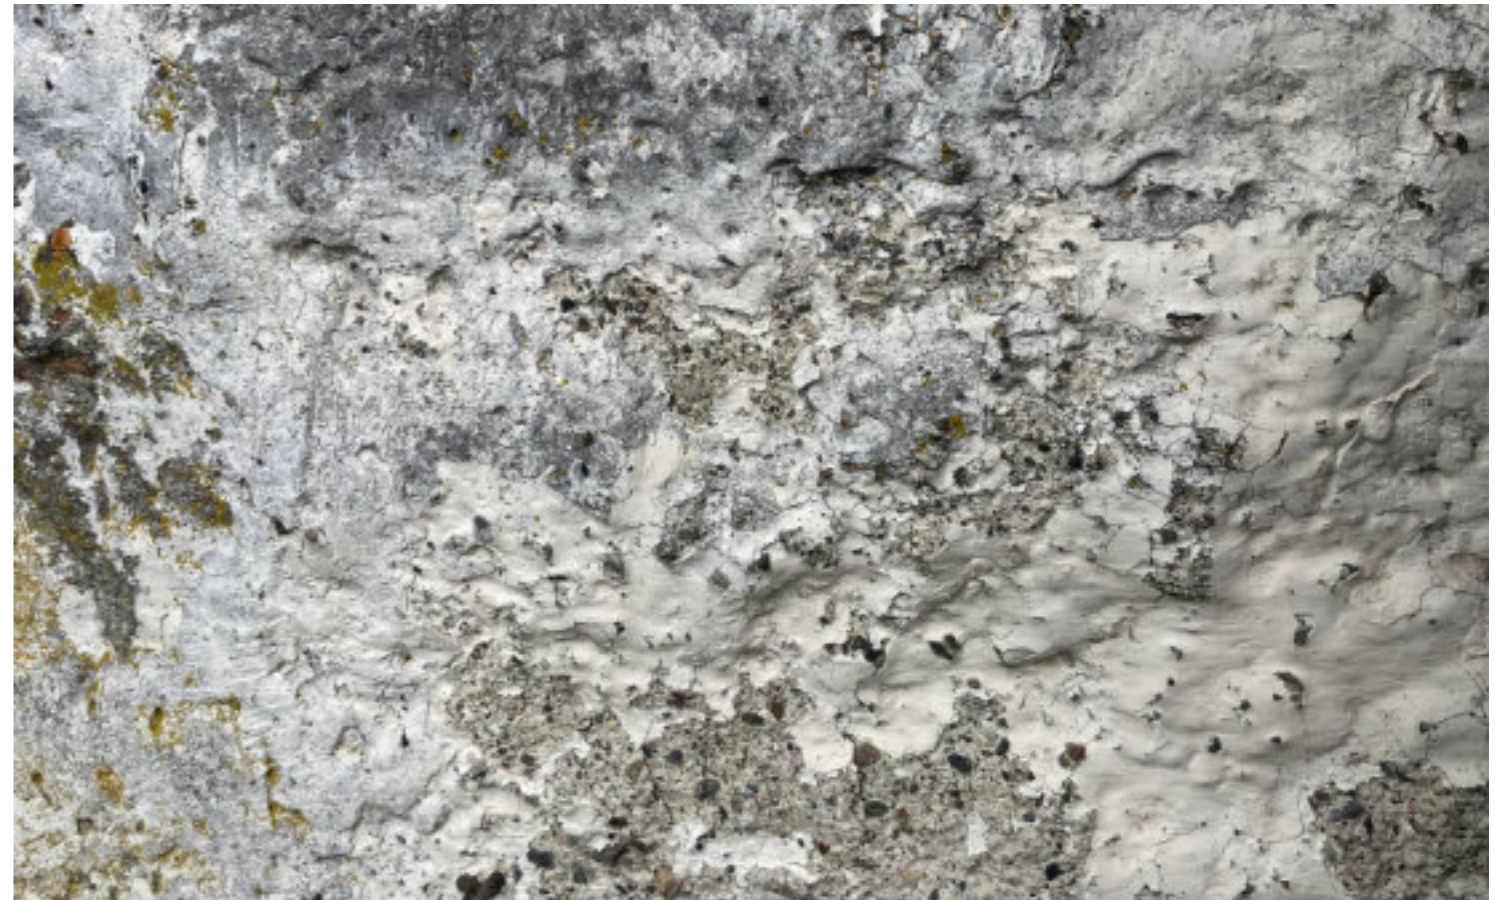
External elevation appears to have been lime rendered/limewashed historically

Assuming these walls are suitable to be retained they should be picked of any loose mortar and render and prepared for repointing with a hydraulic lime-based mortar.

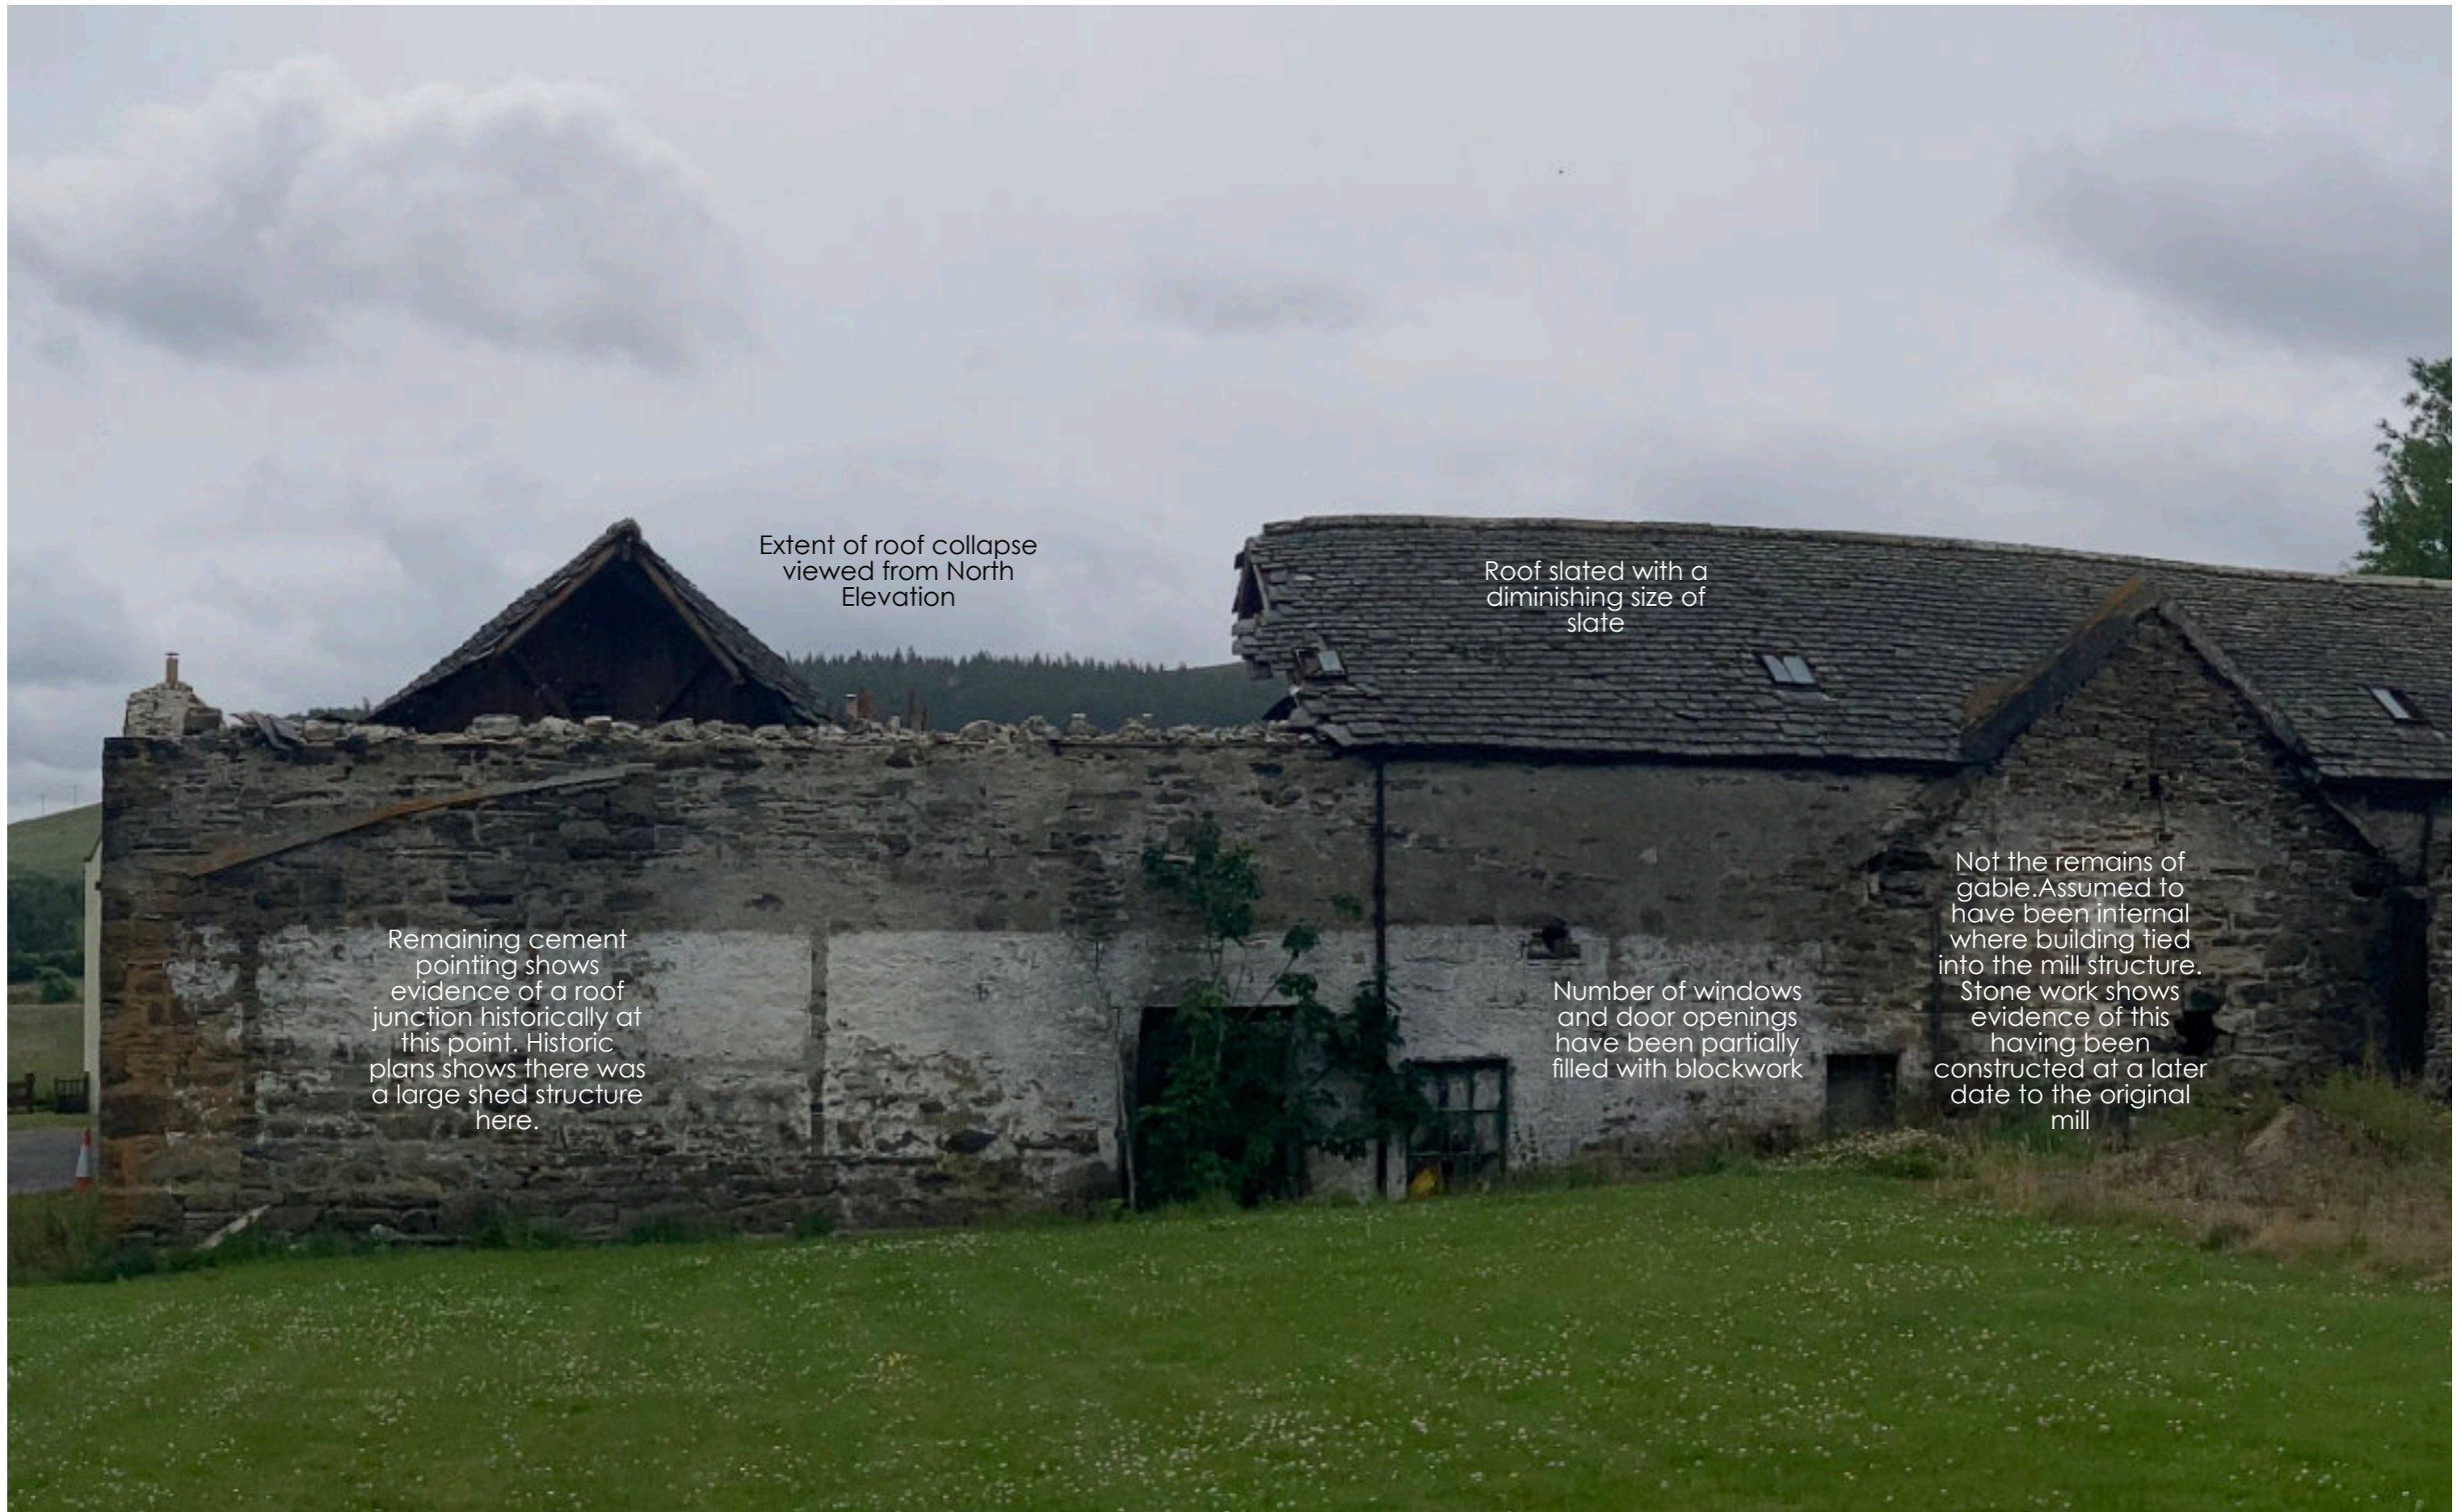
Existing North Elevation - Annotated

Extent of roof collapse  
viewed from North  
Elevation

Roof slated with a  
diminishing size of  
slate

Remaining cement  
pointing shows  
evidence of a roof  
junction historically at  
this point. Historic  
plans shows there was  
a large shed structure  
here.

Number of windows  
and door openings  
have been partially  
filled with blockwork

Not the remains of  
gable. Assumed to  
have been internal  
where building tied  
into the mill structure.  
Stone work shows  
evidence of this  
having been  
constructed at a later  
date to the original  
mill

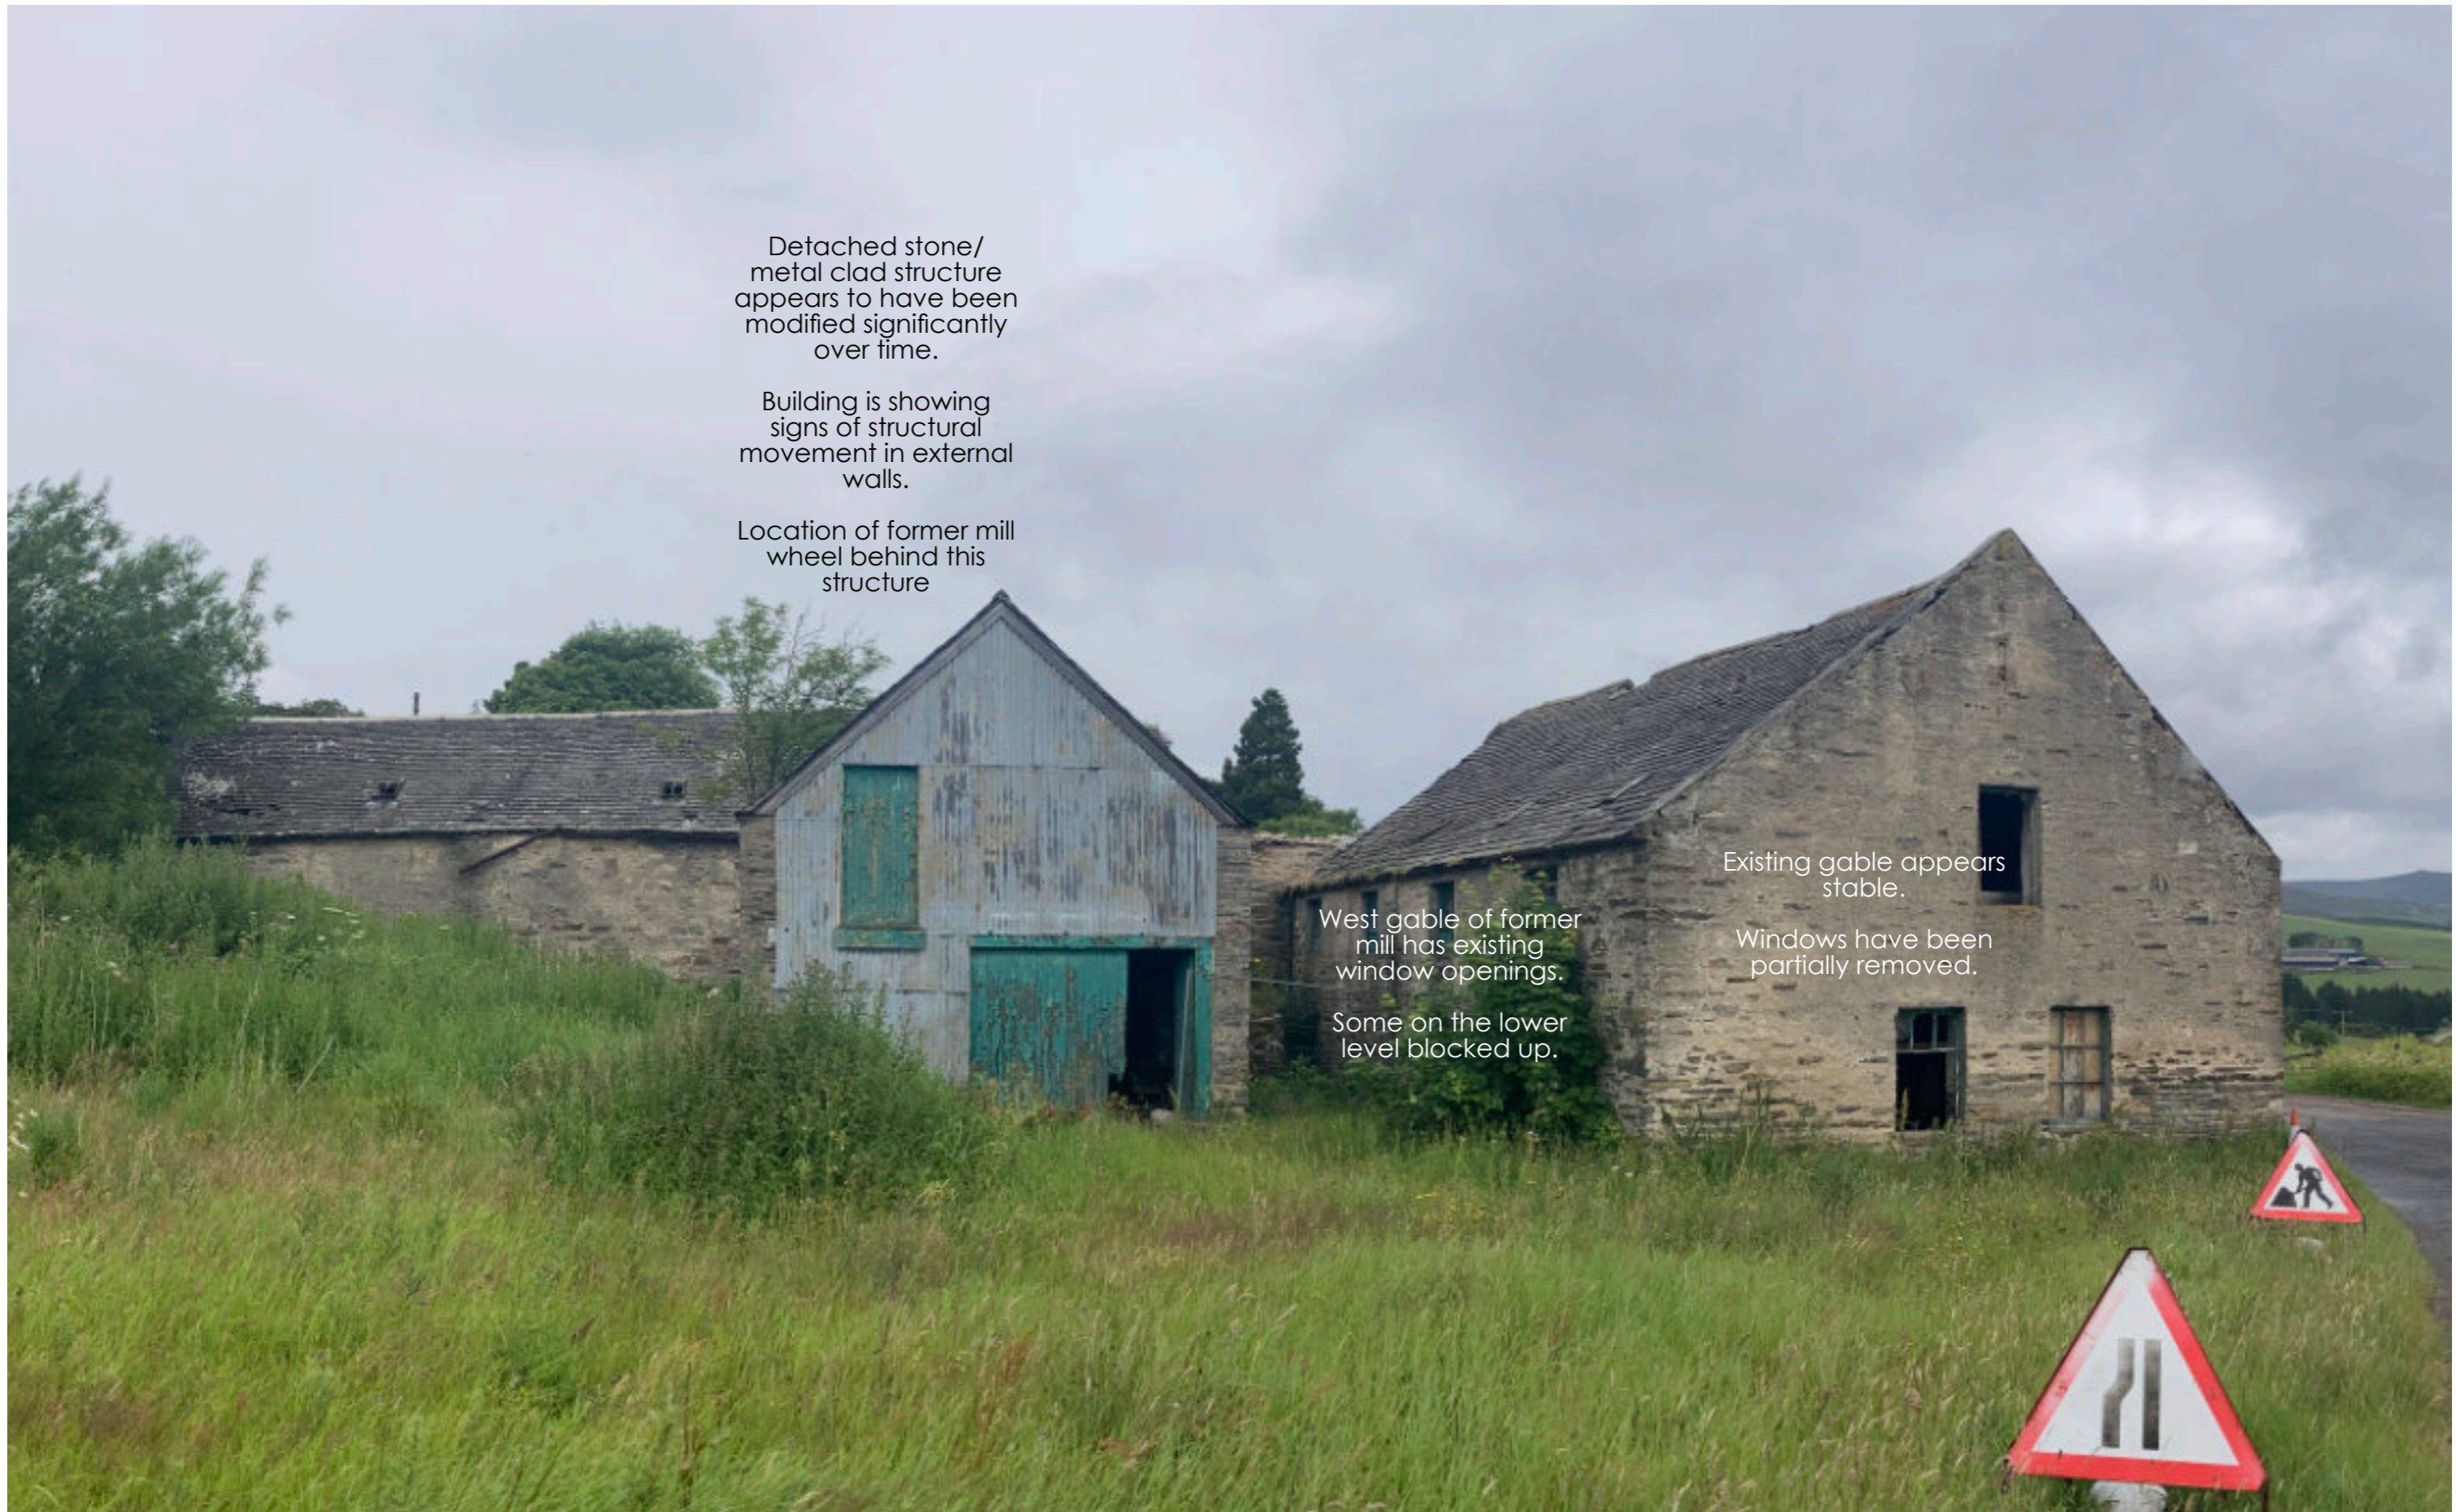
Existing South Elevation - Annotated

Detached stone/  
metal clad structure  
appears to have been  
modified significantly  
over time.

Building is showing  
signs of structural  
movement in external  
walls.

Location of former mill  
wheel behind this  
structure

West gable of former  
mill has existing  
window openings.

Some on the lower  
level blocked up.

Existing gable appears  
stable.

Windows have been  
partially removed.

The freestanding structure to the South of the building has signs of significant cracking and movement, which would require this building to be at least partially demolished to ensure it remains safe.

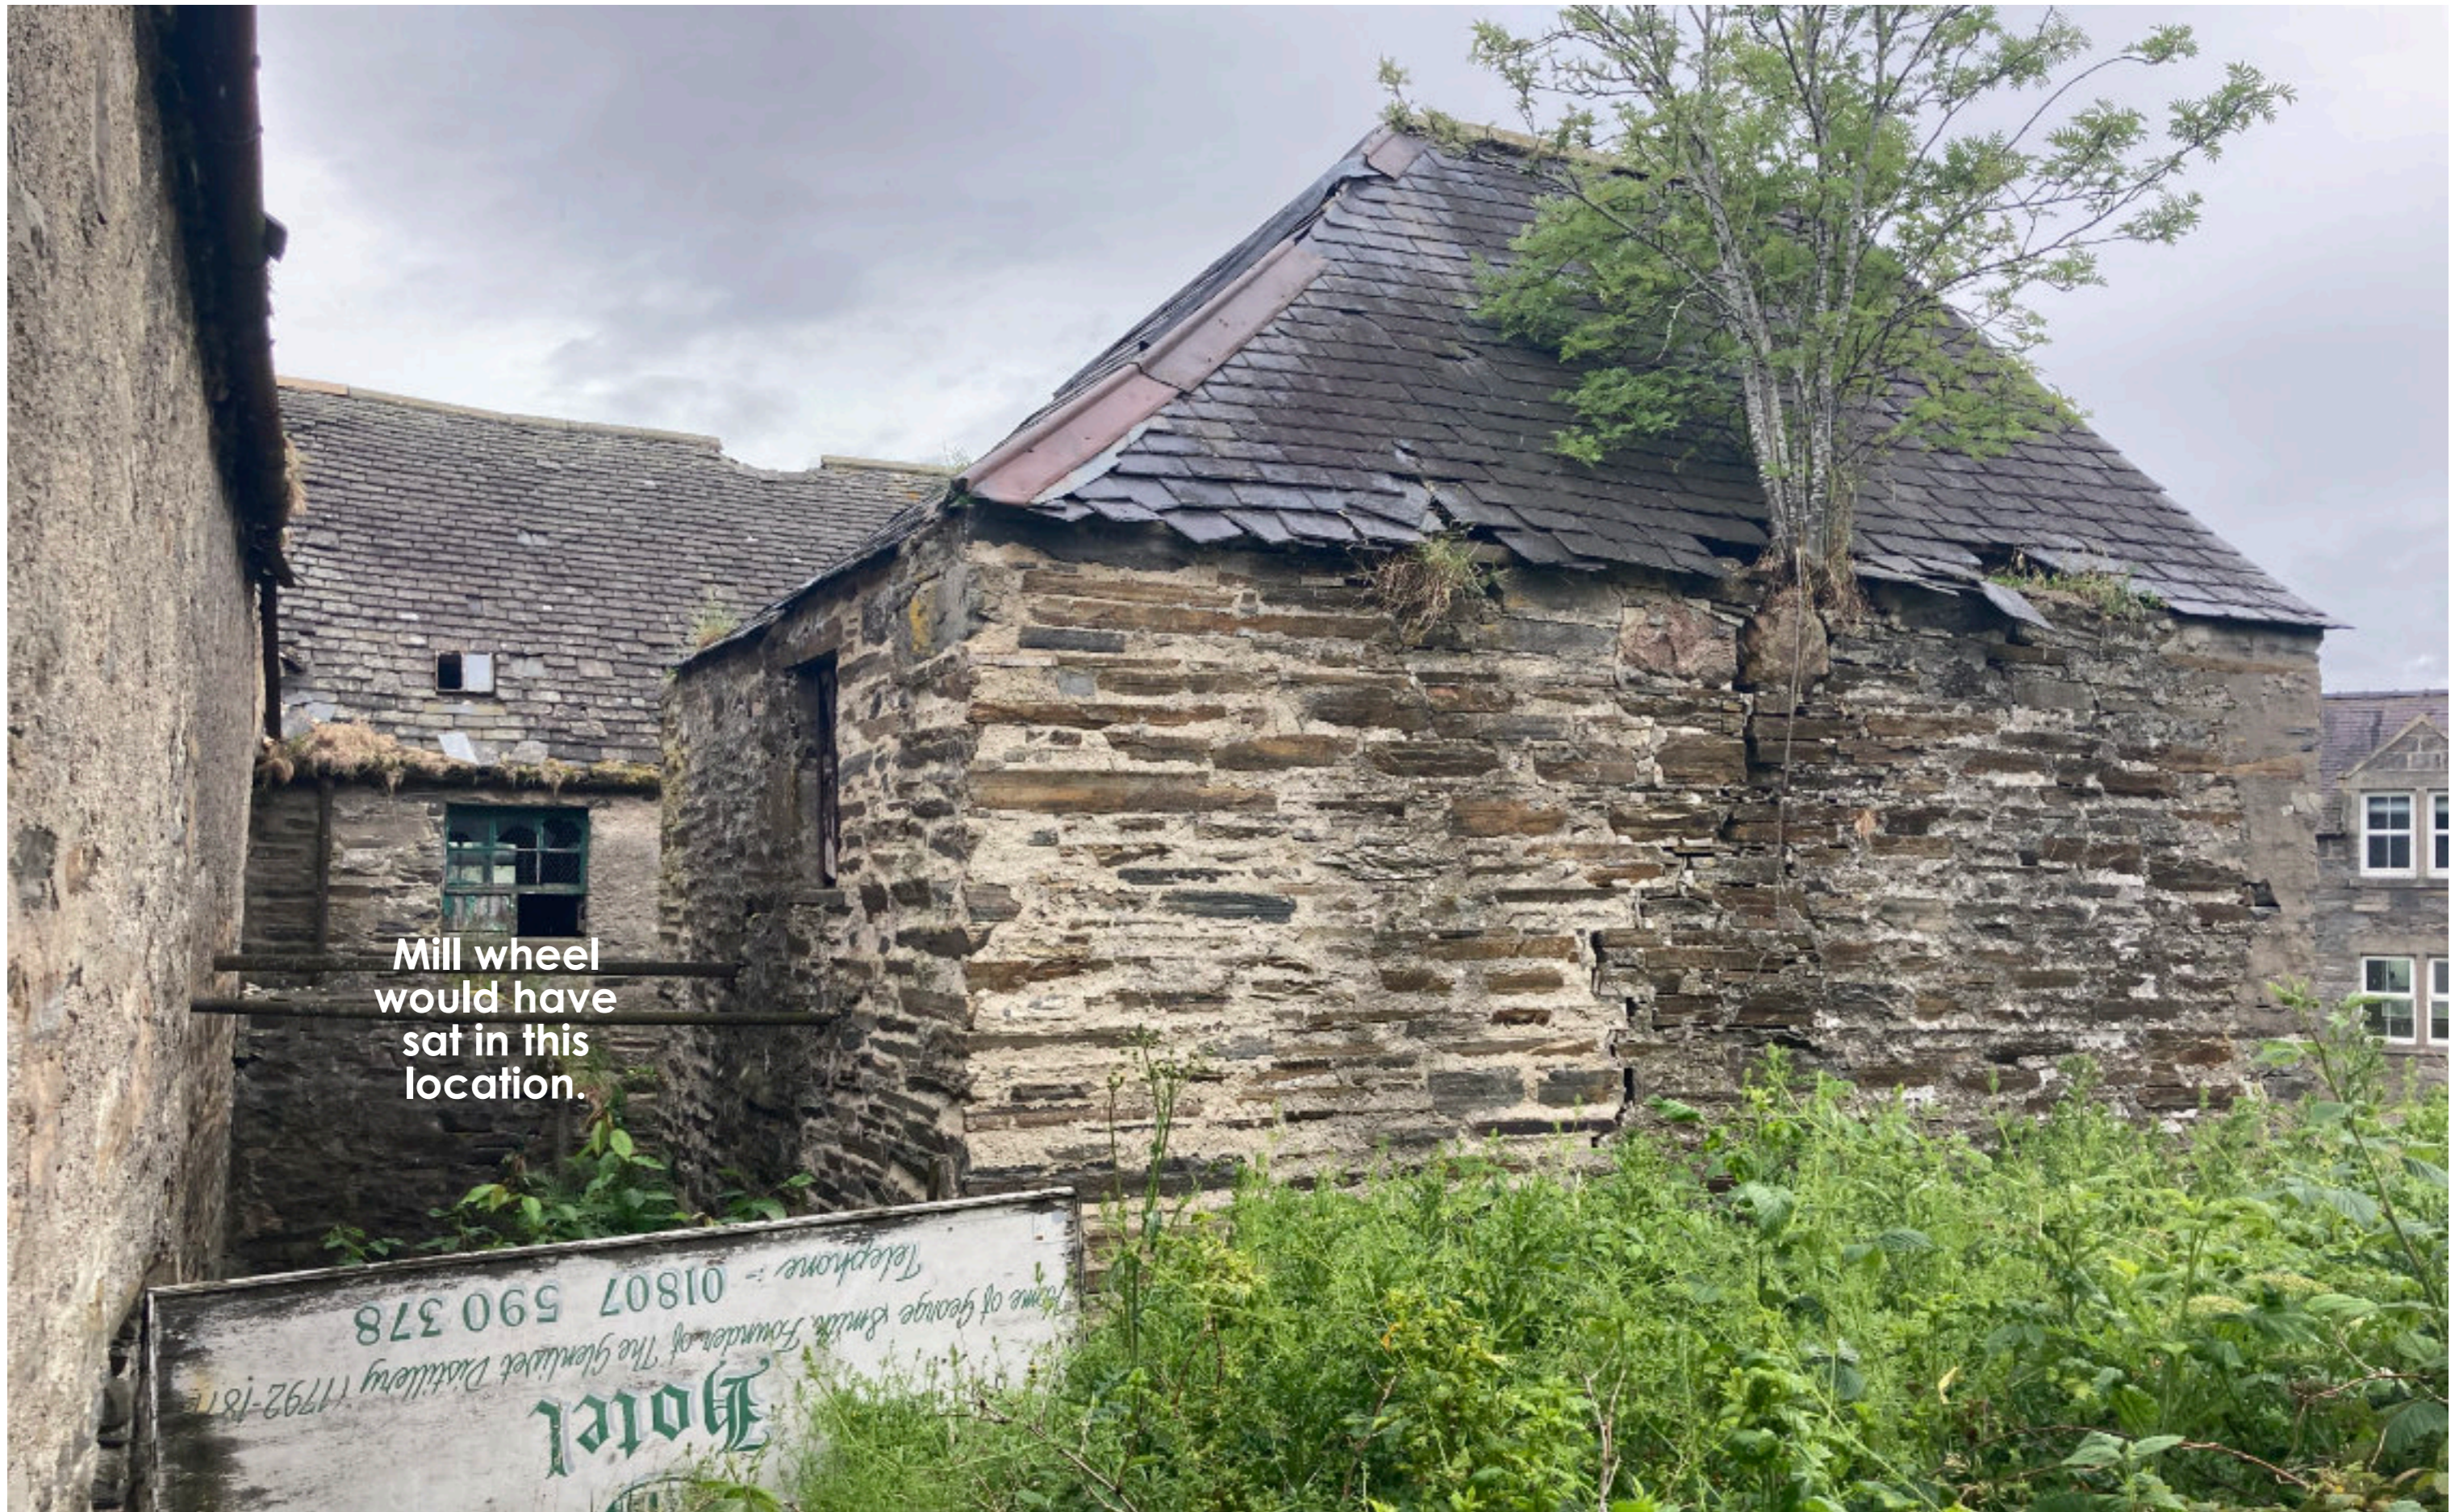
Mill wheel  
would have  
sat in this  
location.

Area between mill and detached structure. - West Elevations - Note level of damage to external wall at right hand of image
