Minmore Mill, Minmore House, Glenlivet, Ballindalloch, AB37 9DB  
CONDITION REPORT  
JULY 2022

The purpose of this report is to record the existing condition of the former Mil building on the site, with the intention of informing the buildings future use and restoration.

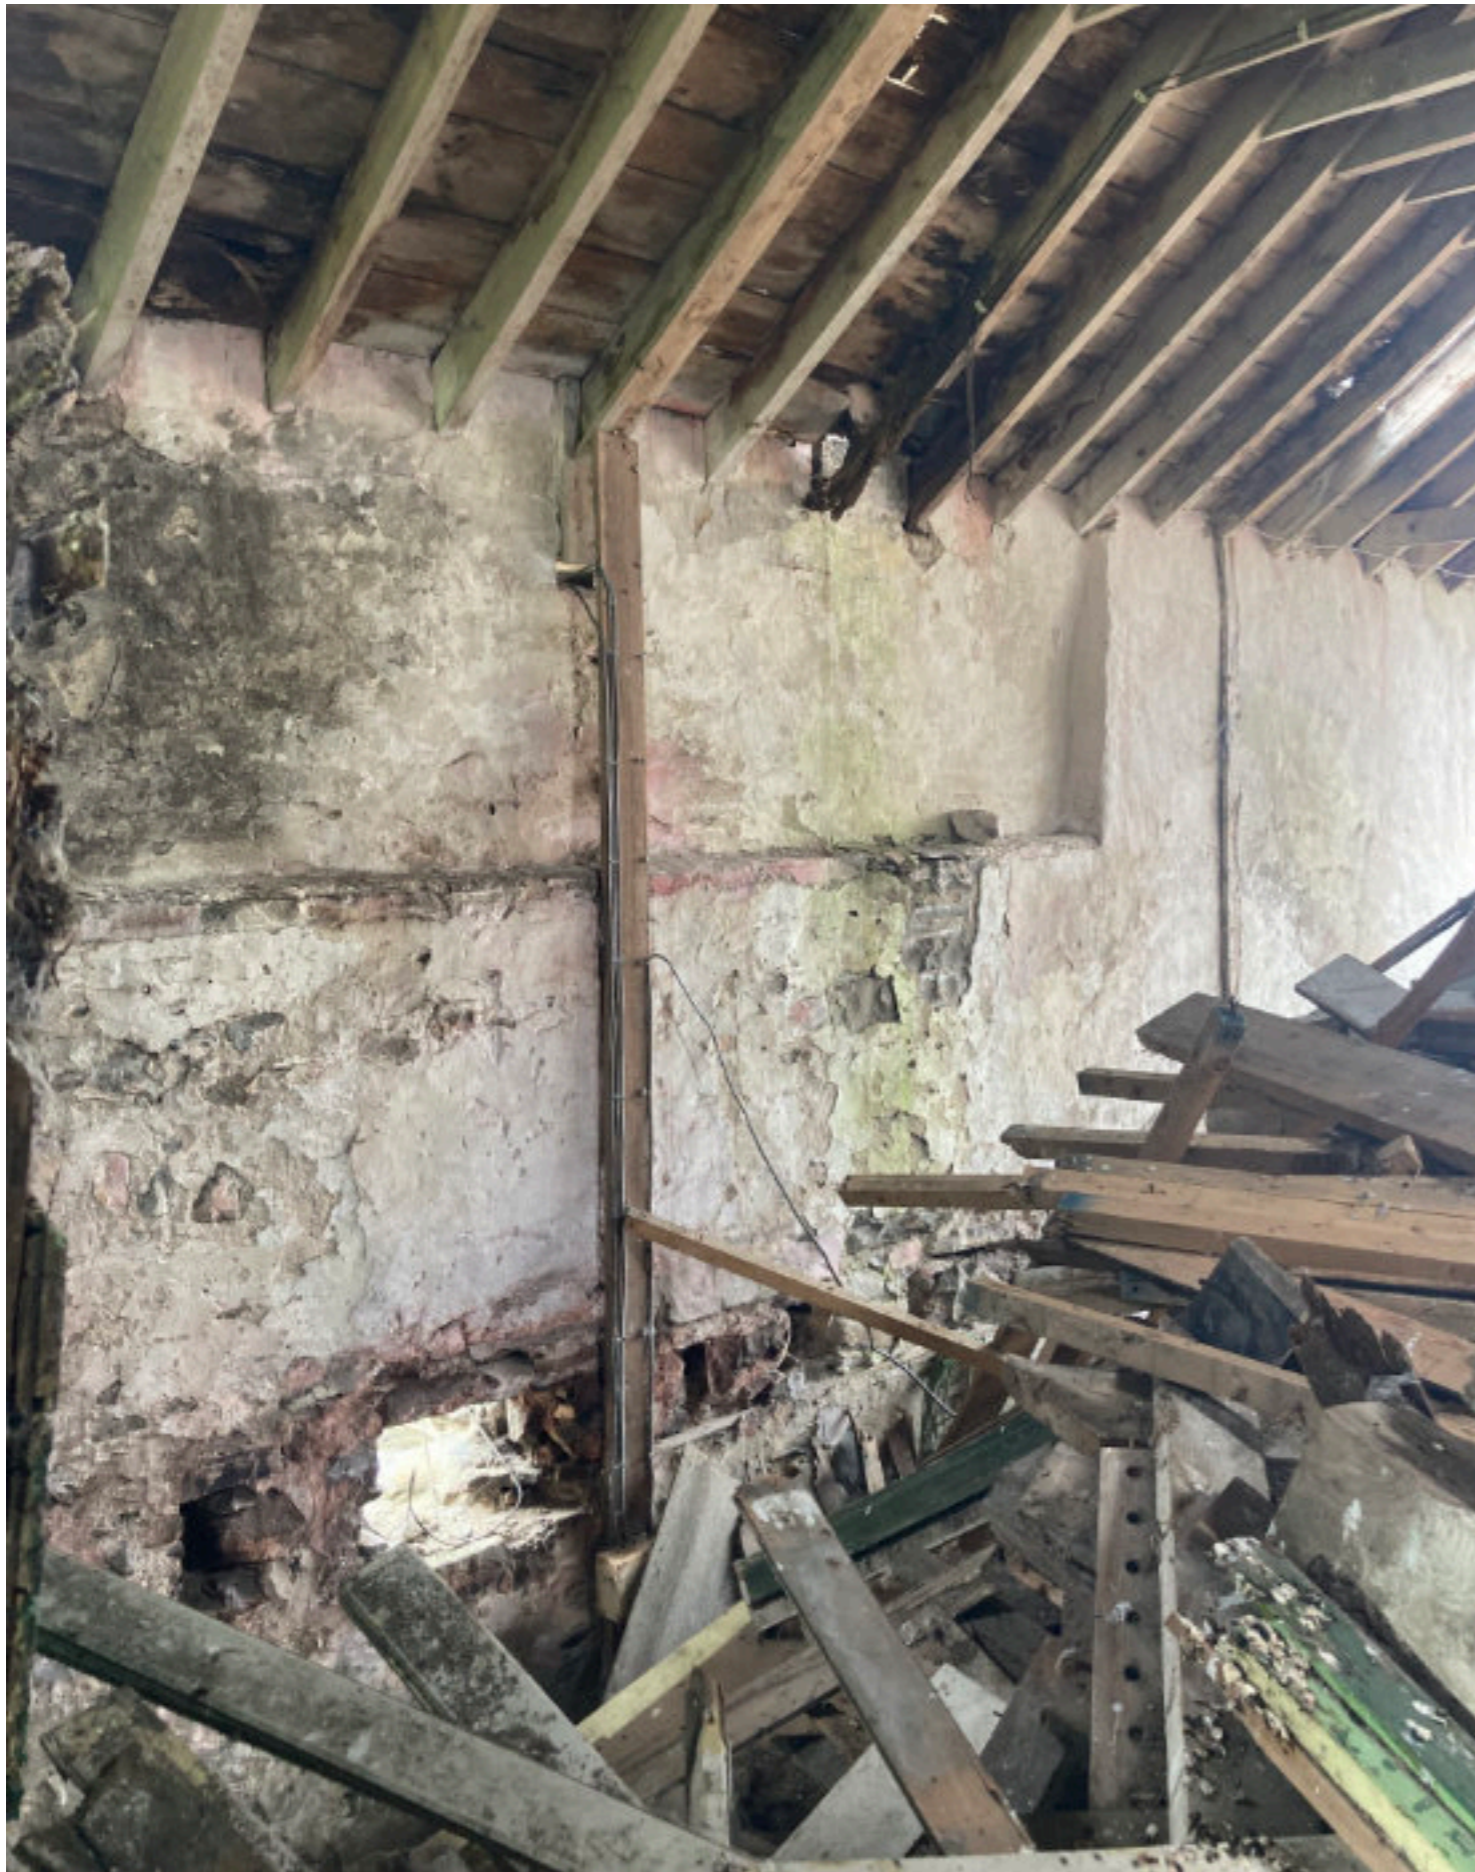
Evidence of external wall adjustment - this relates to exposed gable on North elevation

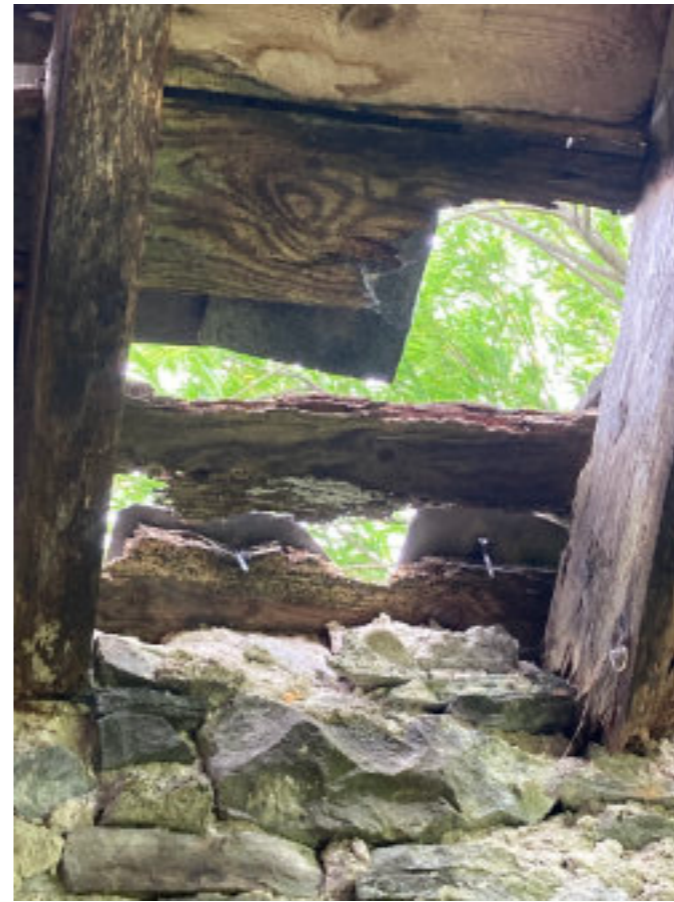
In both instances the slates have been laid on sarking boards, supported by timber raised tie truss. Both truss and sarking have evidence of significant wood worm damage throughout and would be considered beyond repair or retention.

Condition of sarking/existing timbers to remaining roof.

All internal timber from the building should be removed and disposed, as the extent of woodworm and rot is significant and widespread and there would be limited value in attempting to retain any of these timbers. This applies also to the existing doors and windows.

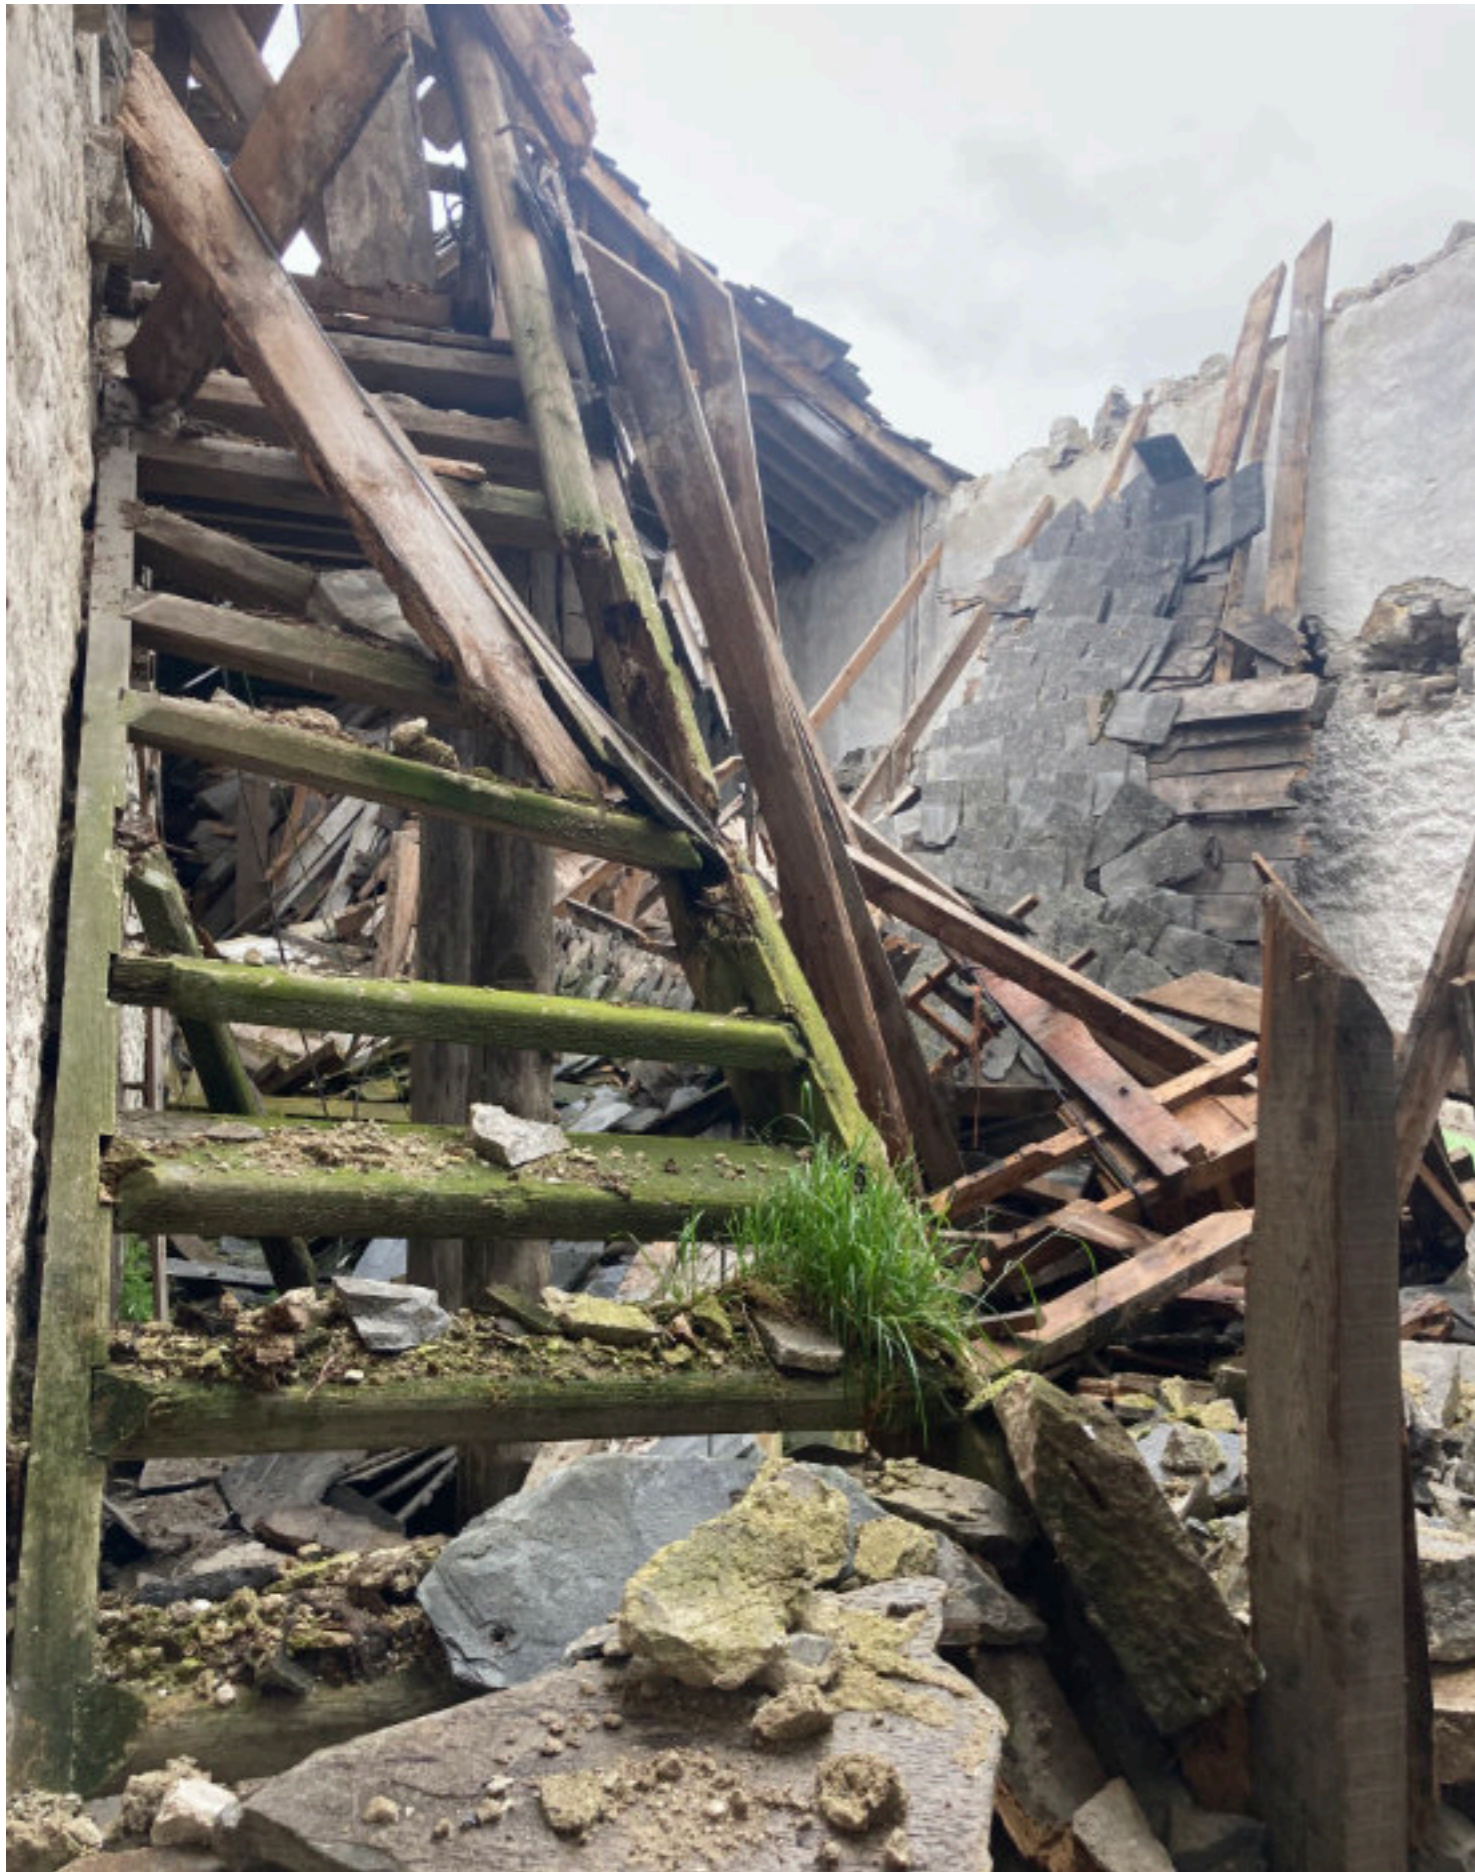
It appears that at some point historically the first-floor joists have been cut and removed to the original mill building, assumed to have been undertaken by a previous farmer owner to get larger vehicles into the building. It may be the case that this removal of structure resulted in the subsequent partial collapse of the roof and gable.

Interior of area where roof has collapsed - note all timbers beyond retention

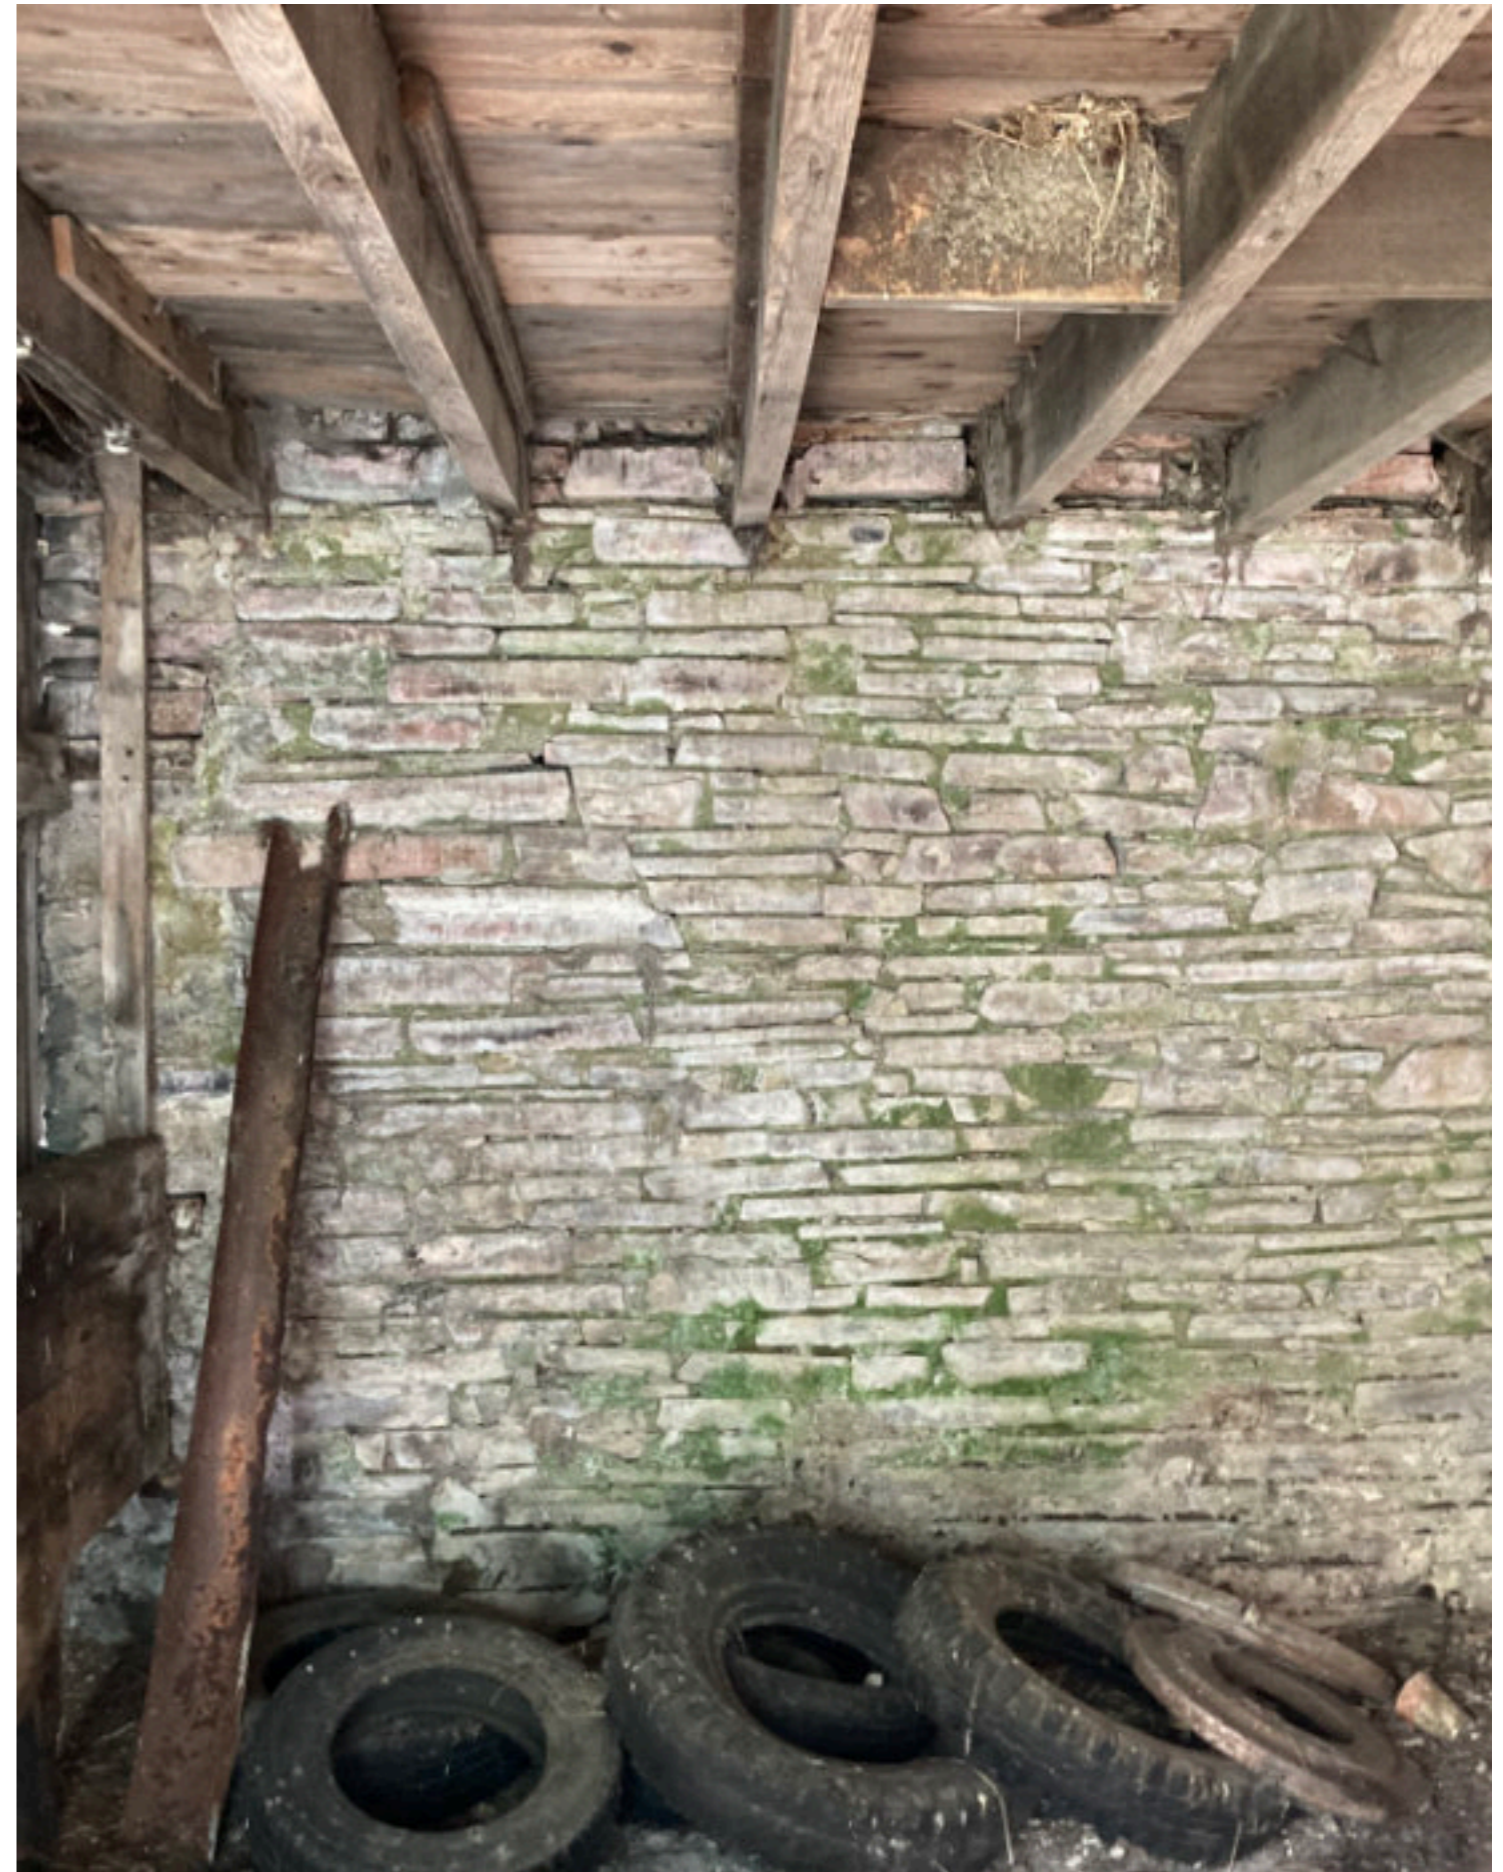
Ground floor accessed at South elevation. Note stone appears to have been exposed
