## Heritage Statement – 26-27 High Street, Lymington, SO41 9AF

Deborah Slade MA(Oxon) MSt(Cantab) MSc MRTPI  
Draycott Chartered Surveyors  
January 2024

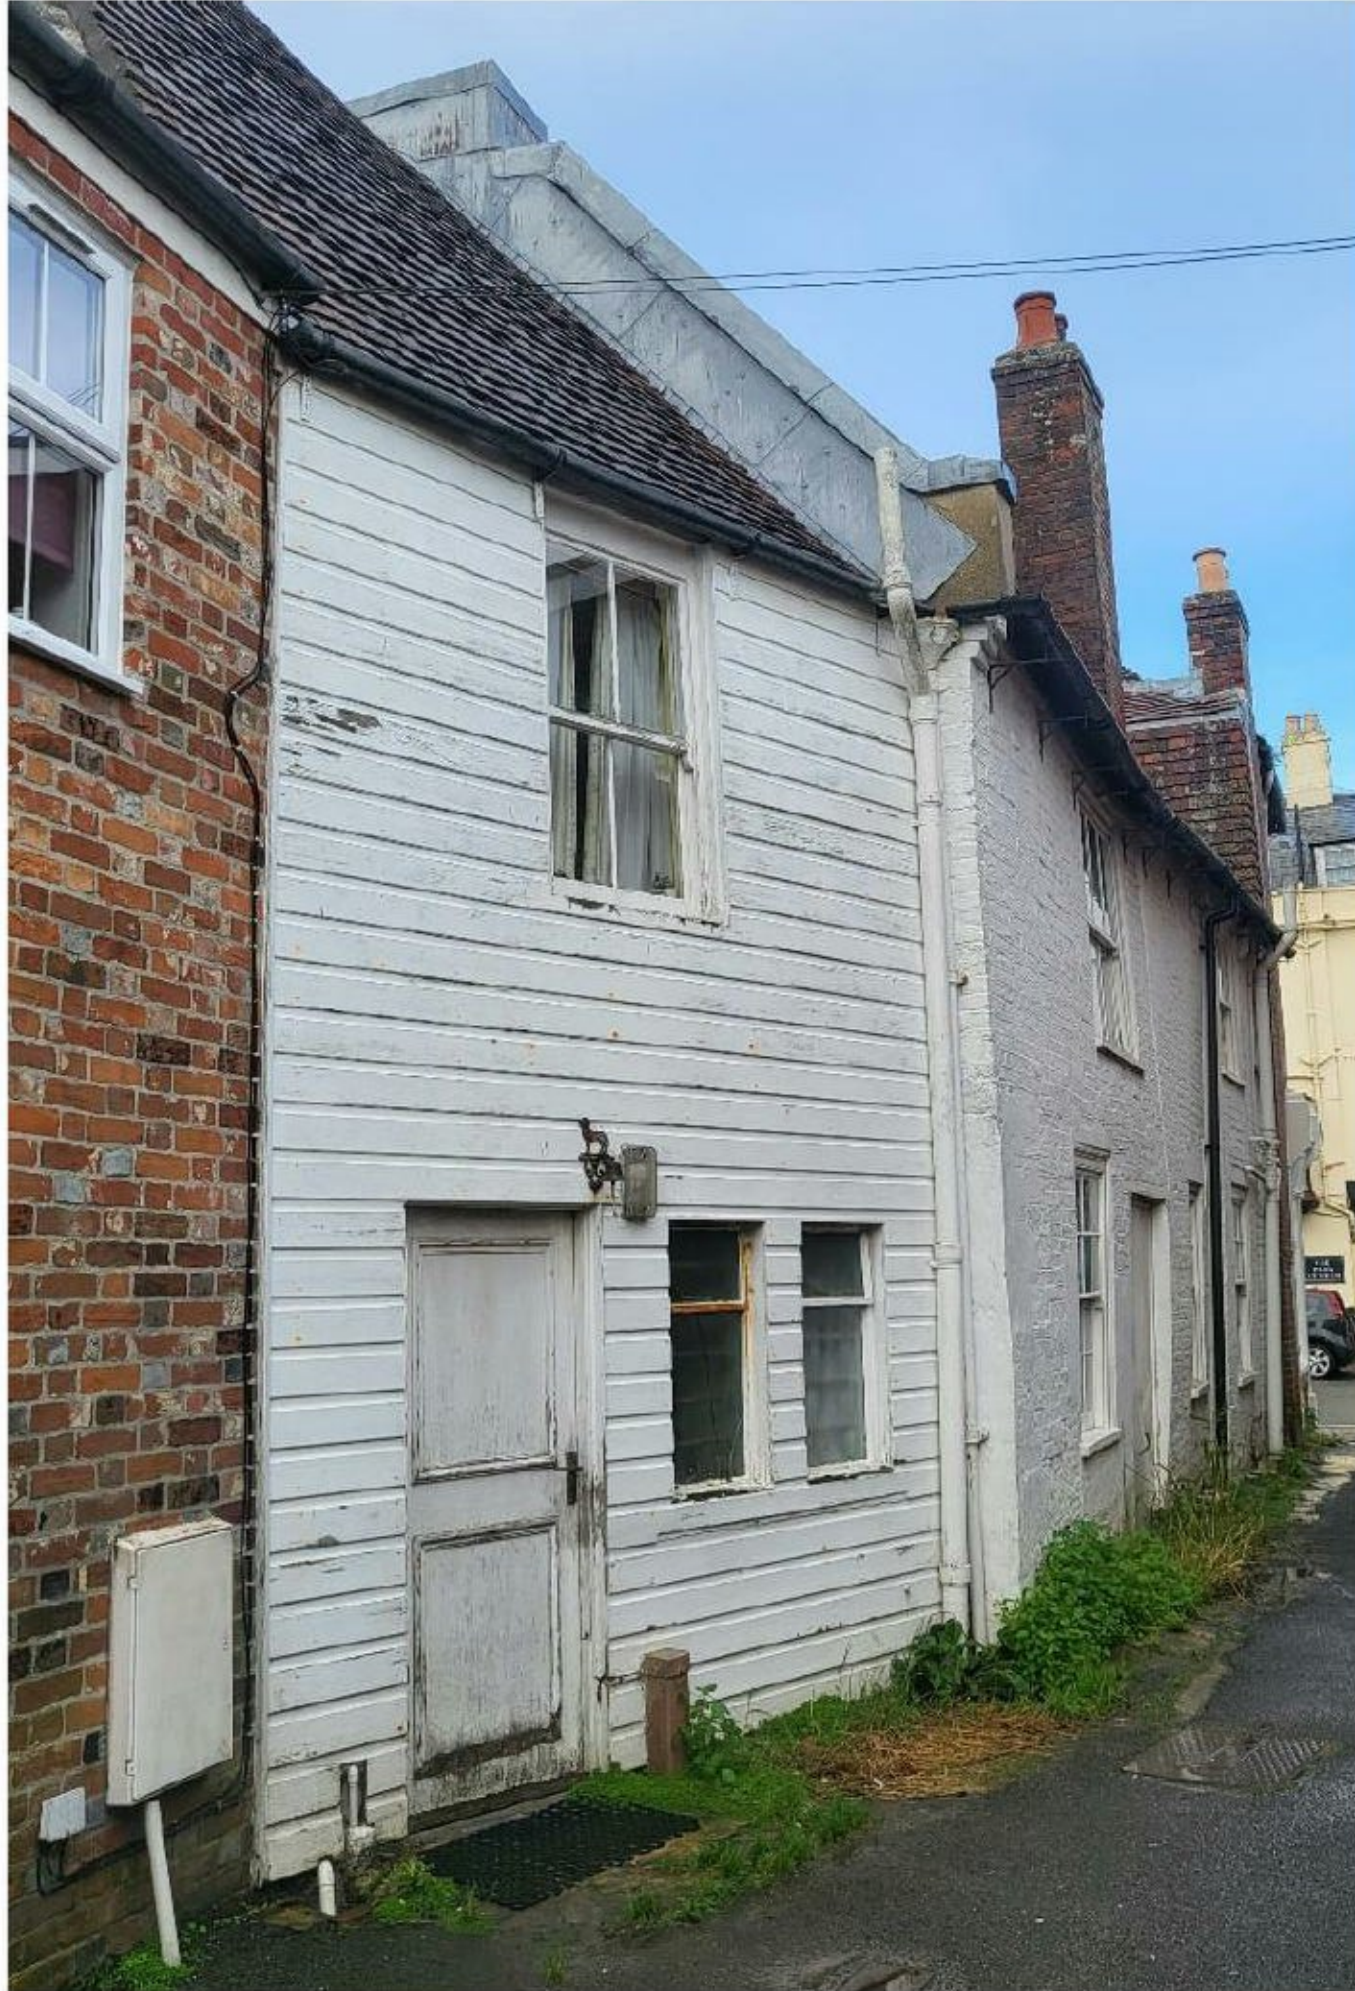
- The roof is leaking;
- The windows to the first floor corridor are leaking;
- The timber-clad element is in need of refurbishment and re-decoration;
- The back room is in need of repair and redecoration;
- The first floor curved window is leaking.
- The poorly- capped chimney is allowing water to travel down the brickwork and cause damp problems internally.

The lead-capped chimney and poor refurbishment of the timber-clad element

Around the chimney, a lead flashing will be provided to match the neighbouring properties. This will be more effective in keeping water out and will be of enhanced visual appearance than a cement fillet. It looks like the chimney has previously been re-built with a lead tray, as shown below.

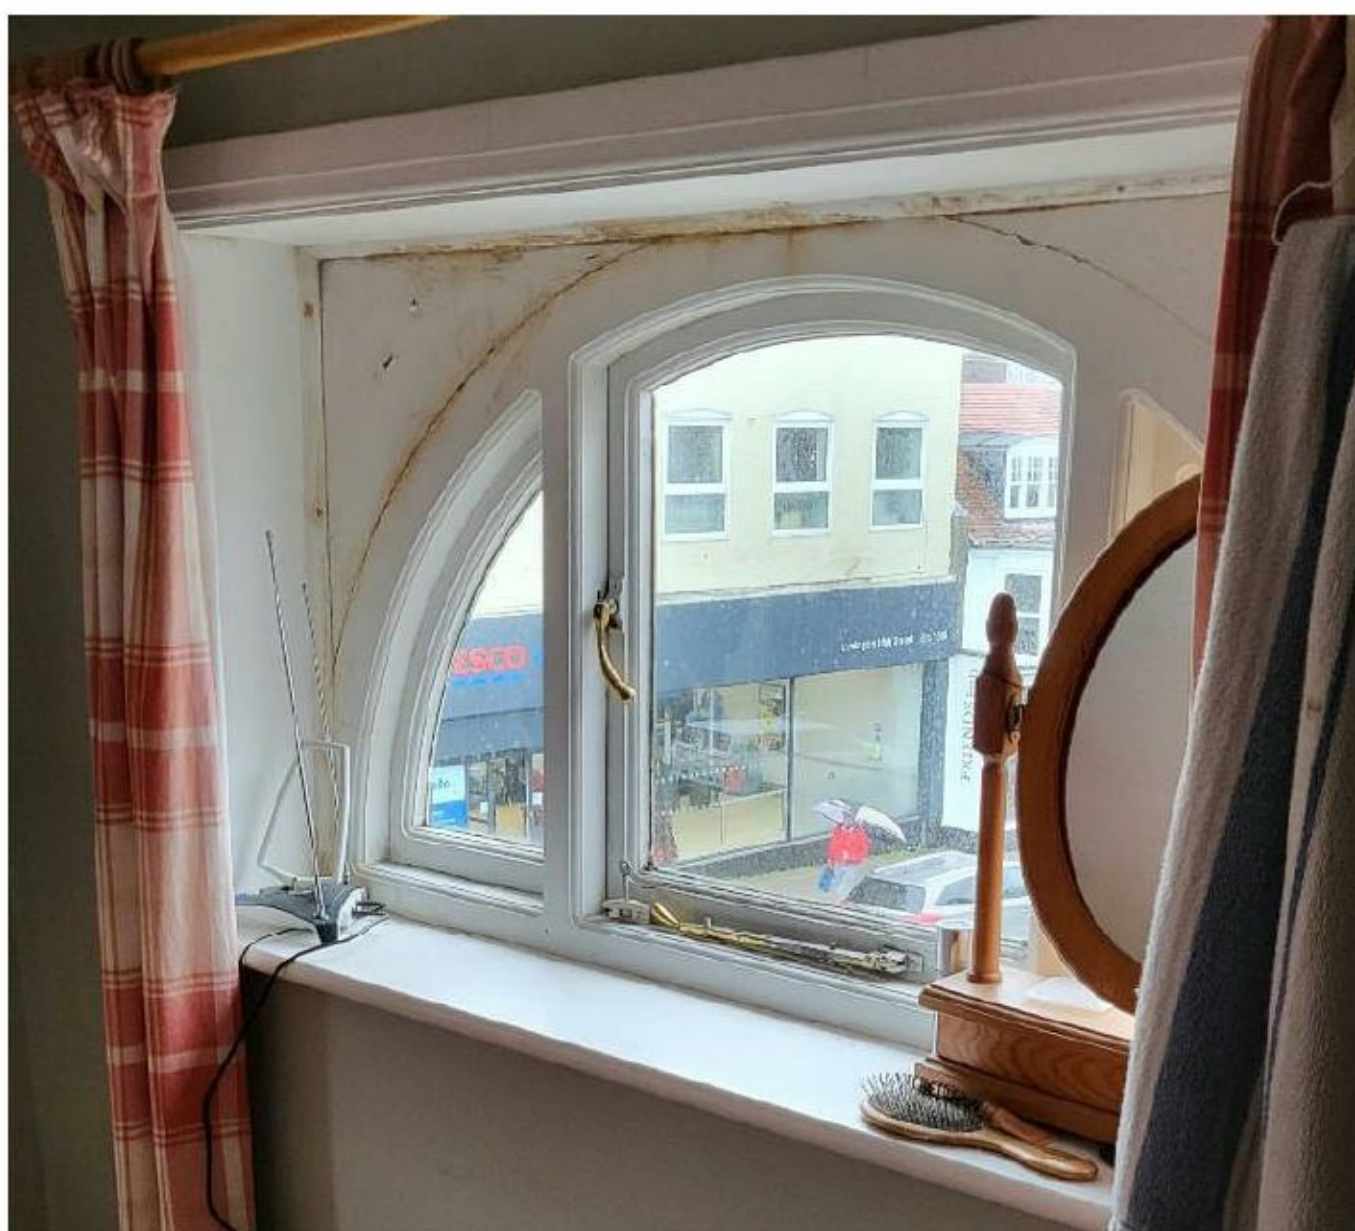
The water-damaged curved window

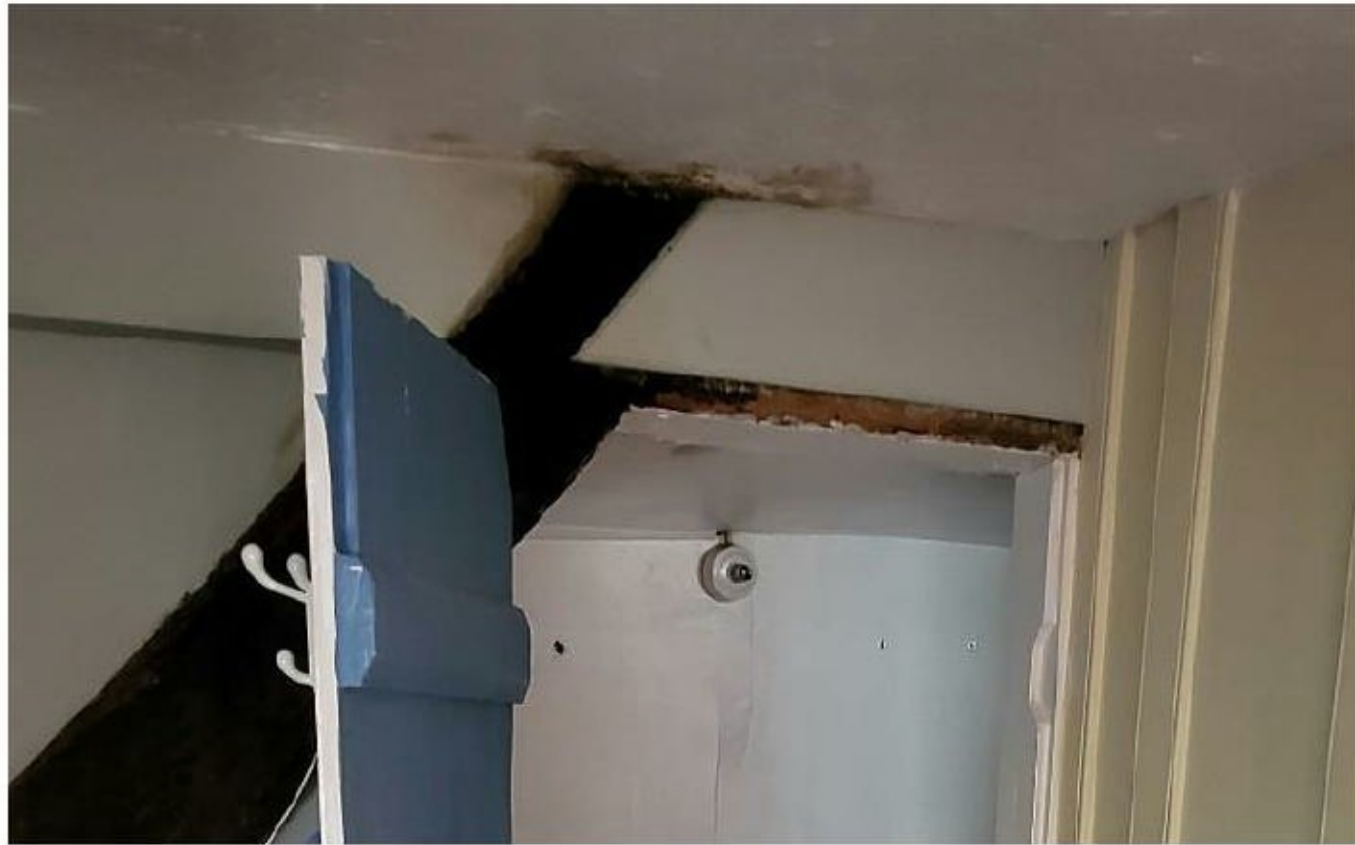
Water ingress from roof at the top of the timber frame

The main repair proposed is to ensure that the roof is watertight. The extent of proposed works is explored later in this statement. The roof is presently leaking badly, with water travelling down the timber frame. The sky is presently visible from the attic, through holes in the roof.

The proposals are therefore to repair the existing building.
