## Heritage Statement – 26-27 High Street, Lymington, SO41 9AF

Deborah Slade MA(Oxon) MSt(Cantab) MSc MRTPI  
Draycott Chartered Surveyors  
January 2024

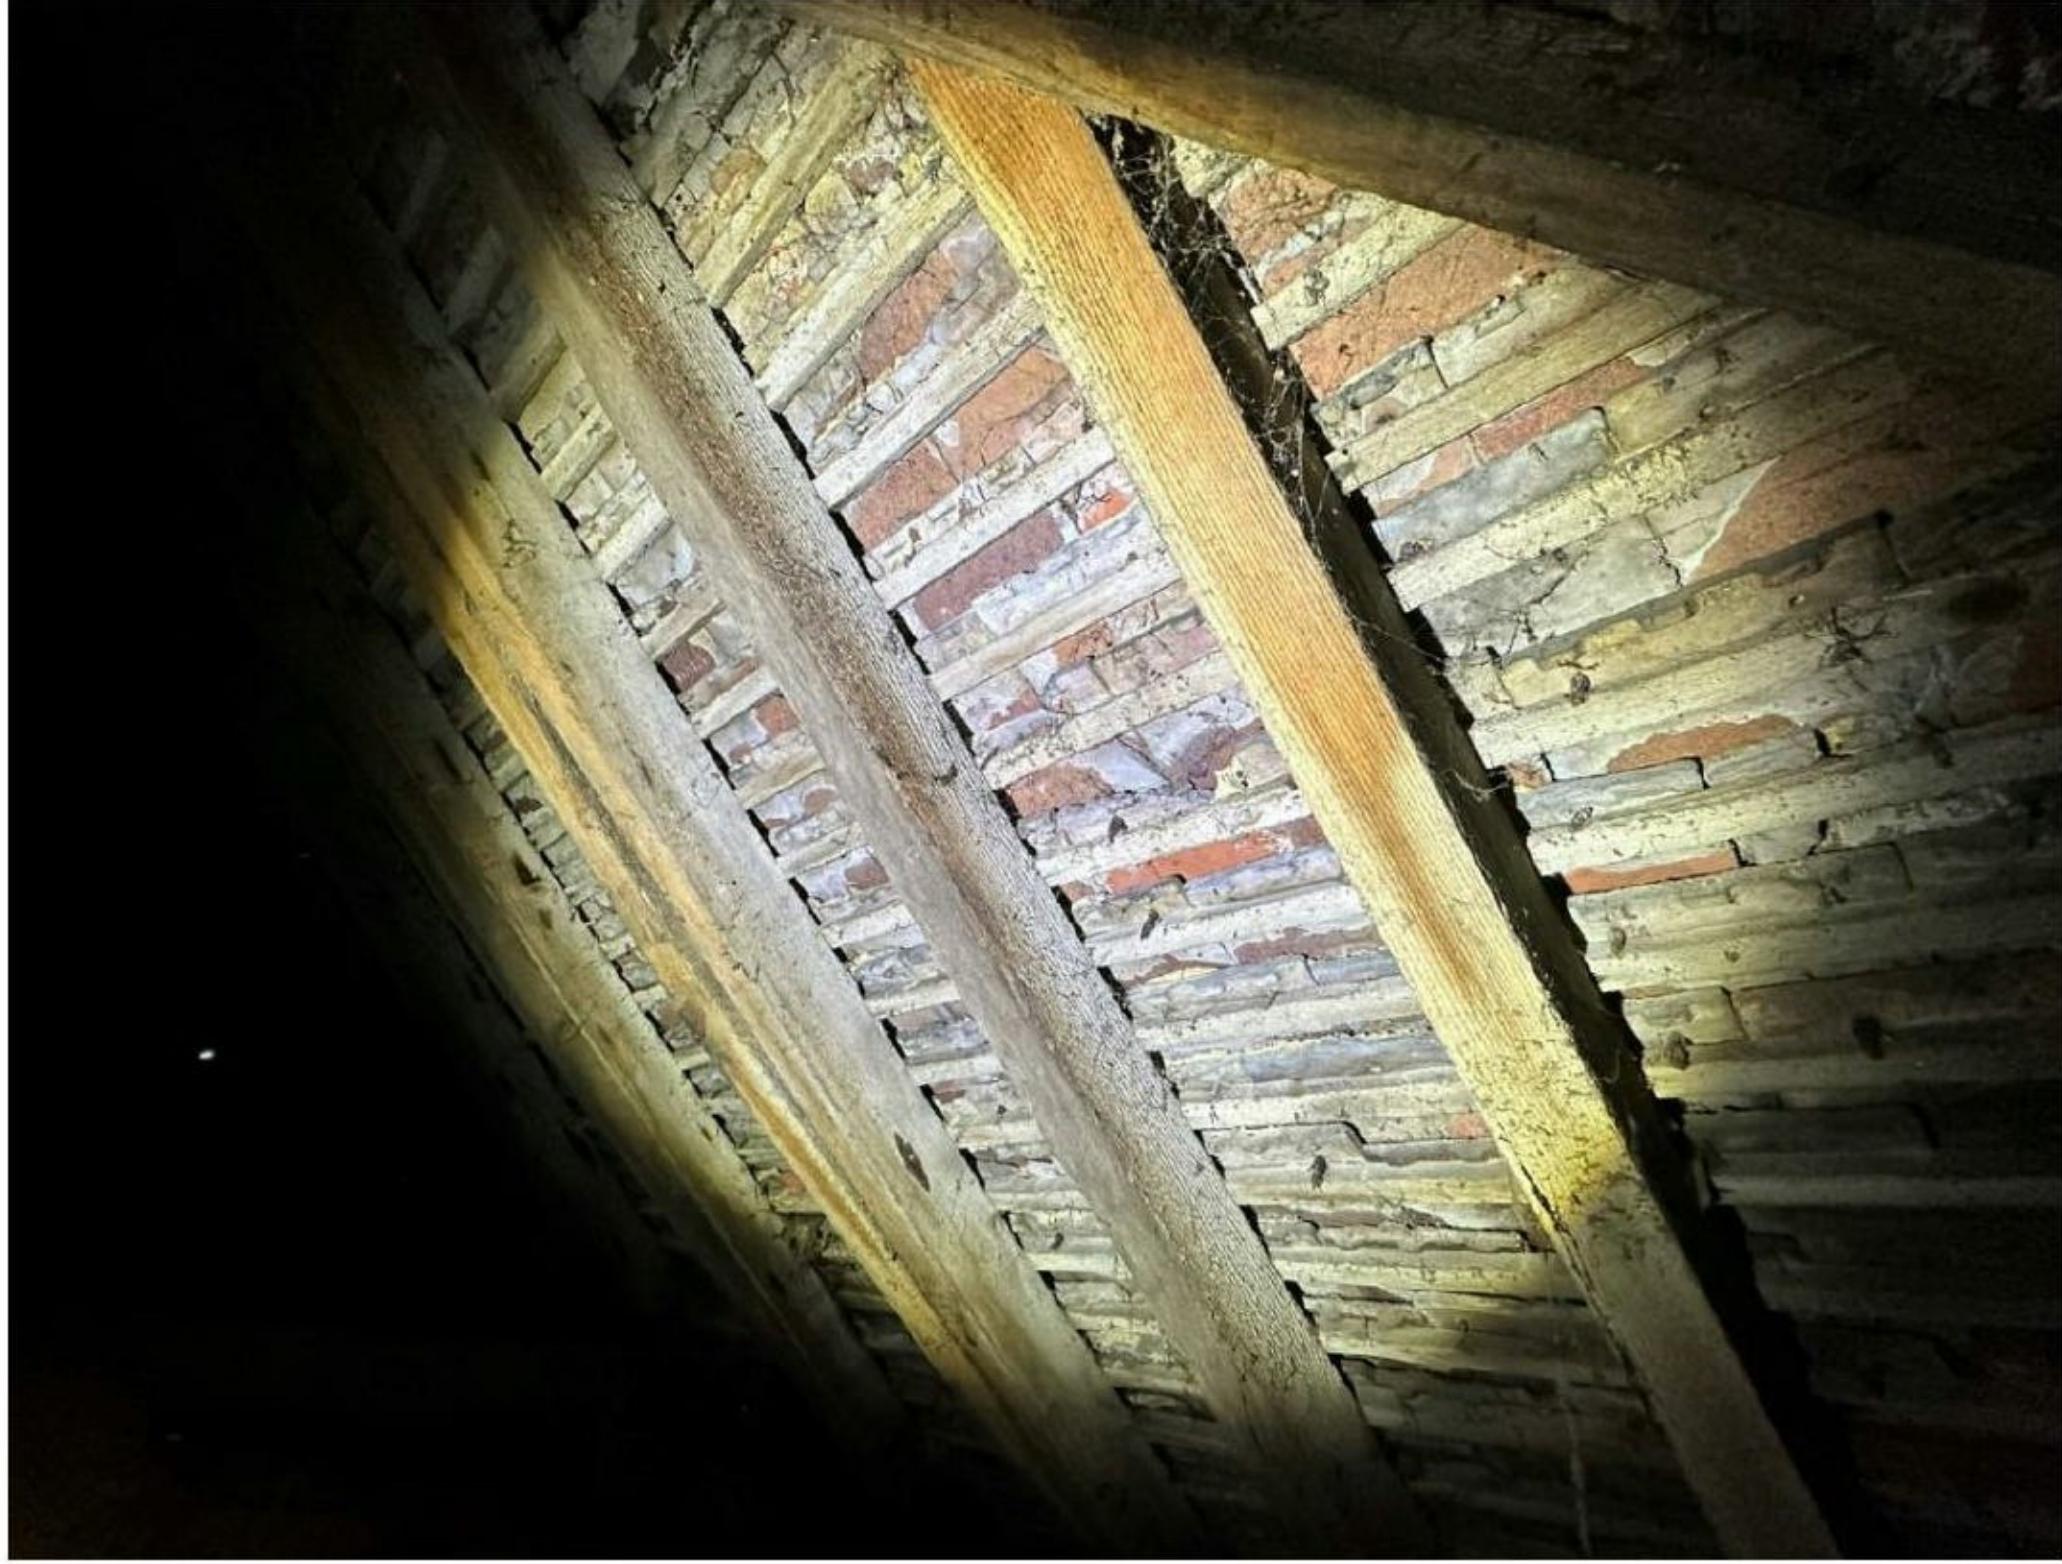
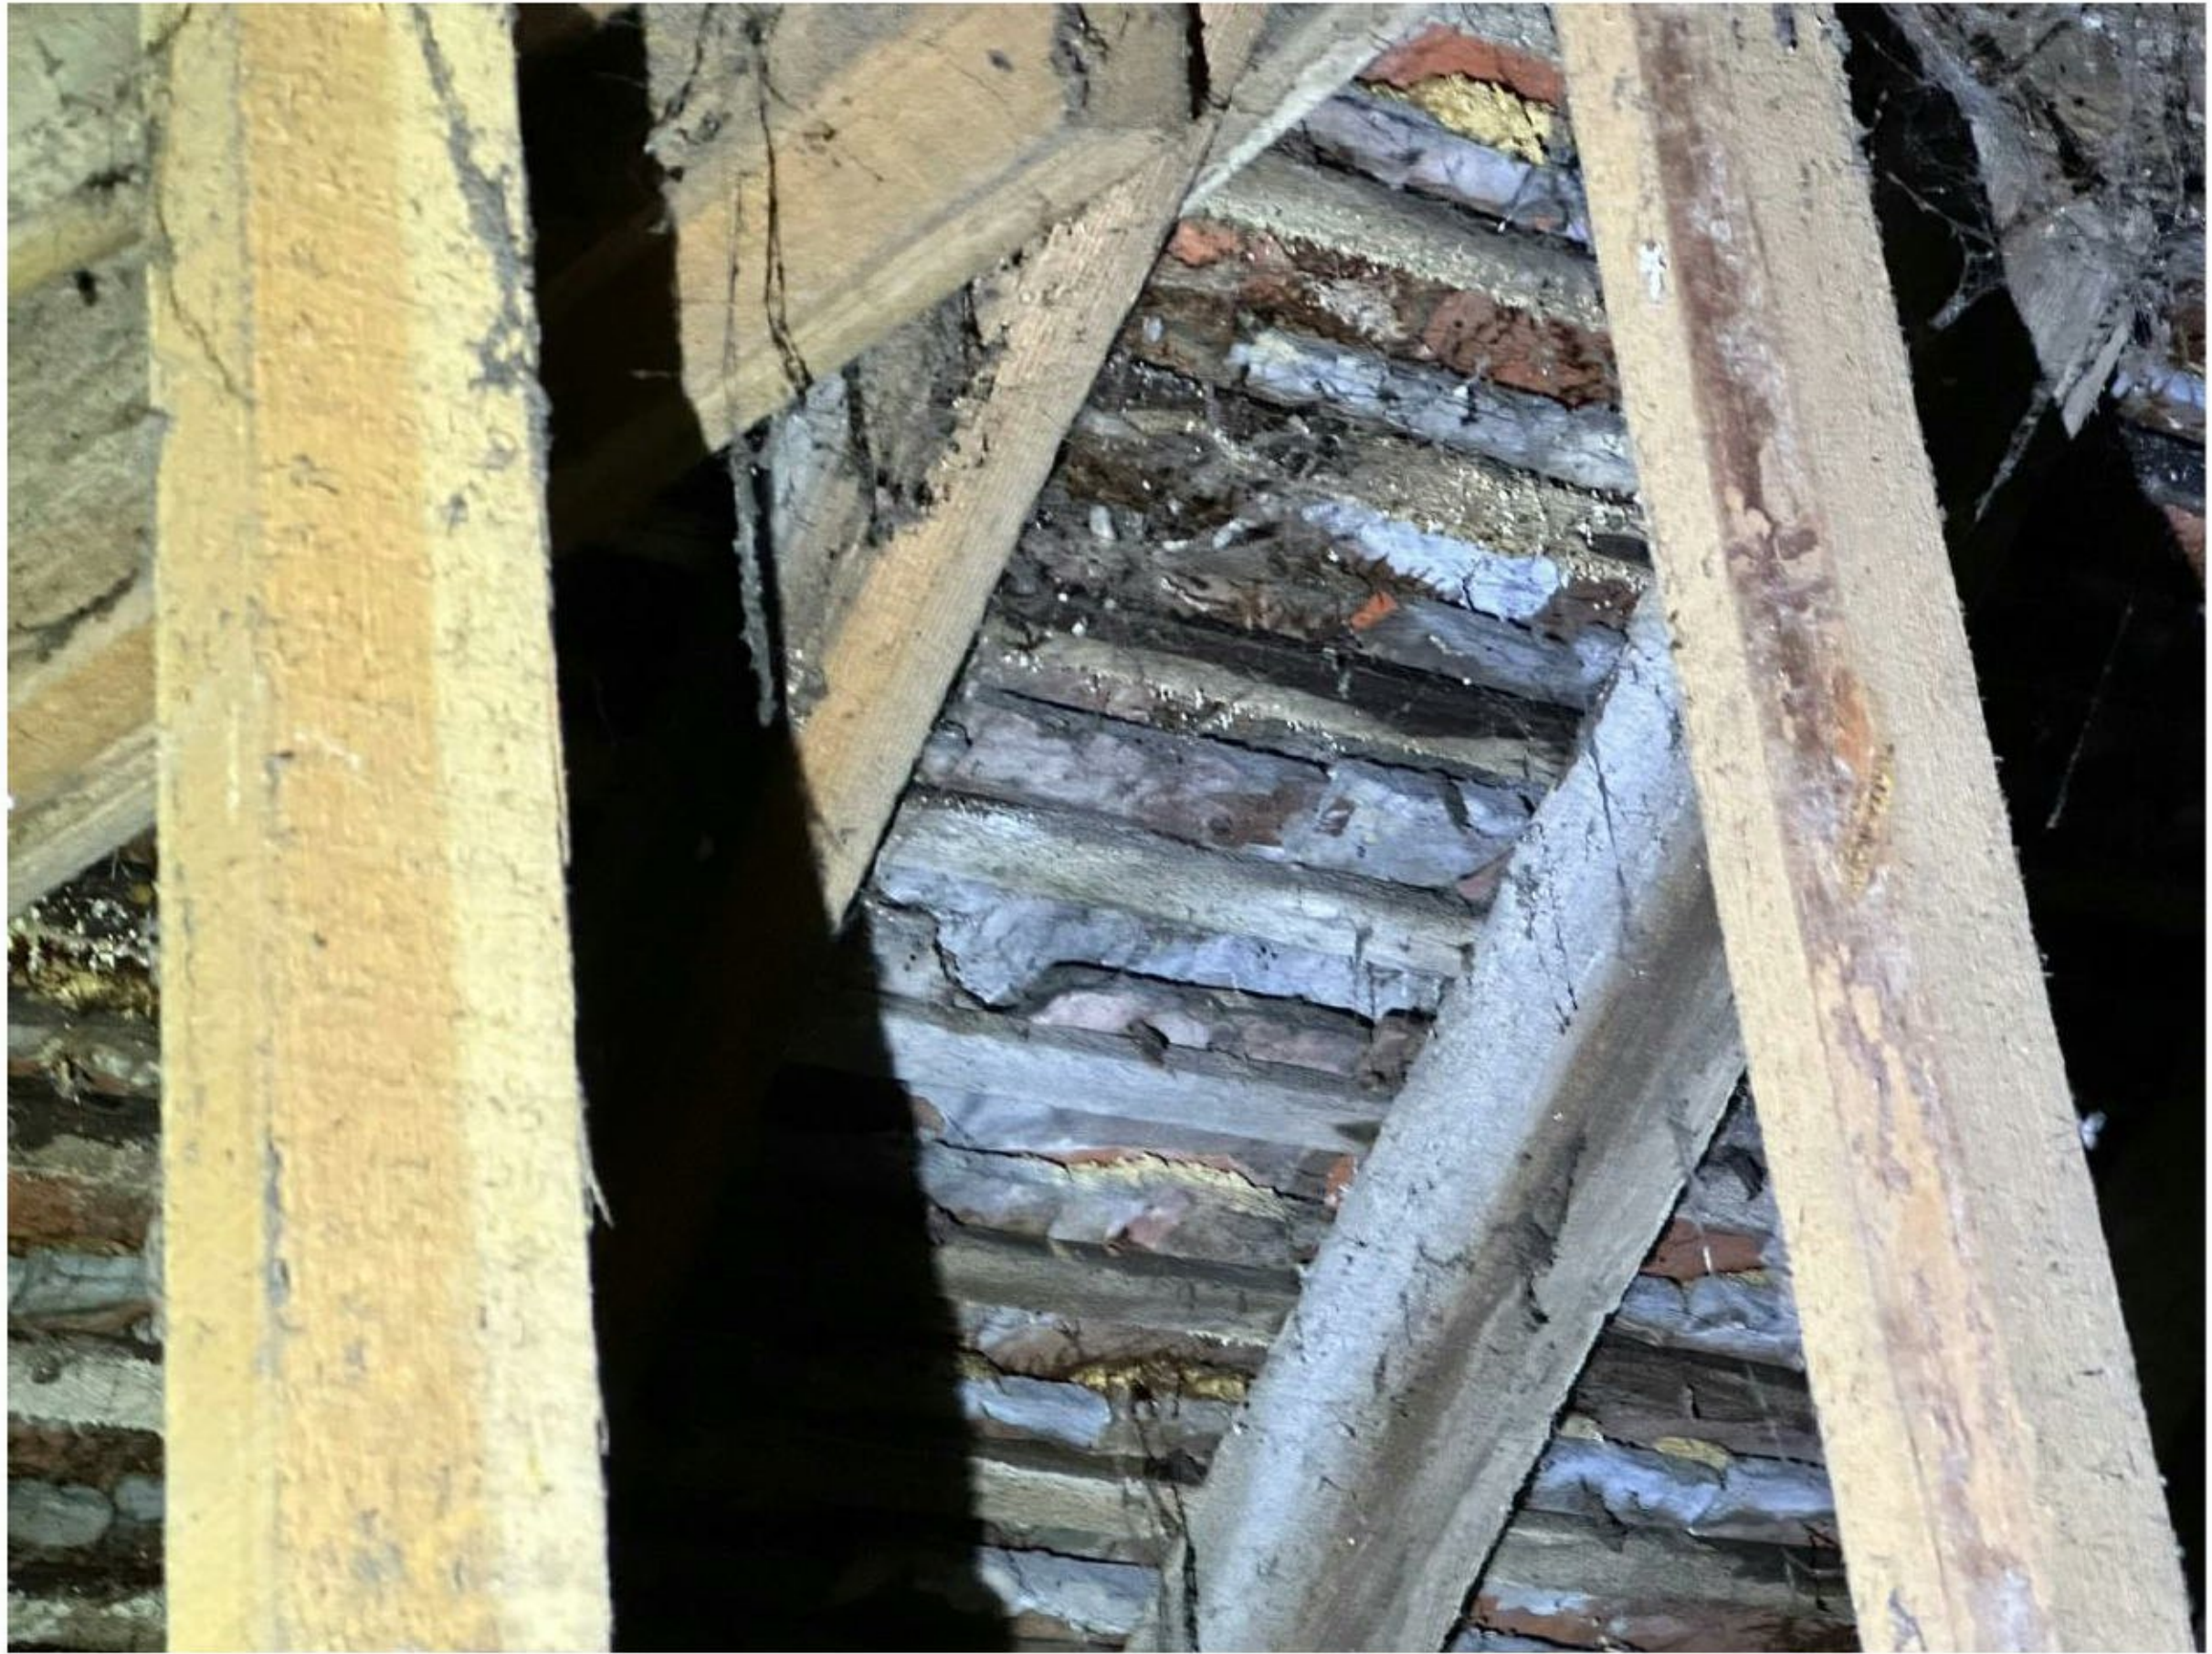
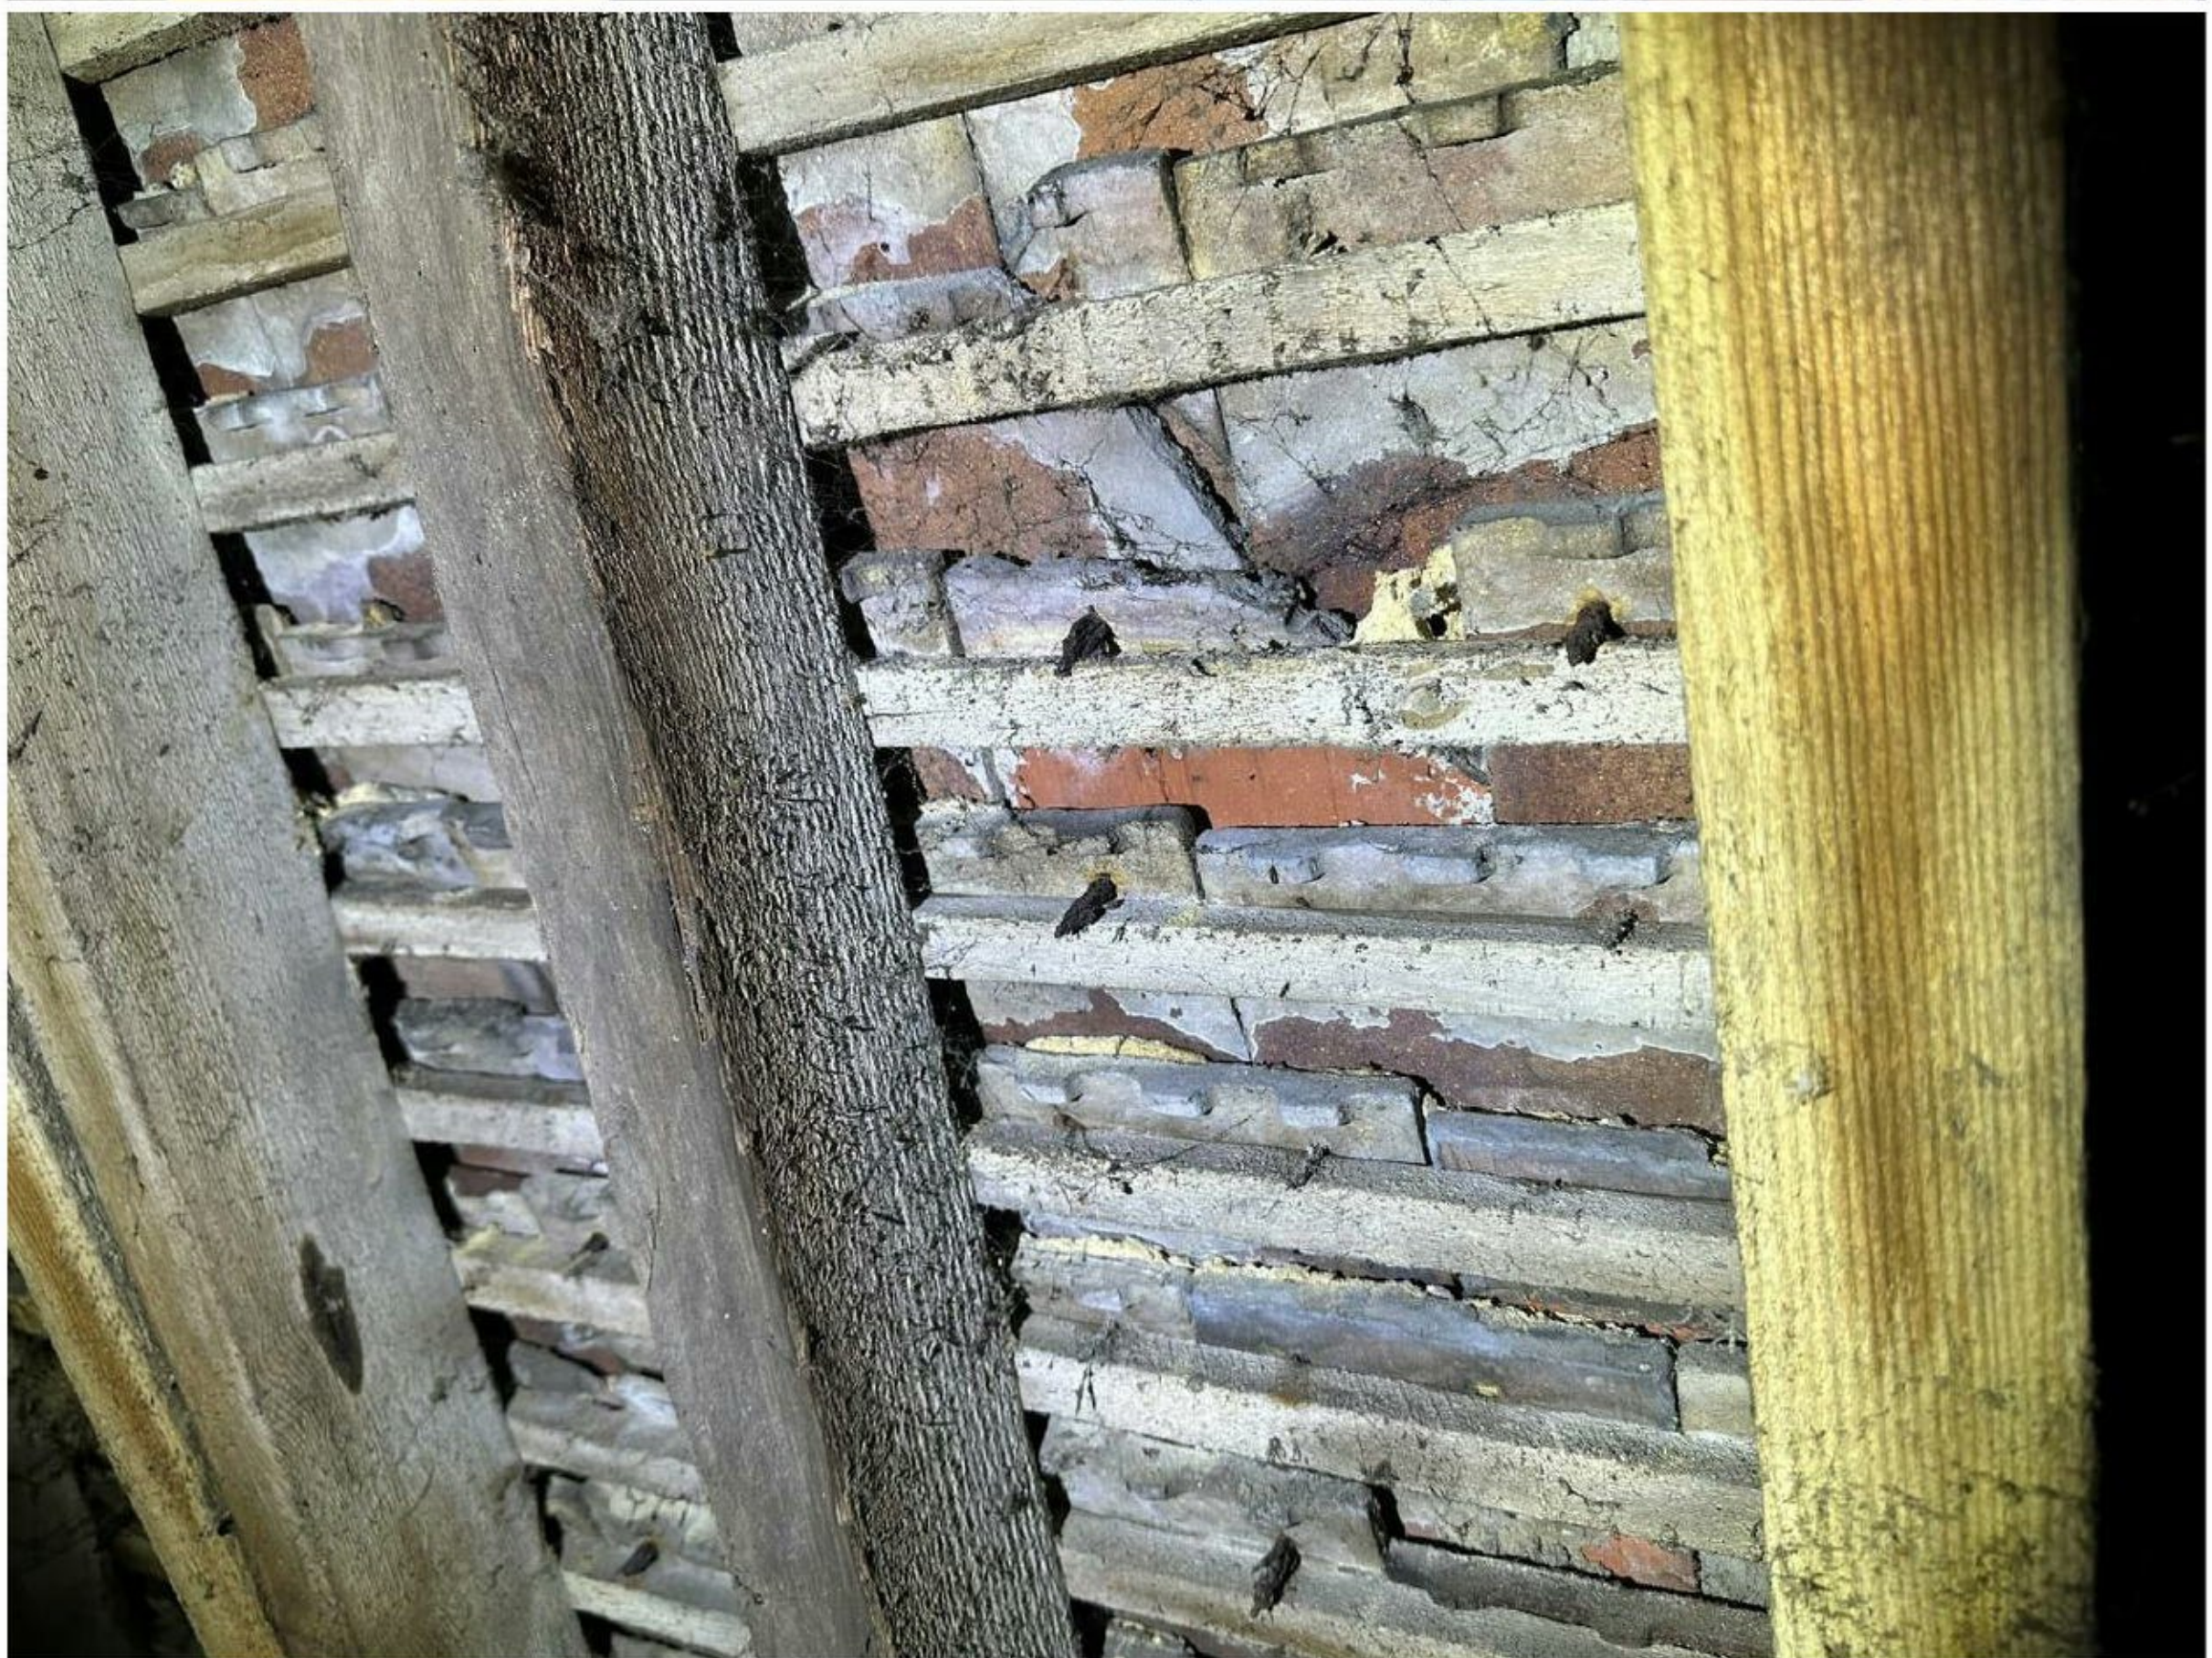
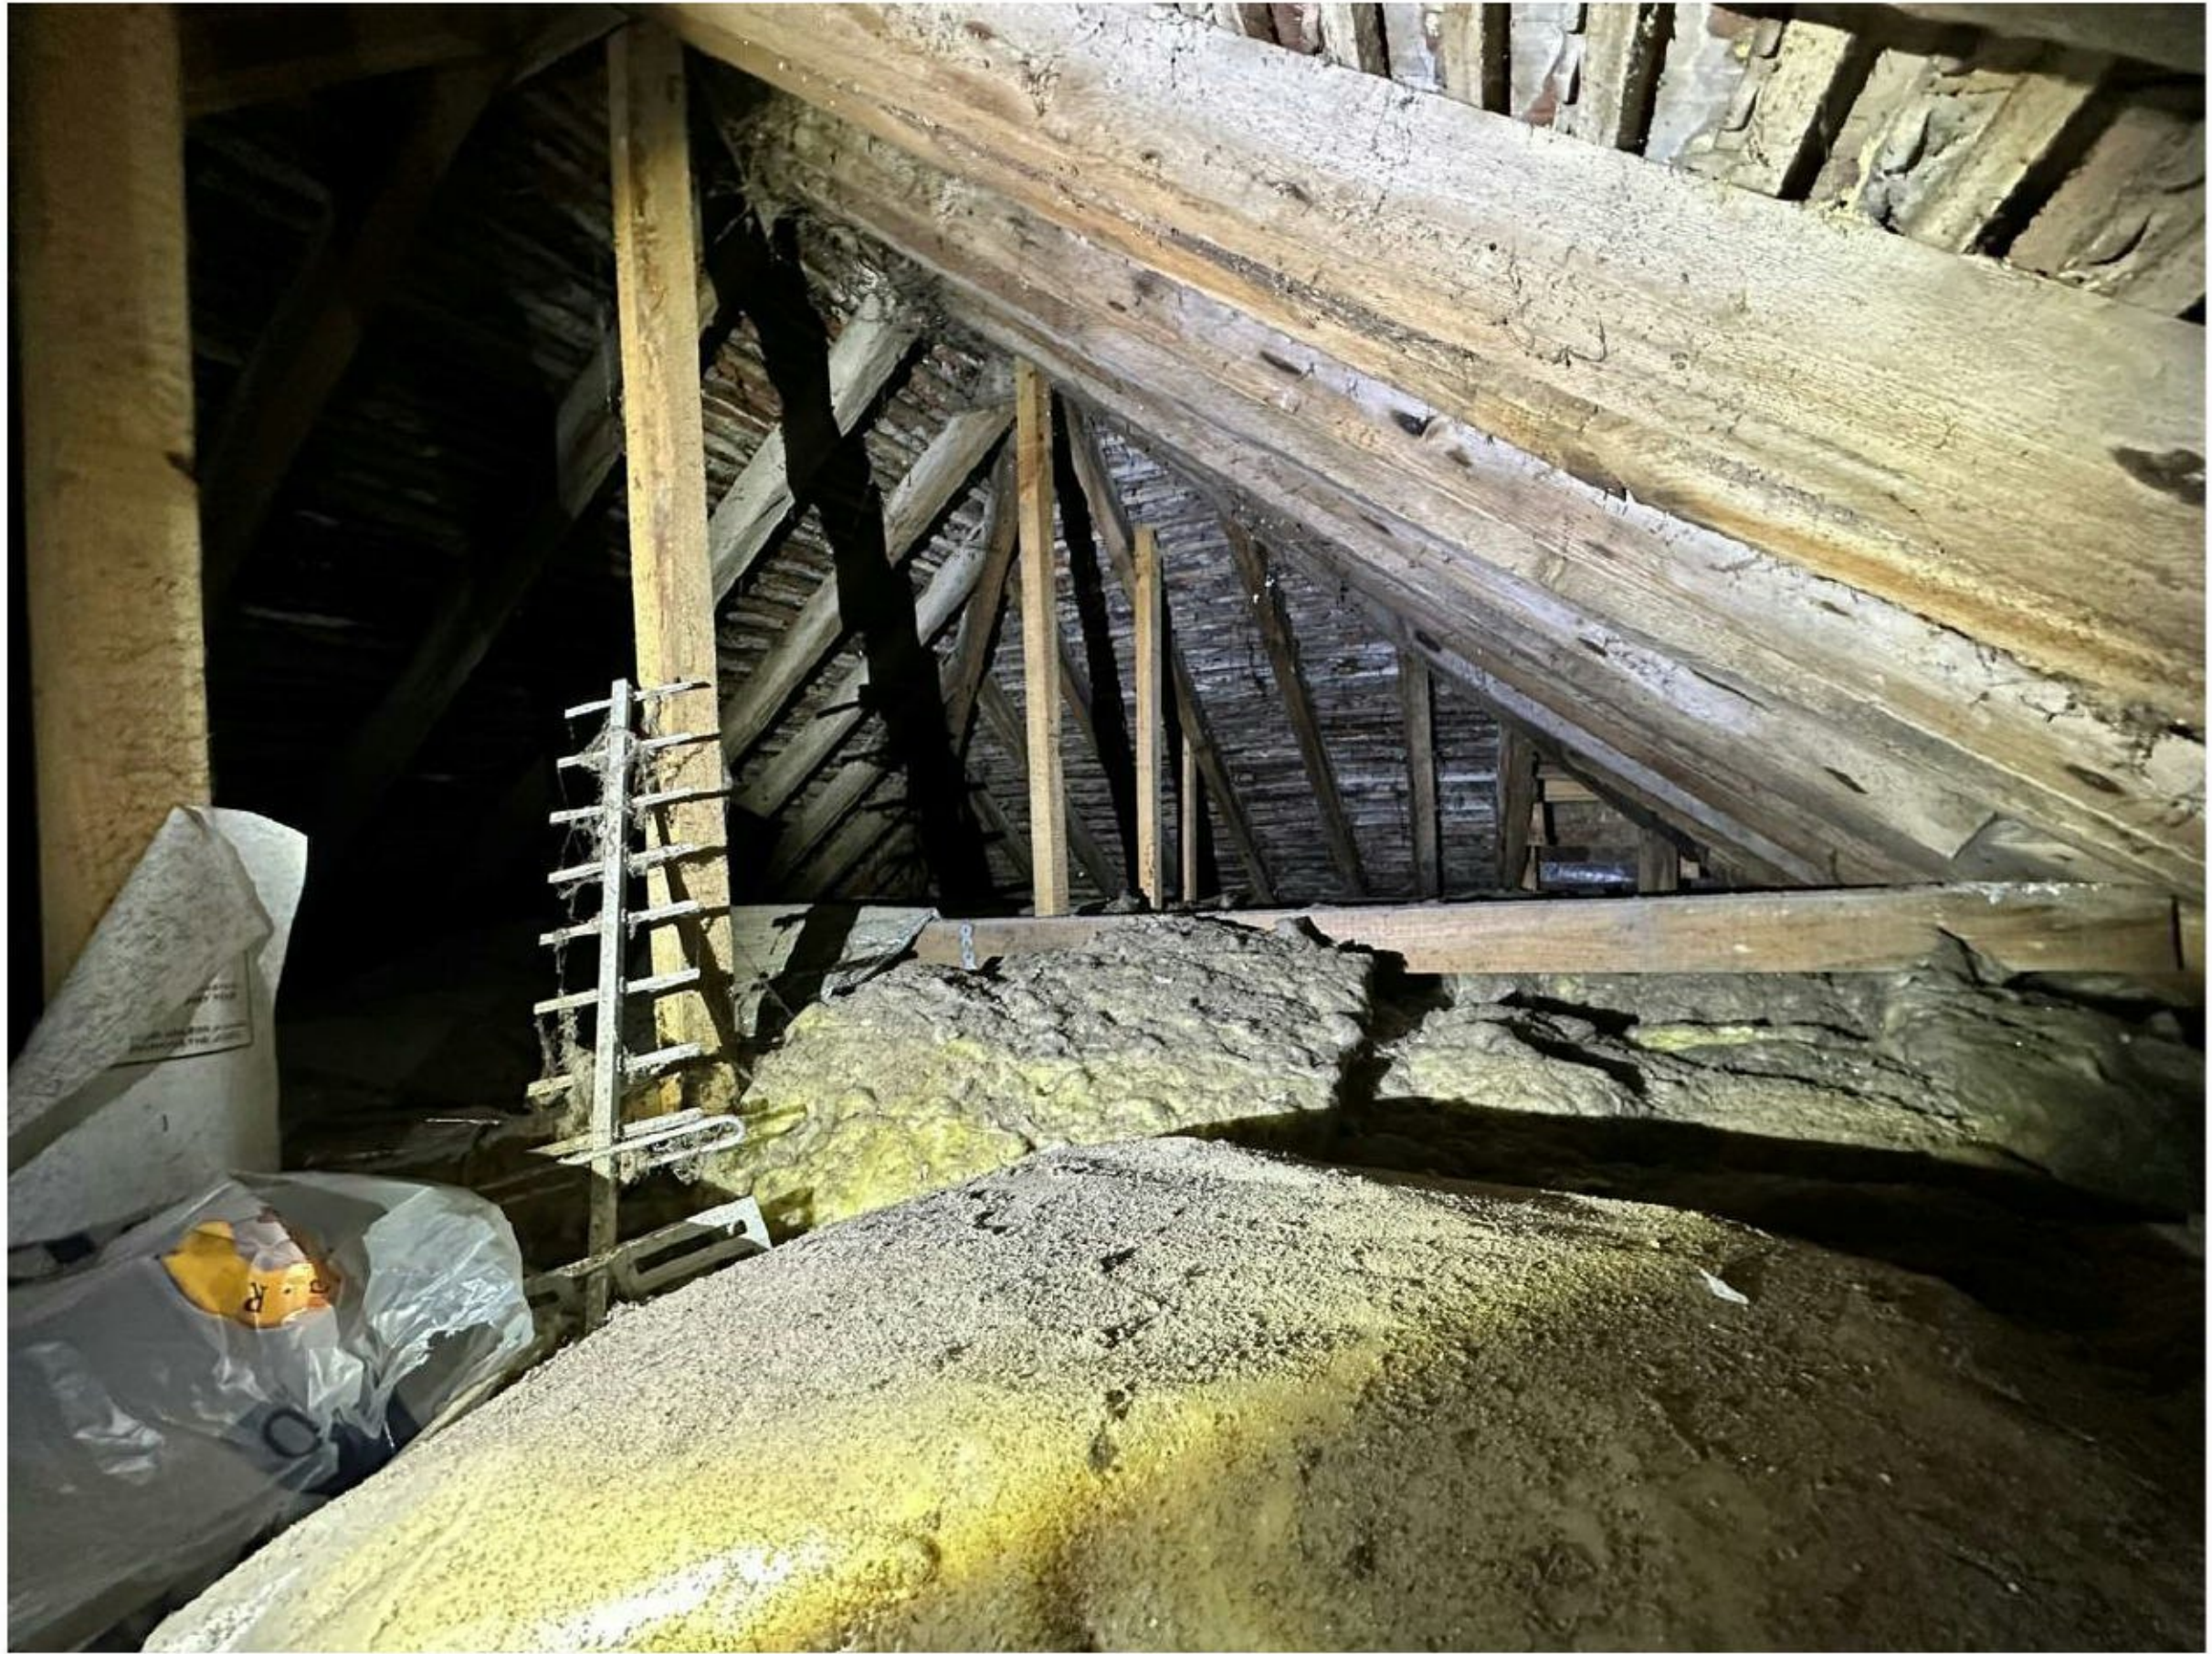
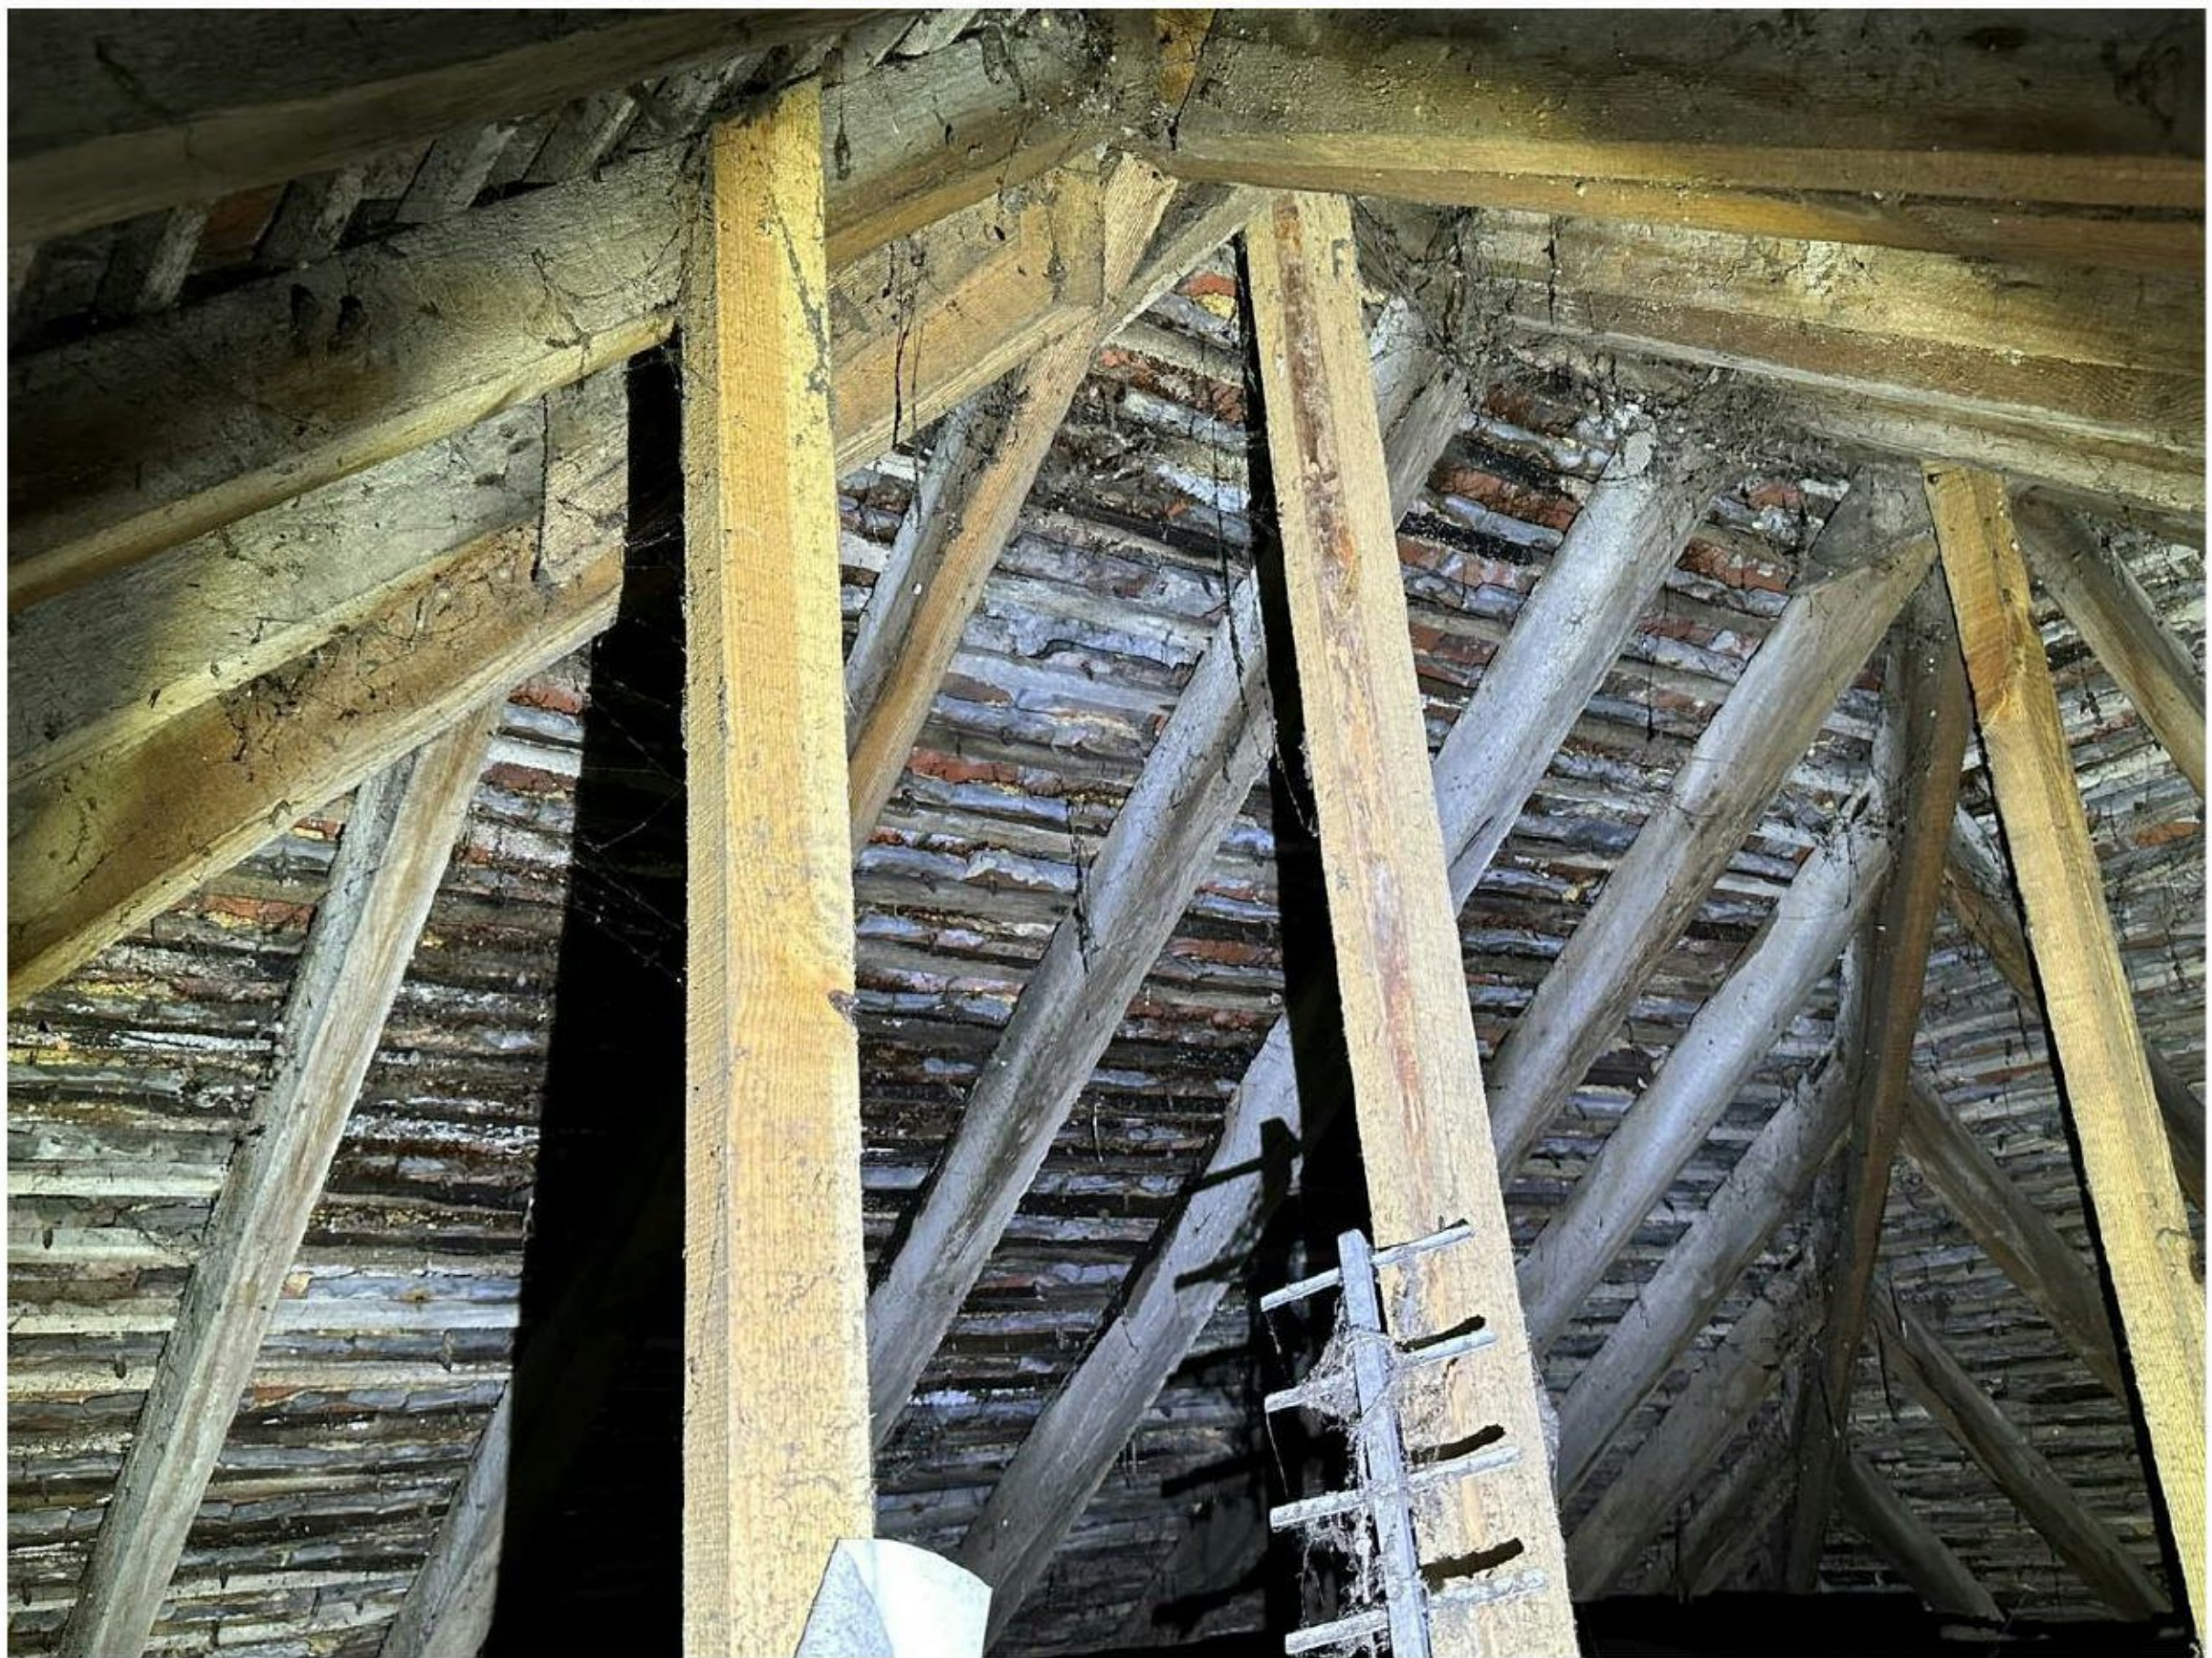
**Photos showing existing roof problems**

The existing roof is suffering from nail rot. The rafters are sound, but battens and tiles need re-laying, as shown below. The extent of the problem is only over the main roof, as shown on the proposed plans. The roof beyond has more modern tiles, and better-quality condition at this point in time.

The roof is suffering from nail rot from the metal fixings in the peg tiles across the majority of the roof.

The conclusion is that tiles are slipping throughout the roof void, and that this is not a localised problem to one portion of the main roof. This is because the nails are rusting through and breaking, which makes peg tiles slip.

Assessment of the whole roof suggests that around 50% of the existing tiles could be salvaged, and re-used again on the roof, with an estimated need for up to one half of additional, reclaimed tiles to match in.

- firstly strip the roof and collect all the tiles that can be re-used;
- re-use them wherever possible, particularly on the front elevation;
- an appropriate reclaimed tile will be used as a match-in on the rear roof planes to make up any shortfall where the existing roof tiles are spalling and broken and cannot be re-used.
