DETAILS OF CRACK MONITORING

Level Monitoring Readings

Our reference: S87

Alleged subsidence at 11 Ketcher Green, Binfield, Bracknell, RG42 5TA

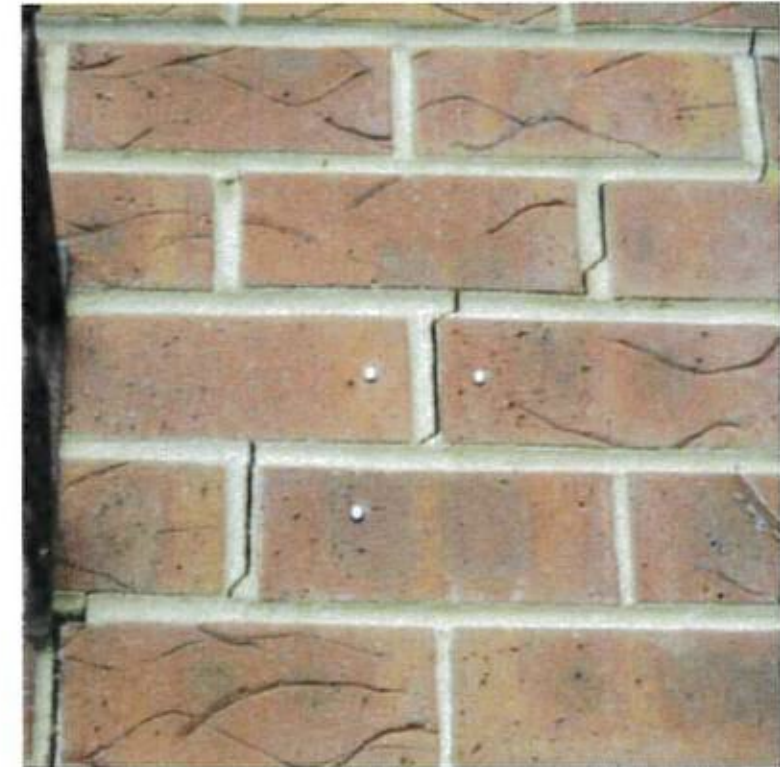
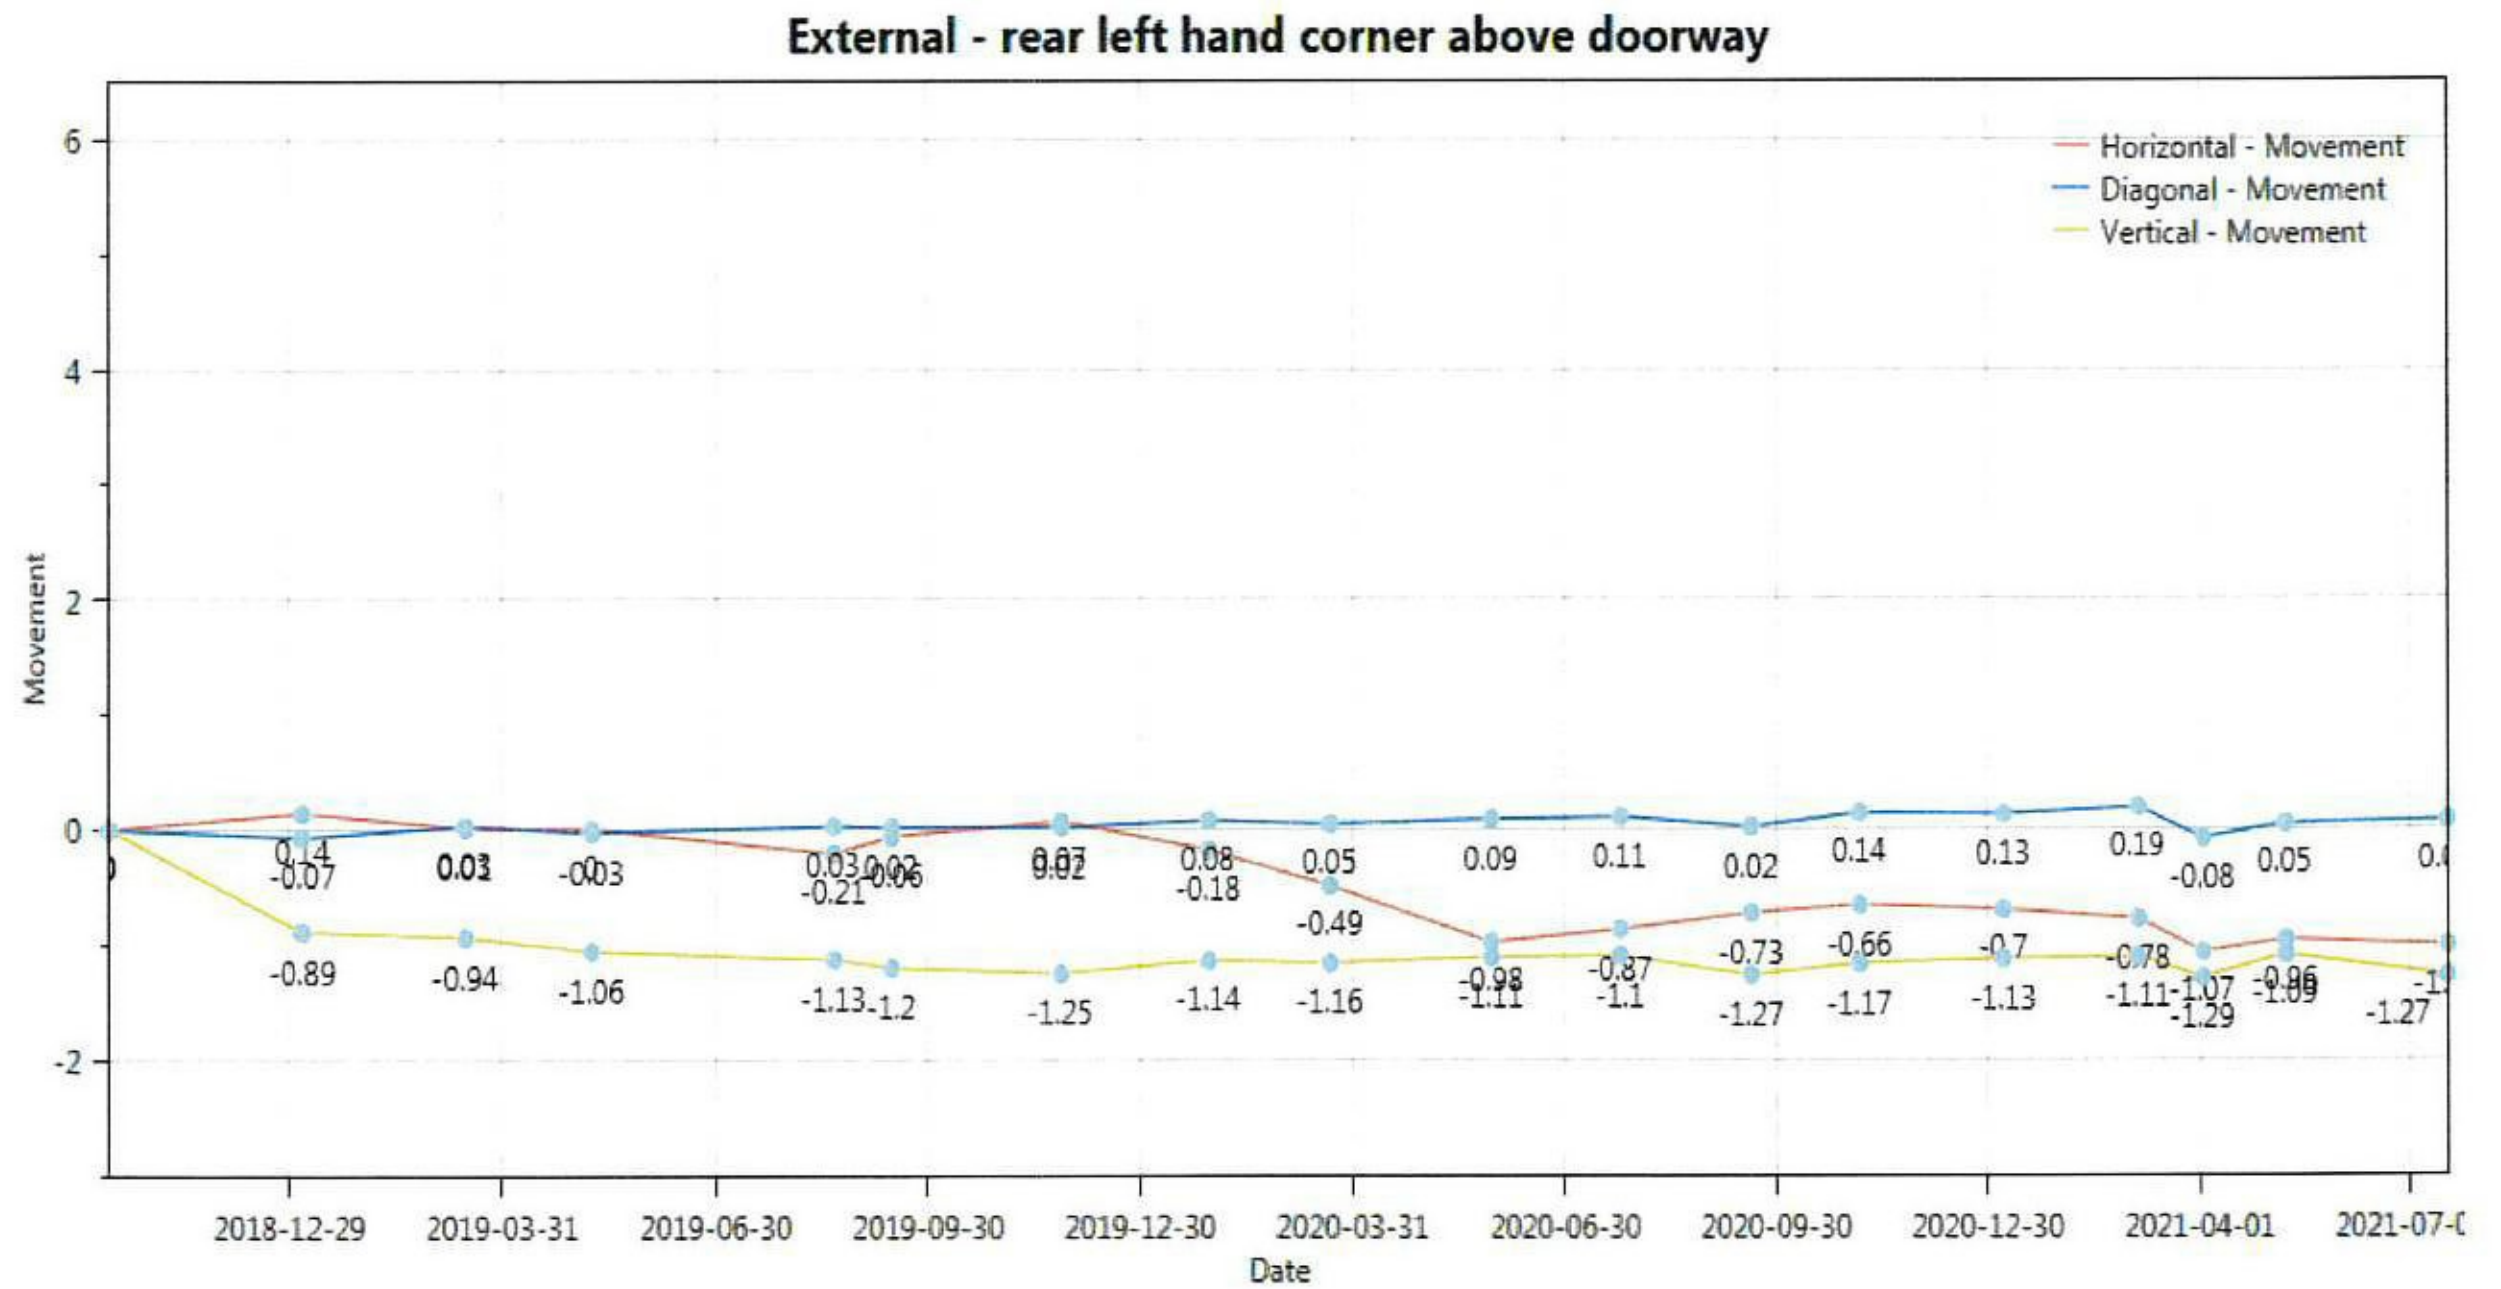
Location External - rear left hand corner above doorway

Alignment Diagonal

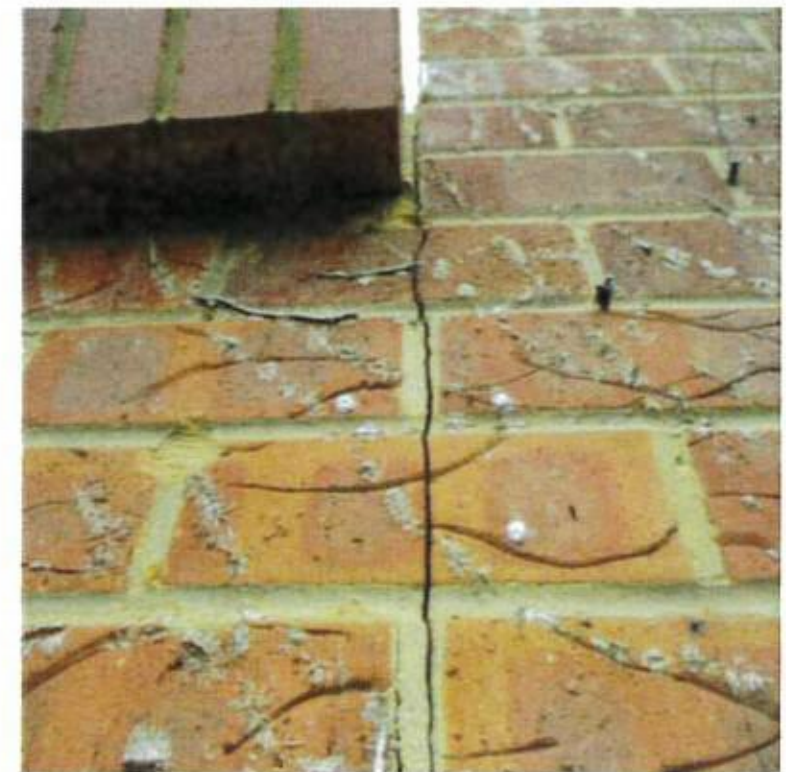
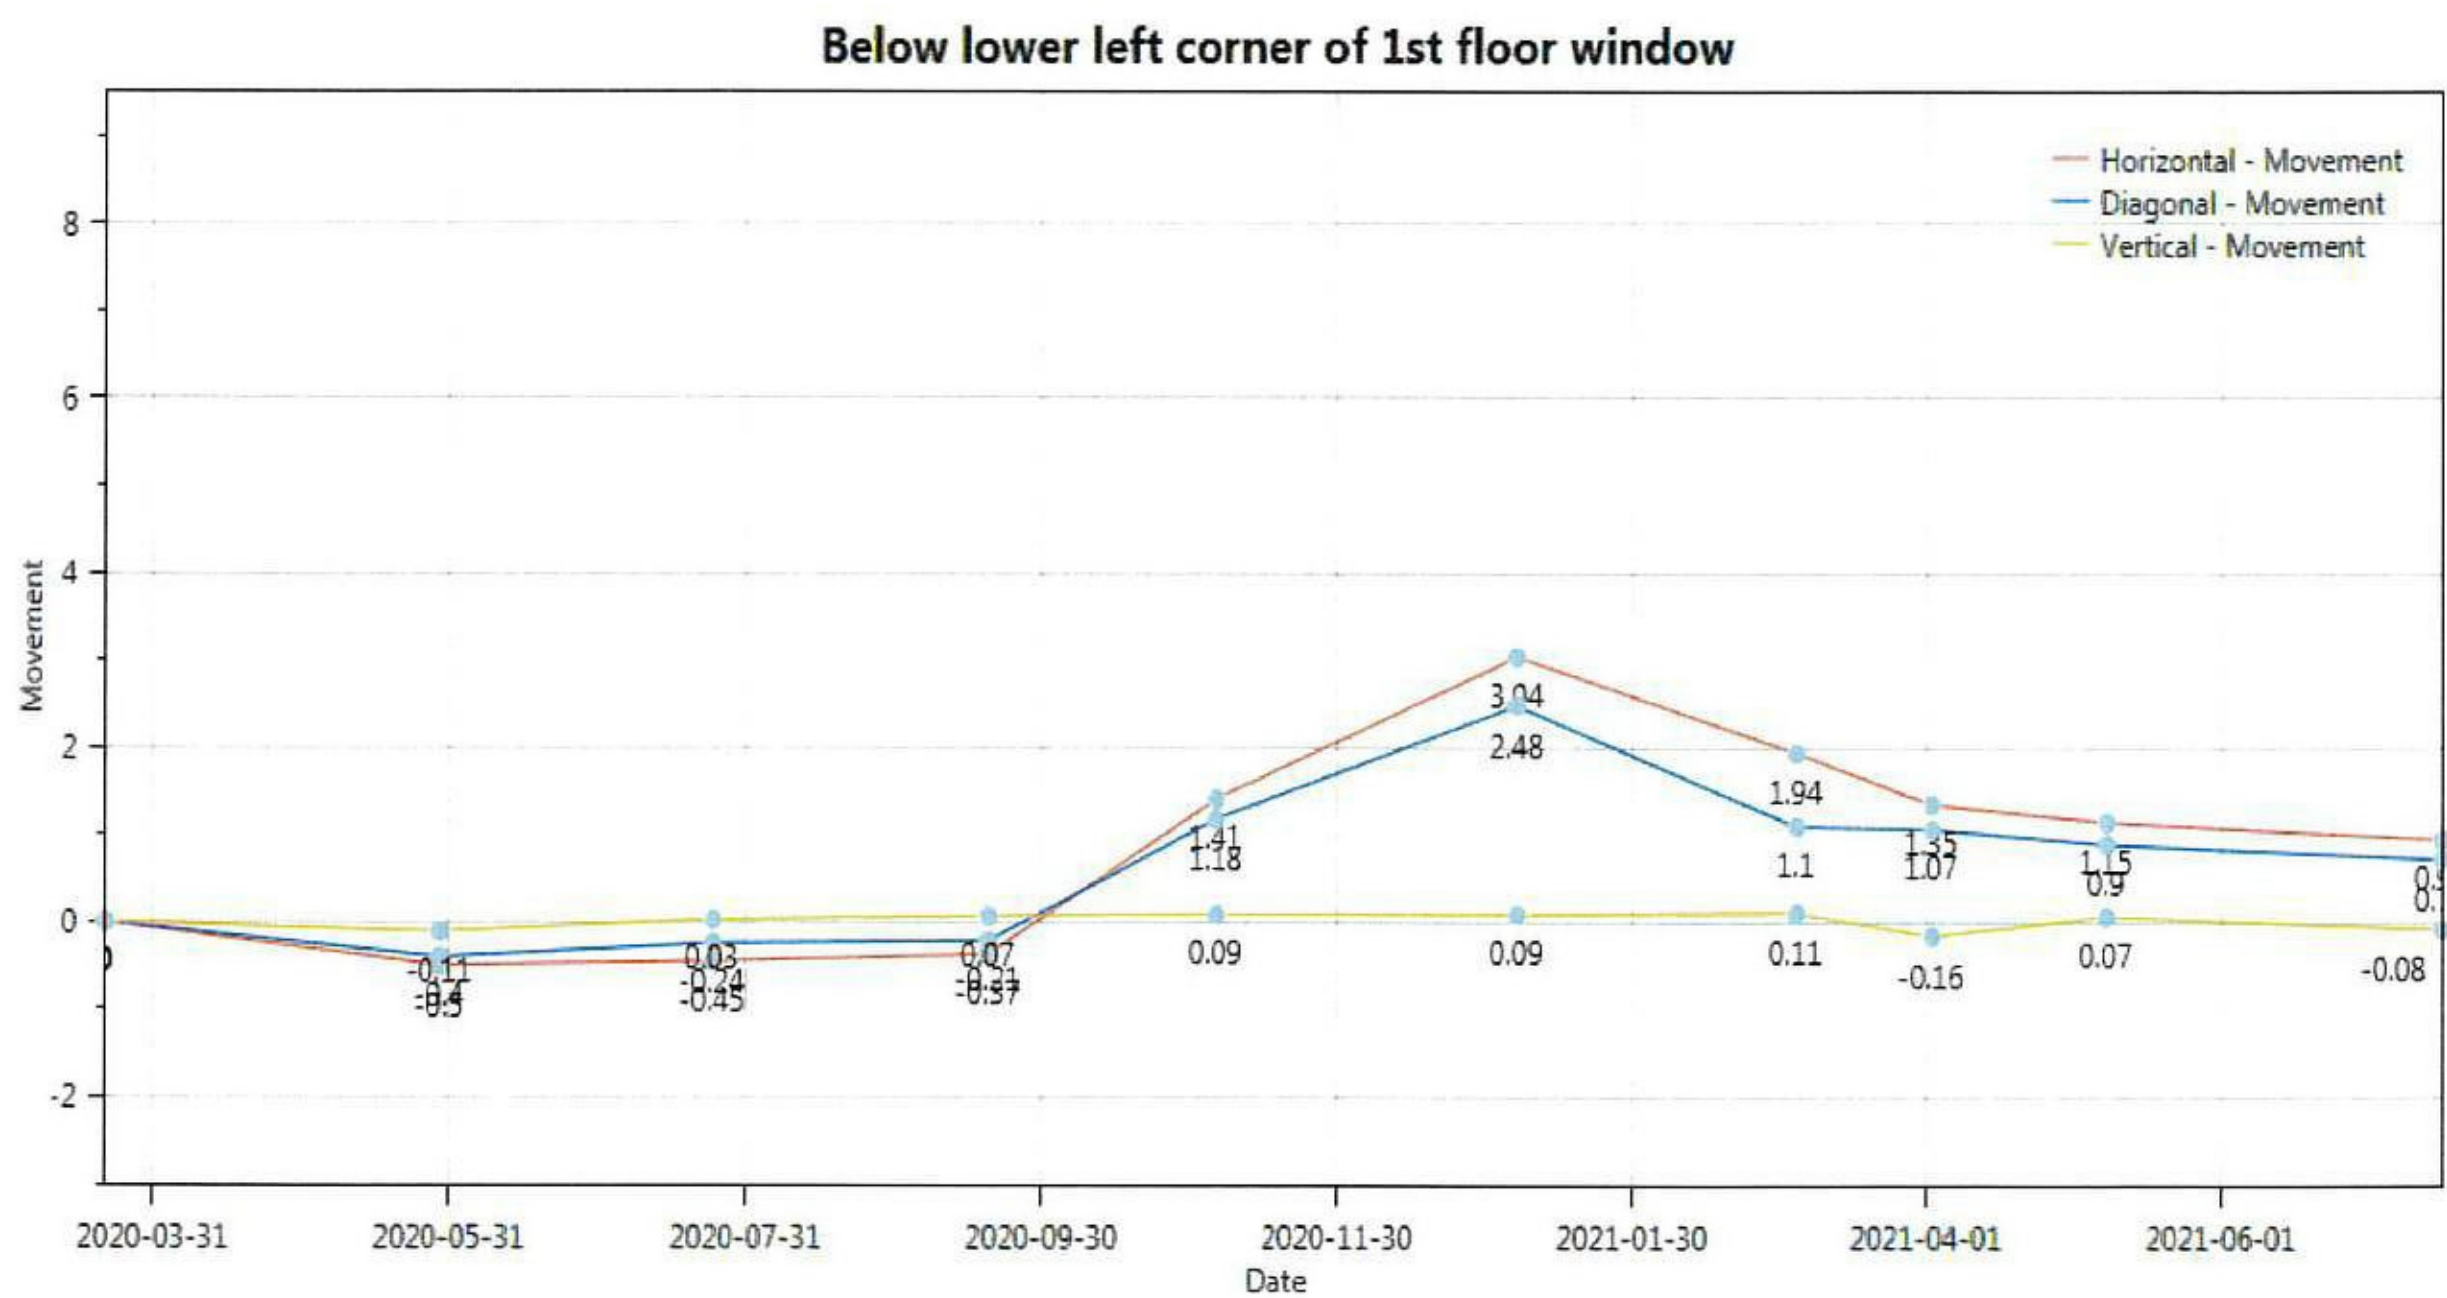
Location Below lower left corner of 1st floor window

Crack Width 3.50 mm

Alignment Diagonal

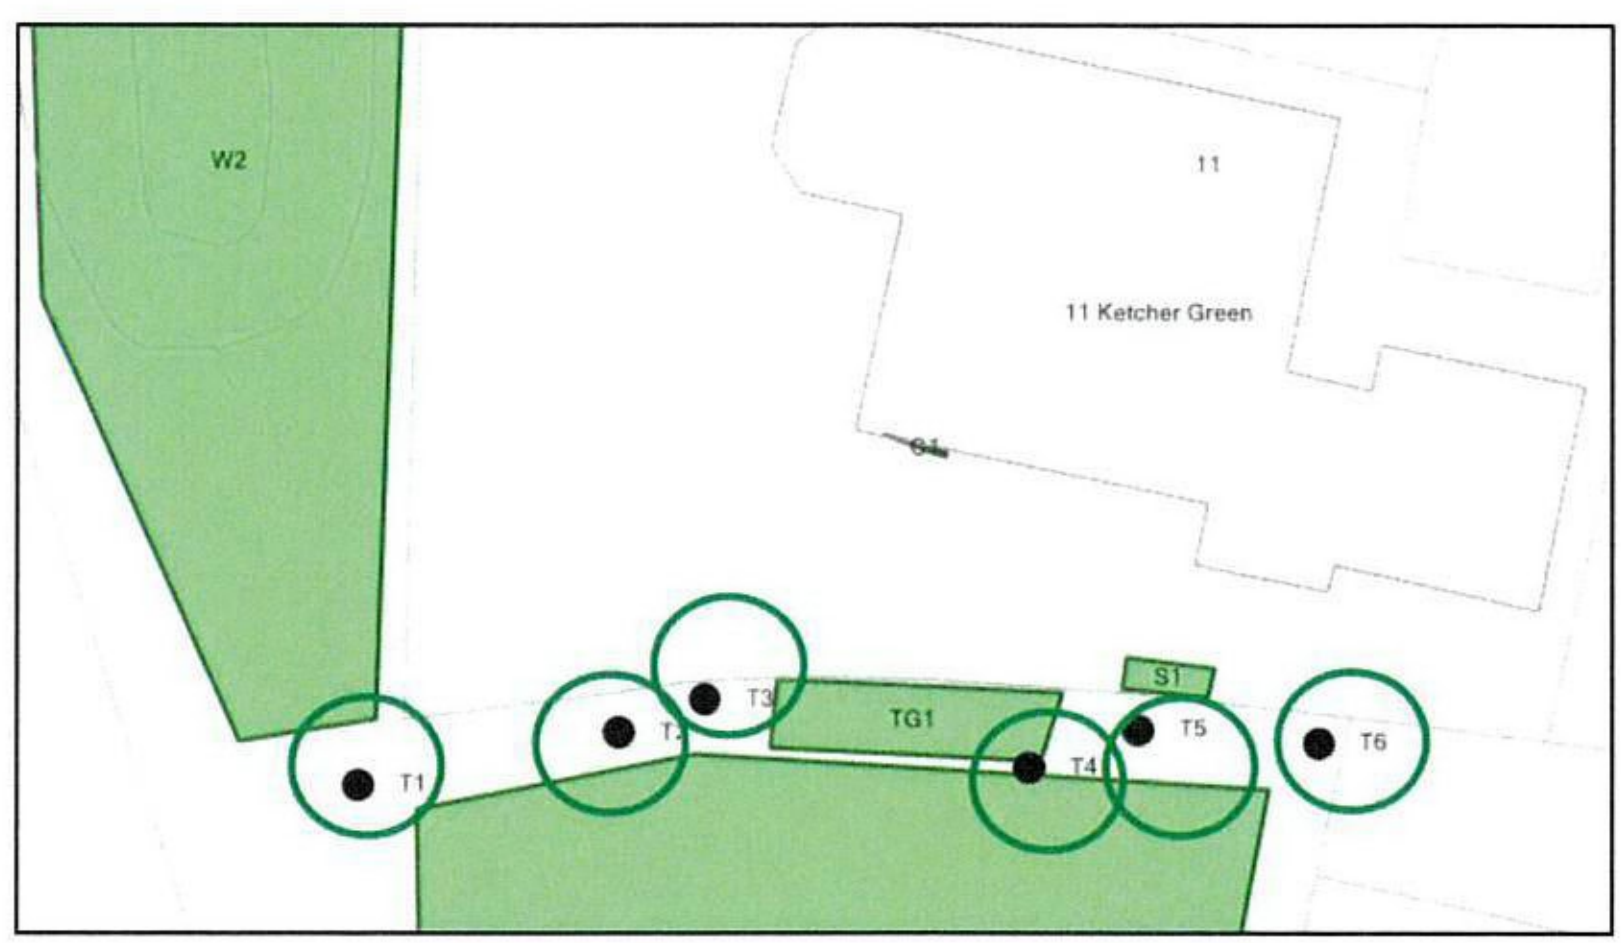
Figure 2. Site plan prepared by PRI showing trees to the south and west of 11 Ketcher Green.

- 8. Property Risk Inspection issued their Arboricultural Assessment Report on 28th January 2020 which recommended the removal of T2 ash, T4 Norway maple and T6 ash, as shown in PRI’s site plan at Figure 2. No detailed explanation was provided as to why T2, T4 and T6 were selected for removal.

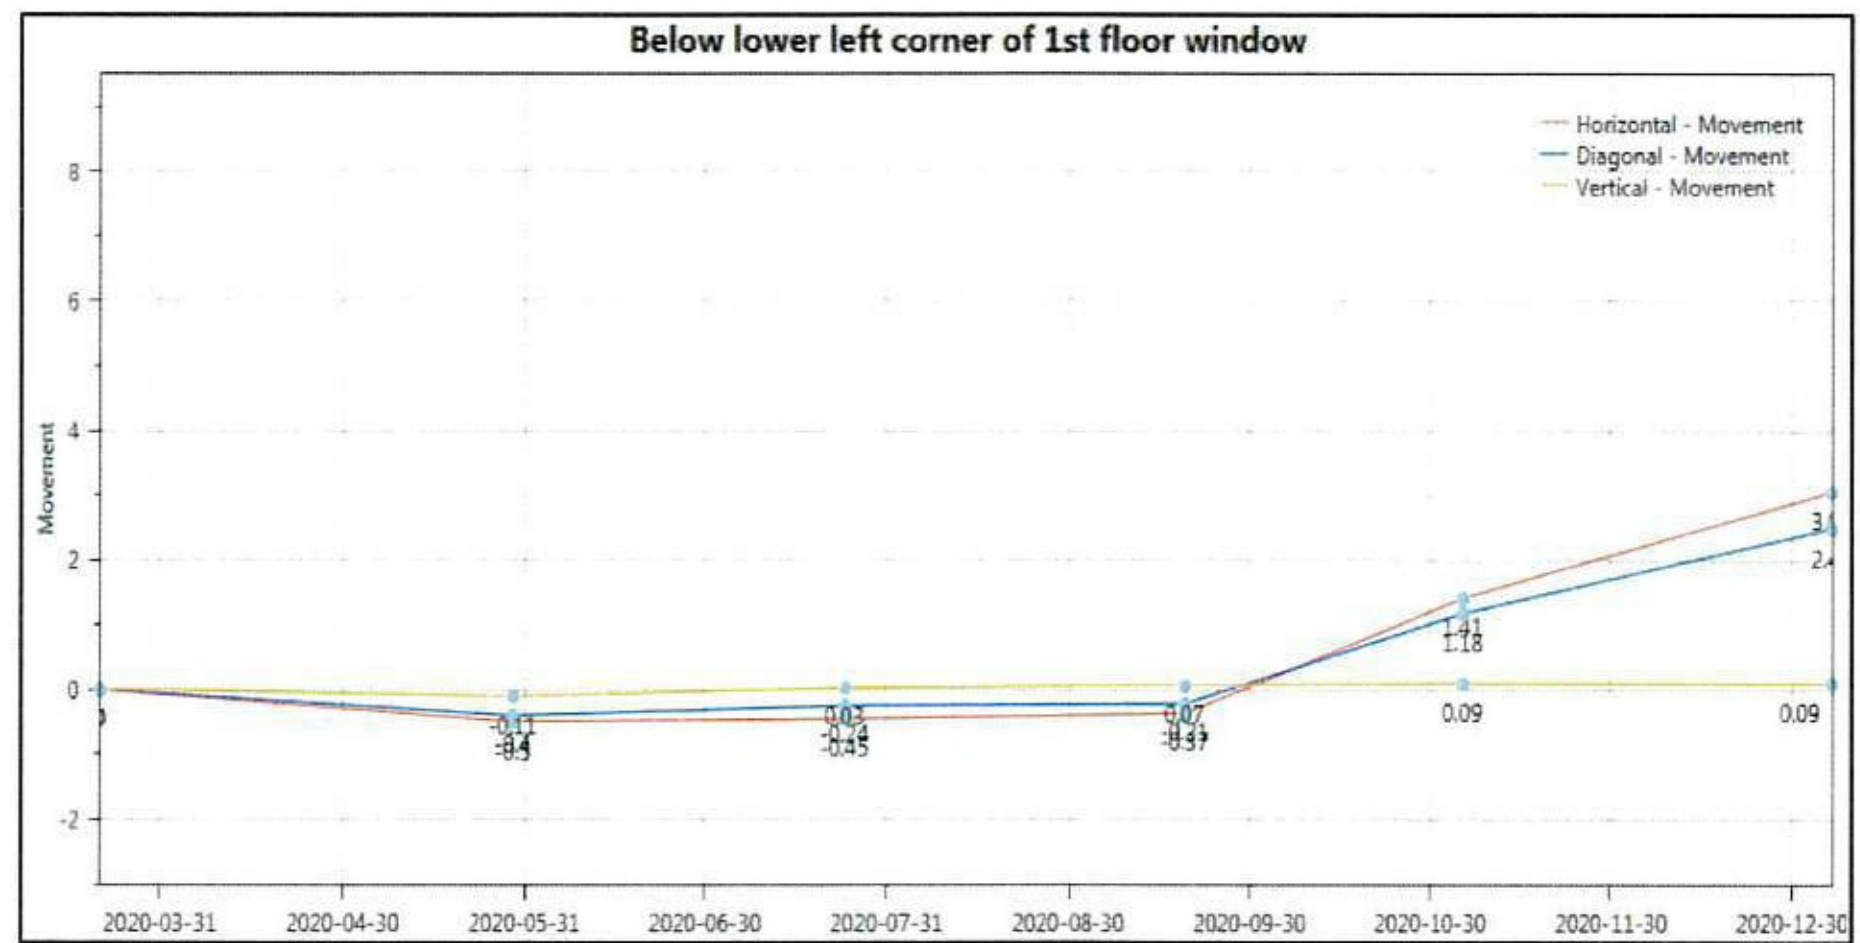
Figure 3. Graph of monitoring of a crack below the 1st floor window of the property.

- 9. Monitoring of an external crack at the lower corner of a first floor window commenced on 11th October 2018 and continued until 5th January 2021. The graph of monitoring results is shown at Figure 3 and confirms that the crack closed very slightly in winter 2019/20 and opened between September 2020 and January 2021 by just over 3mm. A photograph of the crack is shown in (Figure 4).

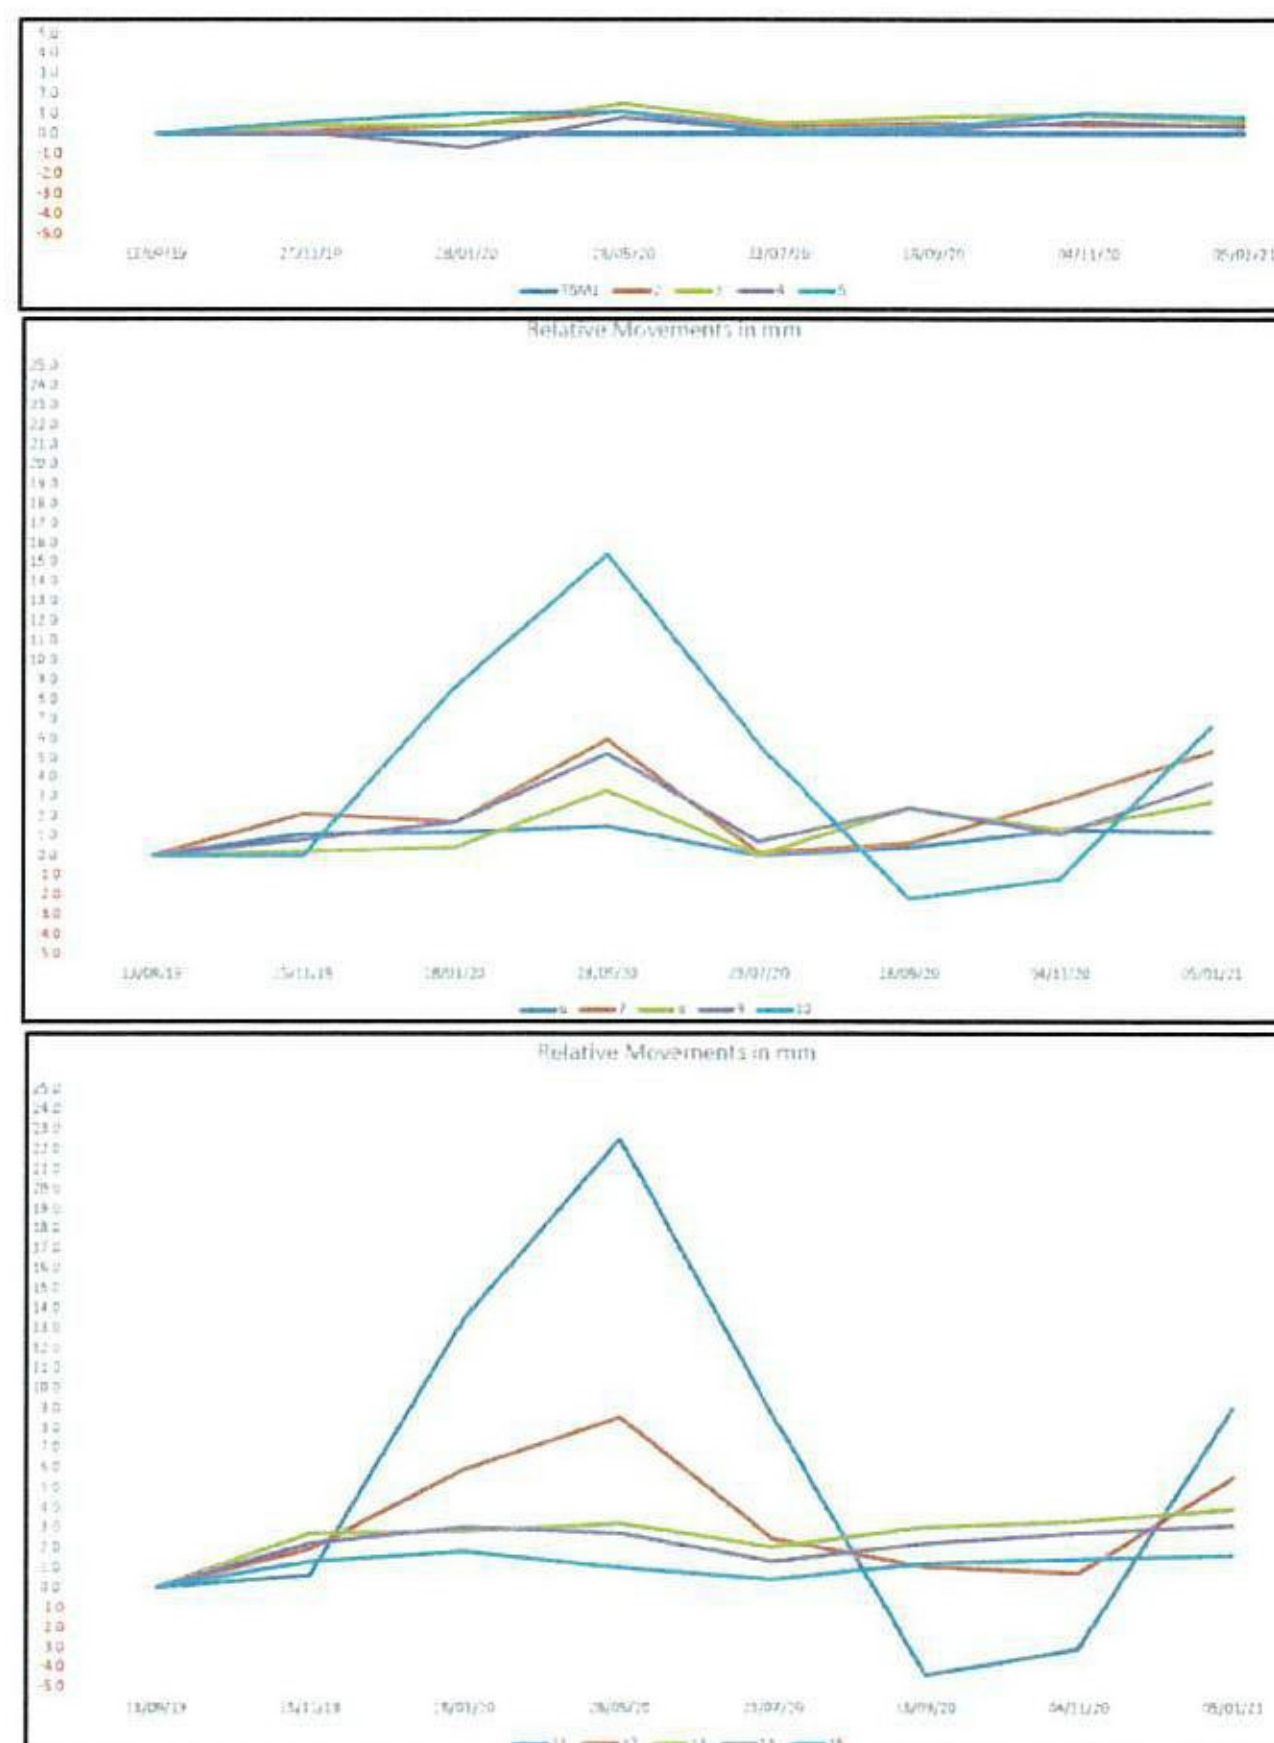
Figure 5. Level monitoring results for the period 13th September 2019 to 5th January 2021. The locations of the monitoring markers are shown in Figure 6.

- 10. Level monitoring, which monitors the level of a building through time (usually on a single brick course), commenced on 13th September 2019 and the latest results available are for 5th January 2021 (Figure 5). The results demonstrate a seasonal pattern of foundation movement, with the building moving downwards in summer and upwards in winter. The maximum amplitude of movement is about 17mm at marker 11, at the rear left corner (Figure 6). This pattern of movement confirms that the building has been suffering from clay shrinkage subsidence damage, which has continued after the removal of T2, thus implicating T3 hawthorn, T4 Norway maple and T6 ash, which, in my opinion, should all be removed.

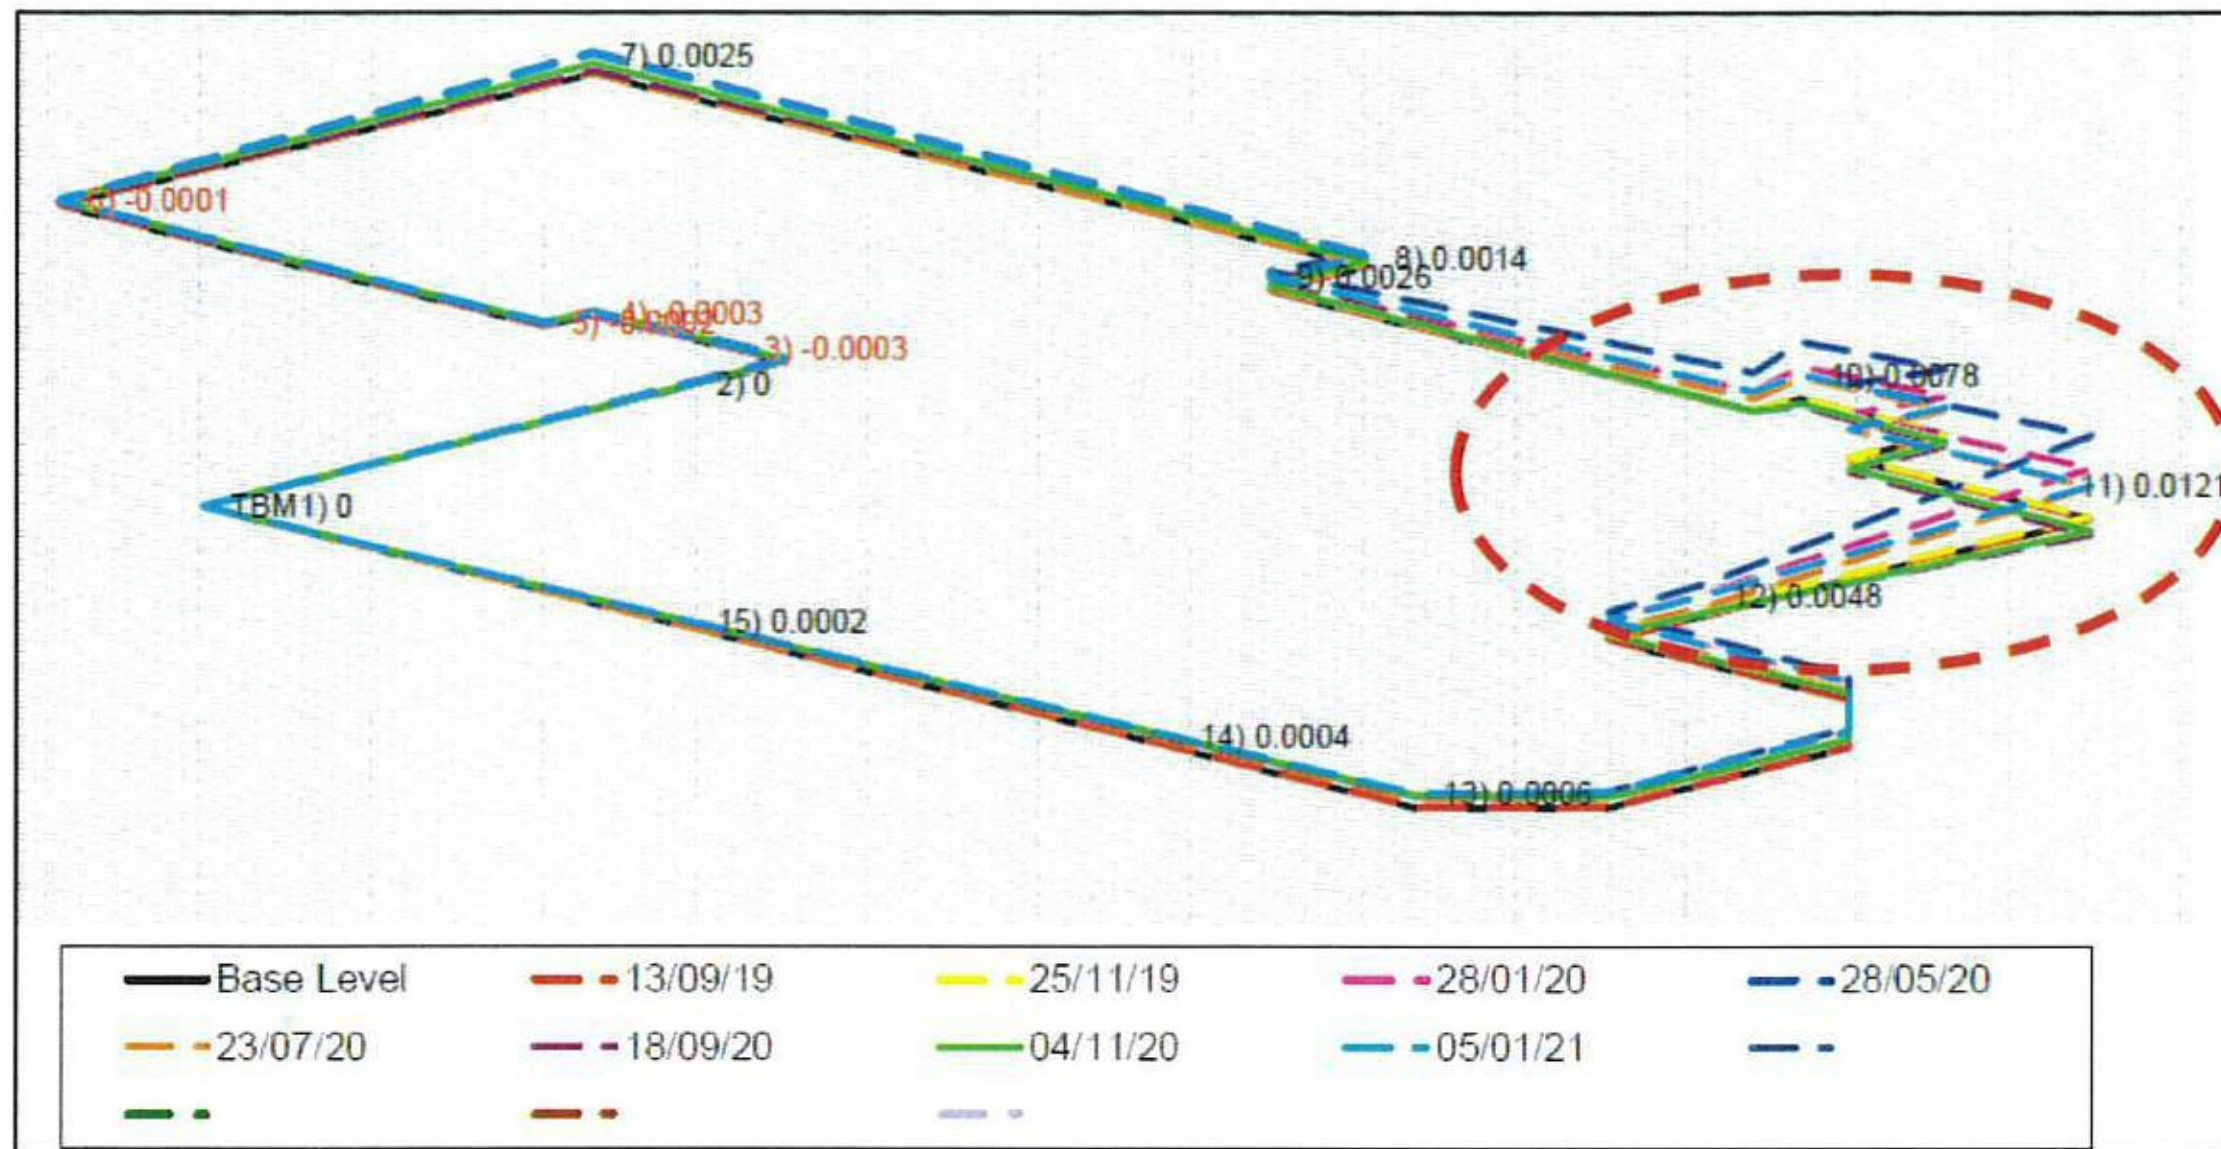
Figure 6. Isometric sketch showing amplitude of subsidence movements at each monitoring marker. The movements are focussed around marker 11 at the rear left hand corner of the property (dashed red line).

13. The evidence reviewed above confirms that 11 Ketcher Green has suffered from tree-related clay-shrinkage subsidence damage which first occurred in the hot dry summer of 2018, and is continuing. The soil below the 1.2m deep foundations is clay with a low to high volume change potential, which is very severely desiccated. Crack monitoring confirmed crack opening during summer 2021, caused by foundation subsidence of around 17mm. This was despite the removal of ash T2 in February 2021, and confirms that the ongoing damage was caused by the remaining trees. The request from DAC Beachcroft is to remove T4 Norway maple and T6 ash. In addition I believe that T3 hawthorn, which is a high water-demand species, should also be removed.

14. I believe that the trees are protected by a Tree Preservation Order, and if so, an application must be submitted to Bracknell Forest Council for removal of T3, T4 and T6. If you submit an application, this report should be provided, together with all the technical evidence, in support of the application.

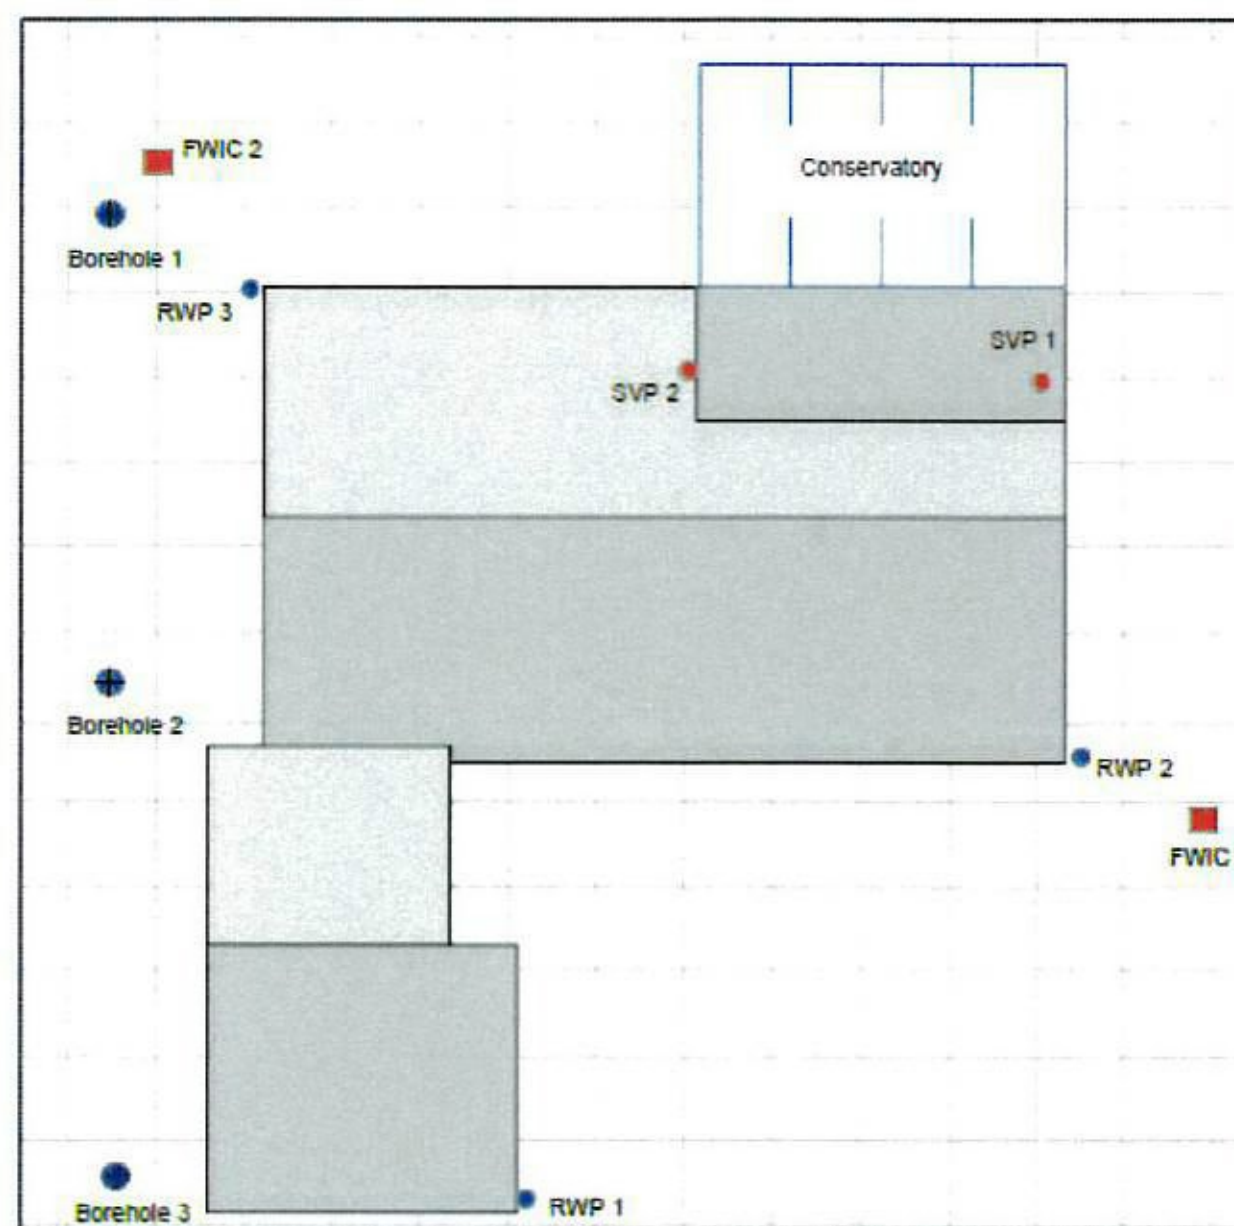
Figure 7. Site plan prepared by Bradgate Surveying.

- On 16th December 2022 Bradgate Surveying issued a site investigation report which provided results from 3 boreholes adjacent to the left hand side of the property (Figure 7). The boreholes extended to about 1.5m and revealed clay of low to high volume change potential, with a plasticity index of 15 – 40% (generally increasing with depth). Roots were observed to a depth of 1.5m but were not identified.

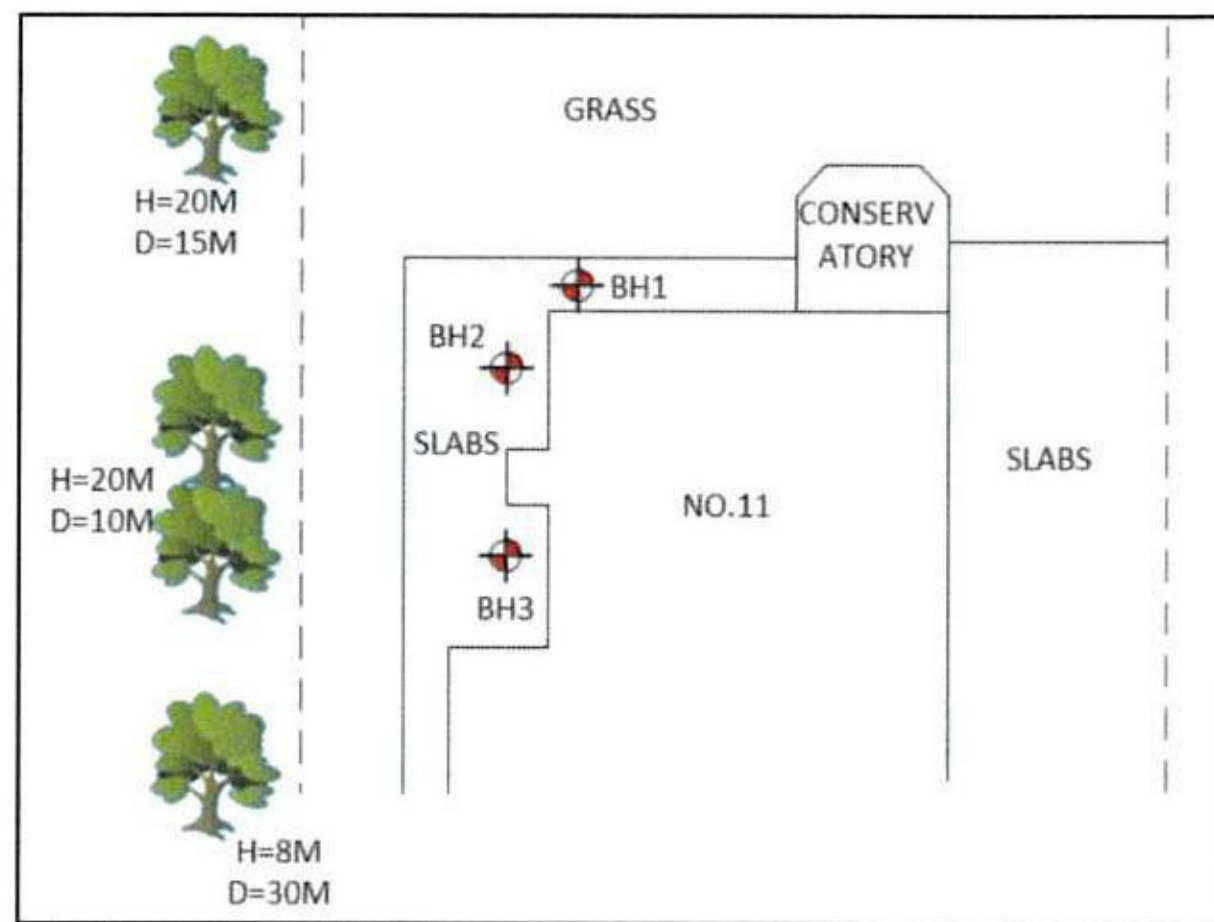
Figure 8. Site plan prepared by ProSite.

- On 2nd April 2023 ProSite carried out a third site investigation which involved opening three boreholes at the rear and left hand side of the property, BH1 – BH3 (Figure 8). In all boreholes the soil was stiff to very stiff silty/sandy CLAY with a plasticity index in the range 19 – 42%, indicating a low to high volume change potential (but generally medium to high). The soil was desiccated in all three boreholes to a depth of around 3m. Roots of maple and ash were found in the boreholes to a depth of 3.3m.
