DESIGN & ACCESS STATEMENT & HERITAGE IMPACT ASSESSMENT THORRINGTON HALL

This statement is written in support of a proposal to repair the timber frame to the property and the Jacobean Staircase within the stair tower.

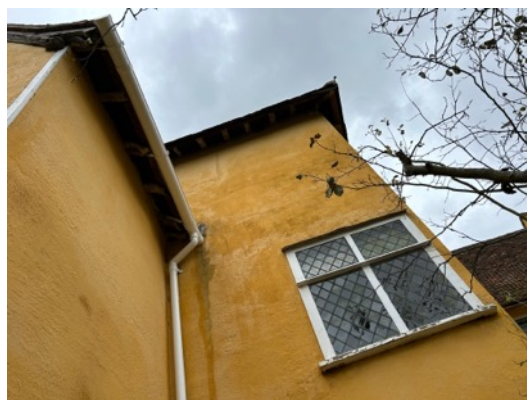
WG1 and gutter overflow above.

It is believed that water ingress into the render is in part due to an unsuitably detailed water outlet at the top of the elevation, for modern rainfall capacity and a lack of rainwater goods generally.

Therefore coupled with the render renewal. The lead valley outlet will be reformed and new rainwater goods will be installed to the roof slopes above. This will ensure that in the future rain is directed away from the elevation rather than the current arrangement, which allows water to directly run down the elevation and into any movement cracks or openings.

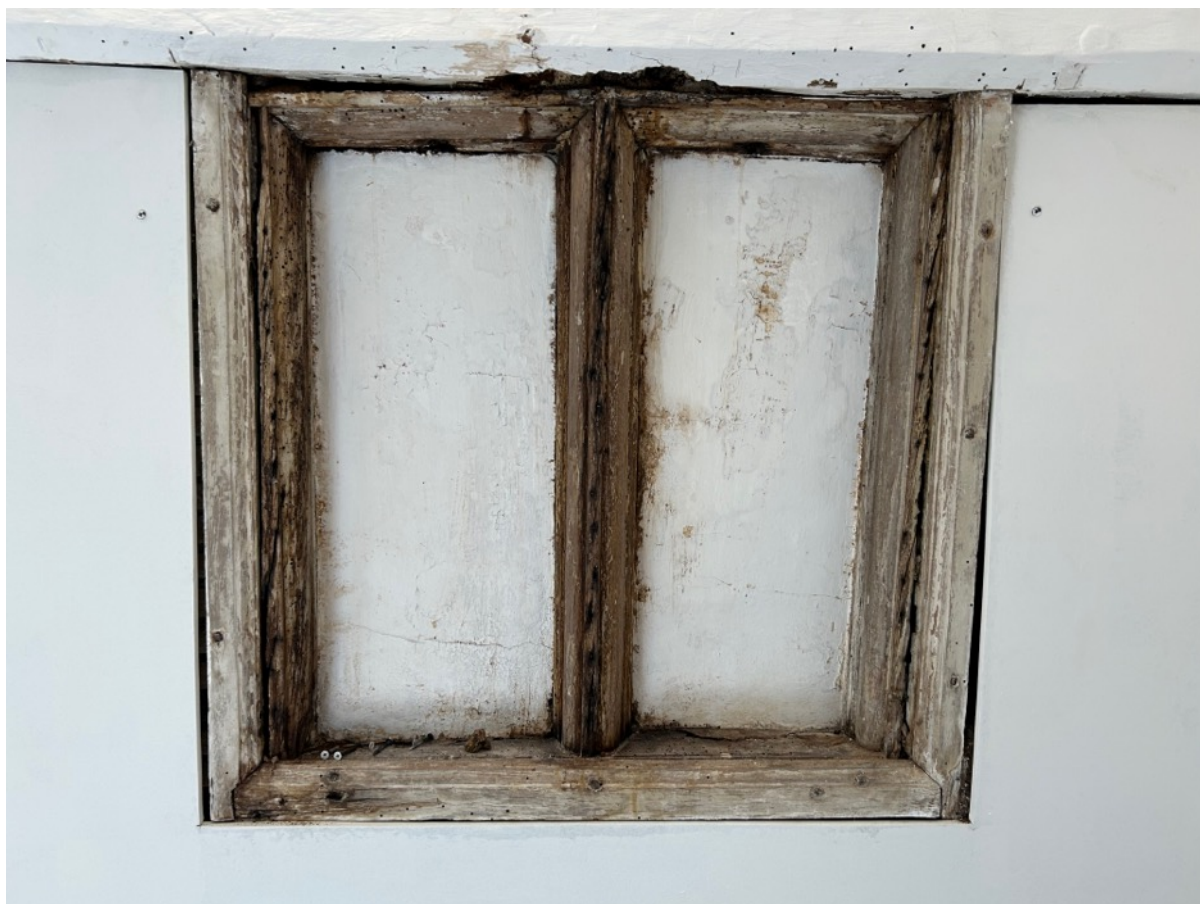
This window is highlighted on the plans as WG3. It is around this window where the water ingress is at its most apparent, and with regret, the remaining window frame is in a poor condition and beyond a reasonable state of repair.

The new window will replicate the detailing of the existing framing in situ, and the new window will be a metal casement, set within the oak frame, as other windows to the property.
