REMEDIATION VALIDATION REPORT FOR THE INDUSTRIAL DEVELOPMENT ON LAND AT PARSON'S YARD, WASHINGTON

PROJECT NUMBER	3955			
PROJECT TITLE	Parson's Yard Depot Site			
CLIENT	Esh Construction Esh House Bowburn North Industrial Estate Bowburn Durham DH6 5PF			
REPORT TITLE	Remediation Validation Report for the Industrial Development on Land at Parson's Yard, Washington			
REPORT REFERENCE	REPORT REFERENCE 3955OR08			
REVISION	Date	Checked		
Rev00	16/10/2023	CM

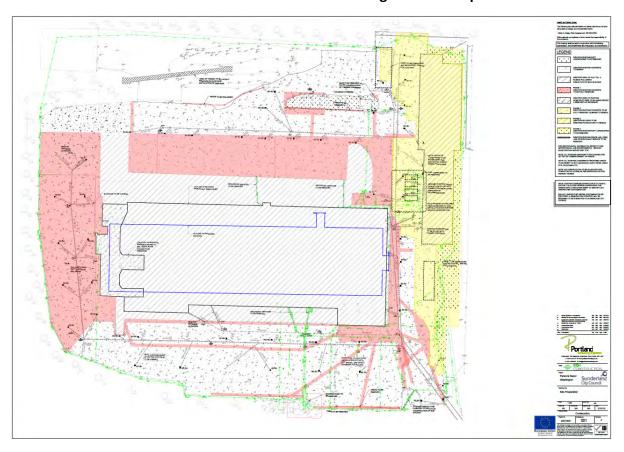
Existing Site Vegetation to be stripped

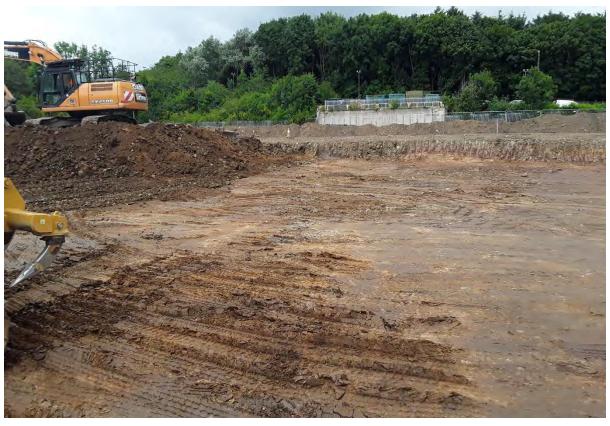
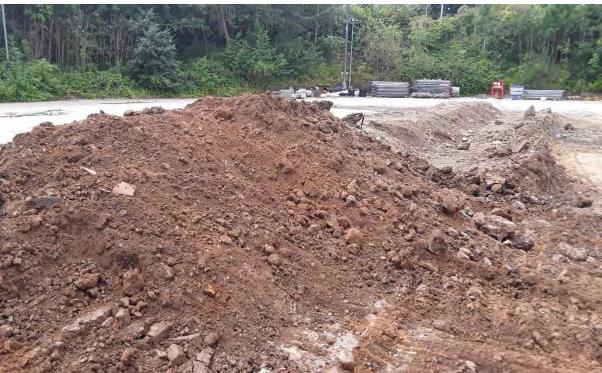
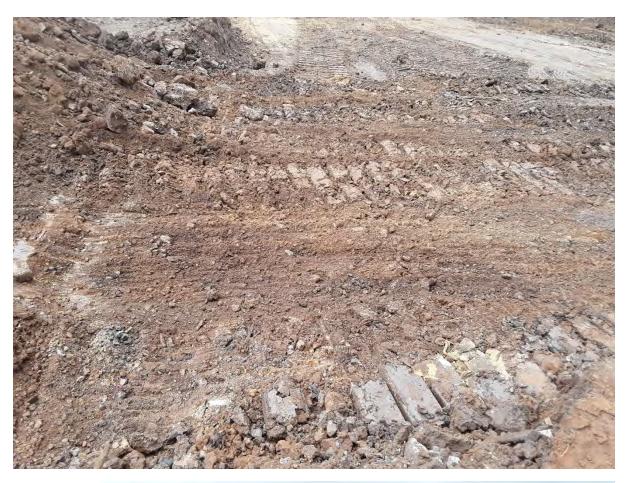
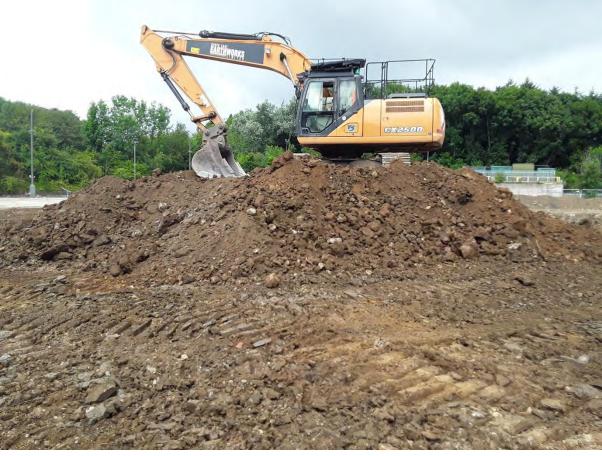
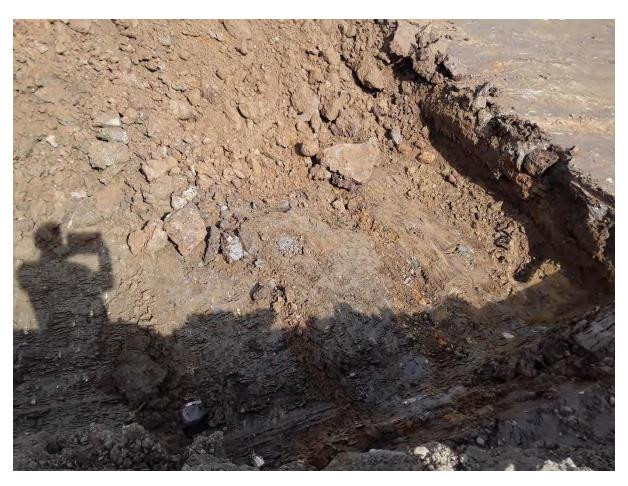
Below Photos Dated 16/08/2021:

Excavation to Formation Area of works is as indicated on Drawing 001 Site Preparation See attached Earthworks Excavation Checklists – Ref No: BEC - 001

No Contaminated Hot Spots Identified During these Works.
