# Arboricultural contact damage report of Nanak Nivas, Chilworth Road, Southampton, SO16 7JS

Carried out by Matthew Rowden on behalf of Jojar Singh, Applicant for the above address.

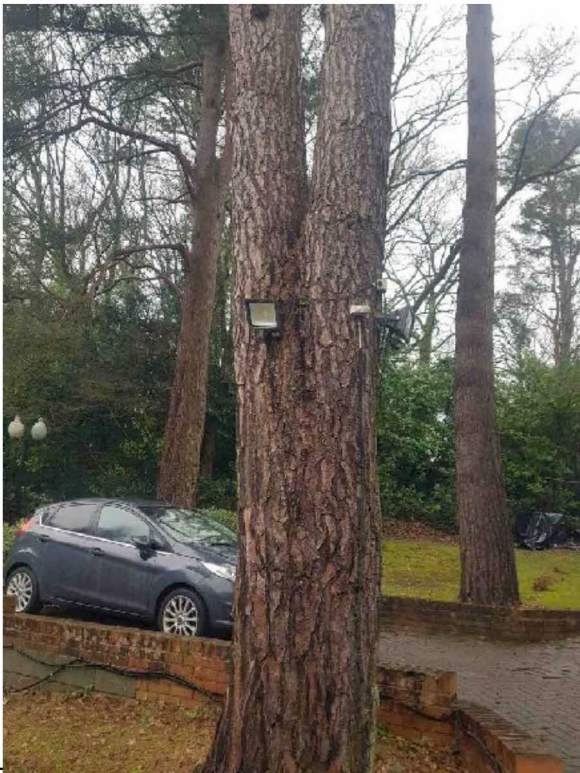
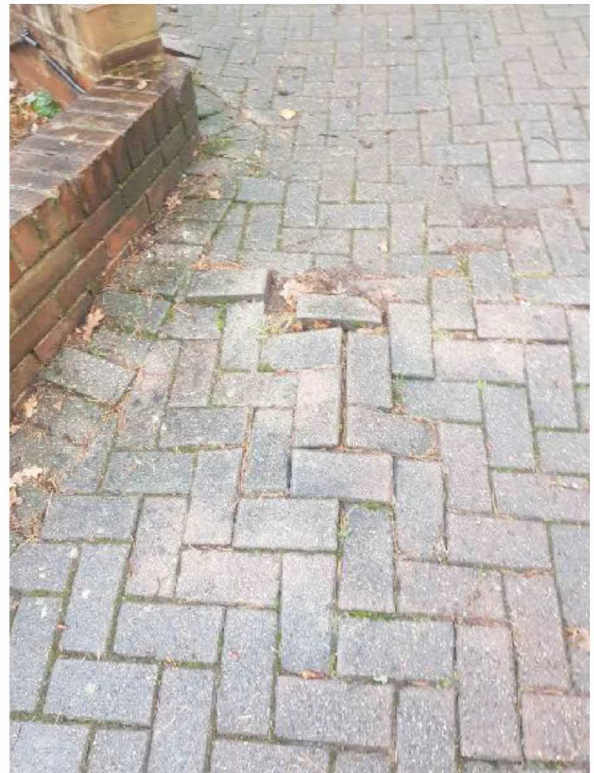
#### T1

- i. T1 is a mature Scots pine with the main stem within 200mm of the wall of the property to the NE aspect of the stem.
- ii. Contact damage has occurred directly in line with the main stem of this tree, with significant cracking and bowing of the wall. The wall is displaced to the North East by 50mm, with cracks exceeding 25mm down the wall (see fig.1).
- iii. The tree has lifted the slabs to the North aspect, causing trip hazards exceeding a height of 100mm.
- iv. The tree has an included bark union at 3m, with a potentially weak and likely point of failure (research by Kane et al. 2008 and Smiley 2003 has confirmed that these unions can entail up to a 50% loss in strength).
- v. T2 is a mature Scots pine within 50mm of the retaining wall to the South aspect.

- Trees 1-4. Fell
- Carry out repairs to driveway after removing the roots from the area. It is likely that the areas of hardcore beneath the gifted slabs will need to be renewed, as the tree roots have pushed between the layers.

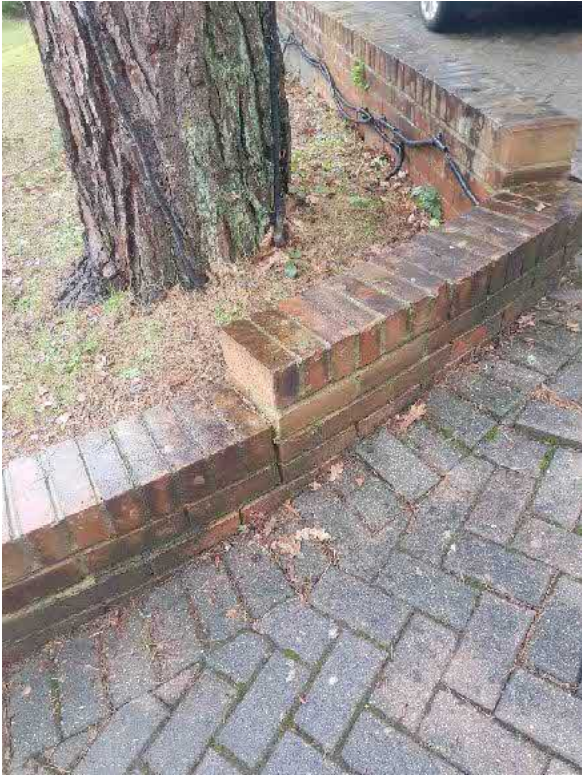
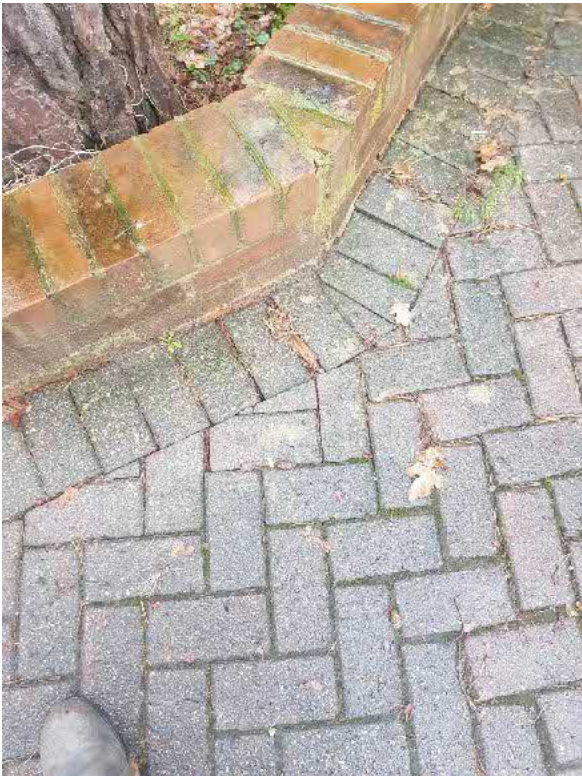
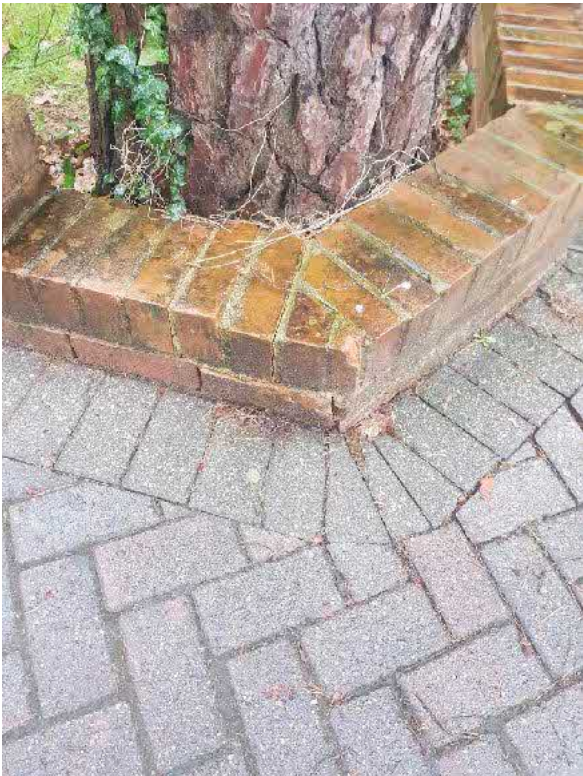
I2

- vi. The wall has been displaced by 50mm as a downward rotation, with cracks exceeding 20mm.
- vii. The slabs to the South aspect in this area have been lifted by 30-50mm.

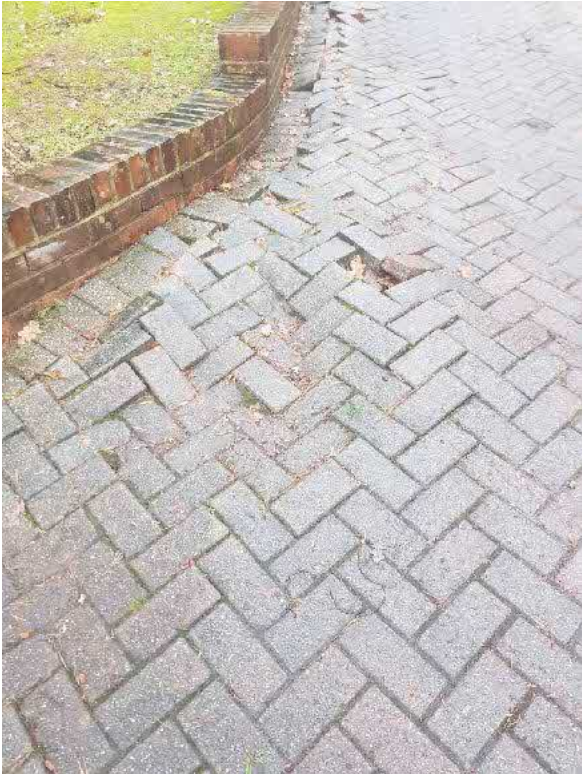
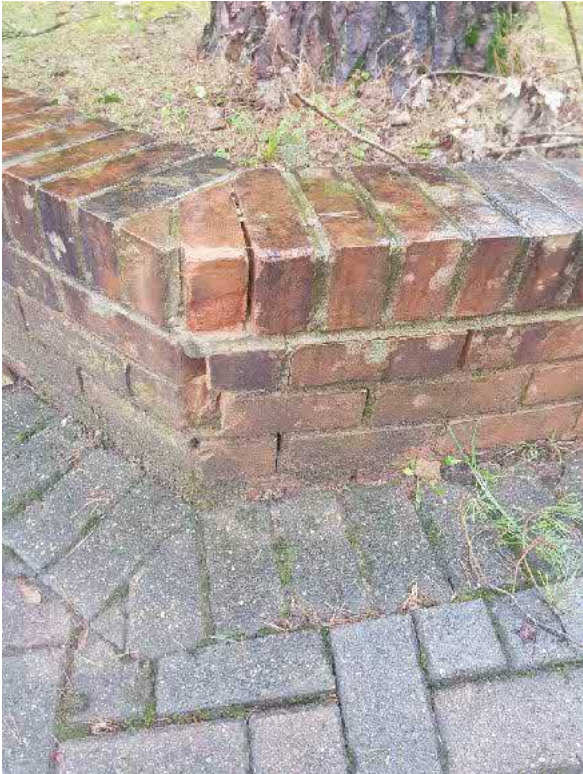
- viii. T3 is a mature Scots pine with its stem within 700mm of the driveway and retaining wall to the North aspect.
- ix. The slabs have been displaced extensively in this area, extending some 5m up the driveway to the West aspect with a trip hazard exceeding a height of 100mm which could also cause extensive damage to vehicles using the driveway.

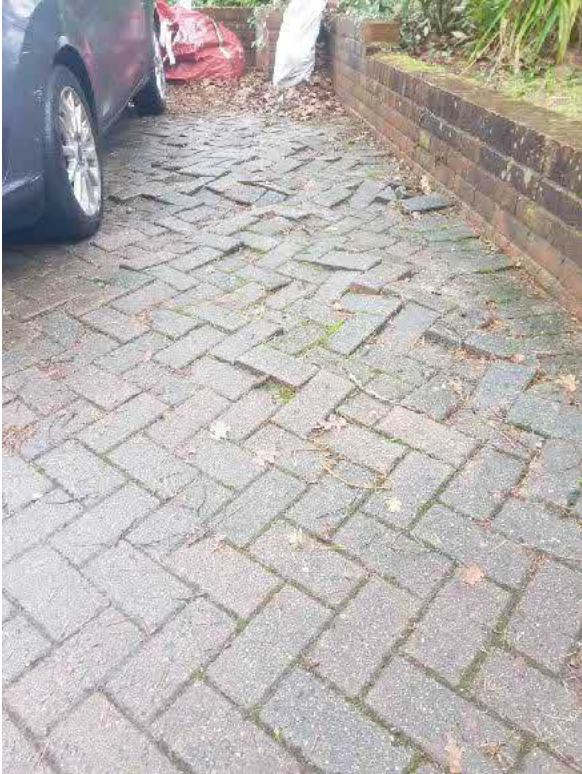
T4

- x. The same is true of T4, although the contact damage from lifting pavings extends to the East aspect throughout the ancillary parking bay.
- xi. The likely rooting area of these trees suggests that around 50% of these trees roots will extend beneath the driveway.
