27th February 2024
Job No: 10297IPS13

The Folly Park House High Street Thornbury

Report on Structural Aspects of the Feasibility of Conversion of a Two Storey Building

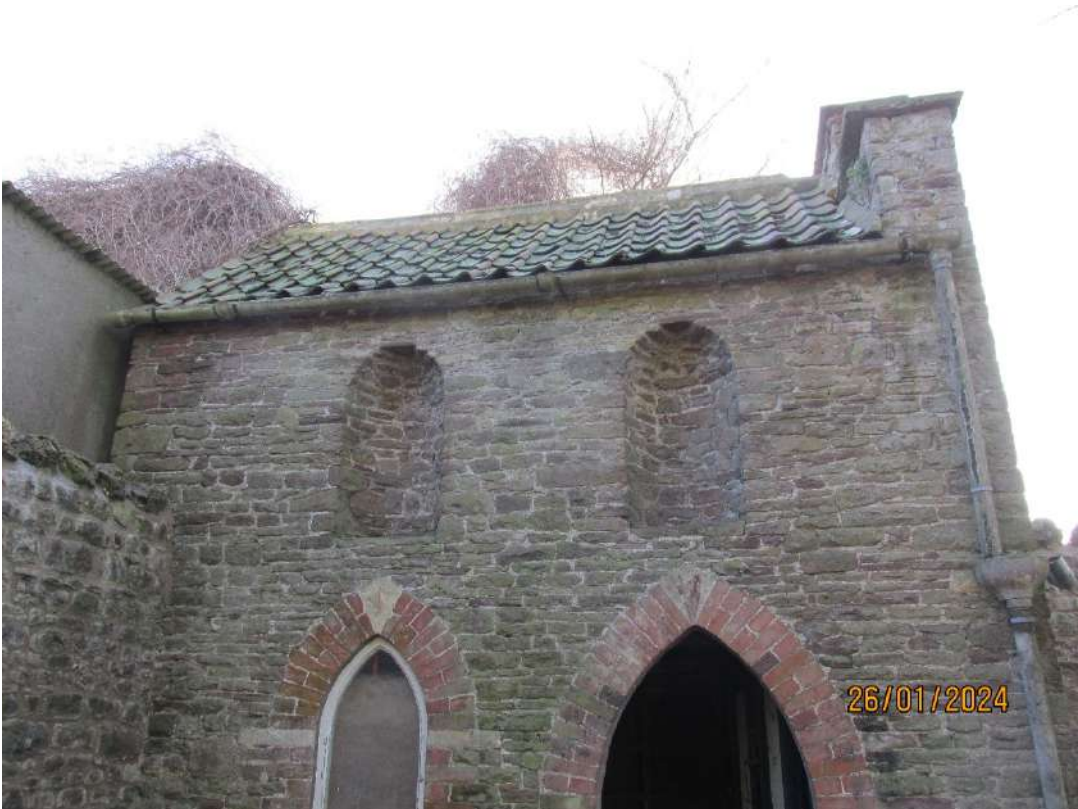
External north elevation of building – First Floor

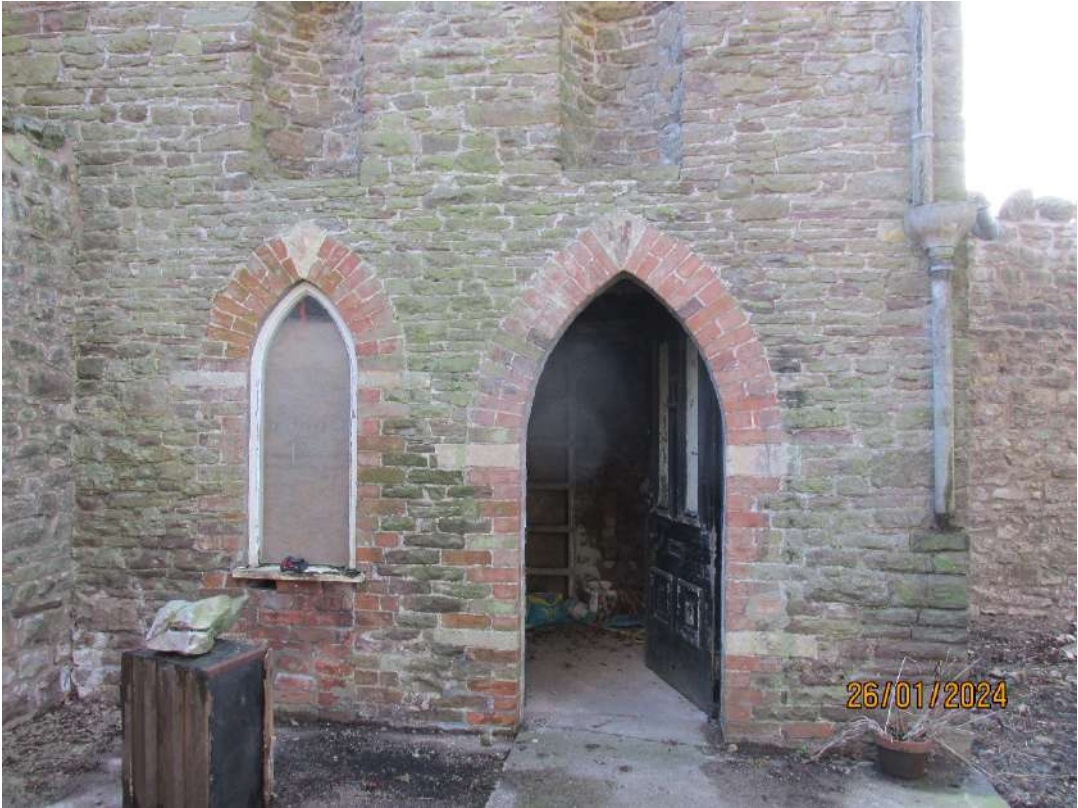
External north elevation of building – Ground Floor

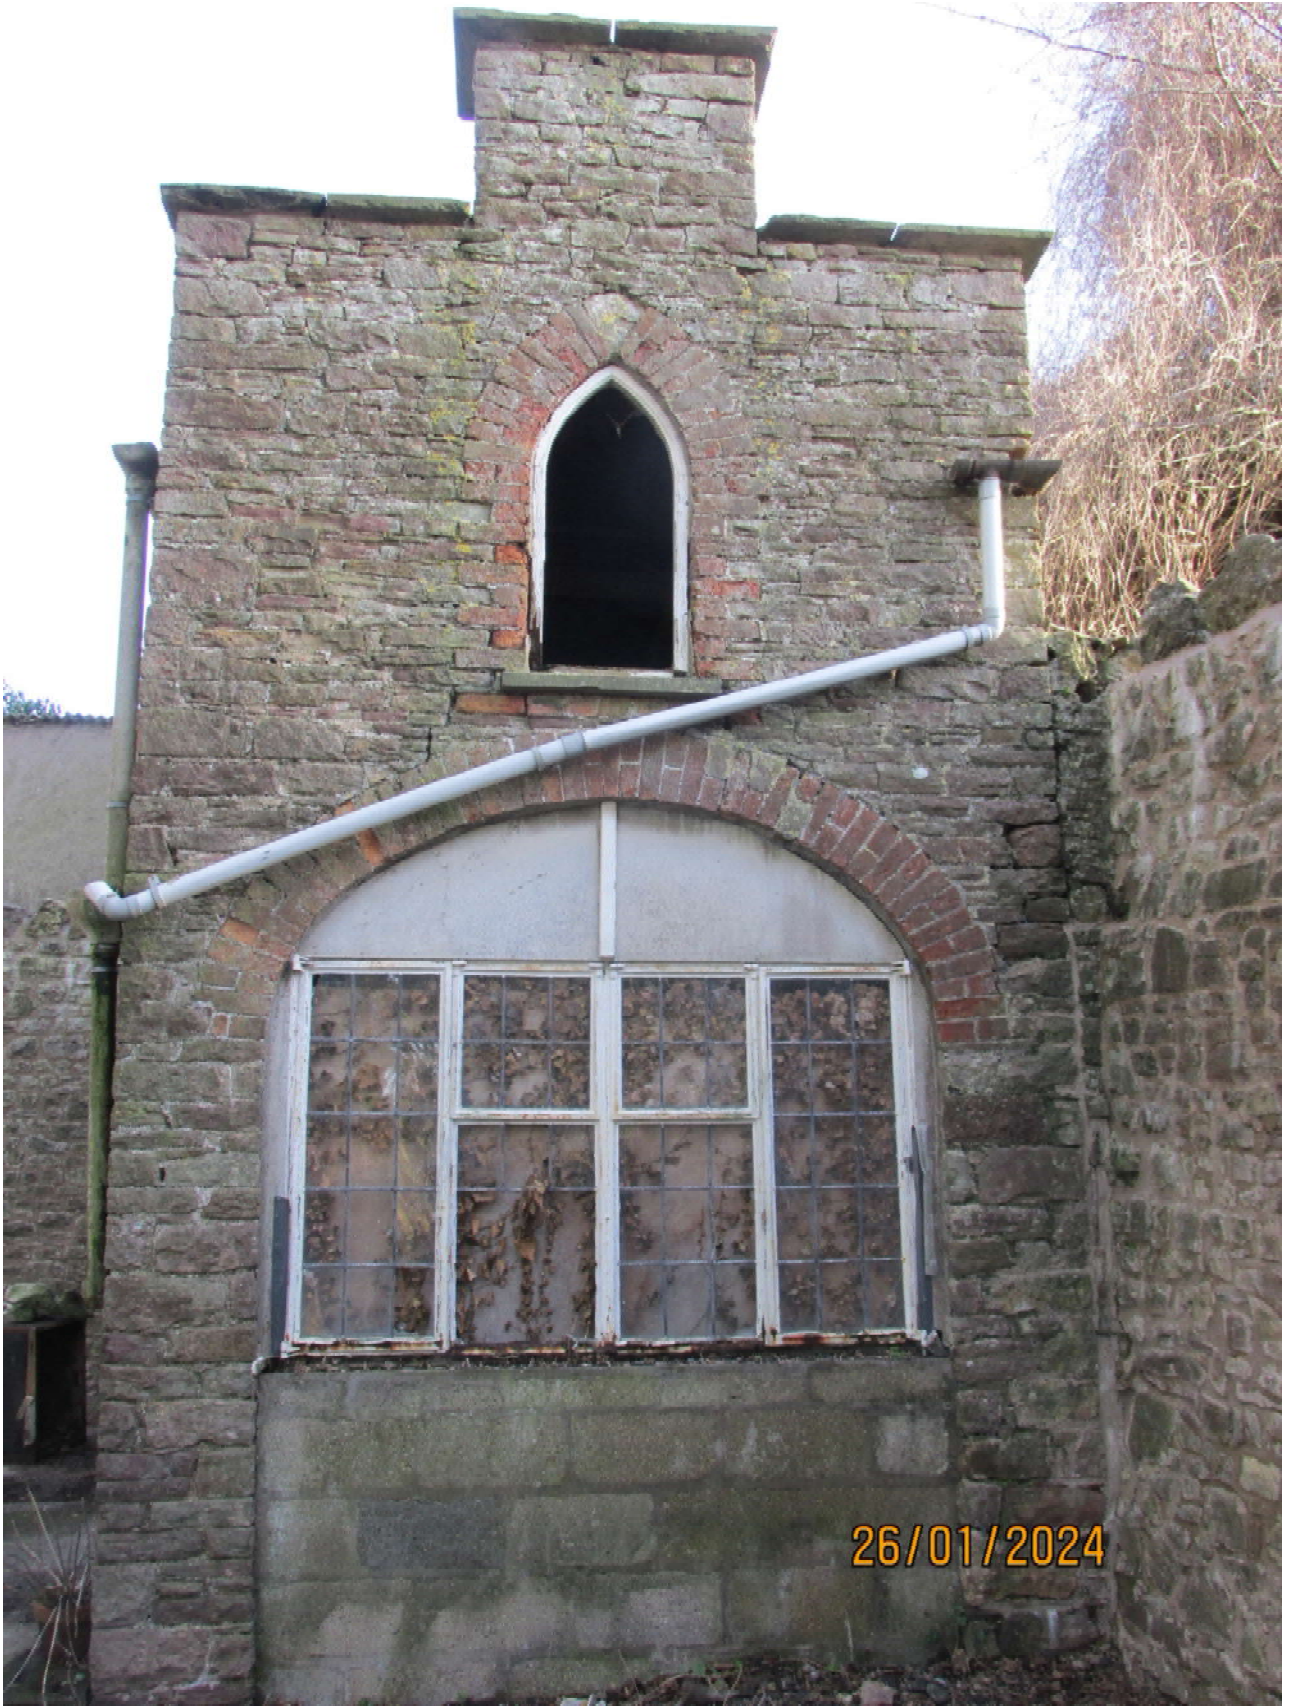
The existing building is currently disused but the masonry of the external walls and roof tiles are in relatively good condition despite it being vacant. There is some cracking of the masonry to the west facing elevation above the ground floor window but this is believed to be due to minor movement of the brick arch rather than a major structural issue. The same window is, we believe, a later addition as below sill level, the construction is concrete blockwork. Internally, the walls are a mix of stone and brickwork and there are patches of plastered and unplastered finishes. There are no signs of significant cracking of the walls that might indicate ground movement.

External west elevation of building

Generally, the structure is in a good condition although some minor remedial works will be required such as stitch repairs to the masonry of the west facing gable walls and preservative treatment of the existing timbers that will remain. Insulation and finishes will need to be incorporated to the walls and ground floor slab as part of the conversion work to satisfy Building Regulations but these elements are not considered structural and the external profile of the building will not change.

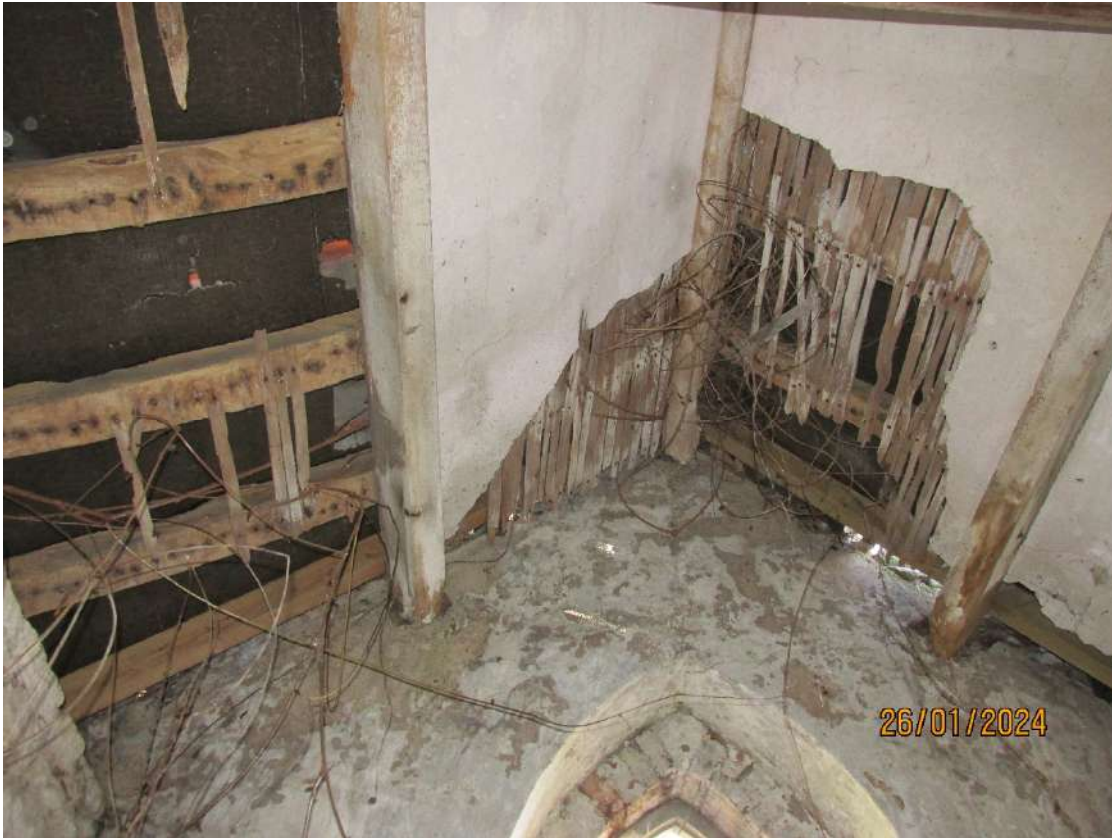
The first floor level has not been inspected as this will be removed and the space left as a double height with vaulted ceiling in the proposed conversion. The roof timbers are relatively sound although there is some minor decay at the eaves where the rafters bear onto the external walls. The finishes, i.e. lathe and plaster ceilings follow the roof pitch, the lathes being fixed to the rafters. However, areas of the plaster have collapsed exposing the rafters

Internal Elevation of west gable wall showing roof structure

- Removal of existing finishes (lathe & plaster) to the interior of the roof and inspection of the existing timbers. No strengthening of the roof structure is envisaged as the replacement finishes and new insulation to the inside of the roof will be equal to or less than the existing load. Preservative treatment to all structural timber will be required.
- Crack stitching to the brick arch over the window within the west facing elevation of the building prior to removal of the window and masonry below sill level. The arch is considered to be self supporting but as there are a number of cracks in the mortar, minor repairs will ensure long term stability.

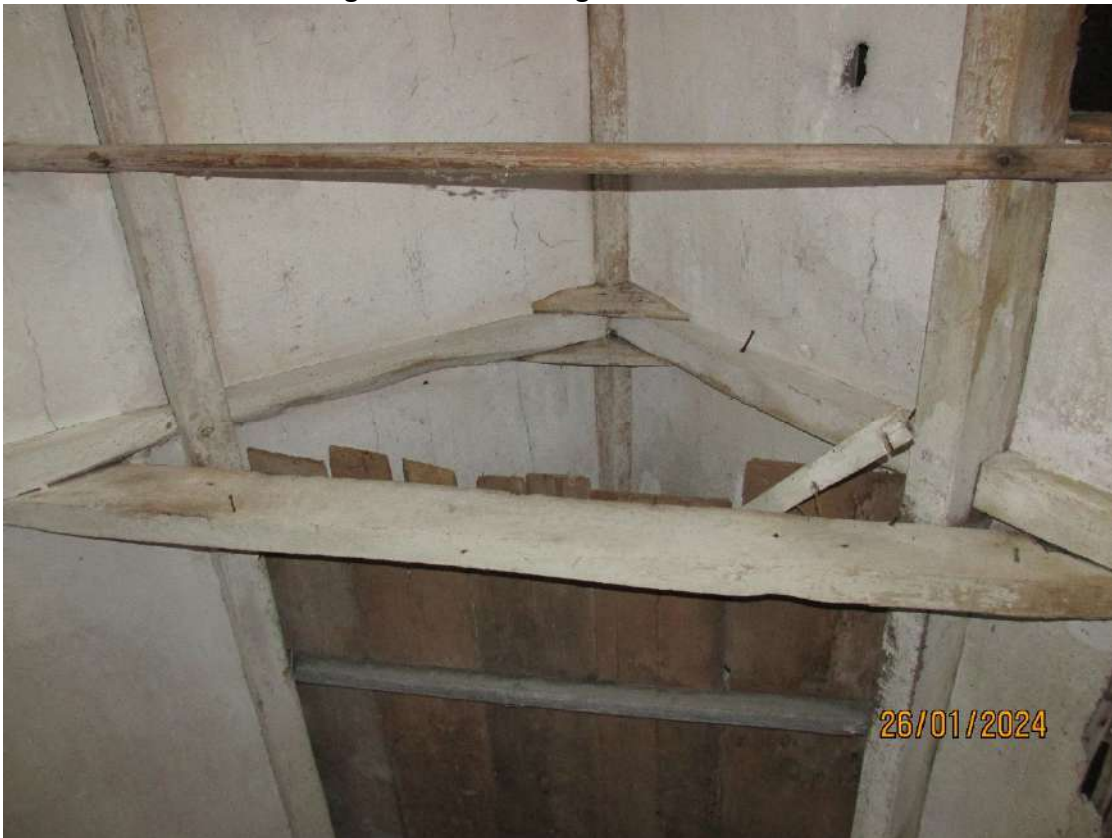
Internal Elevation of roof showing rudimentary truss
