Summary Condition Survey

The Old Stags Head, 65 Church Hill, Penn, Wolverhampton
WV4 5JB

March 2023

3B1Y Limited

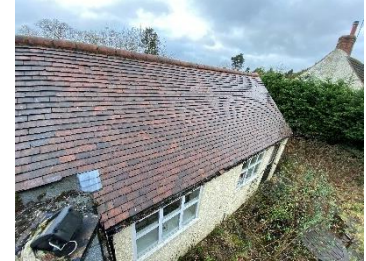
- 5.1 The pitched roofs to the property are generally in a poor condition, with numerous damaged or missing clay tiles. Evidence of historic leaks can be seen internally.

Any damaged or missing tiles should be replaced/reinstated as part of the repair works. Furthermore, there is a lack of insulation between the rafters or above the ceiling within the roof void. The property would benefit from the installation of insulation within the ceiling void to improve the thermal performance. Lead lined valley / upstands also are in poor condition and should be replaced as part of any repair works.

2.1	Pitched Roof Works	
2.1.1	Strip clay tile roof covering including existing battens and felt.	£2,635.00
2.1.2	Replace any missing/damaged tiles.	£500.00

2.1.3	PSUM - allowance for repairs to the roof structure including but not limited to rafters, ridge board, wall plates etc.	£15,000.00
2.1.4	Provide and install new battens and breathable felt underlay and reinstate existing clay tiles.	£16,275.00

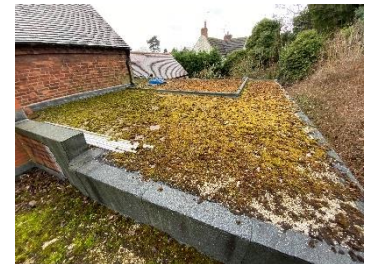
- 5.2 The felt covering to the flat roof areas are in poor condition with significant moss and algae growth covering the roof. The age of the roofs means they are likely reaching the end of their serviceable life and therefore recommend full replacement as part of any refurbishment works. Due to the need to replace the roof covering, building regulations Part L would require the thermal performance to be improved.

2.1.8	Replace all timber fascia boards.	£1,375.00
2.2	Flat Roof Works	
2.2.1	Strip up existing felt roof covering including allowance to clear vegetation growth.	£1,344.00

2.2.2	Carry out repairs / replace any moisture damaged sections of the timber deck ready to receive new waterproof covering.	£8,064.00
2.2.3	Supply and install new felt roof covering with new insulation to meet current building regulations.	£12,320.00

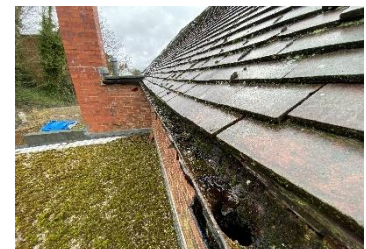
- 5.3 Rainwater goods are generally in a poor condition with failed seals, blockages and loose supports and will be contributing to issues of ingress. Rainwater goods require wholesale replacement.

2.1.6	Replace existing lead detailing including but not limited to lead line valley/gutters and stepped flashing details.	£7,500.00
2.1.7	Remove and dispose of existing rainwater goods and install new gutters and down pipes to match existing arrangement.	£2,090.00

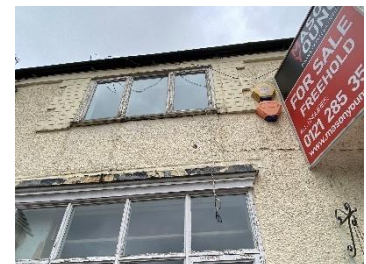
- 5.4 Rendered elevations are generally in fair condition with isolated hairline cracking and deboned sections of render. Areas of cracking and deboned render will require hacking off and reapplying as part of repair and refurbishment work.

2.3.1	Hack off any hollow, de-bonded and cracked render and reapply new rough cast render to match existing.	£3,400.00
2.3.2	Fully and professionally clean all elevations including render, painted brick and fair face brick.	£1,420.00

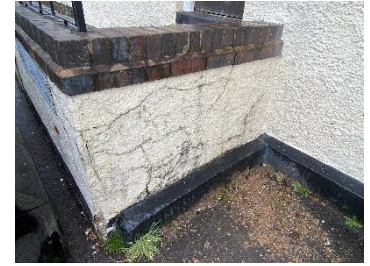
- 5.5 Paint finishes to the to the render and brickwork are generally in poor decorative condition with general heavy soiling and the property would benefit from a full external redecoration to previously painted areas.

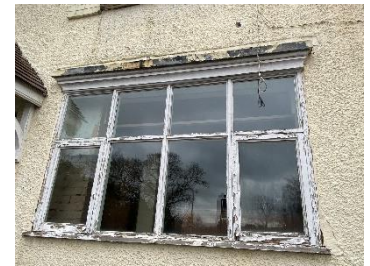
- 5.6 The timber framed windows are in a very poor condition with numerous broken panes and timber decay to the frames, cills, transoms and mullions. Works to replace all window should be undertaken with double glazed unit installed.

2.3.5	Remove all windows and replace with new double glazed equivalents to existing locations.	£24,150.00
2.3.6	Remove all existing external doors and provide new modern equivalent.	£3,150.00

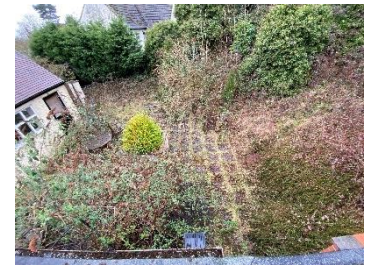
- 5.7 Hard landscaped areas to the left and right of the property are in poor condition. The concrete paving slabs to the left hand side are uneven and subject to significant vegetation growth between the slabs. Repair works will require cutting back all vegetation, removing the slabs and relaying on a new substate replacing and damaged paving slabs. While removed all slabs should be cleaned. A full jet wash of the concrete hardstanding to the right of the property should be carried out removing all debris.

2.4.3	Jet wash all hard standing areas.	£1,275.00
2.4.4	Undertake repair to the concrete hardstanding.	£2,500.00
2.4.5	Remove concrete paviours and set aside for reuse. Prepare substrate to ensure level. Relay concrete paviours and replace any which are damaged.	£6,612.00

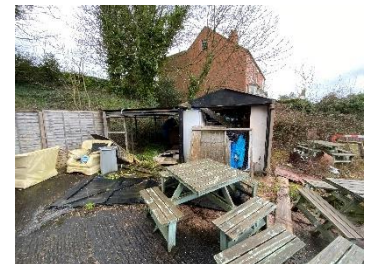
- 5.8 Two garages/sheds are installed to the right hand side of the property. These are in very poor condition and subject to their requirement, should either be demolished and removed from site or will require wholesale replacement with new structure and external building fabric.

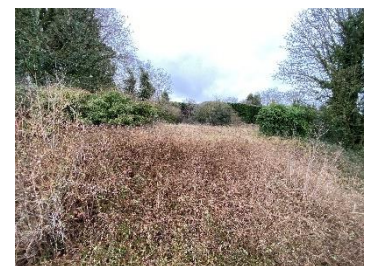
- 5.9 Soft landscaped areas are generally in fair condition albeit has become overgrown in areas and would benefit from routine maintenance.

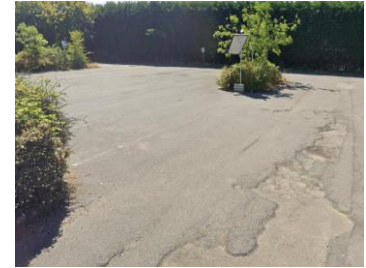
- 5.10 The car parking areas to the front of the property is generally in fair condition with isolated potholes and general surface deterioration of the tarmacadam surface and should be patch repaired as part of any refurbishment works. The line markings to the parking spaces are subject to significant deterioration and will require renewal.

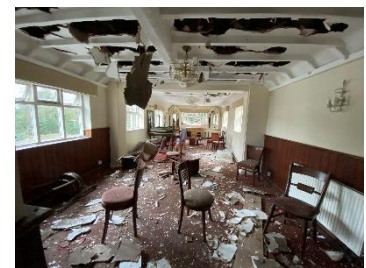
- 5.11 Internally, the finishes are in very poor condition and subject significant deterioration and damage and we recommend that all the finishes are stripped back to the substrate so repairs can be carried out. Following repairs to the substrate finishes can be reinstated.

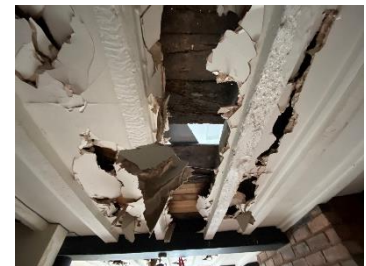
- 5.12 Ceiling finishes are damaged beyond repair due to vandalism to the property. New plasterboard, skim coat and redecoration will be required throughout the property.

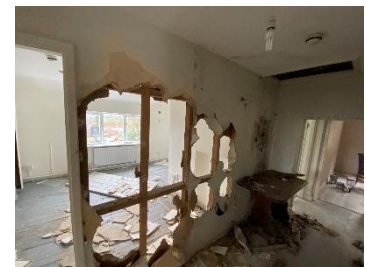
- 5.13 Wall finishes are damaged beyond repair either due to vandalism or subject to mould and rot. New plasterboard, skim coat and redecoration will be required throughout the property.

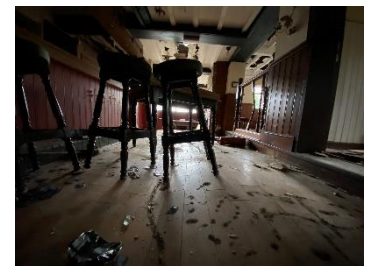
- 5.14 Floor finishes are also in poor condition with bowing and warped floors noted at ground level with full refurbishment of floor structure and finishes is required. Following repairs to the substrate a new latex screed will need to be applied to allow for new floor finishes.

3.1.9	Strip out any remaining pipework / heating to the unit including boiler.	£3,720.00
3.2	Repairs	
3.2.1	PSUM - Undertake repairs to floor joists.	£25,000.00

3.2.2	PSUM - Undertake repairs to exposed wall substrate	£10,000.00
3.2.3	PSUM - Undertake screed repairs where required.	£15,000.00
3.3	Services Installations

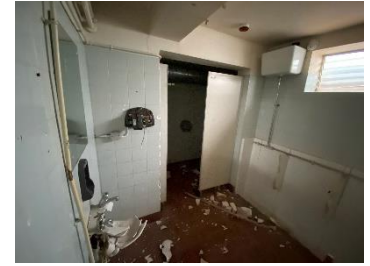
- 5.15 Fixtures and fittings to the property are in poor condition and have been damaged during the period of inoccupation. Bar, sanitary installation, kitchen, and commercial kitchen will need to be stripped out and reinstated with new as part of any refurbishment.
