# **Report on proposed fire treatment measures and Heritage impacts on ceilings at Corn Exchange Road , Stirling**

ZMARCHITECTURE LTD September 2023 **Revised 26.10.2023, recommendation added**

Author Peter Richardson RIBA Architect, Survey Nicholas Blair, RIAS Cons accredited Architect

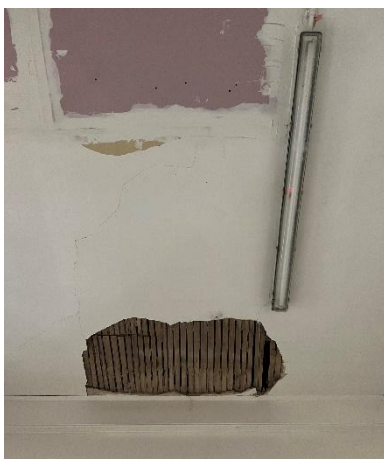
5.1 Beer store

This ceiling has been patched with plasterboard and there is a patch of missing plaster on the lath. It is **not** suitable for the application of intumescent paint and should be fully sheeted with 2 layers of Fireline board.

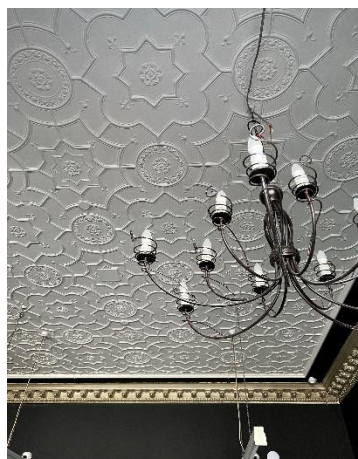
5.2 Office

This ceiling features cornicing and ornamental strapwork. It is in good condition although a treatment to fire protect surface mounted cables and light fittings is required. There are some timber plates where formerly suspended light fittings were hung, these should be removed and made good with plaster before the intumescent application.

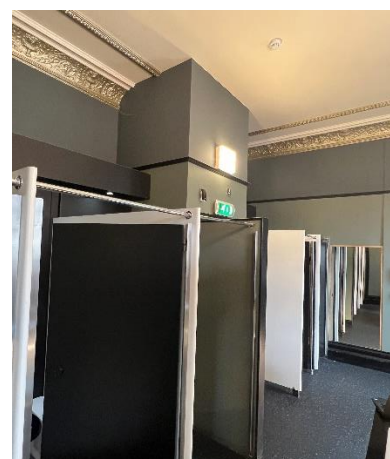
5.3 Female wc

The ceiling features original plaster ceiling roses and perimeter cornicing. Condition is generally sound although there are some minor cracks and evidence of plaster repairs. The modern lobby cuts into the cornice and there could be a potential loss of cornice here. The lobbies should have the same treatment if the original ceiling here is retained.

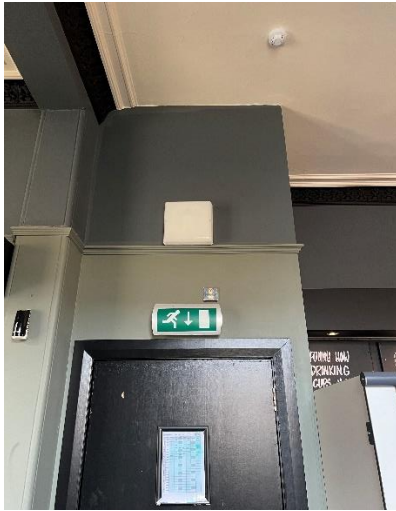
5.4 First floor gents wc

The ceiling features original plaster ceiling roses and perimeter cornicing. The condition is generally sound. The modern lobby cuts into the cornice and there could be a potential loss of cornice/ lath and plaster here. The lobbies should have the same treatment if the original ceiling exists.

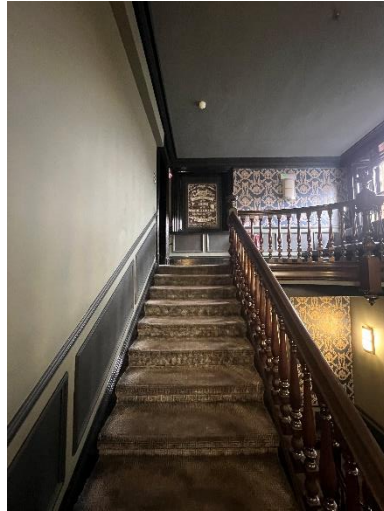
5.5 First floor stairwell

Condition fair, some evidence of plaster repairs and hairline cracking.

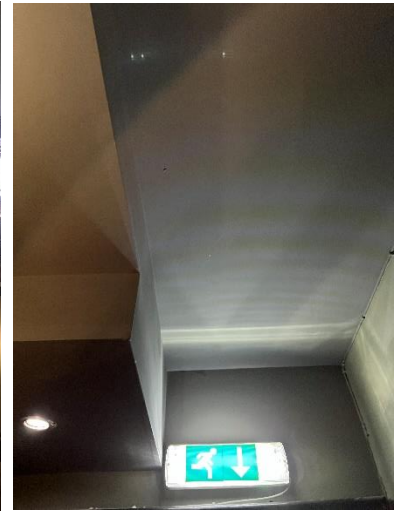
5.6 First floor circulation

This area contained a plasterboard downstand and no inspection of the original ceiling was possible.

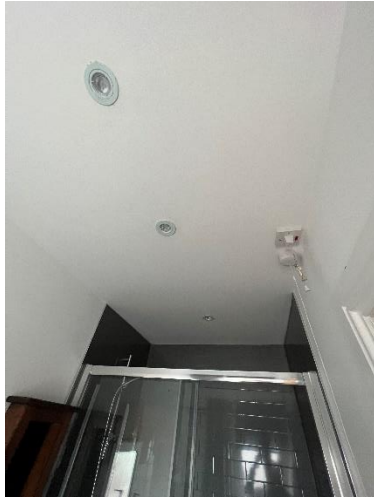
This ceiling is evidently lower than the original ceiling and suspended, it is in good condition but should be double sheeted to maintain 1 hour fire resistance.

Suite 05 2<sup>nd</sup> floor en suite

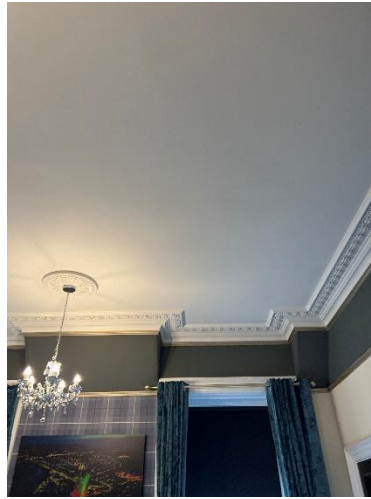
The ceiling is original and apart from minor hairline cracks is in good condition. There is evidence of plaster skim coat repairs and 2 recessed downlights penetrate the ceiling plane. It is not possible to tell if the lights have fire rated domes or encapsulation. The two ceiling roses are non original and the material should be checked that its non combustible / or be appropriate for the Envirograf application. The ensuite partitions are scribed to, or cut the cornice and this ceiling is lowered plasterboard, again this should be double sheeted to maintain the 1 hour resistance performance criteria.

Suite 04 2<sup>nd</sup> floor ceiling rose

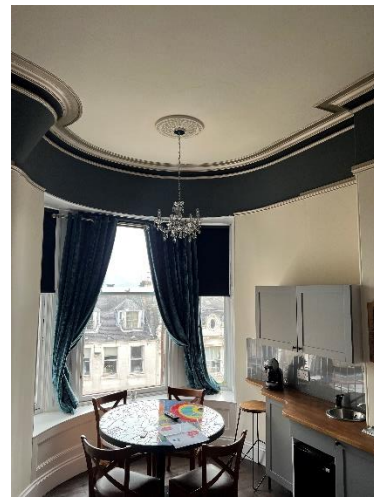
This ceiling is original lath and plaster and in decent condition. There are hairline cracks showing in places and some minor defects. The ceiling roses are non original and the same comment for Suite 04 applies. If they are plaster and non combustible, they should be satisfactory for application.

In the adjoining en suite, again the ceiling is lowered and finished in modern plasterboard. This ceiling is penetrated by an extract fan and duct which will affect performance and fire resistance.

Suite 03 ceiling rose

A fire damper should be fitted to the fan grille or duct aperture, where the ceiling is punctured.

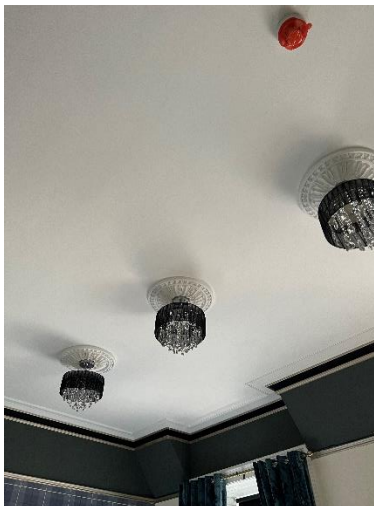
This ceiling is original lath and plaster and in decent condition. There are 3No. non original ceiling roses, if they are plaster and non combustible, they should be satisfactory for the Envirograf application. In the adjoining en suite bathroom, again the ceiling is lowered and finished in modern plasterboard. This should be double sheeted with fire line board to achieve fire resistance.

Suite 02 2<sup>nd</sup> floor ceiling roses and smoke detection

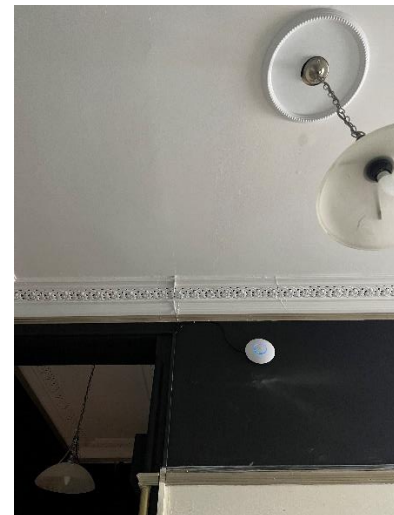
This ceiling is original lath and plaster and in decent condition, with some minor cracking. We note some embedded wiring and a partial loss of some cornice in areas, but the lath and plaster is intact.

There is a large suspended light fitting within the ceiling on a circular plate and it is not possible to know if this is fitted with a fire rated dome or cup. The seal at the cabling should be tightly sealed with intumescent mastic.

Stairwell embedded wiring and light fitting
