## Drainage Investigation Report

### For Subsidence Management Services

**Risk Address:** 36 Yeomead, Bristol, BS48 1JA

**Report Date:** 23rd November 2022

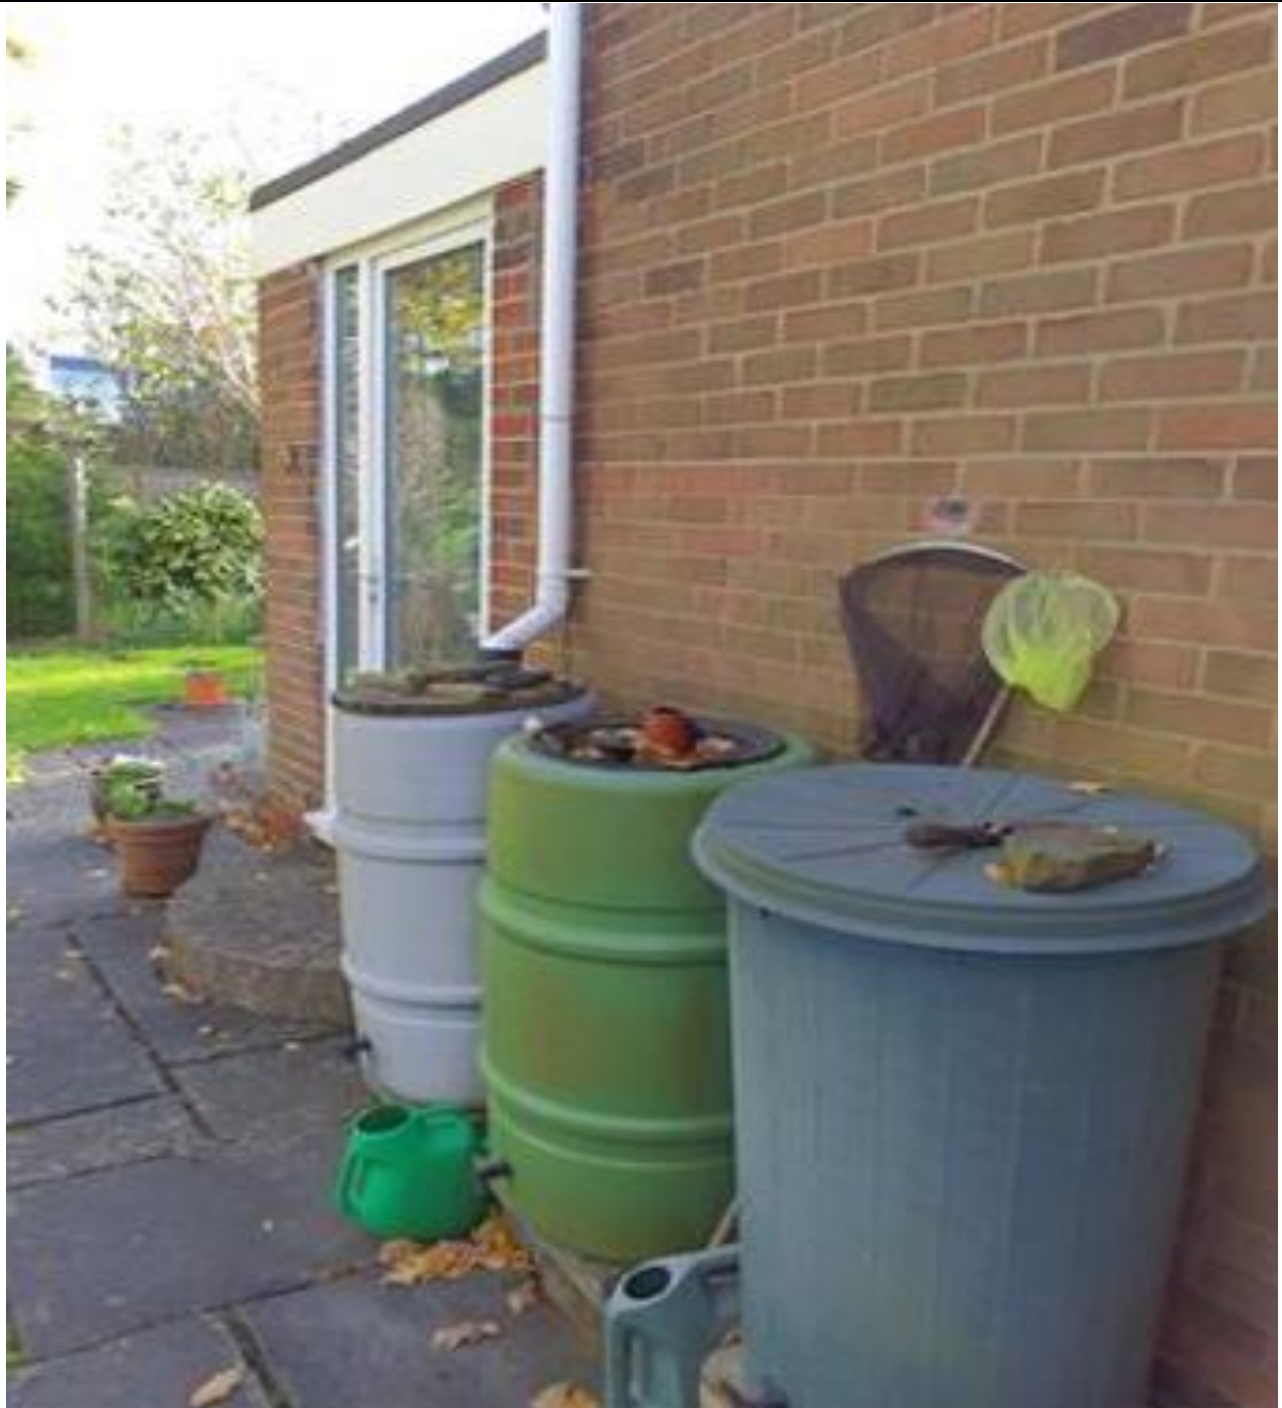
RWP3 is discharging into a water butt - see photos

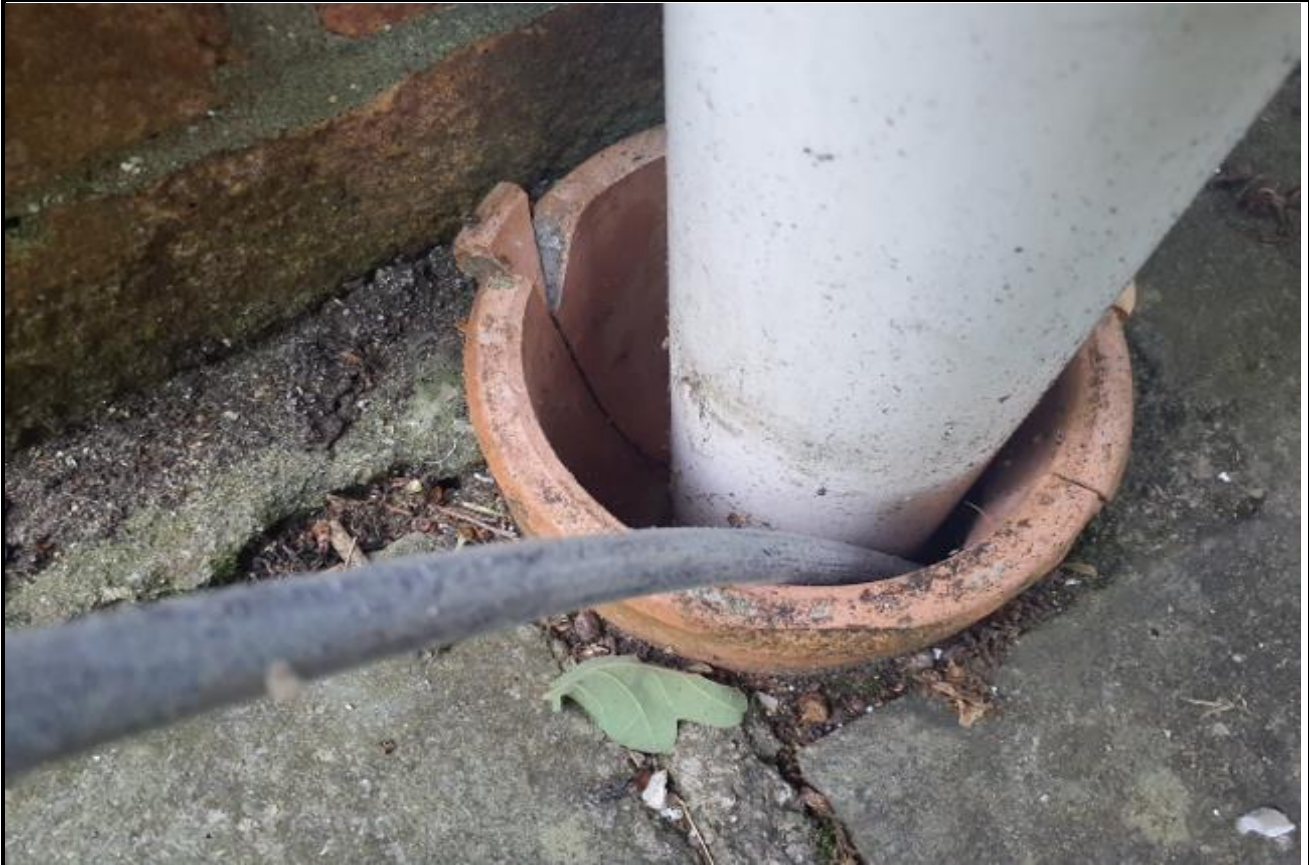
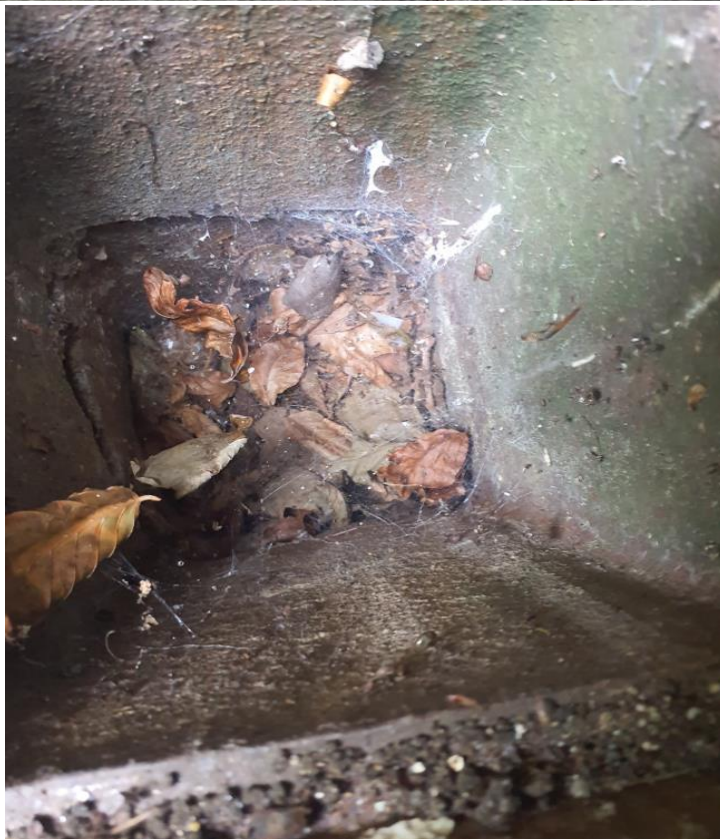
We found there is a gully at the base of RWP3 and another downpipe close by. These are noted as Runs G&H in the updated report/site plan

We also noted there is a gully at the neighbouring property (RWG2) which is in the area of concern.
