Arboricultural Consultancy for Aviva

Insured	Mr Gordon Lindley	Address	36 Yeomead, Nailsea, Bristol, BS48 1JA, Nailsea, Bristol, BS48 1JA		
Client	Subsidence Management Services	Contact	Brad Jenkins	Claim No.	IFS-AVI-SUB-22-0101951
ES Ref	SA-251632	Consultant	Simon Nash	Contact No.	0330 380 1036
Report Date	11/01/2023

GEOTECHNICAL

36 Yeomead, Nailsea, Bristol, BS48 1JA

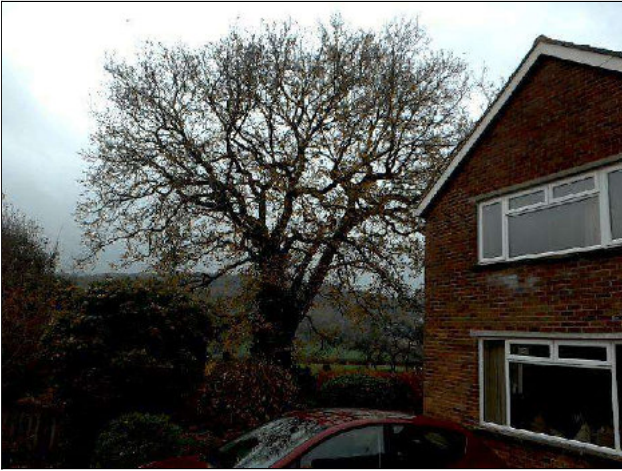
T9 - Oak

With due regards to species profile, size and proximity, the Oak trees (T6 & T9) are considered the dominant features proximate to the focal area(s) of movement and accordingly, where vegetation is confirmed as being causal, we have identified them as the primary cause of the current subsidence damage.

Consequently, we have advocated the complete removal of T6 & T9 as it will offer the most certain arboricultural solution likely to restore long-term stability.

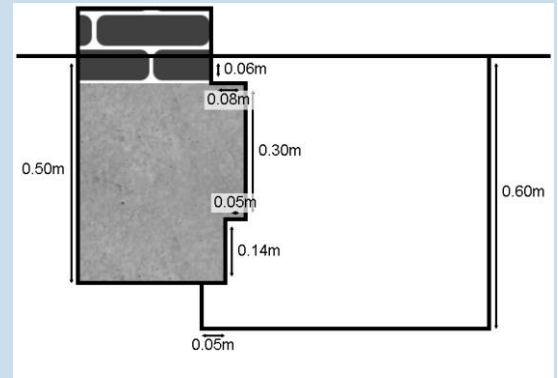
TP/BH1 Foundation Detail and Borehole Log

Extension foundation comprised of brick wall to 60mm bgl, bearing on concrete to 360mm bgl, with a total projection of 80mm from the elevation, bearing on concrete to 500mm bgl, with a total projection of 30mm from the elevation. Underside of foundation (USF) was exposed to 50mm back from the face of the foundation and probed 170mm back from the face of the foundation.

At 0.5m to 1.5m bgl occasional roots of live appearance encountered and sampled in TP/BH1.

At 1.5m to 2.8m bgl no roots encountered. Extensive inspection of soil samples encountered no roots in TP/BH1.

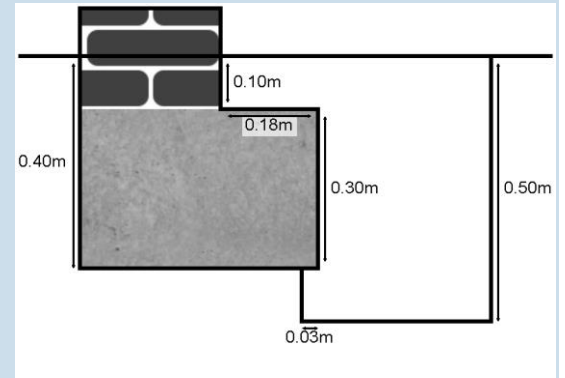
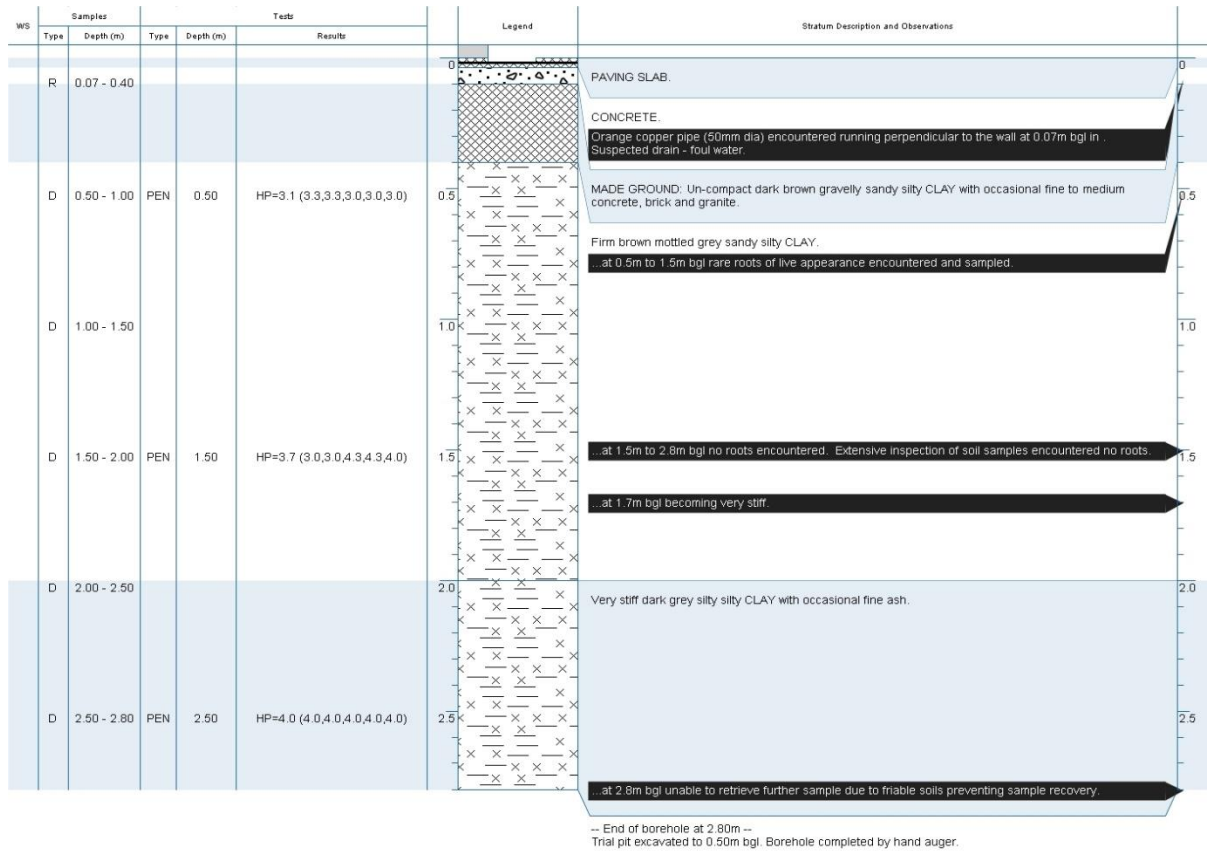
TP/BH2 Foundation Detail and Borehole Log

Extension foundation comprised of brick wall to 100mm bgl, bearing on concrete to 400mm bgl, with a total projection of 180mm from the elevation. Underside of foundation (USF) was exposed to 30mm back from the face of the foundation and probed 250mm back from the face of the foundation.

At 0.5m to 1.5m bgl rare roots of live appearance encountered and sampled in TP/BH2.

At 1.5m to 2.8m bgl no roots encountered. Extensive inspection of soil samples encountered no roots in TP/BH2.

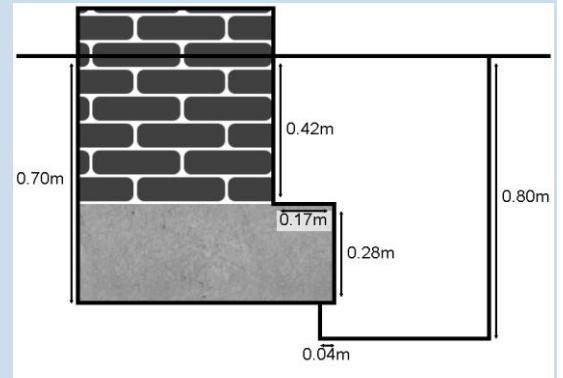
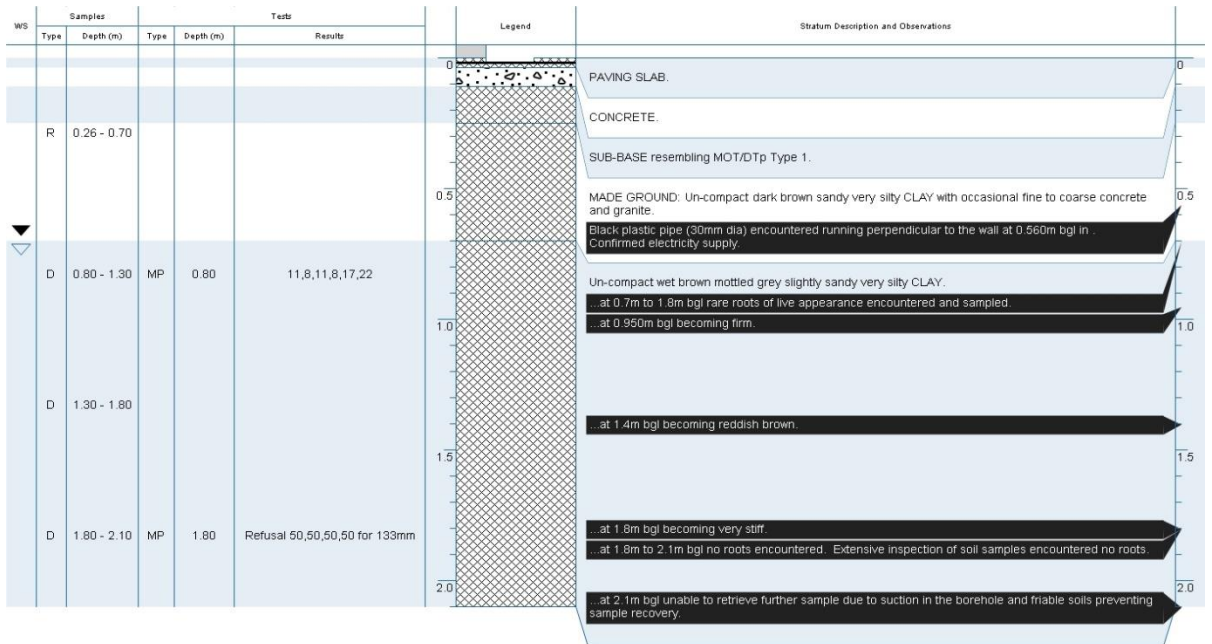
TP/BH3 Foundation Detail and Borehole Log

House foundation comprised of brick wall to 420mm bgl, bearing on concrete to 700mm bgl, with a total projection of 170mm from the elevation. Underside of foundation (USF) was exposed to 40mm back from the face of the foundation and probed 250mm back from the face of the foundation.

At 0.7m to 1.8m bgl rare roots of live appearance encountered and sampled in TP/BH3.

At 1.8m to 2.1m bgl no roots encountered. Extensive inspection of soil samples encountered no roots in TP/BH3.
