## 1.0 About This Report

1 South Road,  
Kingsdown,  
Kent,  
CT14 8AQ.

Instructions were received from Jon More on the 16<sup>th</sup> November 2023 to undertake an invasive Building Survey and produce a report detailing findings to help inform the refurbishment of the property

The inspections were undertaken on the 12 & 19<sup>th</sup> December 2023 during cold and wet/damp weather conditions. The property was furnished but is generally unoccupied.

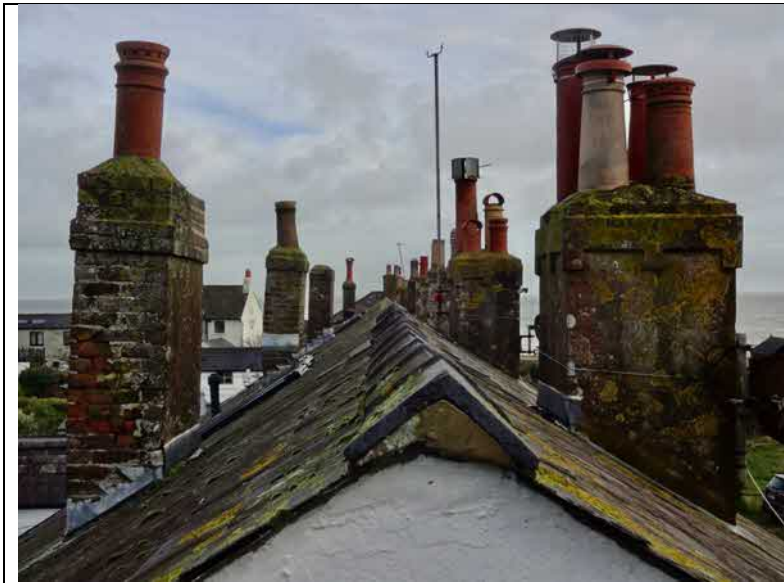
The chimney stacks

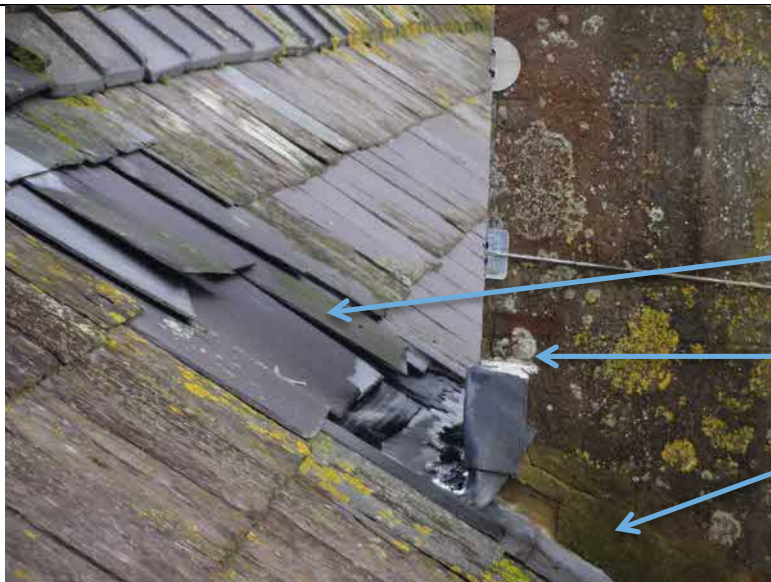
The detailing of the lead back gutter and flashing at the base of the front stack is poor. The back gutter has been worked on recently. The slates behind the stack are missing and mastic has been used in an attempt to point in the flashing that covers the back gutter. The flashings at the side of the stack have not been stepped in to the brickwork. The flashing has been mucked in with a lower quality of cement mortar, which is failing. It should be noted that cement mortars applied to lead will always fail eventually. This is because the lead expands and contracts with changes in temperatures but the cement being rigid tends to crack as it can not accommodate any movement.

Back gutter of front stack

Missing/broken slates

Bodged in mastic

Failed cement fillet

Both stacks will need accessed inspection to establish the amount of repairs required. The fact that the property is in a Conservation Area and is so important to the overall character of the land/seascape it is important that sensitive repairs be carried out to the cement render on the front stack and the retention of the patina is considered. The wholesale removal of the render would be a mistake that would cause irreversible damage to the (shared) stack and its character. The flashing will more than likely need to be replaced on both (shared) stacks and this can be done with a NHL 5 mortar mix. The repairs to the render of the front stack need to be done with a specified NHL 2 mortar mix that will provide flexible repairs and which will also achieve a close aesthetic match.

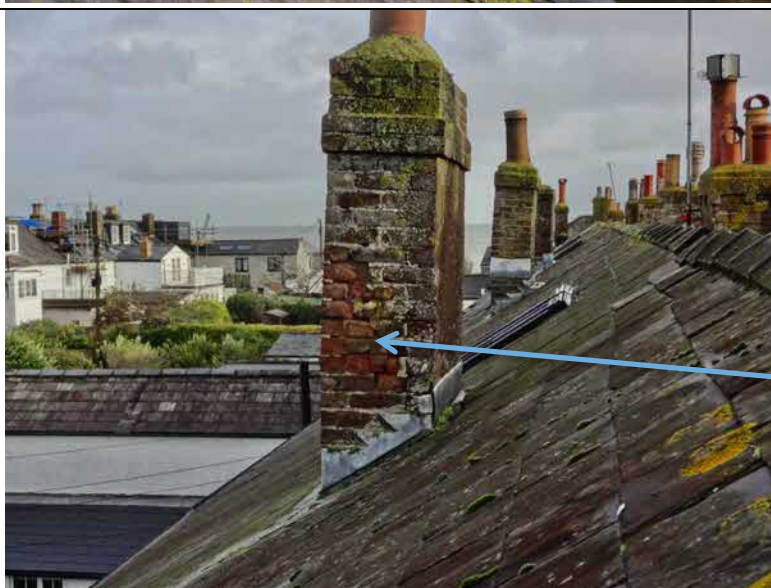
The rear stack has only one pot (and only one flue). The pot and its rain cap are of red clay. The pot is set in cement flaunching and the brickwork facing the front has been rendered with a thin coat of cement. The stack has been re-pointed with cement, which has failed and has damaged some of the bricks to the lefthand side of the stack.

The rear stack

Failed cement mortars

Damaged bricks

The rear stack will need the cement pointing and render stripping and the damaged bricks replaced on a like for like basis and the stack re-pointing, with a specified mortar, which will need to be softer than the bricks. This is likely to be a slaked quick lime, maybe slightly gauged with a pozzolan or a formulated NHL2 mix in order to soften it to what would have been described historically as a feebly hydraulic lime.

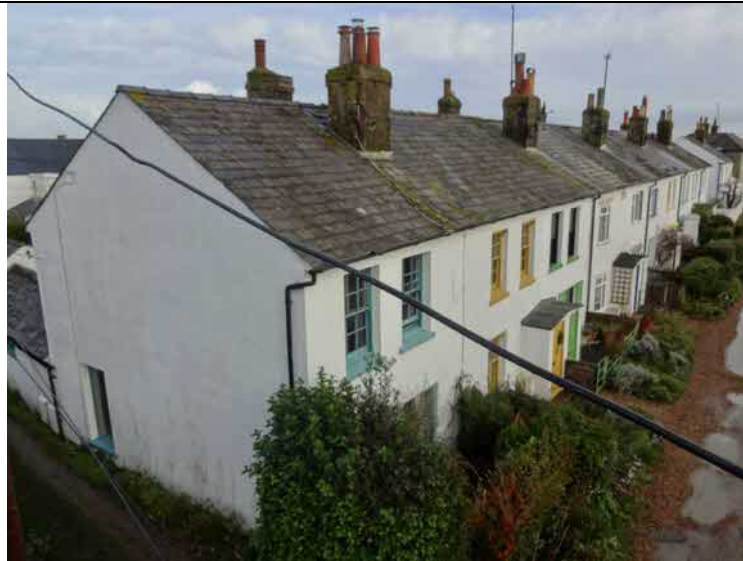
The front roof – in context

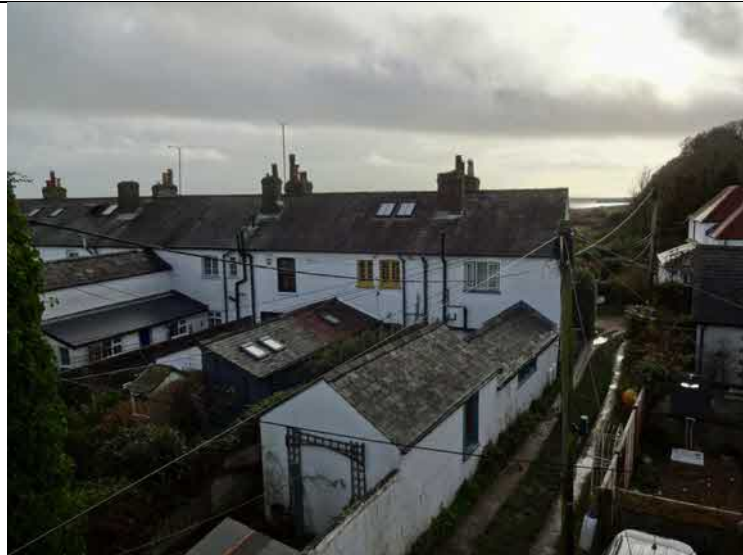
The rear roofs – in context

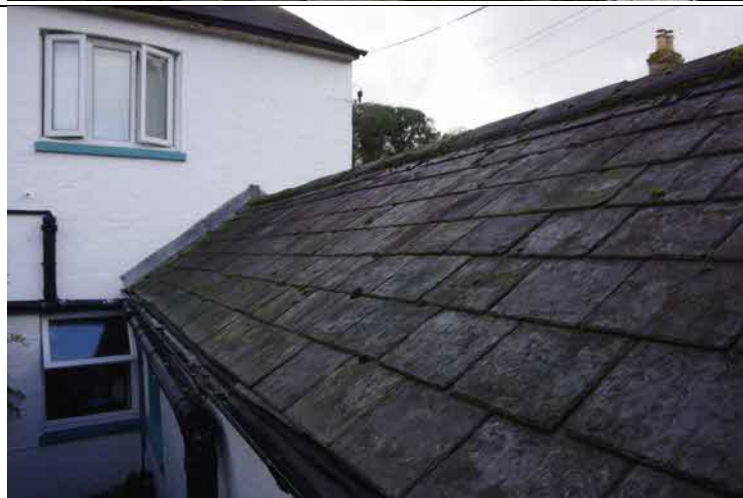
Apart from the missing/ damaged slates behind the back gutter on the front pitch, a slipped slate at the first course of the right-hand pitch at the rear addition and a missing slate at the right-hand pitch of the extension, the roof covering are in a fair and serviceable condition. The missing/damaged slates should be replaced as soon as possible.

The right-hand pitch of the fi  
extension roof

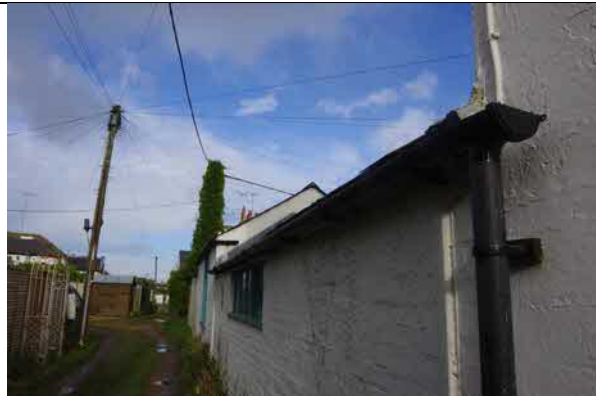
Rainwater runs at the left hand pitches of the extensions

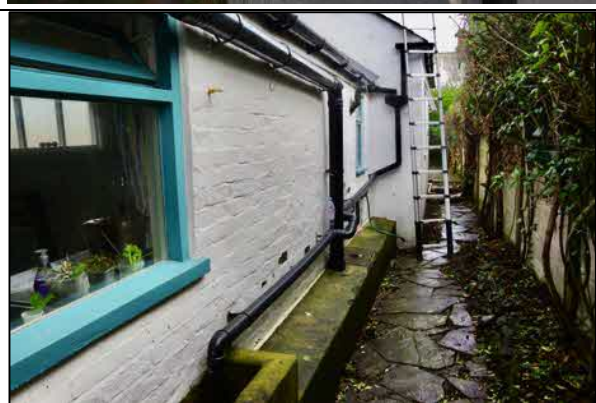
The rainwater management and drainage at the back of the building has been run in an ad hock fashion and is a demonstration of poorly considered drainage design. A plinth has been built to carry the drains at the side of the first extension. The bathroom waste from the main building, the kitchen waste and the rainwater from the right-hand pitches extensions both discharge in to the same drains. The drainage then runs in to shallow below ground drainage at the side of the extension.

Combined foul and rainwater being run in the same drains at the side of the extensions

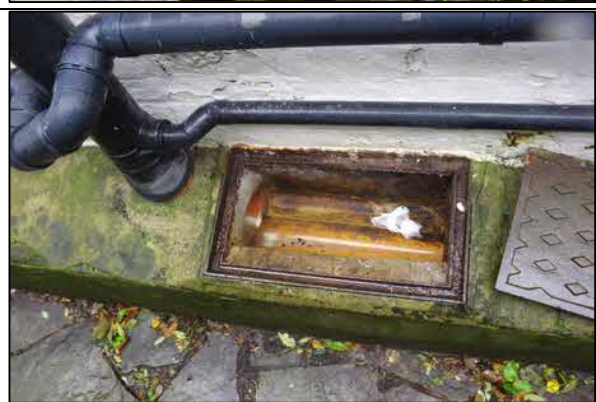
The manhole coverer at the plinth and next to the extensions were lifted and foul waste was observed in both inspection chambers. The drain from the extension bathroom to the drain has been poorly run and will be causing foul water to splash on the benching opposite, where some form of fungus is growing. The other two manhole covers were not lifted as they are a two man lift and the handles are prone to breaking if lifted by one man from one end.

Inside the inspection chambers

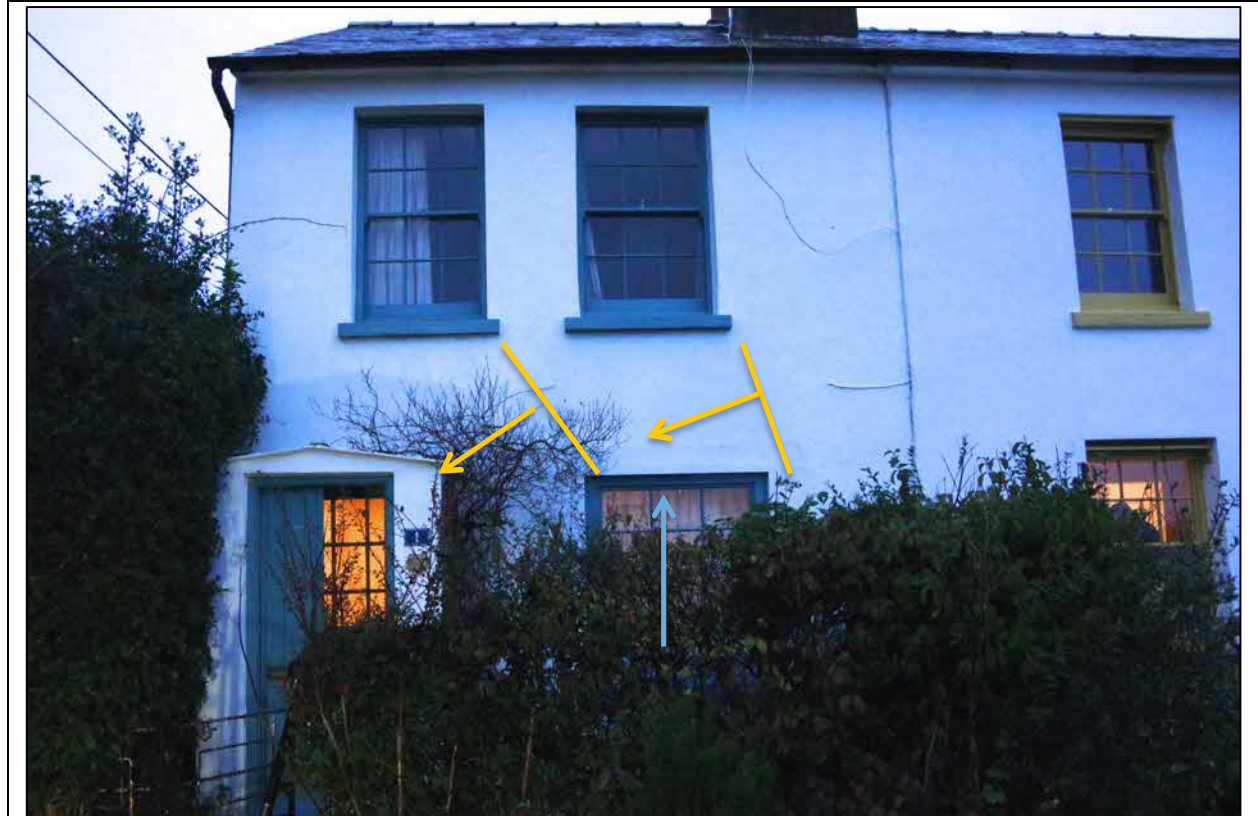
There is diagonal cracking in the render at the front elevation of the main building from the top corners of the ground floor window to the bottoms of the windows above. If an imaginary perpendicular line is struck off from crack paths, they will point towards the cause of the crack. In this case the arrows point towards the tops of the of the lower structural openings.

It is common to see cracking between the tops and bottoms of an old buildings structural openings which have been rendered with cement. The cement will crack as the building moves throughout the seasons with thermal expansion and cracking will occur at the weakest points in the masonry. Normally, the structural openings of an old building would be directly above each other and the cracks would run in pairs vertically between the corners. However the buildings structural openings are unusually offset and it looks like the movement has taken the path of least resistance and the render has cracked at the weakest points.

Diagonal cracking between the structural openings at the front elevation

The yellow lines indicate the crack paths and the perpendicular arrows are pointing at the tops of the structural openings below

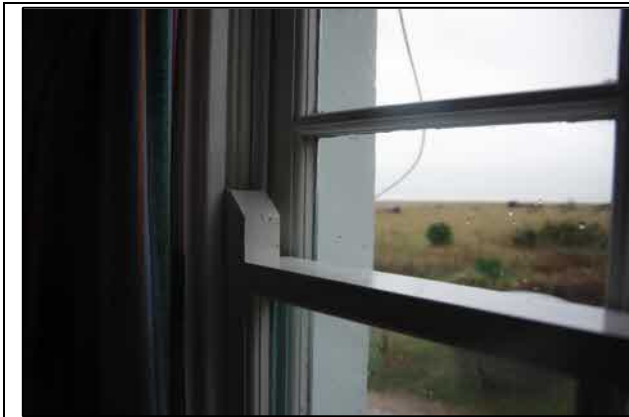
There are replacement timber boxed sashes and at the front elevation. The sashes have the wrong detailing. The sashes have a six over six configuration but have horns and an increase in meeting rail dimensions that were introduced as glass sizes increased after the relaxation of the Window Tax in 1850. The horns on the sashes were designed for two over two sashes. This glass configuration and the reduction of glazing bars, which helped support the glass with their wedged tenons and mortices resulted in the need for thicker meeting rails and horns to help support them being introduced. The main rhythm of the windows at the first floor in the terrace are a two over two configuration. Note; the structural opening of the ground floor window is smaller than No.s 3 and upwards of South Rd, which have Regency/ Georgian style bow bays at the ground floor.

Example of crude and incorrect detailing at the meeting rail of sliding sash

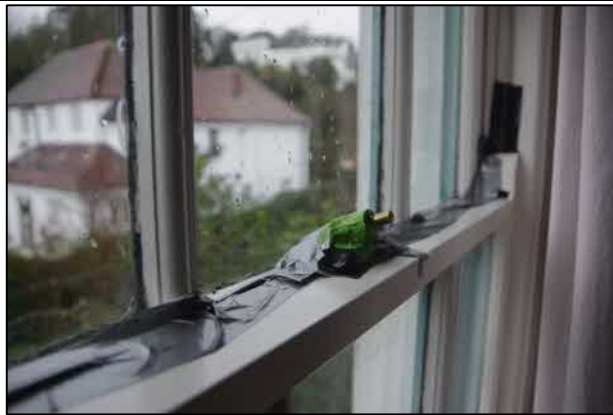
The windows have crude brush strip on the parting bead but the windows are still loose in their boxes and are draughty. The timber in the windows and the boxes were found to be firm when pressed with a Stanley knife.

Extremely draughty window taped up

The buildings energy efficiency would improve with brush stripping/ draught proofing the doors and windows. New factory made timber double glazed windows throughout could be considered, along with a new back door.

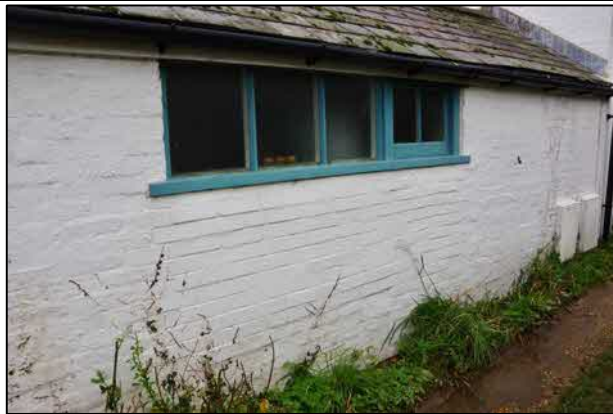
Timber windows in the street scene at the first extension

Note brick infill work below the windows

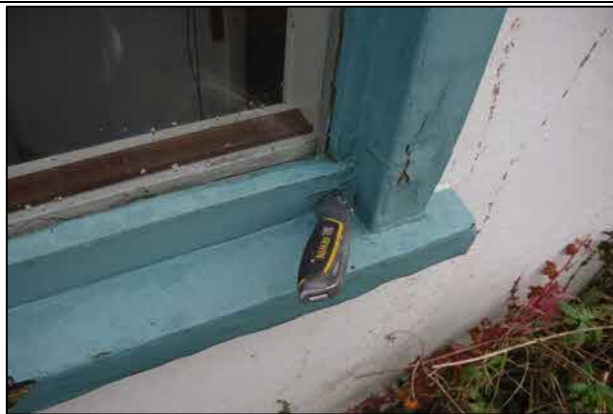
There are various styles of timber windows elsewhere in the extensions. The window to the left of the second extension is decaying.

Decaying timber at the second extension, at the street scene
