Internal Decay Assessment of a Common Beech

Gatekeepers Lodge Dyrham SN14 8HN

For Lawrence Tree Services

July 2023

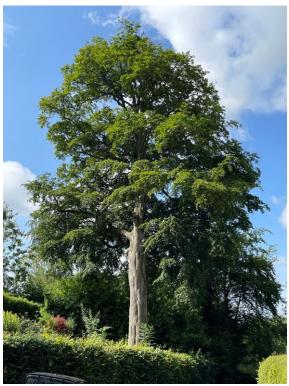
Pl. 1 – Common beech

- Growing on steep bank over road, 12.5m southeast of house and 13m west of Gatekeepers Lodge.
- Previously group canopy with adjacent beech to east, now felled.
- *Kretzschmaria deusta* fruit bodies with decay between buttress roots on southeast and south aspects.
- Previous branch failure at 6m above ground level (agl) on south aspect and at 8m agl on northwest aspect with exudation.
- Clear stem to crown break at 6m agl with occluded and partially occluded pruning wounds.
- Crown asymmetry to west.
- Previous remedial pruning/crown reduction.
- Major deadwood.

- 6.10 In my opinion, based on the survey findings and apparent increase in decay, the tree has a short safe life expectancy and is likely to require removal within five years.

- 6.11 If retained, it should be visually inspected annually and a repeat internal decay assessment carried out in 2026.

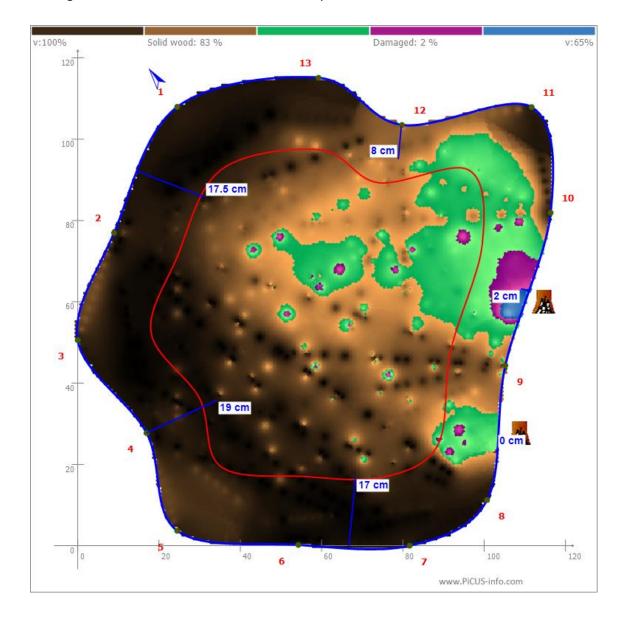
7.0 PiCUS Tomograph results July 2023

- 5.1 One tomograph was taken at 5cm agl to assess any increase in the extent of decay.
- The tomogram is presented in section 7.0 and the findings are summarised below. The 2017 findings are shown in brackets.

Measurement level	Percentage of cross-section identified as:				
		Cavity or decay (pink/blue shading)	Incipient decay / early wood degradation (green shading)	Sound wood (brown shading)		
	5cm	2% (0%)	15% <i>(2%)</i>	83% <i>(98%)</i>

- 6.1 The tomograph results are not conclusive but indicate an increase in the extent of decay since the last survey with 17% of the cross-section affected as opposed to 2% in 2017.

- 6.2 Due to the colonisation strategy of *Kretzschmaria deusta*, tomography does not always accurately plot early changes to wood properties. However, the pattern of light brown shading and green mottling indicate a reduction in sound velocities consistent with early stage decay.

Tomogram taken at 5cm agl.

Stem diameter at measurement level is 122cm.

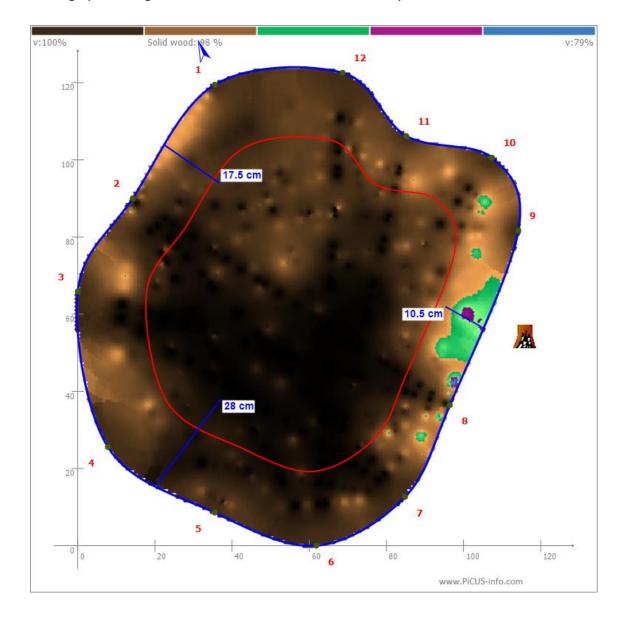
8.0 PiCUS Tomograph results November 2017

Tomogram taken at 5cm agl.

Stem diameter at measurement level is 118cm.

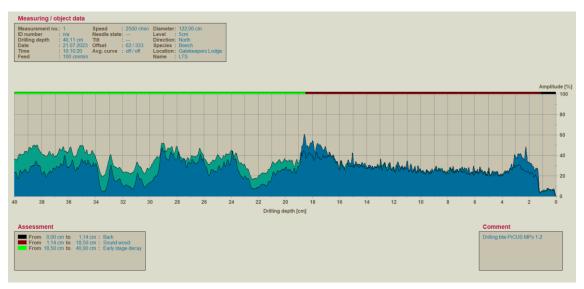
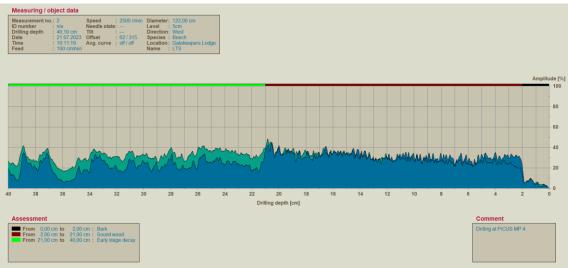
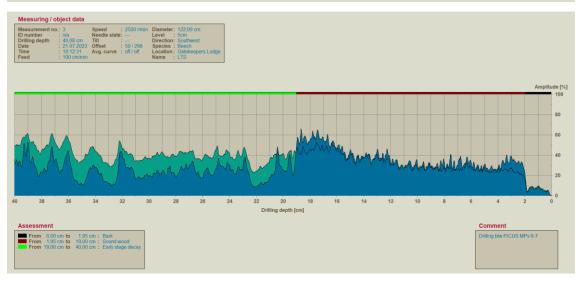
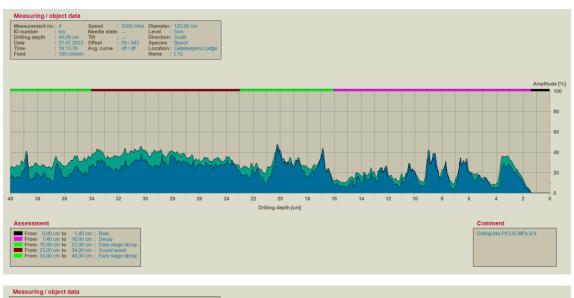
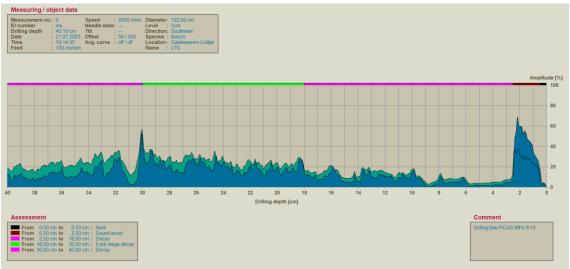
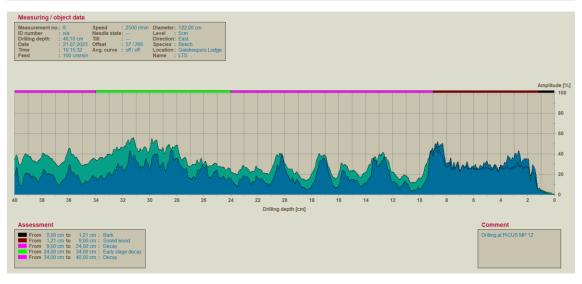
9.0 Resi-PD400 Resistograph results

Drill no.	Cardinal pt. PiCUS MP	Height (cm) agl	Stem Radius (cm) R	Radial depth of sound wood including bark (cm)	Radial depth of sound wood excluding bark (cm)	t/R ratio
R1	North 1-2	5	61.0	18.5 <i>(19.0)</i>	17.5 <i>(17.5)</i>	0.29
R2	West 4	5	61.0	21.0 (30.0)	19.0 (28.0)	0.31
R3	Southwest 6-7	5	61.0	19.0	17.0	0.28
R4	South 8-9	5	61.0	1.5	0.0	0.00
R5	Southeast 9-10	5	61.0	2.5 (12.0)	2.0 (10.5)	0.03
R6	East 12	5	61.0	9.0	8.0	0.13

- 6.4 Readings R1, R2 and R3 identify sound residual wood of between 17cm and 19cm (28% to 31% of the stem radius).
- 6.5 Two readings, R4 and R5, taken into the area of fruit bodies confirm early and late stage decay to maximum drill depth (40cm) with no residual wall remaining.

- 6.6 R6 taken on the east aspect identifies only 8cm of sound wood (13% of the stem radius).
- 6.7 The resistograph readings confirm a marked increase in the extent of decay since 2017 which is now on the borderline of Mattheck's safety margin. The crown reduction has reduced wind loading and increased the tree's safety factor but may have also contributed to an increased rate of decay.
