Project: **Risk Assessment of Trees**

Site: **The Old Stables, 6 Newell Hall Mews, Otley, LS21 2SF**

Date: **31/03/2022**

Reference: **BA11344**

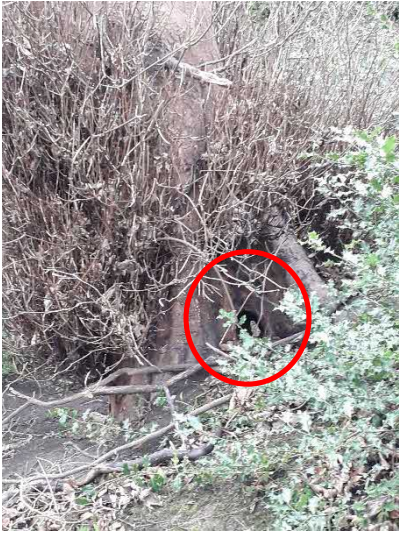
Moderate Risk Tree				
T1675 Sycamore				
TRAQ Risk Assessment				
Direct Damage	Root Plate Failure	Main Stem failure	Main Leader failure	Branch Failure
Low	Moderate	Low	Low	Low
<p>Growing at a higher level. Buttress obscured by shooting. A hole in the buttress leads to decayed volume. Single stem with a moderate lean. Unable to access without fall arrest system. Hollow in the stem appears to extend through the tree in its entirety. The tree was inspected from as close as possible without compromising safety.</p>		<p>Clear area around the stem. Once the epicormic growth is removed a visual inspection may conclude no further action required or may require to assess the buttress using a Sonic Tomography. Fall arrest systems needed to fully inspect.</p>

Priority	6 months	Next inspection	Pending investigation

T1674	Ideally, undertake Tomography of the buttress and lower stem to understand the extent of decay versus sound wood. Rope access equipment needed.	Within 6 months
T1675	Ideally, undertake Tomography of the buttress and lower stem to understand the extent of decay versus sound wood. Rope access equipment needed.	Within 6 months
T1679	Ideally, undertake Tomography of the buttress and lower stem to understand the extent of decay versus sound wood.	Within 6 months
T1680	Ideally, undertake Tomography of the buttress and lower stem to understand the extent of decay versus sound wood.	Within 6 months

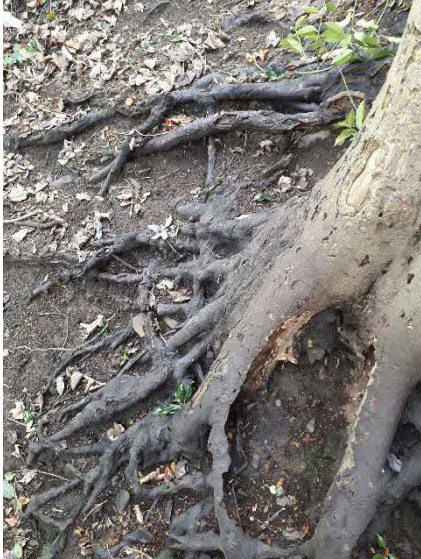
Moderate Risk Tree				
T1677 Sycamore				
TRAQ Risk Assessment				
Direct Damage	Root Plate Failure	Main Stem failure	Main Leader failure	Branch Failure
Low	Moderate	Low	Low	Low
<p>Located on boundary. Single stem growing close neighbouring properties. Unbalanced crown shape. Significant asymmetry to the canopy. Crown distorted due to group pressure. Fire damage to surface roots and lower stem. Extensive damage to the root system.</p>		<p>Remove the tree.</p>

Priority	6 months	Next inspection	None if removed

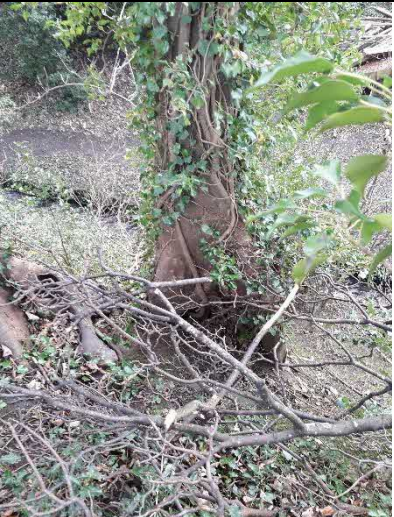
Low Risk Tree				
T1674 Sycamore				
TRAQ Risk Assessment				
Direct Damage	Root Plate Failure	Main Stem failure	Main Leader failure	Branch Failure
Low	Moderate	Moderate	Low	Low
<p>Growing as part of a group on a bank. Decay within the buttress can be seen. Single stem. Ivy has developed and prevented inspection. Unable to fully access without fall arrest systems. It appears that the tree historically was biforked at ground level with the eastern codominant stem now gone/decay present. The tree is sheltered by neighbouring trees.</p> <p>Overall risk is low as if failure was to occur at the base then the tree is likely to hang up in neighbouring trees but is within striking distance of nearby property.</p>		<p>Remove the tree.</p> <p>Or</p> <p>Investigate further with the use of rope access, probes, sonic tomography or Microsecond Timer.</p>

Priority	3 months	Next Inspection	In line with academy programme
