BATTISFORD HALL

FARM BARNS

HERITAGE IMPACT ASSESSMENT

Date of inspection: 28th February 2017

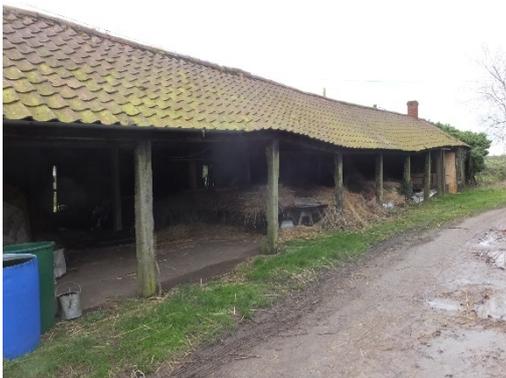
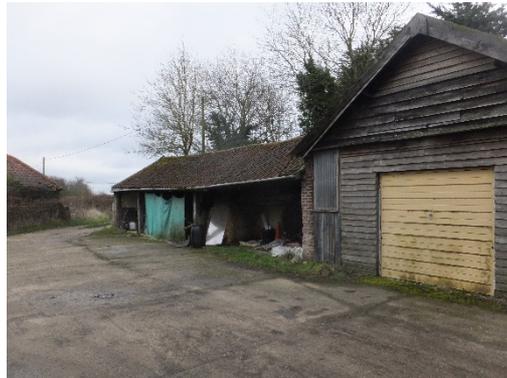
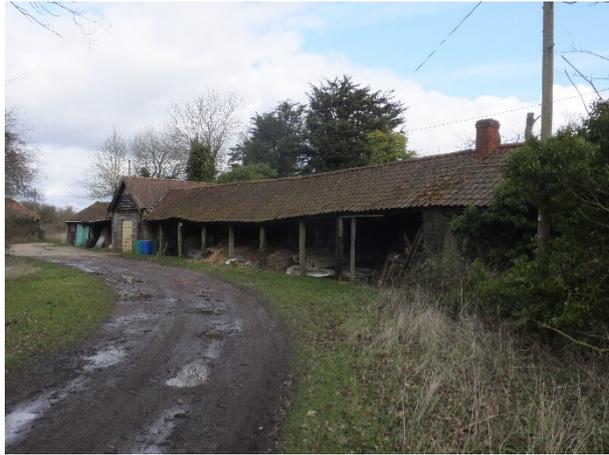
2.1 **Cart lodge:** (“Cart lodge” on Whitworth drawings)

Comprising a brick built room with a hearth and chimney, eight open bays, an enclosed bay with garage door, and four further bays. The open front faces approximately west, with the main axis approximately north- south

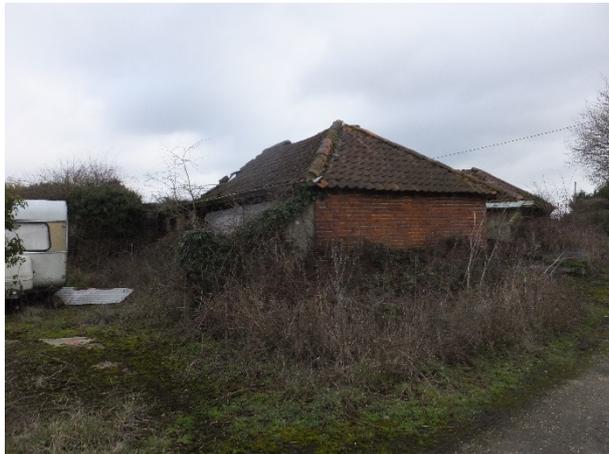
2.2 **Piggery:** (no ref on Whitworth drawing):

Subdivided into two, possibly adapted from another use, opening west on to an open courtyard

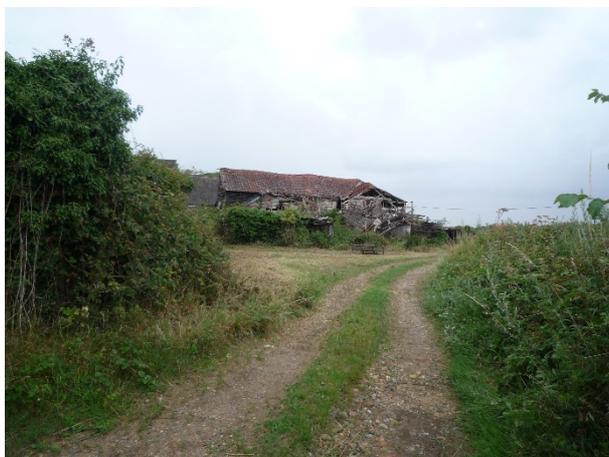
2.3 **Piggery:** (no separate ref on Whitworth drawings):

Low pitched roofed building forming western side to previous enclosure, probably a former stable for heavy horses, opening west onto a larger open courtyard.

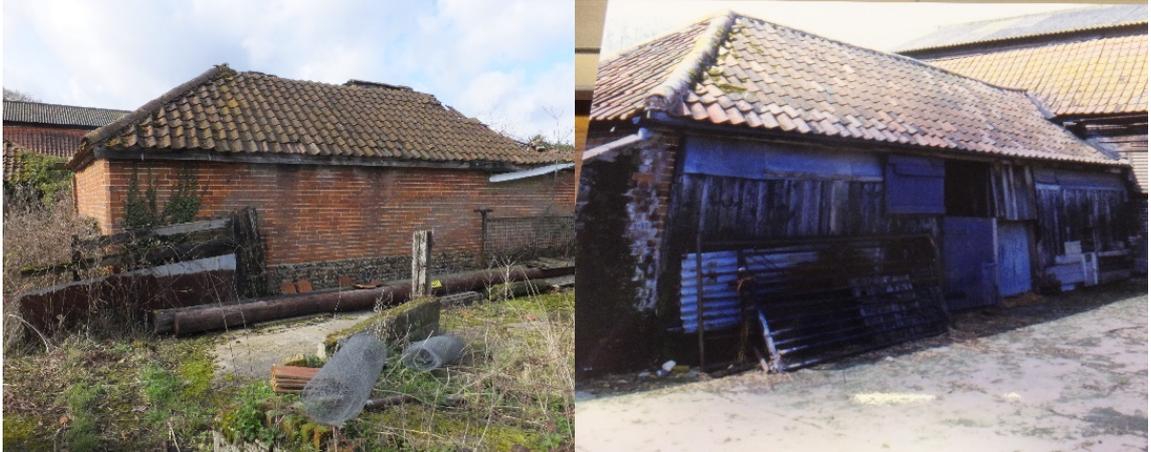
2.4 **Piggery:** (no separate ref on Whitworth drawings):

Low brick built piggery, possibly former stabling for heavy horses, forming south side to open courtyard.

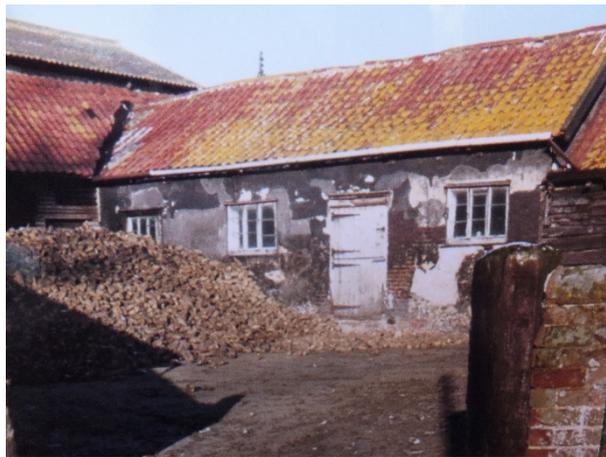
2.5 **Stables:**

Forming northern side to courtyard, part masonry, part timber framed, only part of south and north walls now standing.

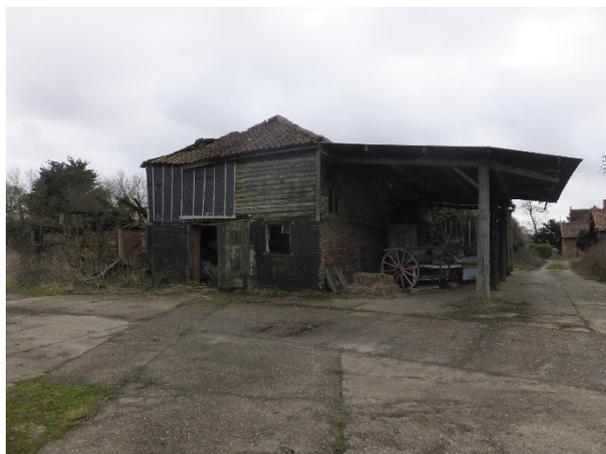
2.6 **Mill:** (“old mill” on Whitworth drawings):

Substantial brick structure with first floor intact (but inaccessible), main axis running north – south. Range of lean-to outbuildings to east in derelict condition, double height cart shelter to west intact.

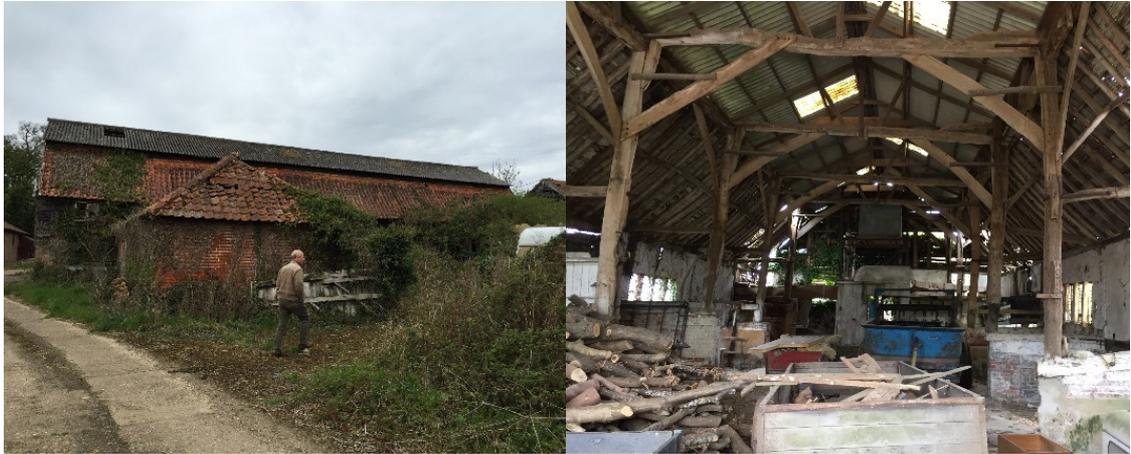
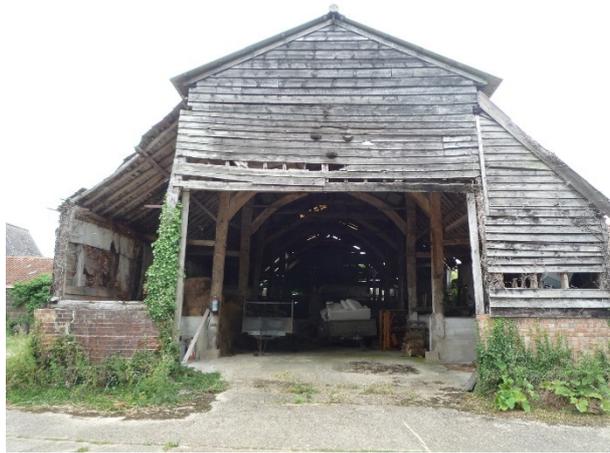
2.7 **Aisled barn:** (“open barn” on drawings):

Of seven bays, formerly a threshing and storage facility, currently used for storage of machinery, main axis north south, with further lean-to structure beyond east aisle, in timber frame construction and derelict.

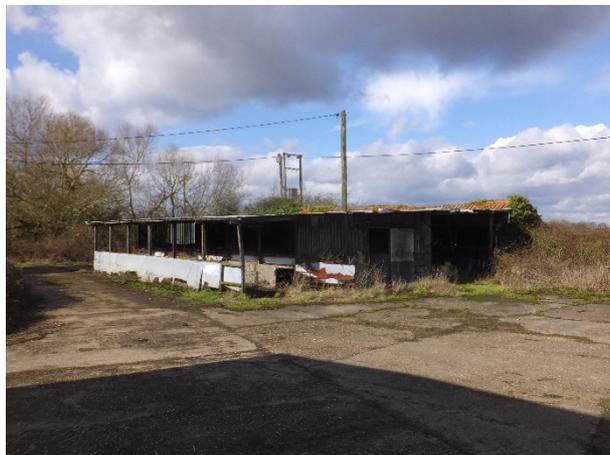
2.8 **Low timber framed shed:** (“The Pig Shed” on Whitworth drawings):

Formerly a piggery, now converted to a nursery unit or possible chicken or turkey production, with a later lean-to addition which quadruples the floor area.

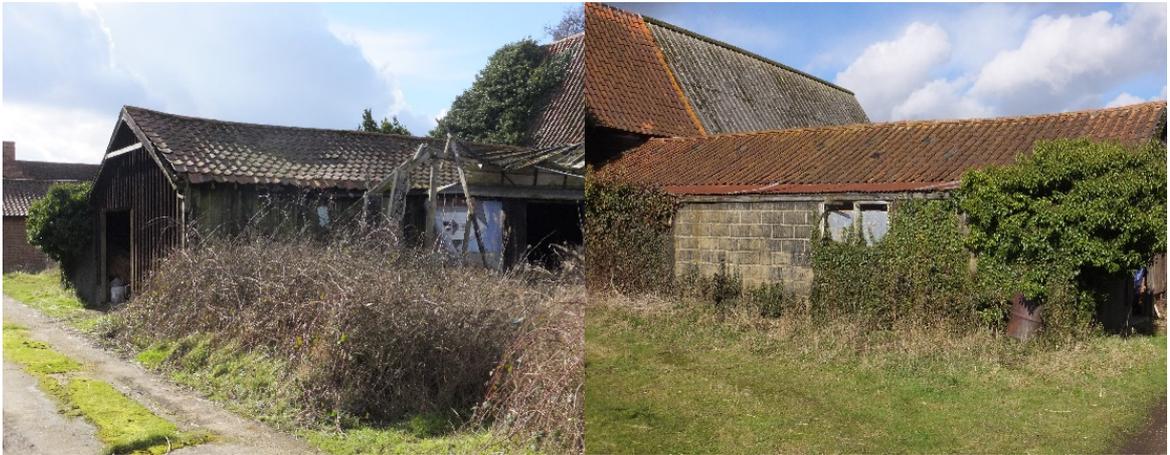
2.9 **Low shed:** (No ref on Whitworth drawings):

Timber framed construction, main axis east/west, with C20th extension to south, used for storage purposes.

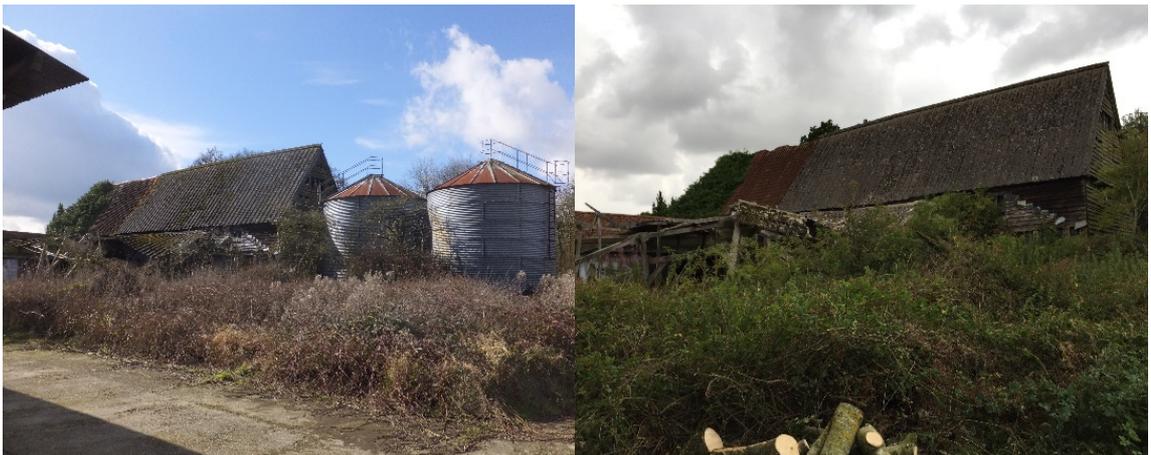
2.10 **Aisle-less barn:** (“Grain Barn” on Whitworth drawings):

Presenting as a ten bay building, but actually two barns constructed end to end, main axis north/south, now containing corn storage and drying equipment, with a lean-to structure at southern end, west side. *Major extensions in timber framed construction to east side now derelict.*

10	Grain barn: older section: frame details	High	High	Re-inspect and record frame details once grain mechanism removed. Possibly high value building. may require further expert involvement to interpret once exposed.
	External envelope details	Medium	Medium	Urgent repairs needed to frame to retain integrity
	Southern most five bays: external envelope	Medium	Medium	Retain evidence of original usage in brick vents
13	<i>Clay lump apple store</i>	<i>Medium</i>	<i>High</i>	<i>Rebuild clay lump walls would be an idea, but building not in development area</i>

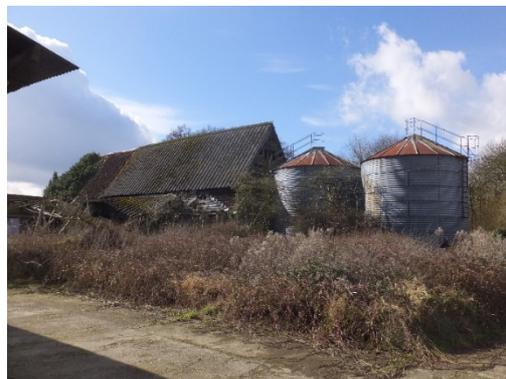
2.11 *Two external circular corrugated iron corn bins.*

With no heritage significance.

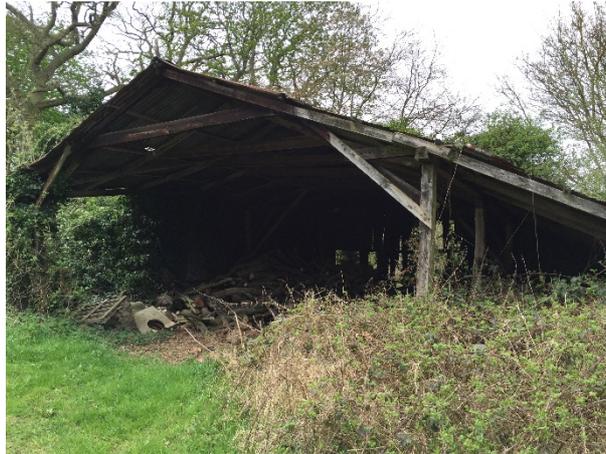
2.12 **Open ended shed:**

Crude timber framed construction, currently used for the storage of logs, no heritage impact.

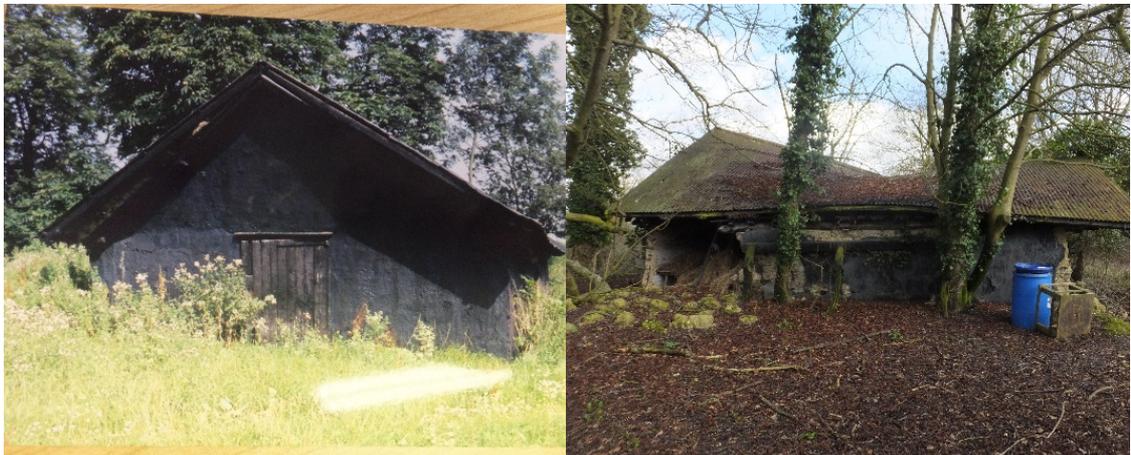
2.13 **Single cell storage building (“Apple Store” on Whitworth drawings):**

of clay lump construction with bricked gable, formerly thatched, but now covered in corrugated iron and semi derelict.

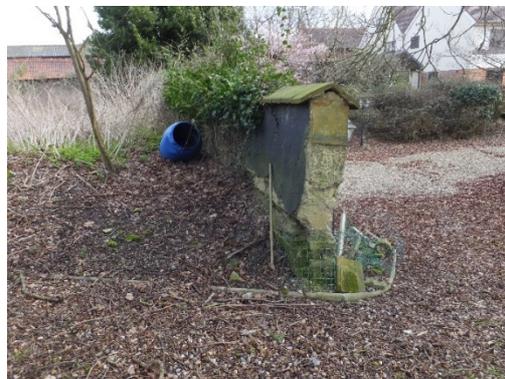
2.15 **Boundary wall:**

Extending beyond west gable of farm office range, short section in clay lump capped with terracotta (very unusual in Suffolk).

15	<i>Clay lump boundary wall</i>	<i>Medium</i>	<i>Medium</i>	<i>Condition puts this at risk, retention would be worthwhile, but outside development boundary</i>

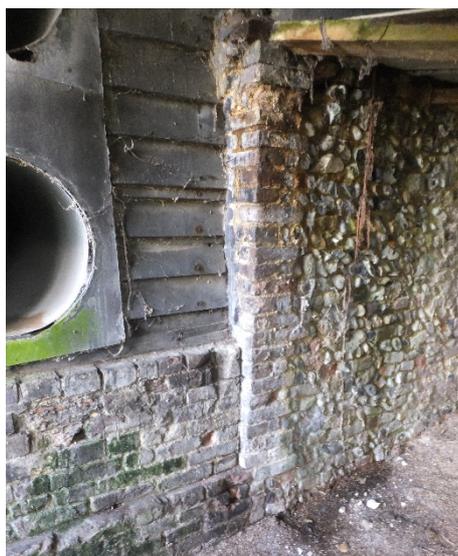
(Straight joint in plinth, west side)

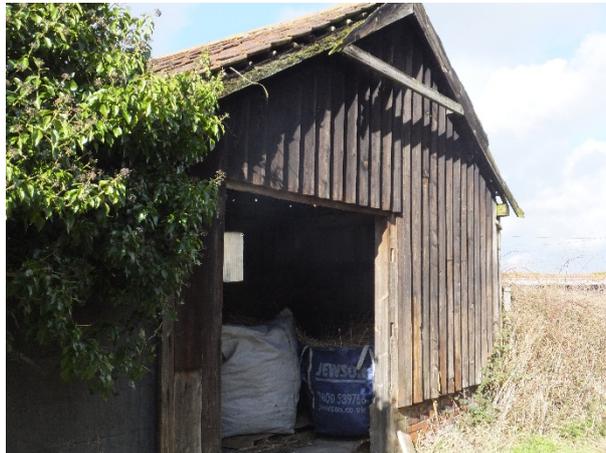
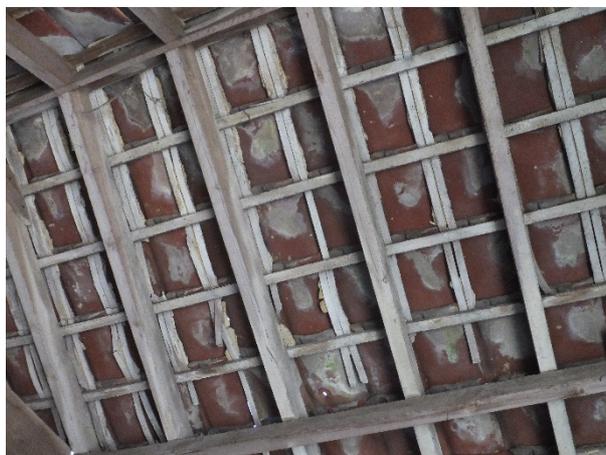
7.6 **Building 9:** which is tangential to Building 10 is much later in construction, possibly early C19th and has been altered and extended since to the south.

Timber framed construction formerly with vertical weather boarded sides in tarred softwood boards, with a stub of flint walling to the barn end on the north wall which may be a remnant from an earlier building. However, its roof finish of red clay pantiles has been "semi-torched" on the underside with softwood lathe and lime mortar to deter rain entry.

This formed part of a range of outshot buildings to the east side of building 10, the remainder of which have been subsequently demolished.

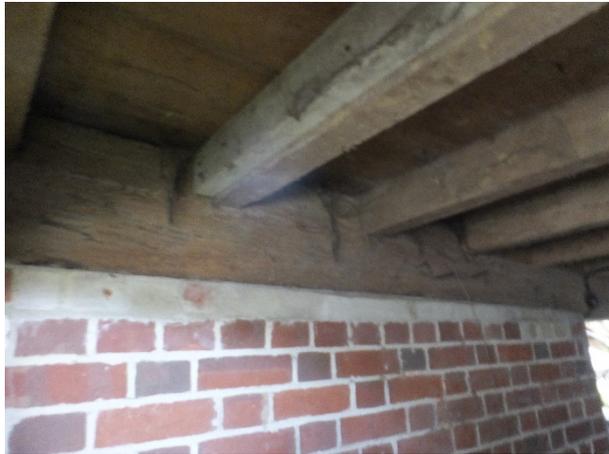
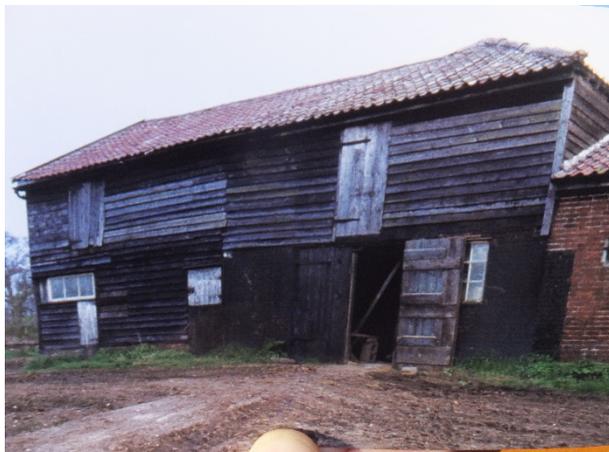
7.7 **Building 6:** the old mill, is probably next in order of date and interest. This is in substantially better order than the others and was clearly constructed for the purpose which it appears to have retained throughout its working life.

Brick walls to east and west and the lower part of the north and south gables support a substantial timber structure, with 12" x 13" oak beams supporting 5" X 4" oak joists at 18" centres, with softwood floor boarding above forming a second floor and a softwood roof structure of lower tie design early C19 with red pantiles roof finish at a pitch of 26 degrees. Although there has been some adaption of the openings in the west wall, and the loss of annexed storage buildings to the east, the main building retains its interest.

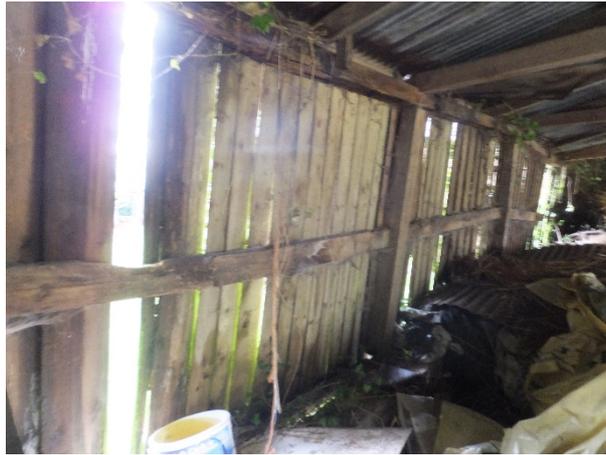
- 7.9 **Building 1:** is a cart lodge with a warming room or heated office at its southern end, eight open bays, an enclosed bay and then a further four bays at its northern end. The latter appear to be of cruder and later construction. The rear framing is in softwood, with vertical timber boarding, much patched and adapted.

The northern range also contains a tack room and stables reached from the northern end of the range, with roofs pitched at 47 degrees to the front and 25 degrees and a central valley gutter.

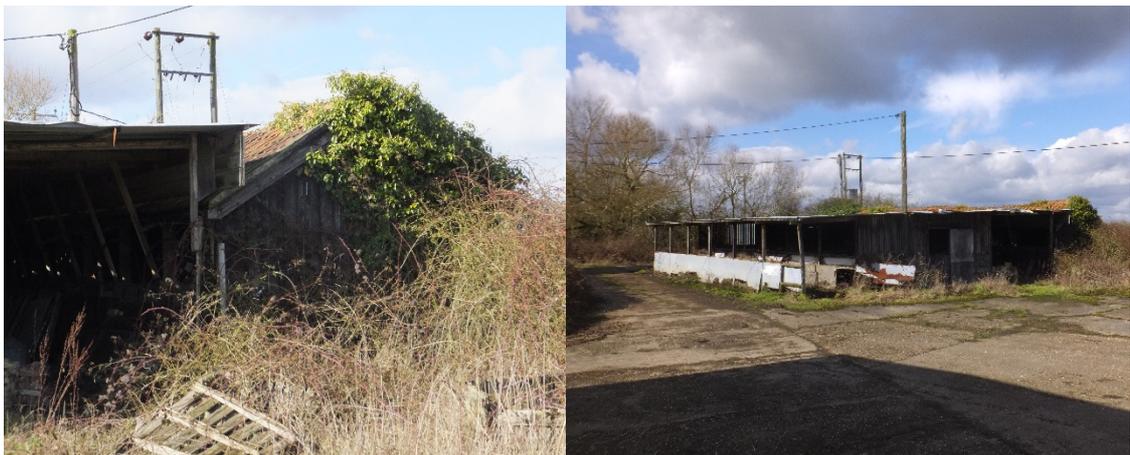
- 7.10 **Building 8:** is a stand-alone former pig shed, with softwood timber framing over a brick plinth, and formerly with gates and enclosures on the south side, now removed and replaced with a C20th extension to form a turkey shed or some such, itself in disrepair.

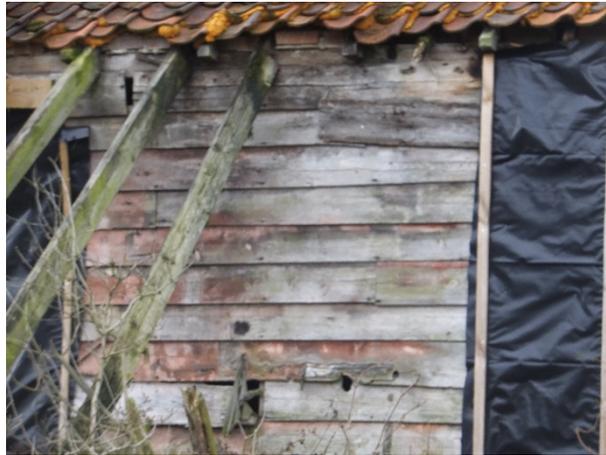
Traces of red ochre pigment.
