Whitfield Court - Photo's to be including in Heritage Statement

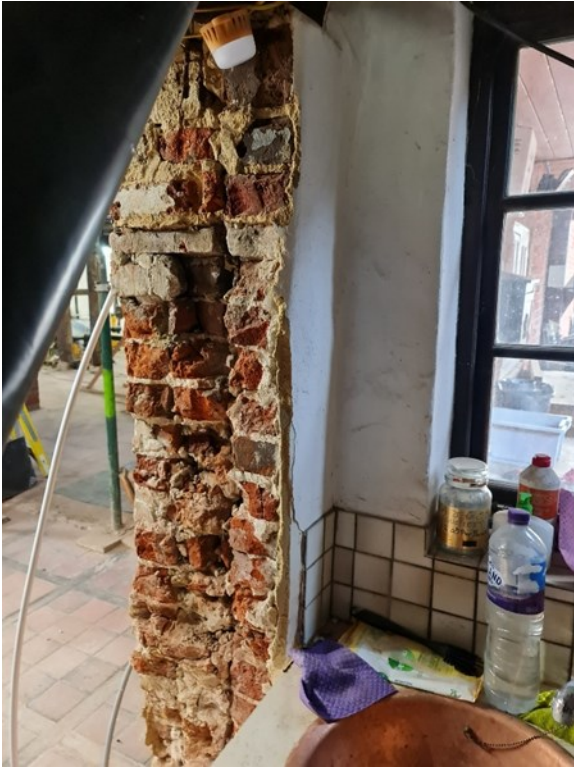
P.1 - GF Kitchen - SE Elevation

Substandard & rotten brickwork to nib under beam

Note 3 - on DRWG CLT Ltd - P100

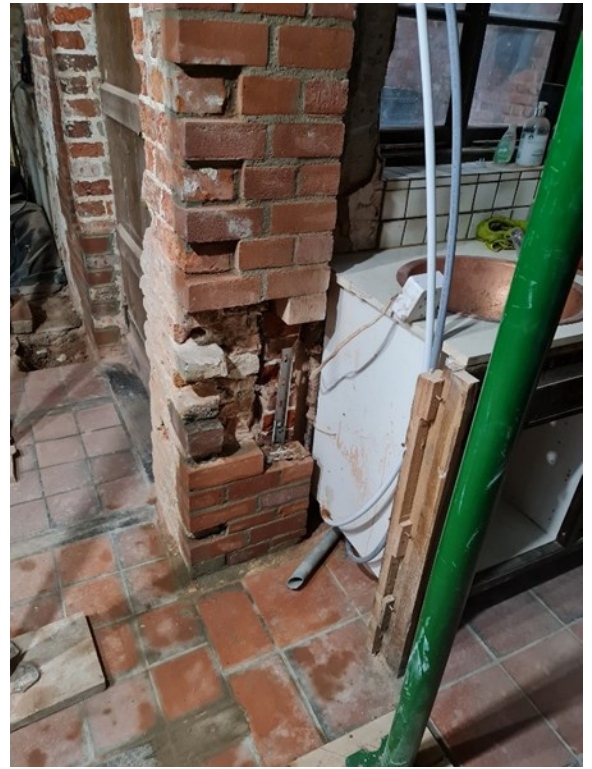
P.2 - GF Kitchen - SE Elevation

Note 3 - on DRWG CLT Ltd - P100

Pier repair as per Structural Eng consultation

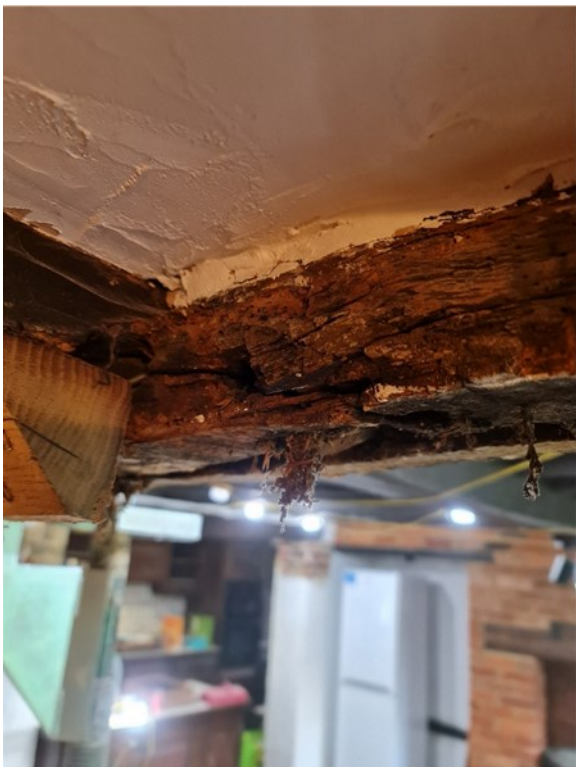
P.3 - GF Dining Room -

Splits to existing ceiling beam

Note 6 - on DRWG CLT Ltd - P100

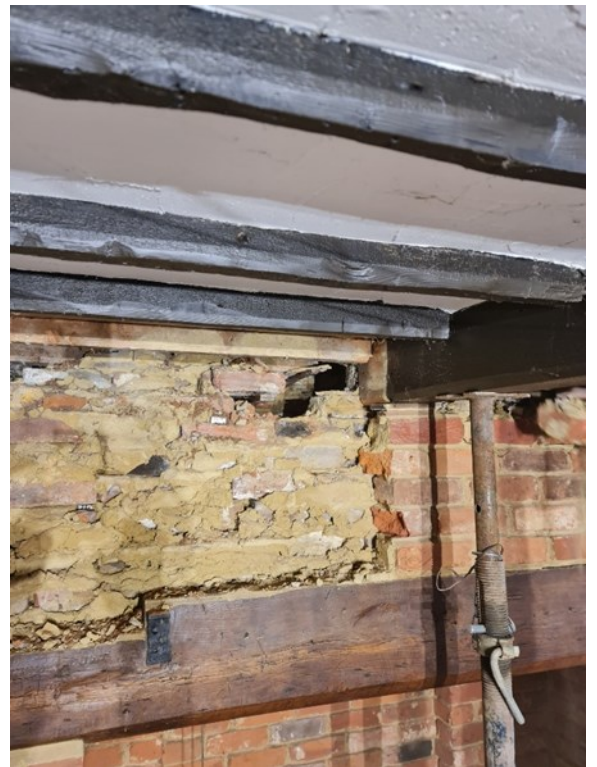
P.4 - GF Kitchen—North Elevation

Substandard brickwork above bressummer beam

Note 4 - on DRWG CLT Ltd - P100

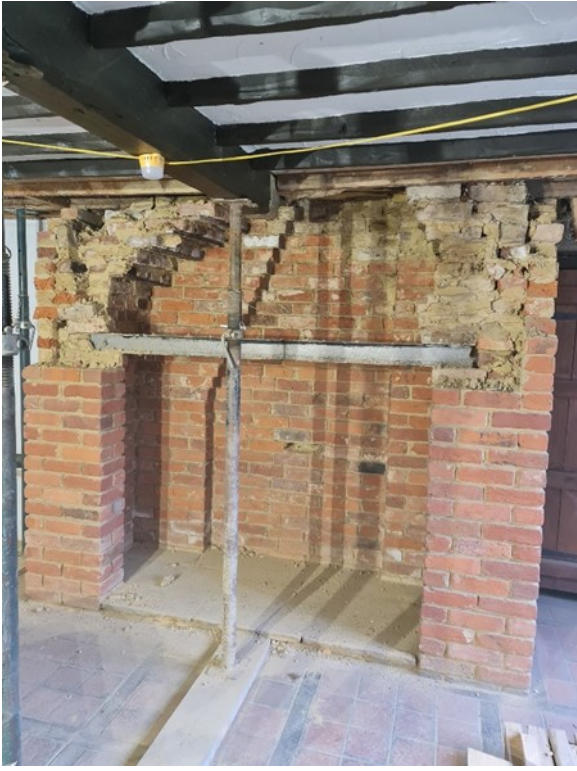
P.5 - GF Kitchen - North Elevation
Existing aluminium lintel in fireplace
Note 4 - on DRWG CLT Ltd - P100

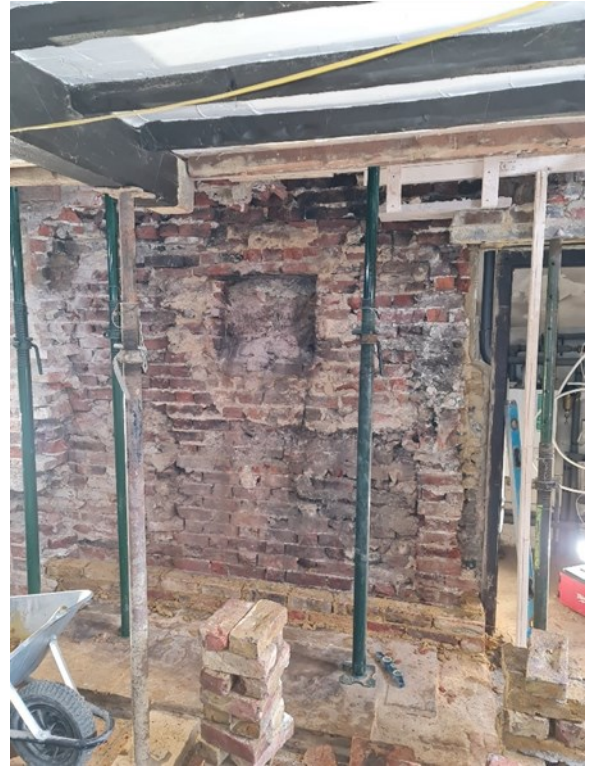
P.6 - GF Kitchen - North Elevation
Substandard brickwork removed behind dismantled chimney breast
Note 4 - on DRWG CLT Ltd - P100

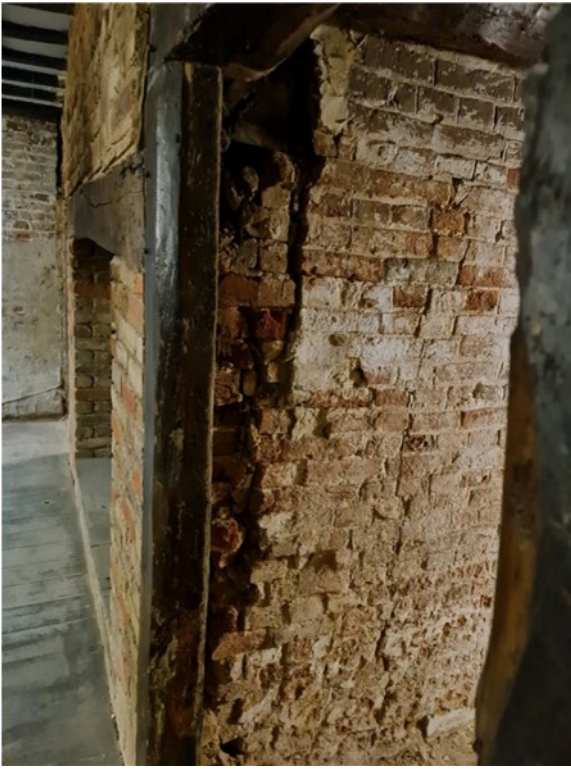
P.7 - GF Lounge - NE Elevation
Showing cracked brickwork to chimney
Note 7 - DRWG CLT Ltd - P100

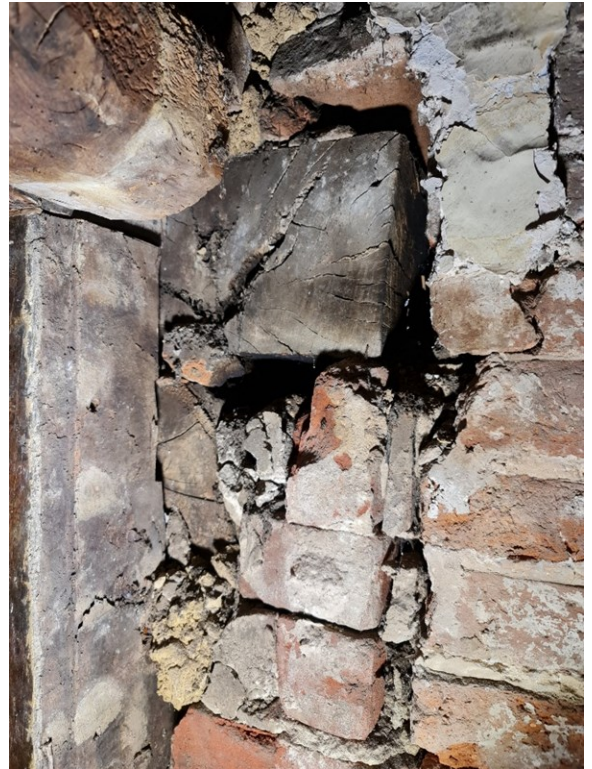
P.8 - GF Lounge - NE Elevation
Substandard brickwork to P.7 supporting bressummer beam
Note 7 - DRWG CLT Ltd - P100

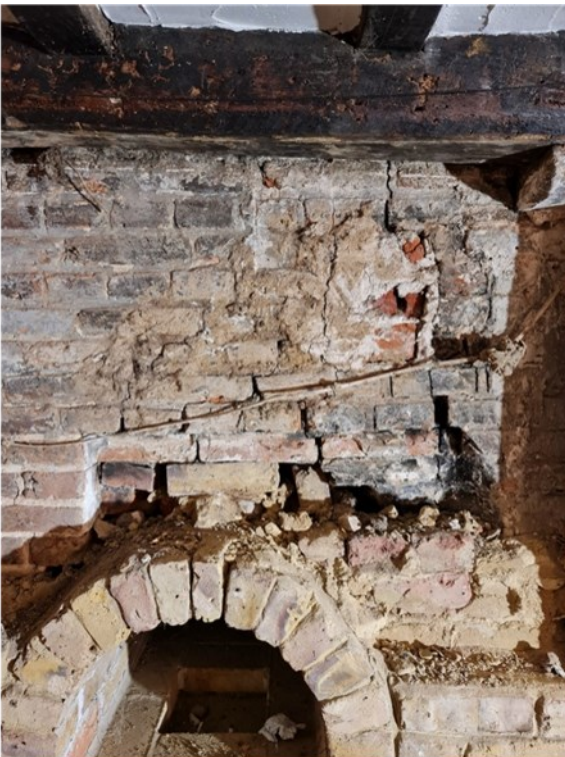
P.9 - GF Lounge - North Elevation
Cracked and Substandard brickwork above fake ovens
Note 7 - on DRWG CLT Ltd - P100

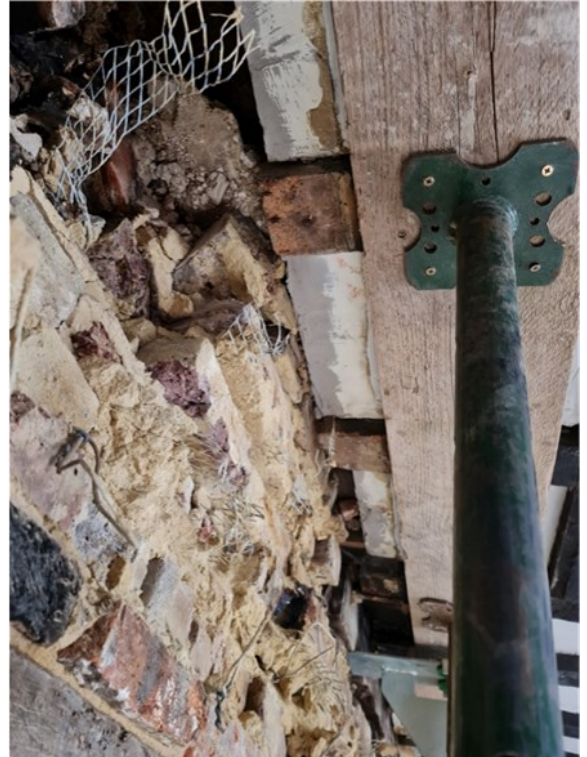
P.10 - GF Lounge - South Elevation
Substandard brickwork and concrete above bressummer beam
Note 7 - on DRWG CLT Ltd - P100

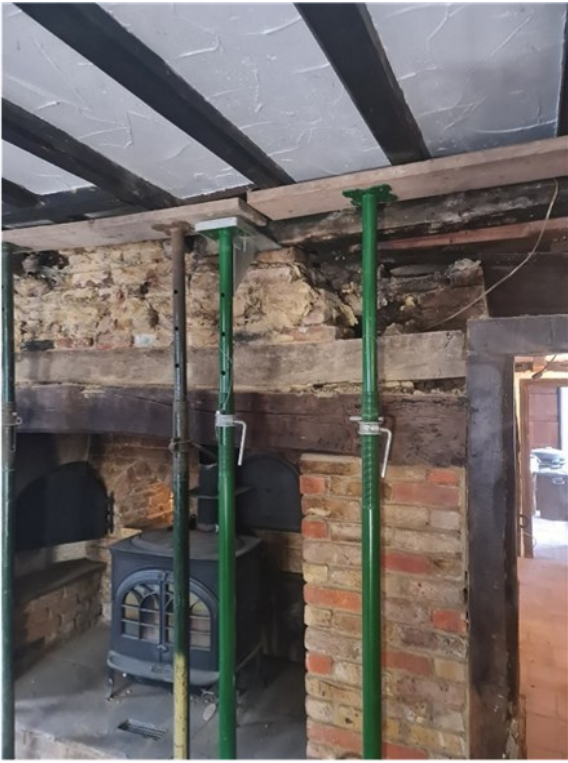
P.11 - GF Lounge - South Elevation

Substandard brickwork and concrete infill above bressummer beam

Note 7 - on DRWG CLT Ltd - P100

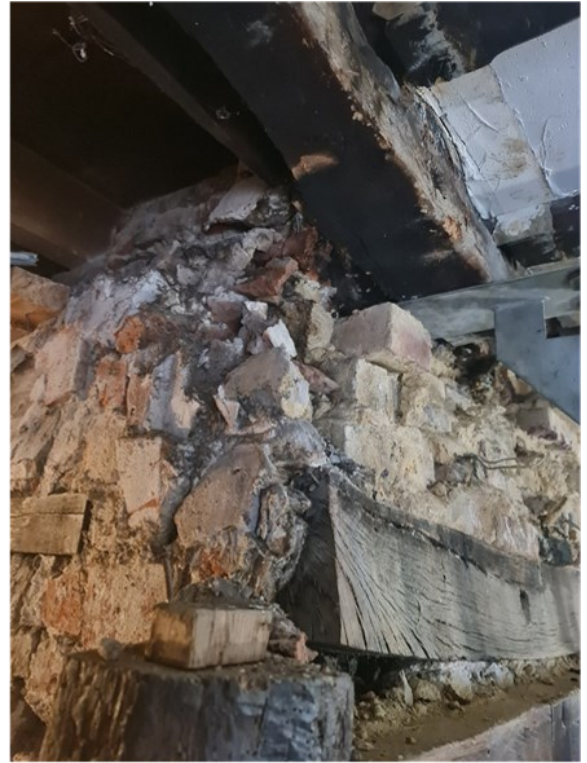
P.12 - GF Lounge - South Elevation

Substandard brickwork and concrete above bressummer beam

Note 7 - on DRWG CLT Ltd - P100

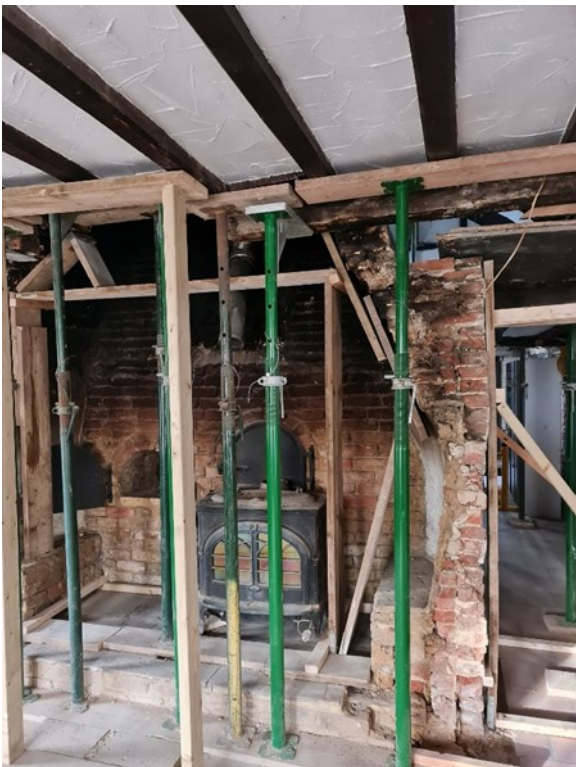
P.13 - GF Lounge - South Elevation

Dangerous brickwork where compromised by previous contractors

Note 7 - on DRWG CLT Ltd - P100

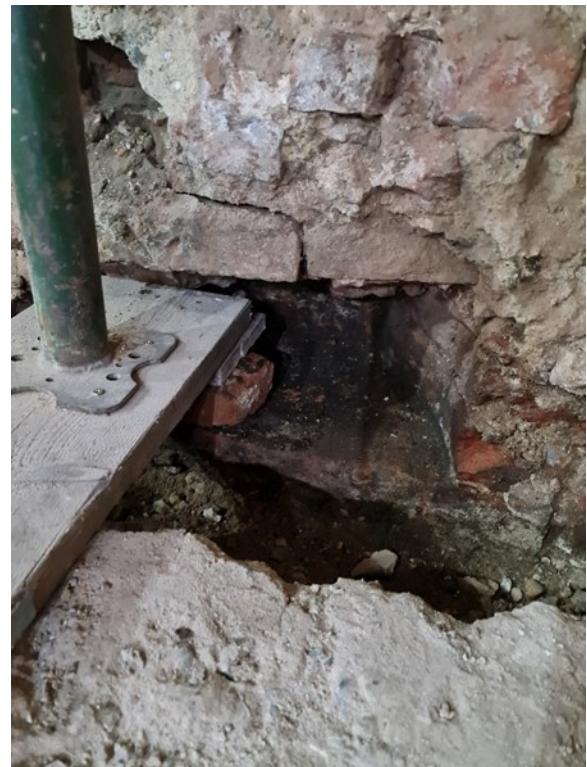
P.14 - GF Dining Room - North Elevation

Voids found in original brickwork at floor level

Note 6 - on DRWG CLT Ltd - P100

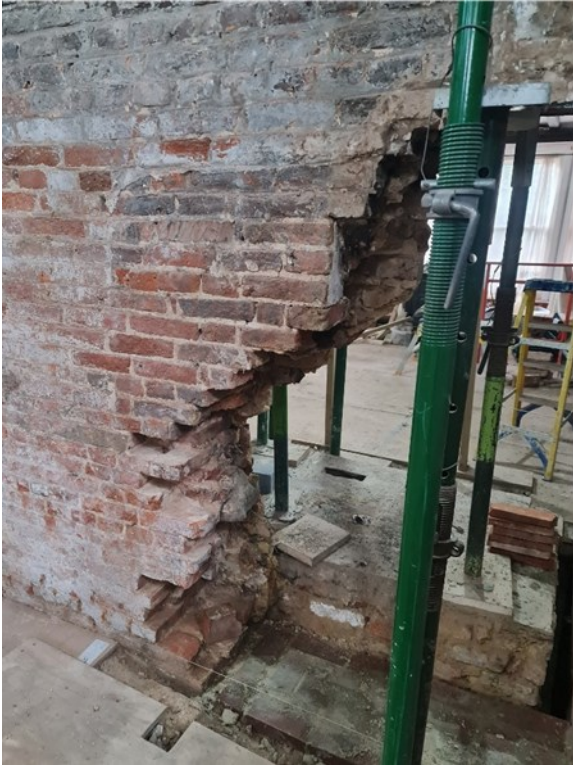
P.15 - GF Dining Room

Existing brickwork retained after rotten brickwork removed

Note 6 - on DRWG CLT Ltd - P100

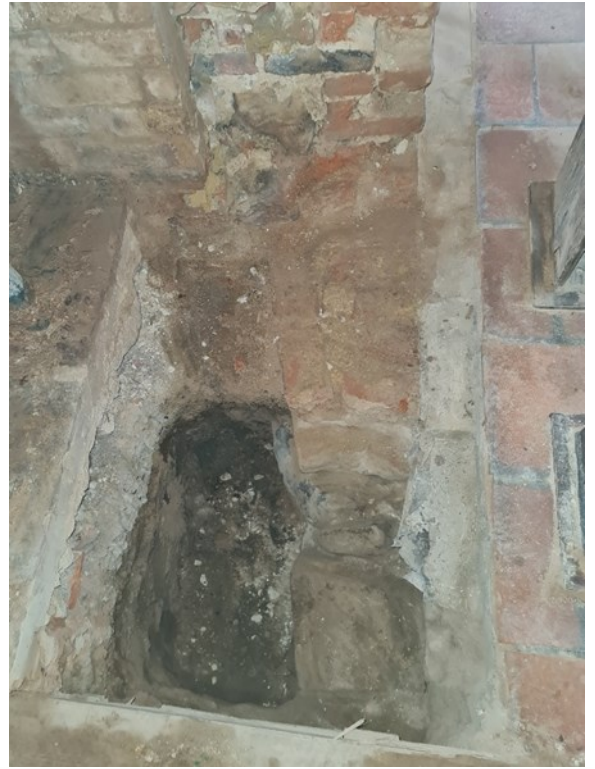
P.16 - GF Lounge / Stairwell

Existing chimney foundation stones and ground conditions

Note 7 - on DRWG CLT Ltd - P100

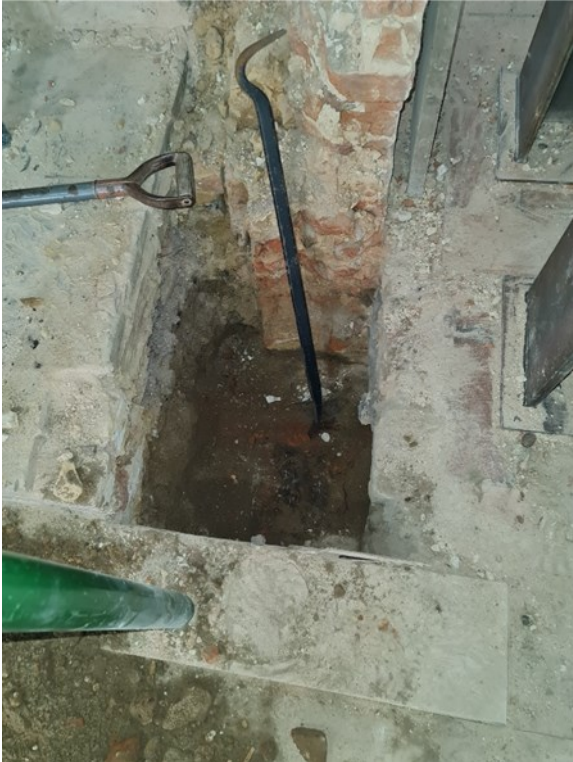
P.17 - GF Lounge / Stairwell

Excavation to right hand side of chimney breast return - New footing to 8

Note 7 - on DRWG CLT Ltd - P100

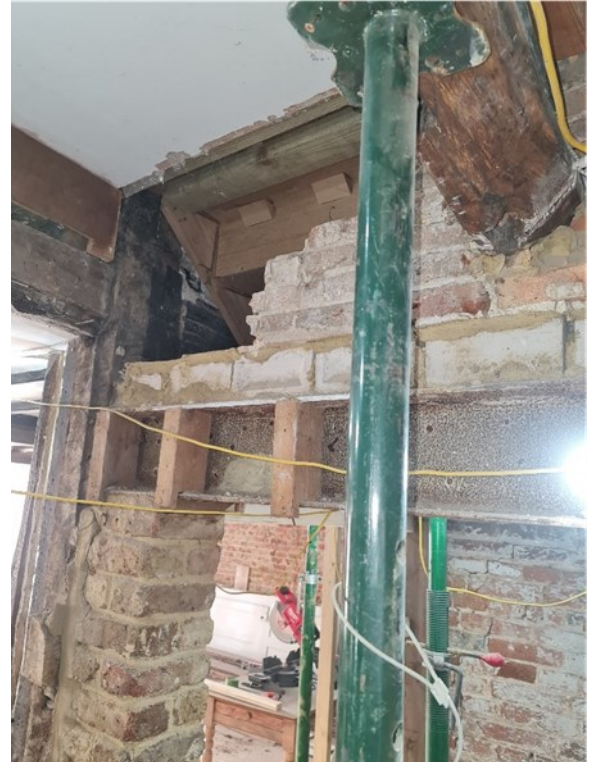
P.18 - GF Stairwell

Substandard brickwork as infill support above lintel, substandard pier to be replaced in timber

Note 8 - on DRWG CLT Ltd - P100

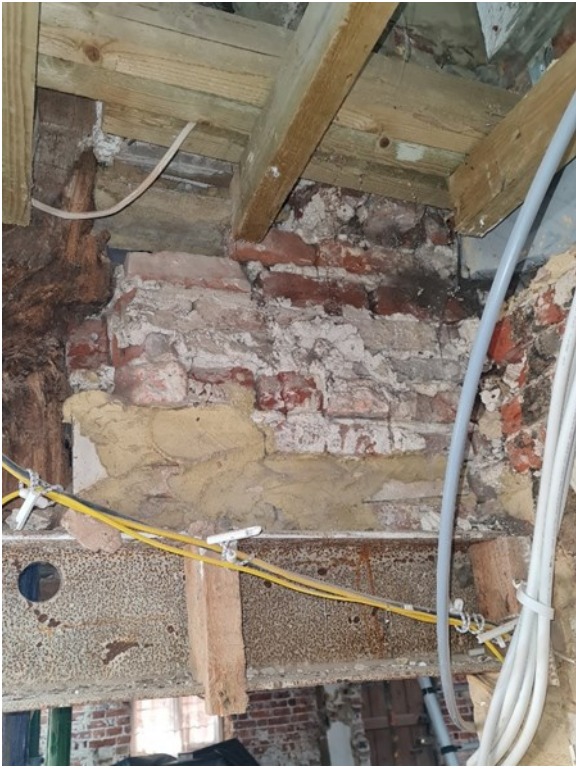
P.19 - GF Stairwell

Substandard brickwork inc. floor joists

Note 10 - on DRWG CLT Ltd - P100

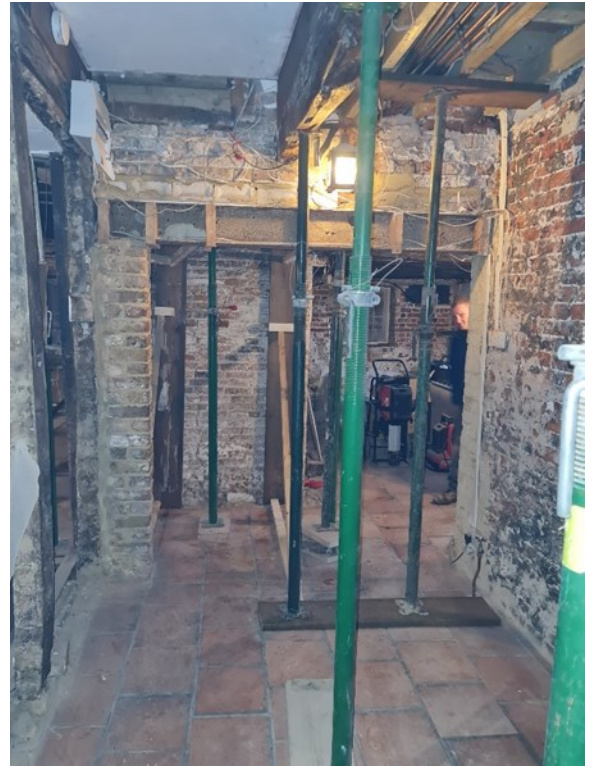
P.20 - GF Stairwell

Substandard brickwork & voids above steel

Note 10 - on DRWG CLT Ltd - P100

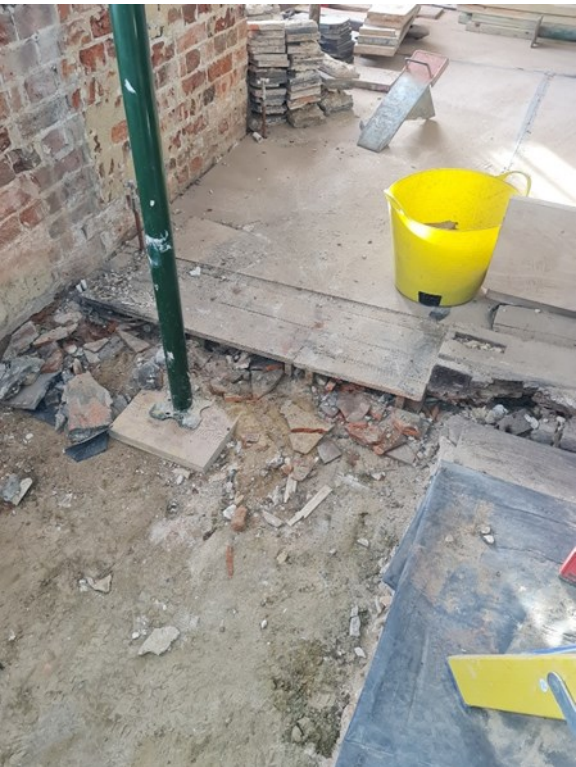
P.21 - Entrance Hall

Tiled floor lifted to reveal earth substrate

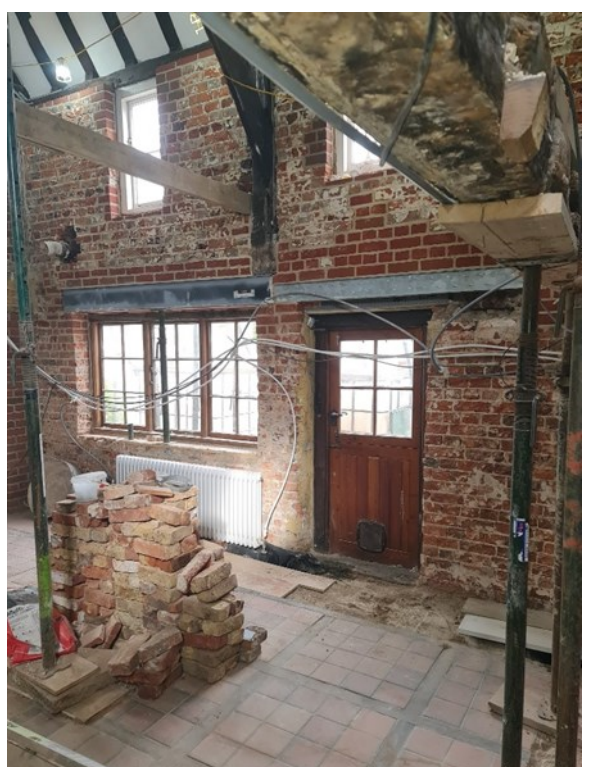
P.22 - GF - NE Elevation Replacement of rotten Lintels

New lintels & brickwork to existing kitchen window

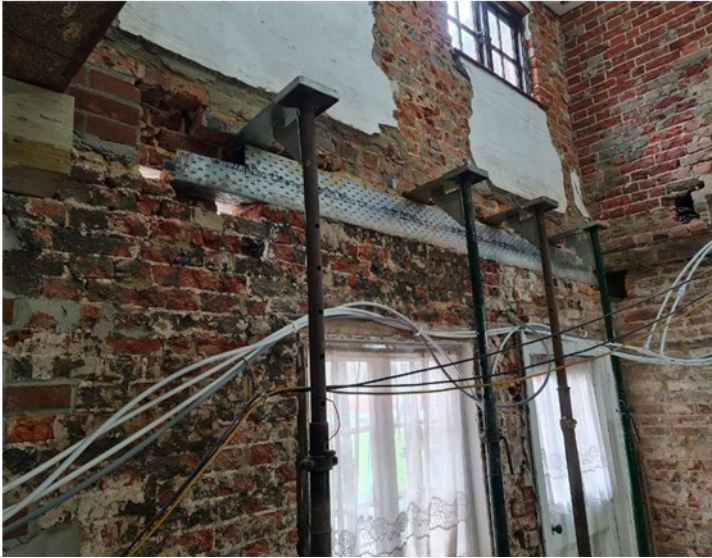
P.23 - GF - NE Elevation - Stairwell

Substandard brickwork & un-satisfactory lintel installation

Note 12 - on DRWG CLT Ltd - P100

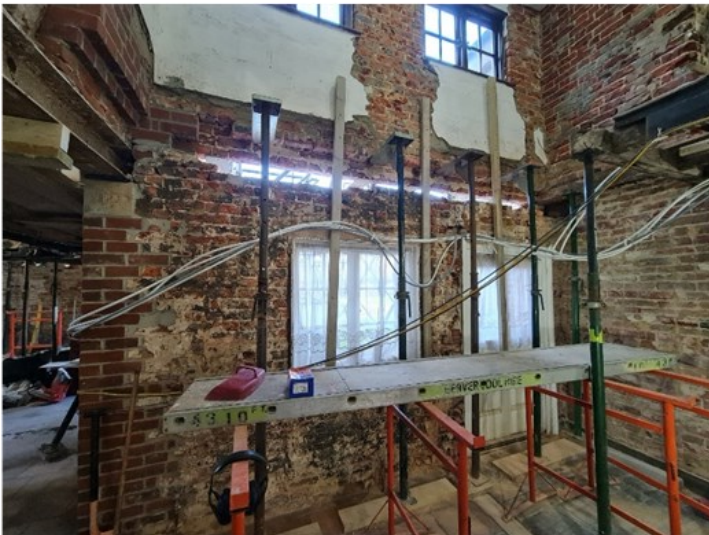
P.24 - GF - NE Elevation - Stairwell

Note 12 - on DRWG CLT Ltd - P100

Wall pinned and lintel removed ready for brickwork repair

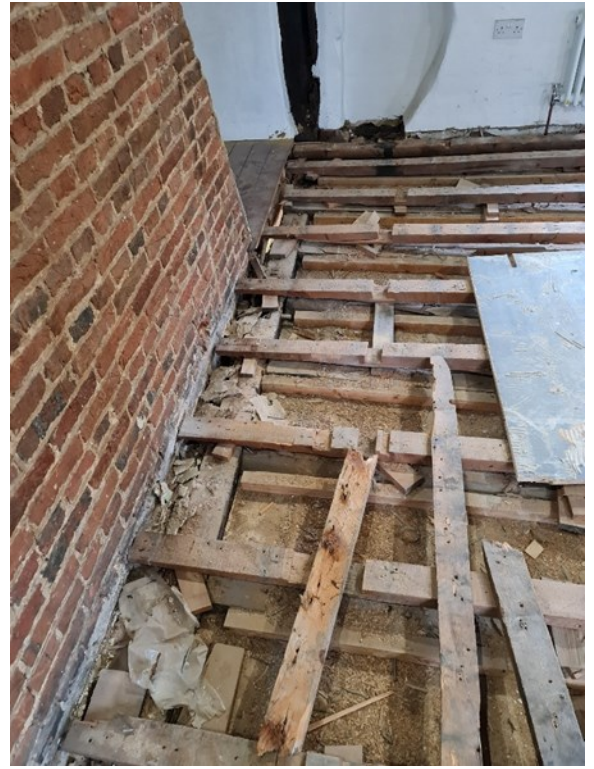
Poorly installed false floor above dining room
Note 21 - on DRWG CLT Ltd - P101

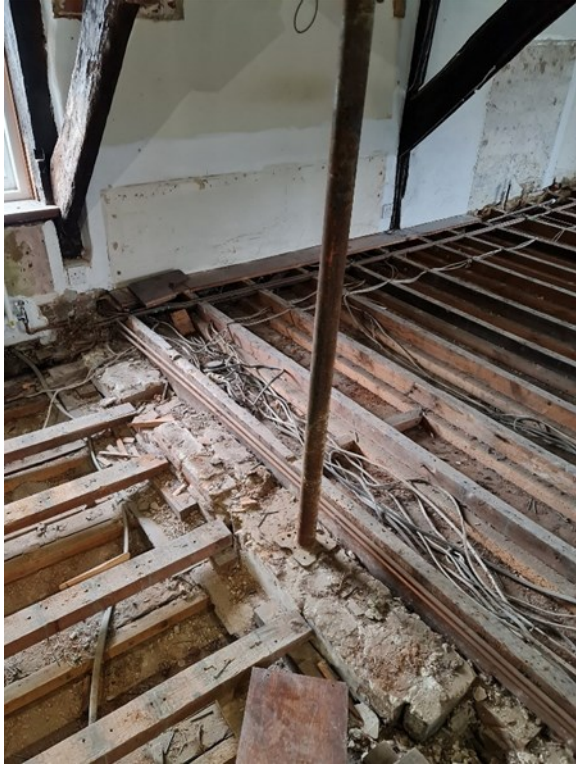
False floor bearing onto rotten beam
Note 21 - on DRWG CLT Ltd - P101

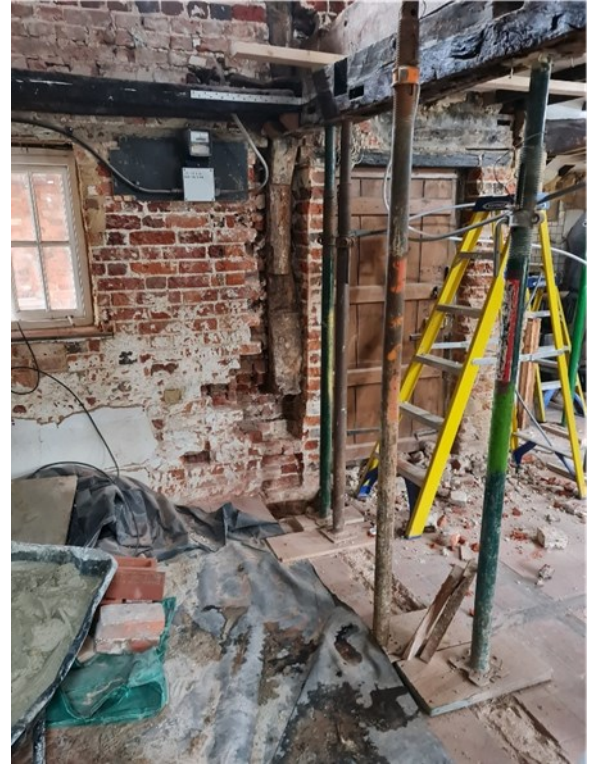
Existing post cut previously & rotten brickwork
beneath toothed out

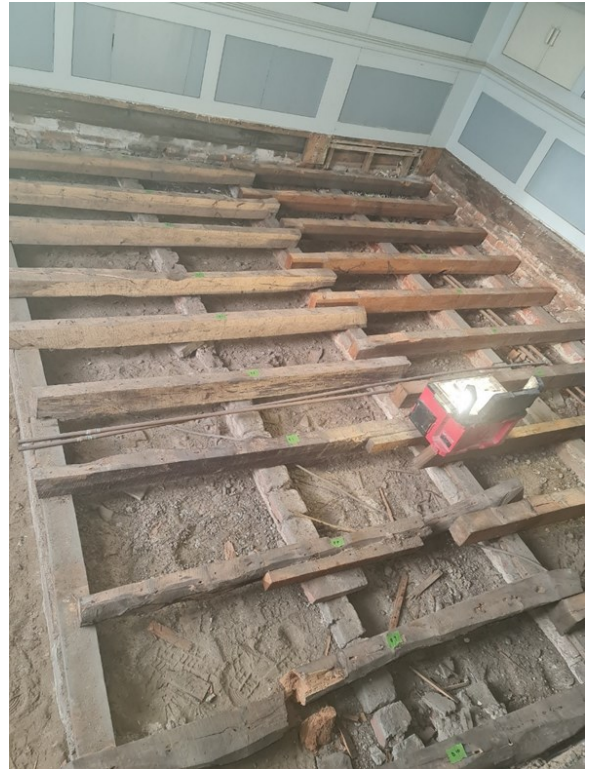
P.31 - GF Music Room - South Elevation
Substandard sleeper walls & rotten floor joists

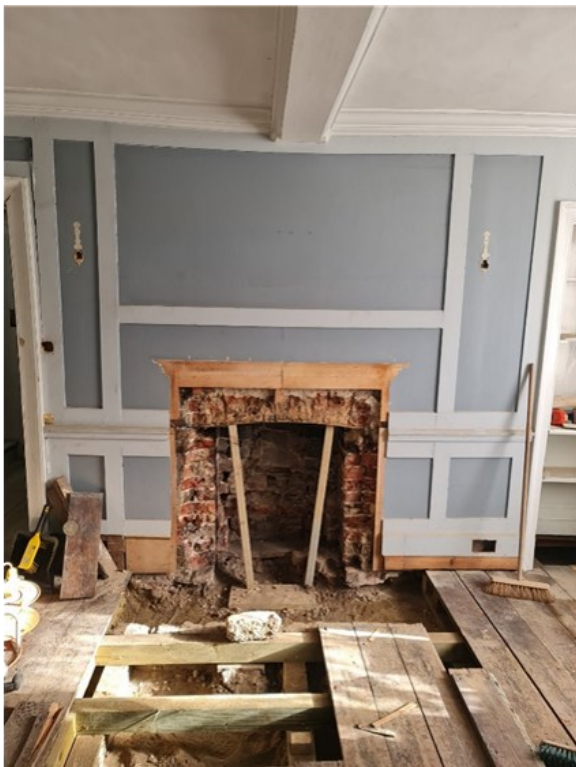
P.32 - GF Music Room - SE Elevation
Fireplace showing rotten brickwork

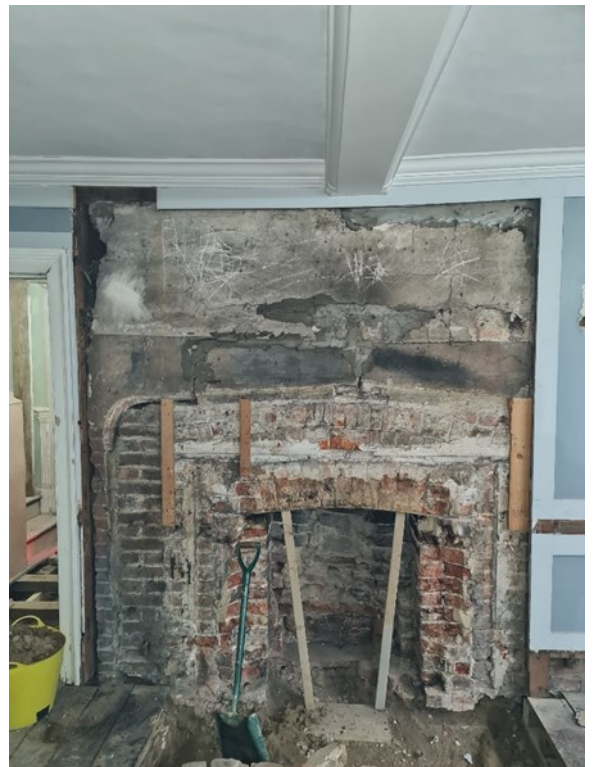
P. 33 - GF Music Room - SE Elevation
Fireplace showing additional cracking to supporting arches

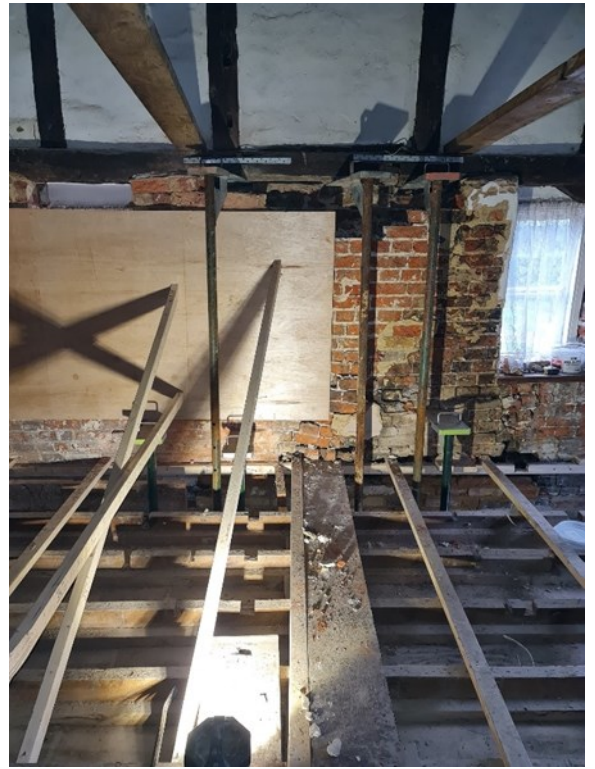
P.39 - 1st Floor En-Suite - North Wall
Substandard wall propped to stop collapse
Note 20 - on DRWG CLT Ltd - P101

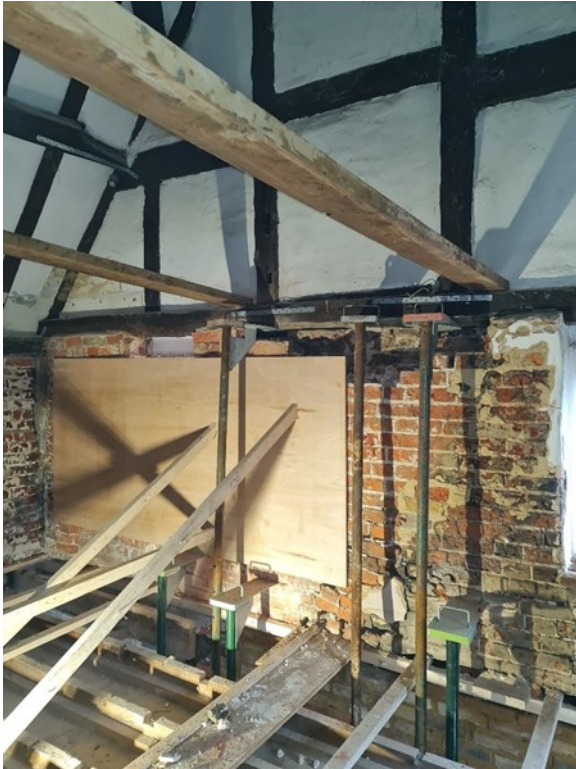
P.40 - 1st Floor En-Suite - North Wall
Substandard wall propped to stop collapse
Note 20 - on DRWG CLT Ltd - P101

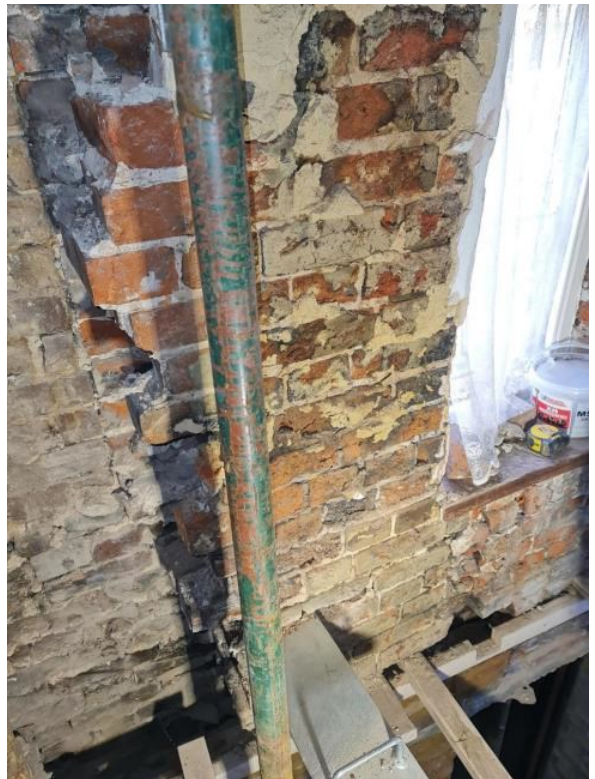
P.41. - 1st Floor En-Suite - North Wall
Bad connection between previously altered brickwork
Note 20 - on DRWG CLT Ltd - P101

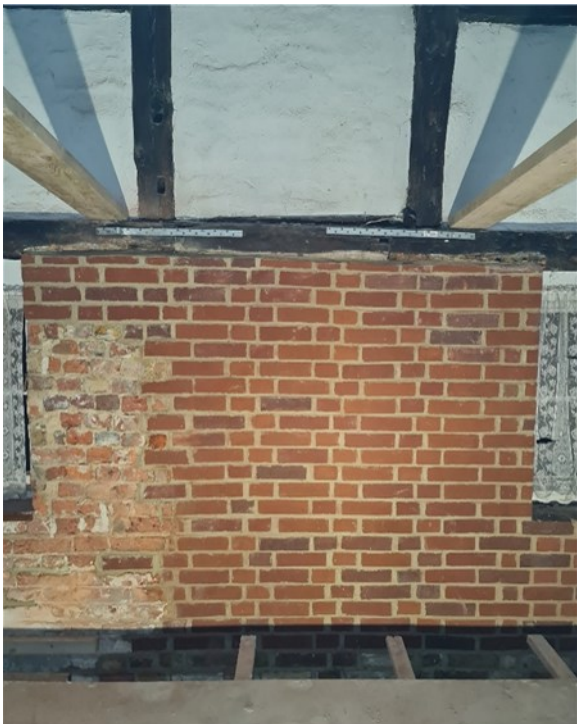
P.42 - 1st Floor Master En-Suite - North Elevation

Note 20 - on DRWG CLT Ltd - P101

Brickwork rebuilt

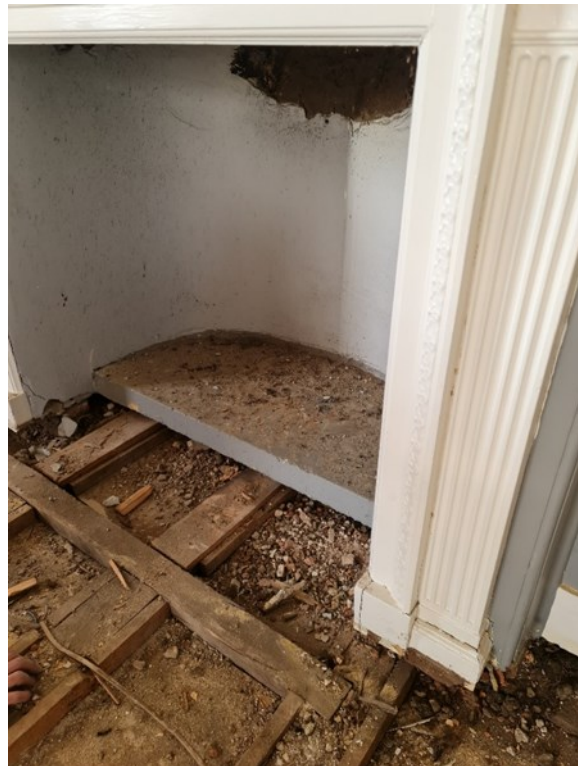
P.43 - 1st Floor South East Bedroom

Fireplace & concrete hearth unsupported by floor joists

Bedroom 04 - on DRWG CLT Ltd

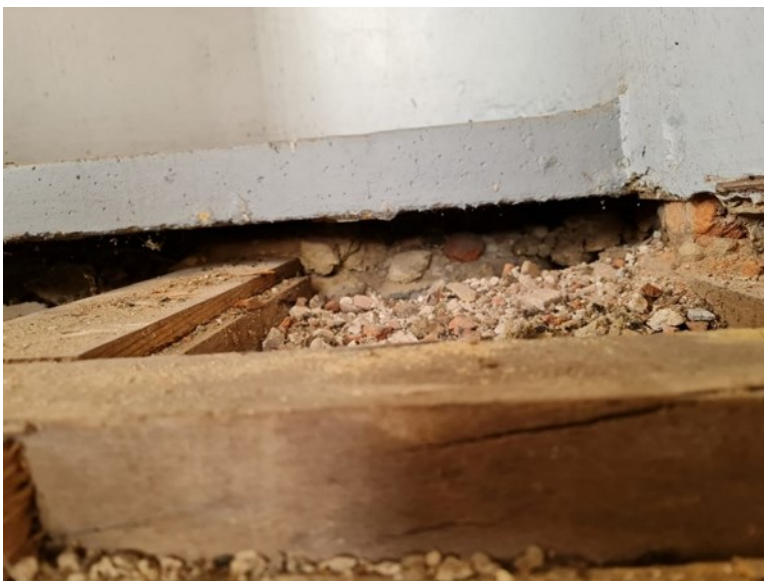
P.44 - 1st Floor South East Bedroom

Void beneath fireplace and brickwork

Bedroom 04 - on DRWG CLT Ltd

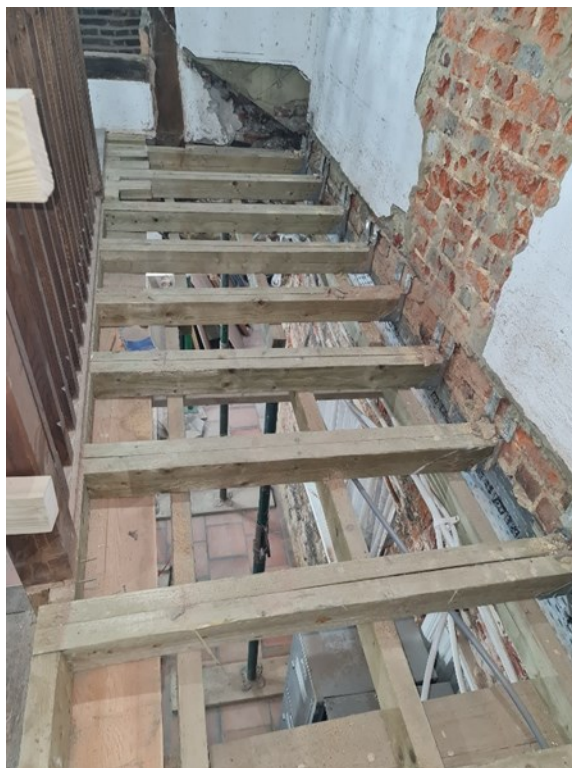
P.45 - 1st Floor - Stairwell Landing

Substandard arrangement & wall connections

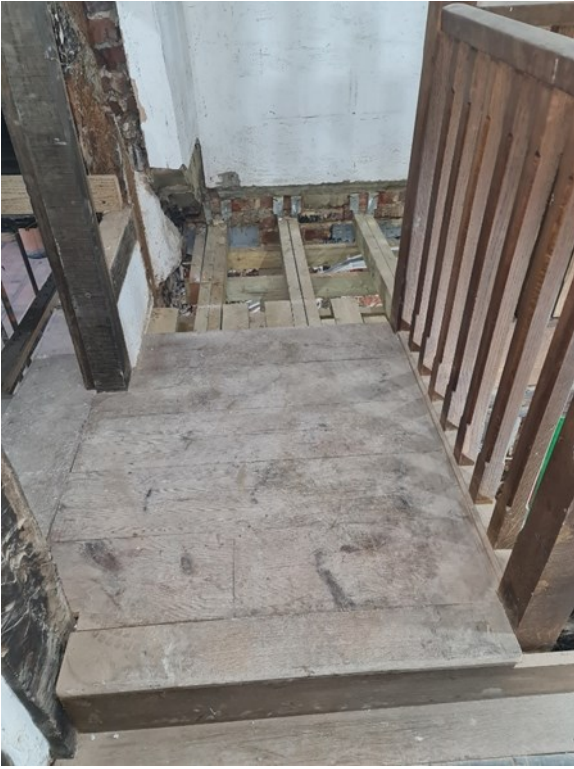
P.46 - 2nd Floor - Stairwell Landing

Substandard floor and joisting layout forming raised landing area

Note 24 - on DRWG CLT Ltd - P101

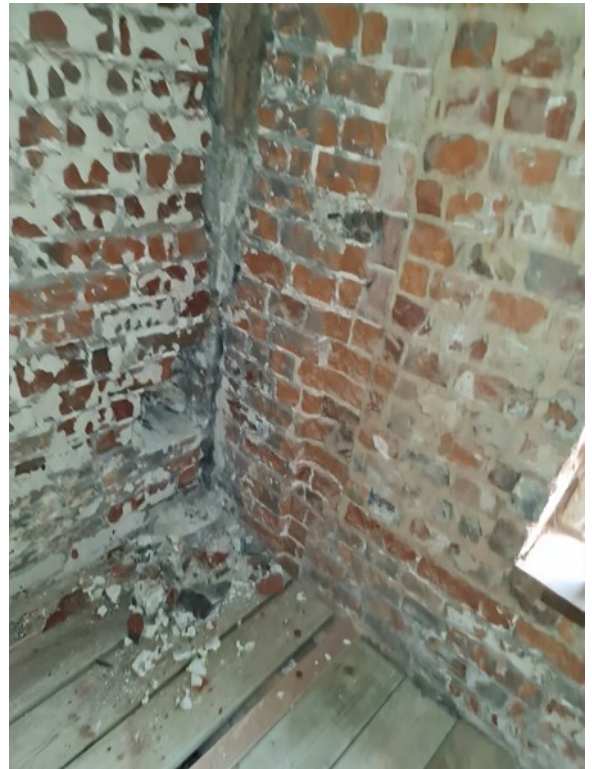
P.47 - 1st Floor Master En-Suite - NW Corner

Existing timber post with substandard brickwork shown

Note 24 - on DRWG CLT Ltd - P101

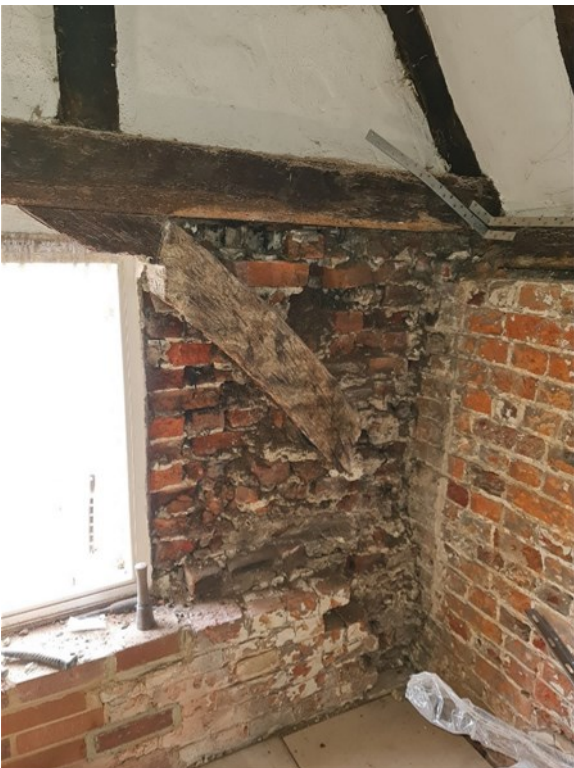
P.48 - 1st Floor Master En-suite - N/NE Corner

Existing frame brace previously cut and encased in substandard brickwork

Note 20 - on DRWG CLT Ltd - P101

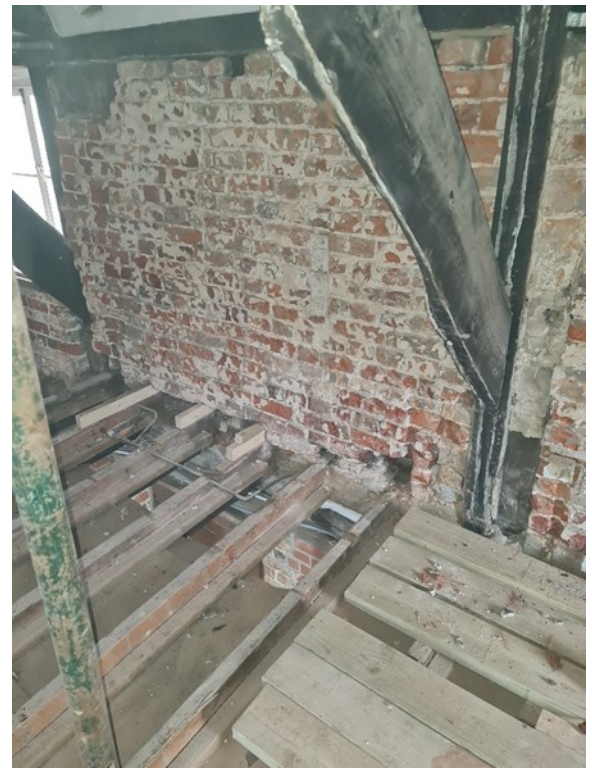
P.49 - 1st Floor Master Bedroom - NW Elevation

Cracked brickwork and voids in wall

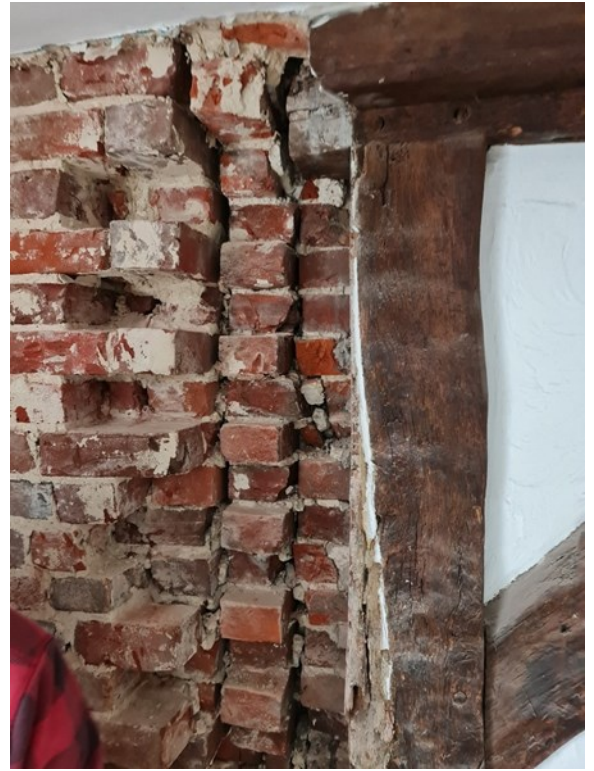
P.51 - 1st Floor Bathroom - NE Elevation
Detail showing lack of tie-in

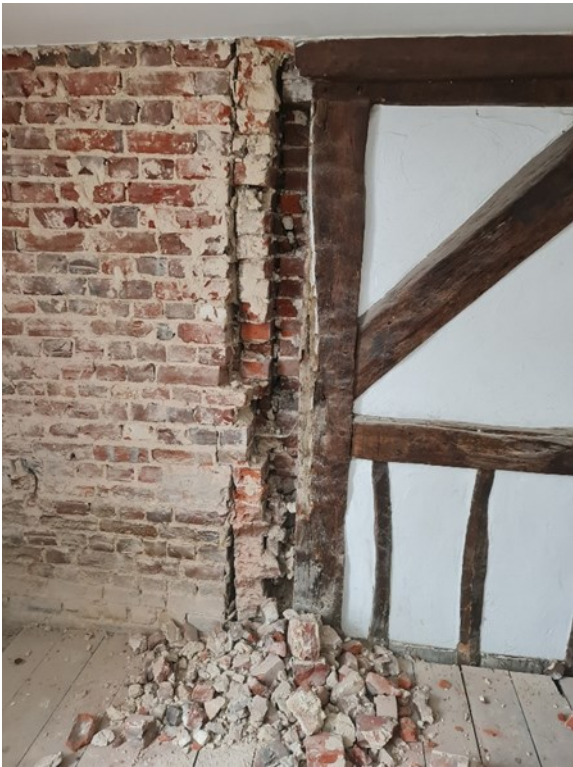
P.52 - 1st Floor Bathroom - NE Elevation
Poorly constructed corner return showing unbonded brickwork
