27<sup>th</sup> February 2024

**Ref: BSCB-2402-TM**

## Tree Management Survey

## Braemar Studio, Chapel Brae

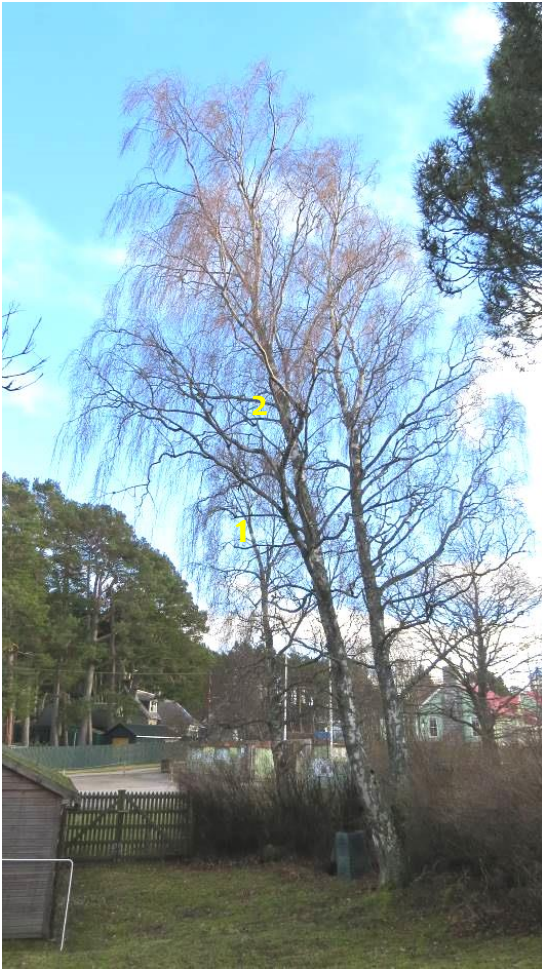
Photo 1: Birch 1 & 2 growing adjacent to south boundary. Birch 2 has some shallow cavities but appears healthy.

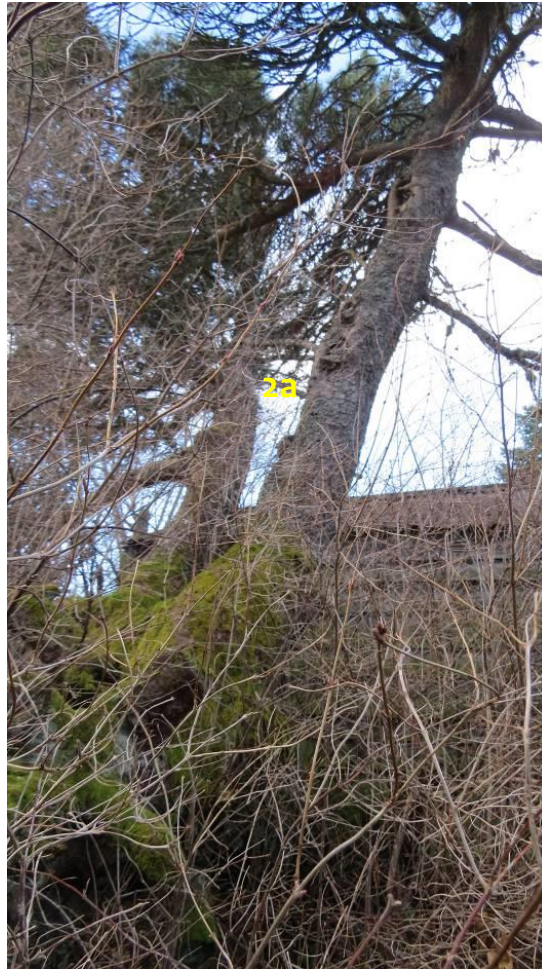
Photo 2: Lodgepole pine 2a, showing two canopy branches now forming the trunks.

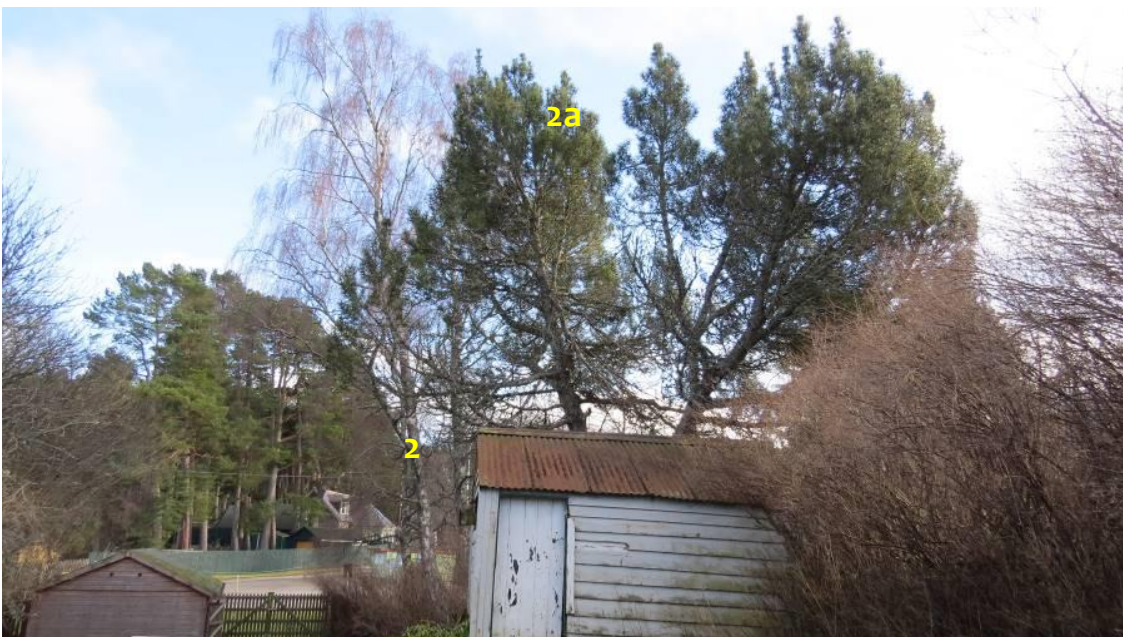
Photo 3: Lodgepole pine 2a, with two canopy branches forming main stems.

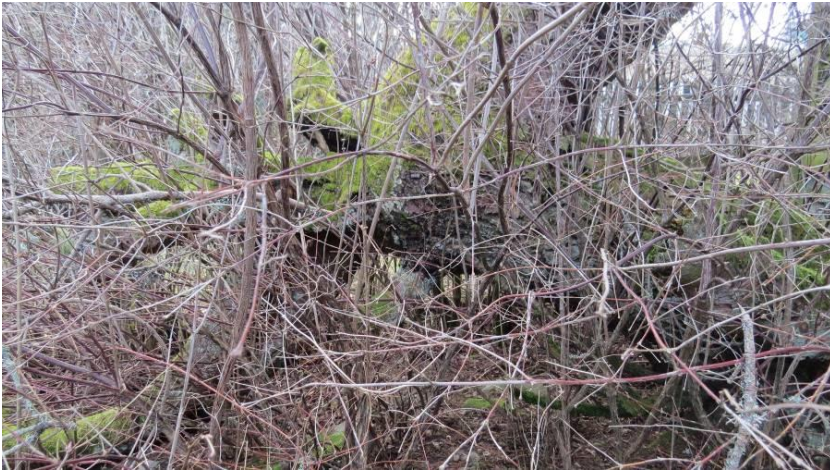
Photo 4:  
Lodgepole pine 2a.  
New main stem growing  
from adjacent to stem.  
Windblown in past with  
two canopy branches  
forming stems. Trunk  
supported by branches.

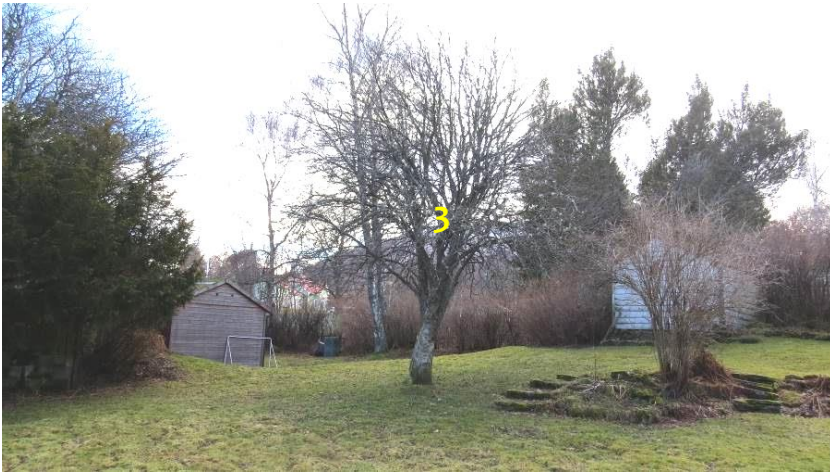
Photo 5:  
Rowan 3, multi-branched  
tree, appears healthy.

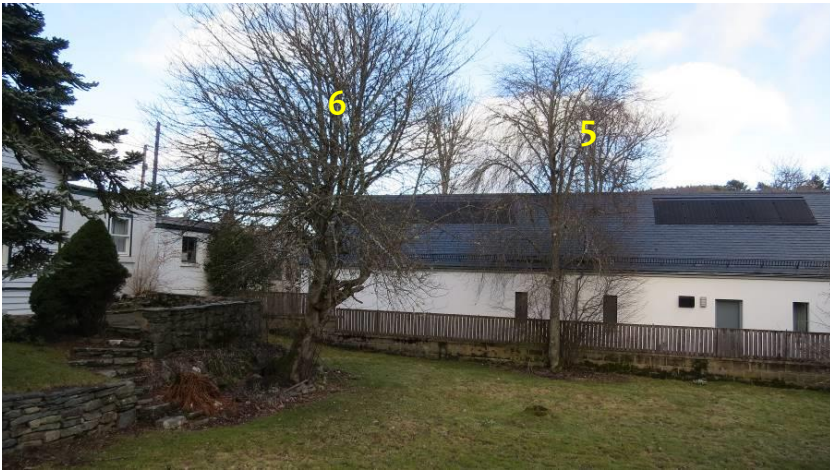
Photo 6:  
Bird cherry 5 and bird  
cherry 6.  
Bird cherry 6 was  
originally three-stemmed.  
The north limb has been  
removed with substantial  
rot. Tree leans south  
– fell for safety.

Bird cherries 4 and 6 should be felled for safety

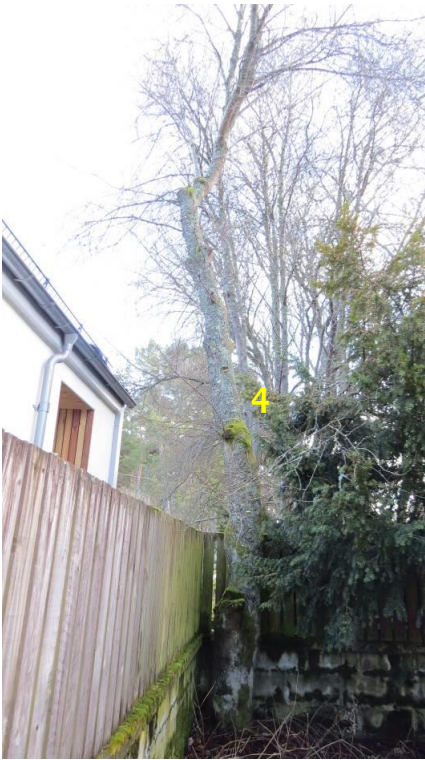
Photo 6: Tree 4 growing adjacent to dwarf wall. Tree has had canopy branches to east removed. Fell for health and safety.

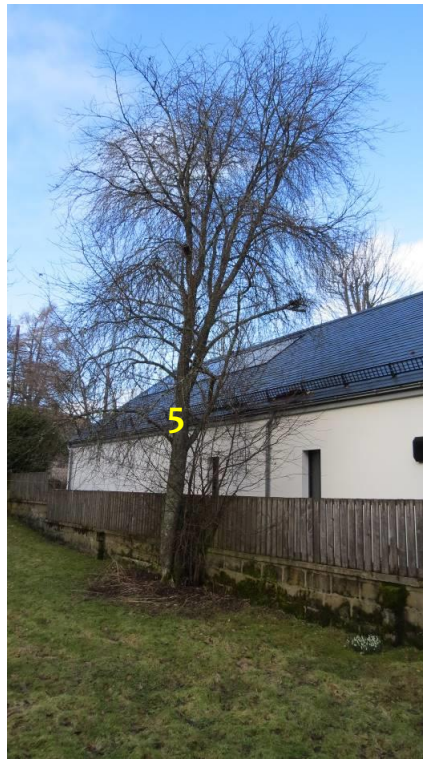
Photo 7: Bird cherry 5, leaning over neighbouring property. Thin canopy 15% and reduce by 3-4m to balance tree.

5	Bird cherry	28	3	3	4	2	10	3.4	M	C	Twin-stemmed from 4m. Tree leans east with canopy over house.	Thin canopy 15% and reduce by 3-4m to balance tree.
6	Bird cherry	41	5	4	6	5	9	4.9	M	C	Tree leans south. Poor condition with branch cuts having some rot. Large north stem has been cut off at base with rot apparent.	Fell for safety.
7	Noble fir	63	4	4	5	3	17	7.6	M	U	Twin-stemmed from 3.5m. Limb divergence angle weak and cracking, could fail.	Fell for safety.
8	Noble fir	40	4	3	1	4	14	4.8	M	C	Tree leans northwest, canopy suppressed by tree 7 to east. Tree will be exposed and more prone to wind blow, when tree 7 is felled.	Fell for safety.

Bird cherry 5 - Canopy should be thinned by 15% and reduced 3 – 4m to reduce weight and spread over house.

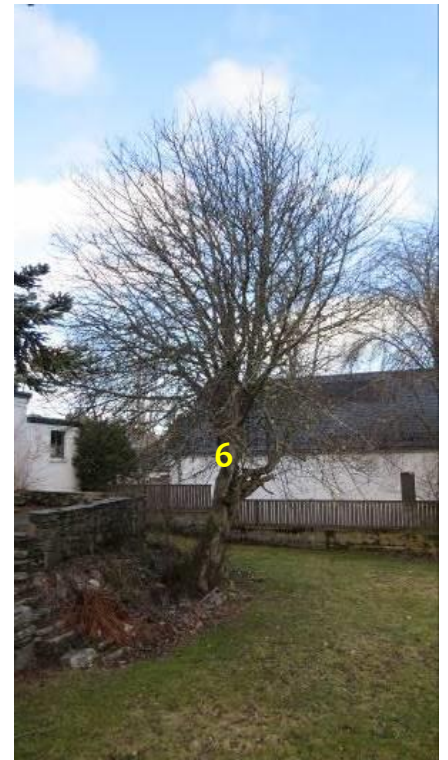
Photo 10: Bird cherry 6, leans south with rot at base. Fell for safety.

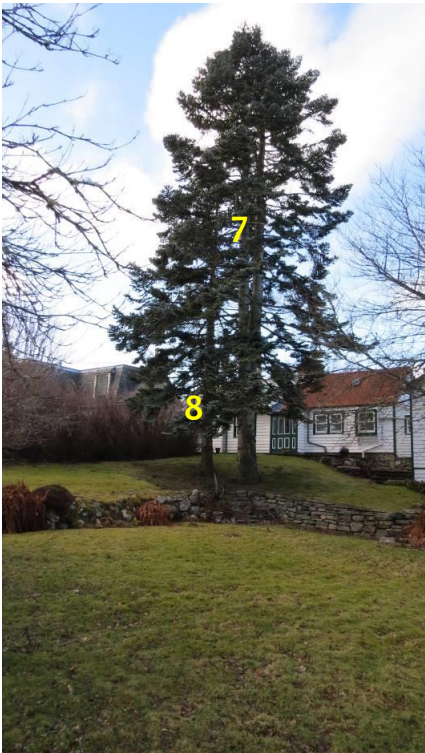
Photo 11: Noble firs 7 and 8 growing within 5m of the house. Tree 7 is twin stemmed from 3.5m.

Noble fir trees 7 and 8 should also be felled for safety

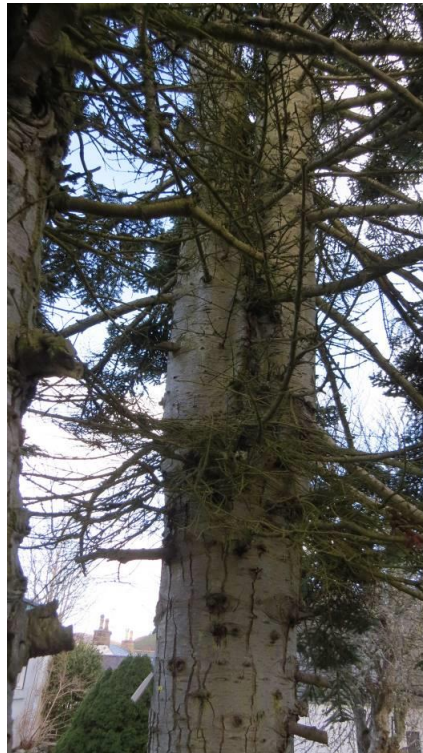
Photo 12: Tree 7 with twin-stemmed area with weak divergence angle and cracking giving instability in this area of the tree. Fell for safety.

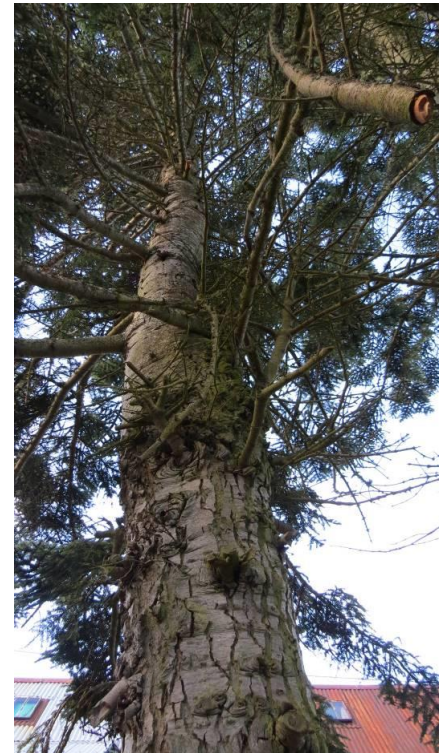
Photo 14: Noble fir 8 leans northwest, towards house, with suppressed canopy to southeast due to Tree 7. Fell for safety.
