Engineers Report

Risk Address Penbryn, Green Street
Eye
Hoxne
IP21 5AX

360 Reference LIV-SN-22-006110
Insurer Reference 800-08-001206
Policy Holder Miss Jo Chimes

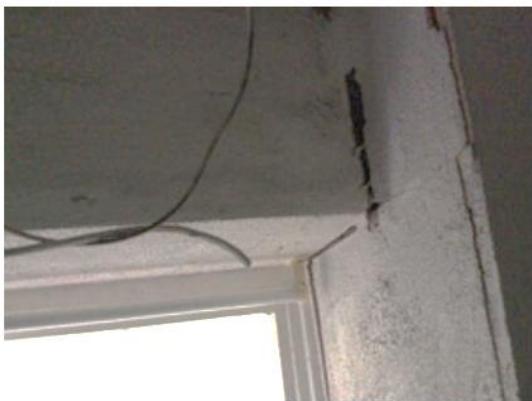
Vertical tapered cracking was evident above and below the right elevation window, up to approximately 10mm wide

Picture 1: Internal cracking to WC

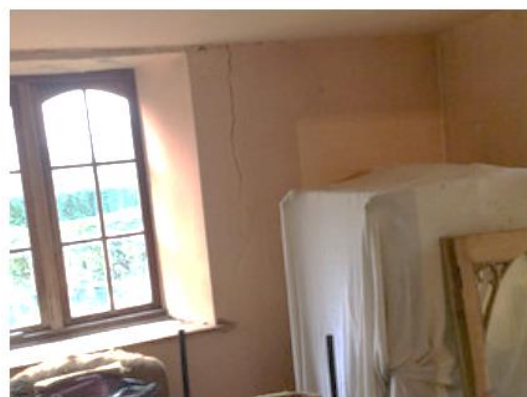
Vertical tapered cracking, up to approximately 3/4mm wide is evident to the left hand side of the front window which extends from ceiling level tapering downwards.

Picture 2: Internal cracking to Left Hand room

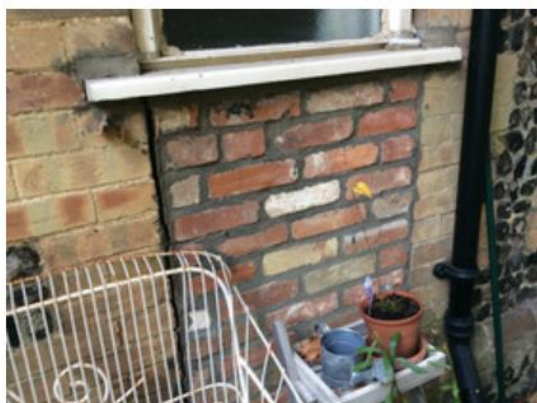
A tapered, vertical crack, varying in width up to approximately 20mm wide, is evident below the WC window where the original doorway was partially bricked up. There is a circa 15mm stepped crack to the arch lintel above the window and a circa 15mm tapered gap between the window frame and brickwork.

Picture 3: External cracking to right elevation Picture 4: External cracking to right elevation
