**CCTV REPORT FOR: PENBRYN
GREEN STREET
HOXNE
EYE
IP21 5AX**

Site Visit: 24-May-23
Report Date: 20-Jun-23

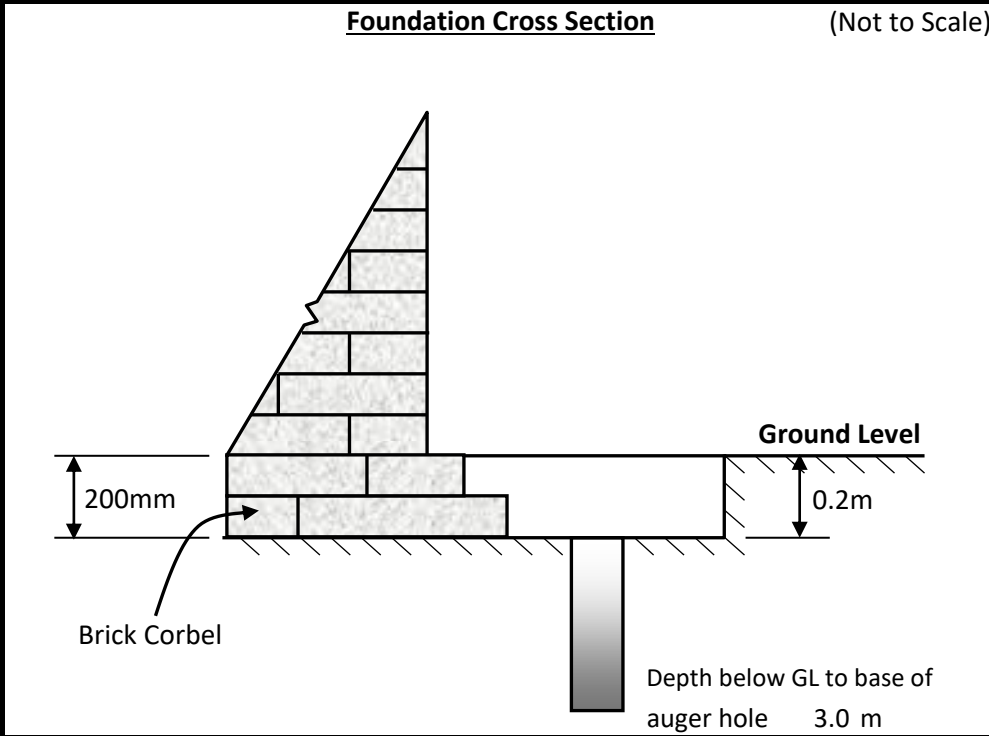
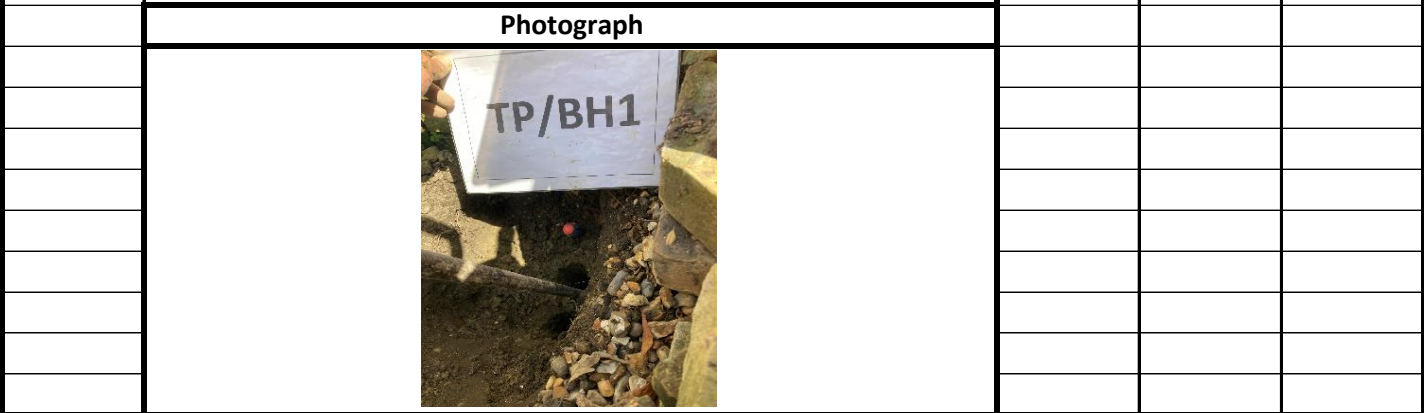
Location: Front left hand corner	T/H No. 1
Ground Surface: Dry	Weather: Dry
	Date: 24-May-23

Roots Depth & Diameter:
From 0.2m
Down to 0.8m
up to 1mm diameter
Water Depth Hit & Rise:
None observed on site
Reason for Termination:
Encountered obstruction
Layer of chalk

Depth (m)	Soil Descriptions <i>(NB: Field crew description only)</i>	Test Type	Depth (m)	
			From	To
G.L.				
0.20	Soft/firm grey/brown slightly sandy CLAY with some medium gravel (inc. chalk)	V(n) 74	0.200	
1.00	Firm/stiff grey/brown CLAY with some medium gravel (inc. chalk)	V(n) 88	1.000	
3.00	End of Borehole	V(n) 96	1.500	
		V(n) 99	2.000	
		V(n) 108	2.500

Stone / brick fill as foundation

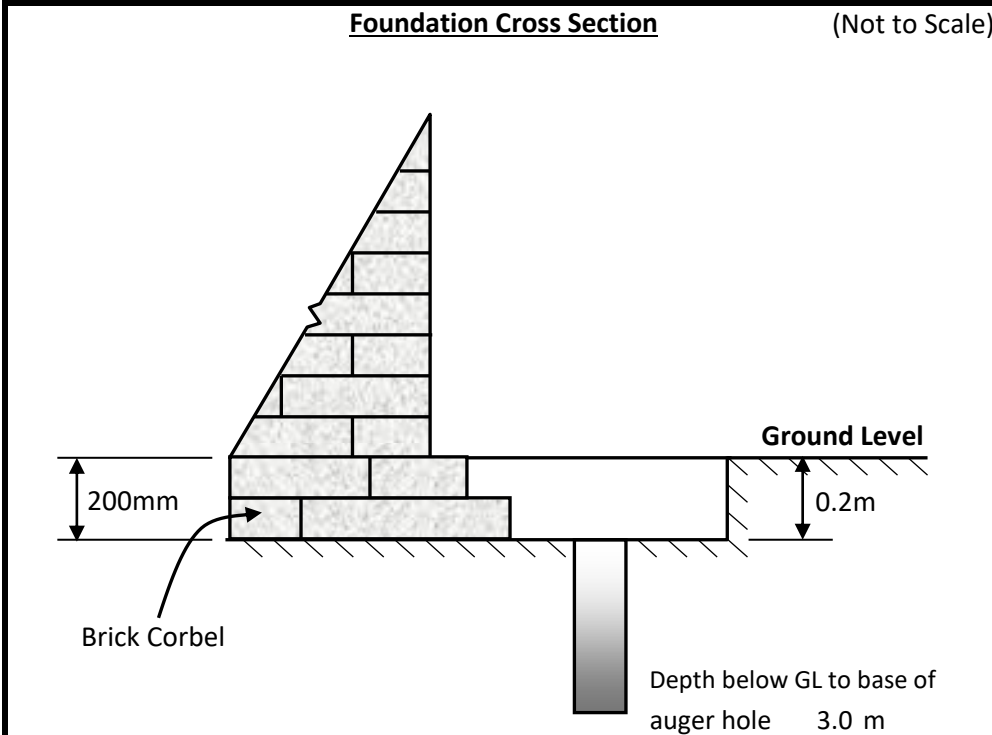
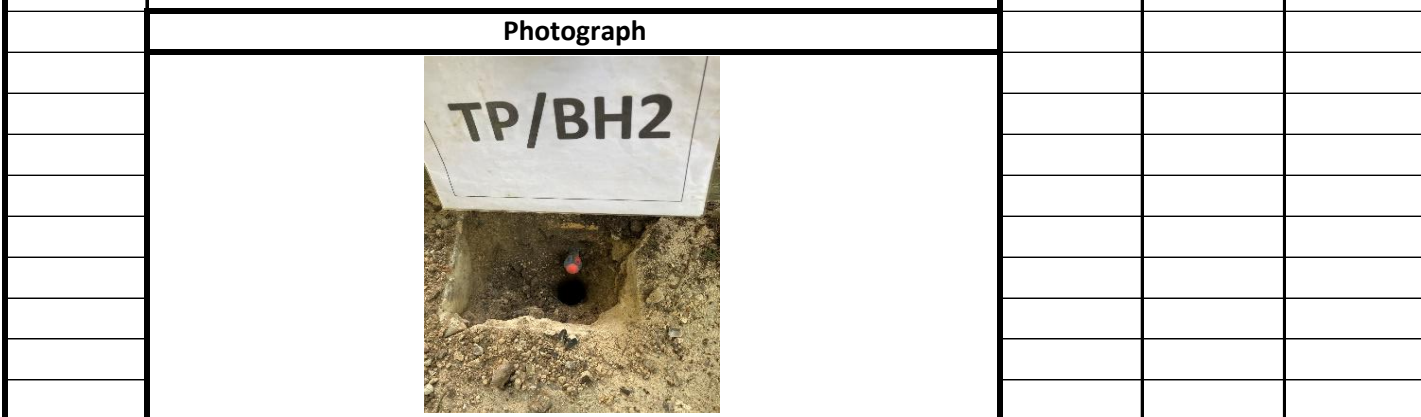
Location: Rear right hand corner	T/H No. 2
Ground Surface: Dry	Weather: Dry
	Date: 24-May-23

Roots Depth & Diameter:
From 0.2m
Down to 1.5m
up to 1mm diameter
Water Depth Hit & Rise:
None observed on site
Reason for Termination:
Encountered obstruction
Layer of chalk

Depth (m)	Soil Descriptions <i>(NB: Field crew description only)</i>	Test Type	Depth (m)	
			From	To
G.L.				
0.20	Soft/firm brown slightly sandy CLAY with some medium gravel (inc. brick & chalk)	V(n) 58	0.200	
1.00	Firm/stiff grey/brown slightly sandy CLAY with some medium gravel (inc. chalk)	V(n) 78	1.000	
1.50	Firm/stiff grey/brown CLAY with some medium gravel (inc. brick & chalk)	V(n) 84	1.500	
2.00	Firm/stiff grey/brown CLAY with some medium gravel (inc. chalk)	V(n) 98	2.000	
3.00	End of Borehole	V(n) 105	2.500

Stone / brick fill as foundation

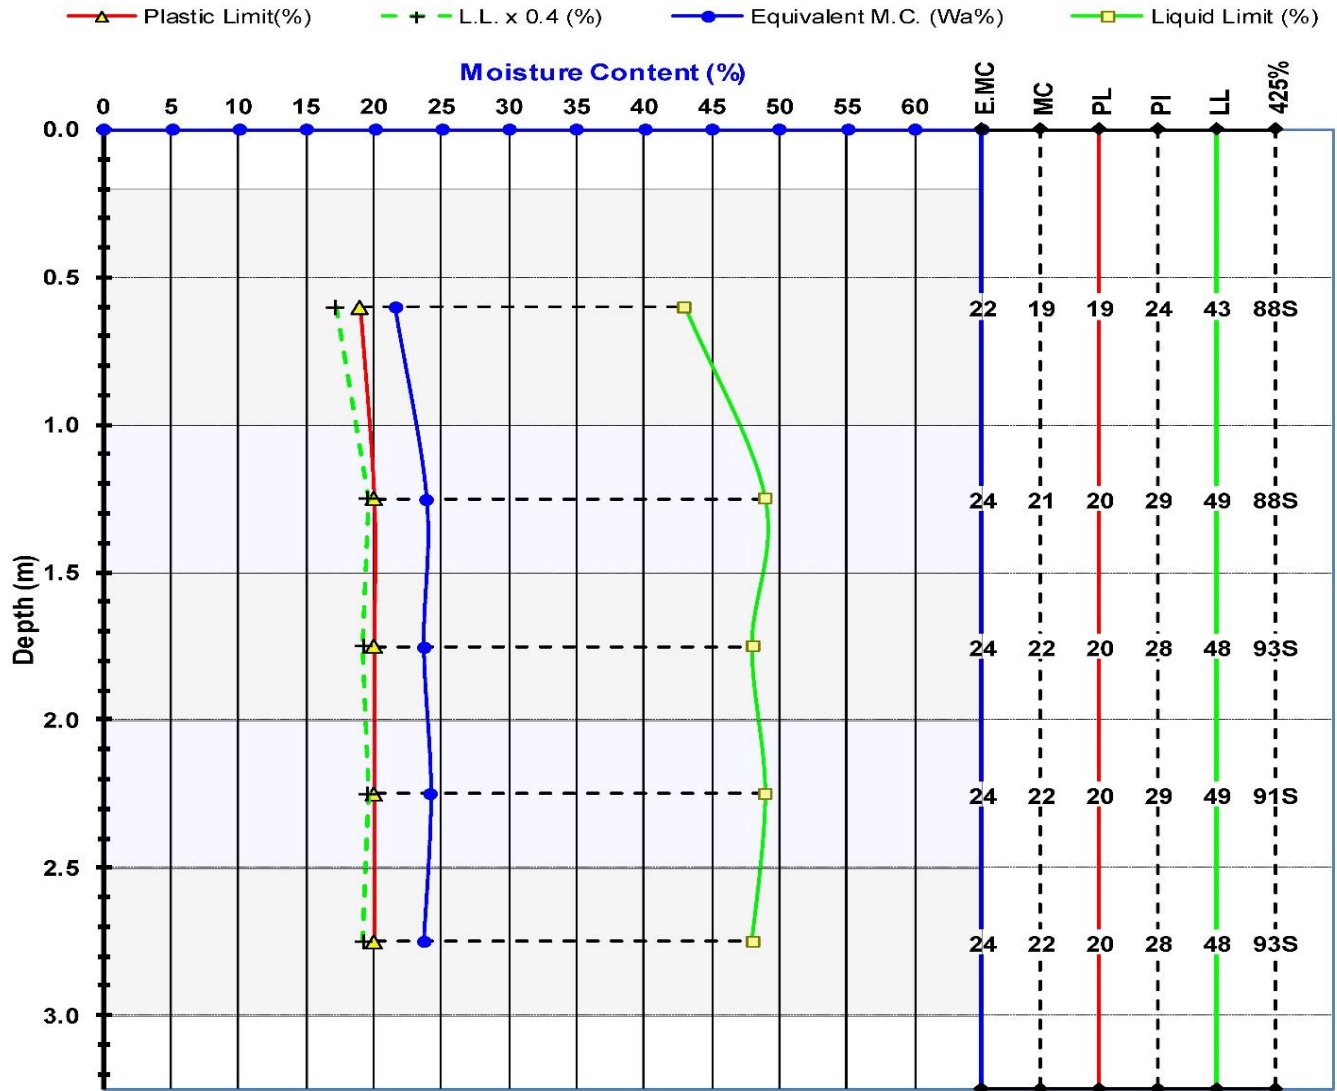
Depth T (m)	Depth B (m)	1 - Front LHC		Plasticity (BS 5930)	Volume Change (BRE 240)
		Brief Soil Description			
0.2	1	Soft/firm grey/brown slightly sandy CLAY with some medium gravel (inc. chalk)		Intmd. CI	21% Medium
1	1.5	Firm/stiff grey/brown CLAY with some medium gravel (inc. chalk)		Intmd. CI	26% Medium
1.5	2	Firm/stiff grey/brown CLAY with some medium gravel (inc. chalk)		Intmd. CI	26% Medium
2	2.5	Firm/stiff grey/brown CLAY with some medium gravel (inc. chalk)		Intmd. CI	26% Medium
2.5	3	Firm/stiff grey/brown CLAY with some medium gravel (inc. chalk)		Intmd. CI	26% Medium

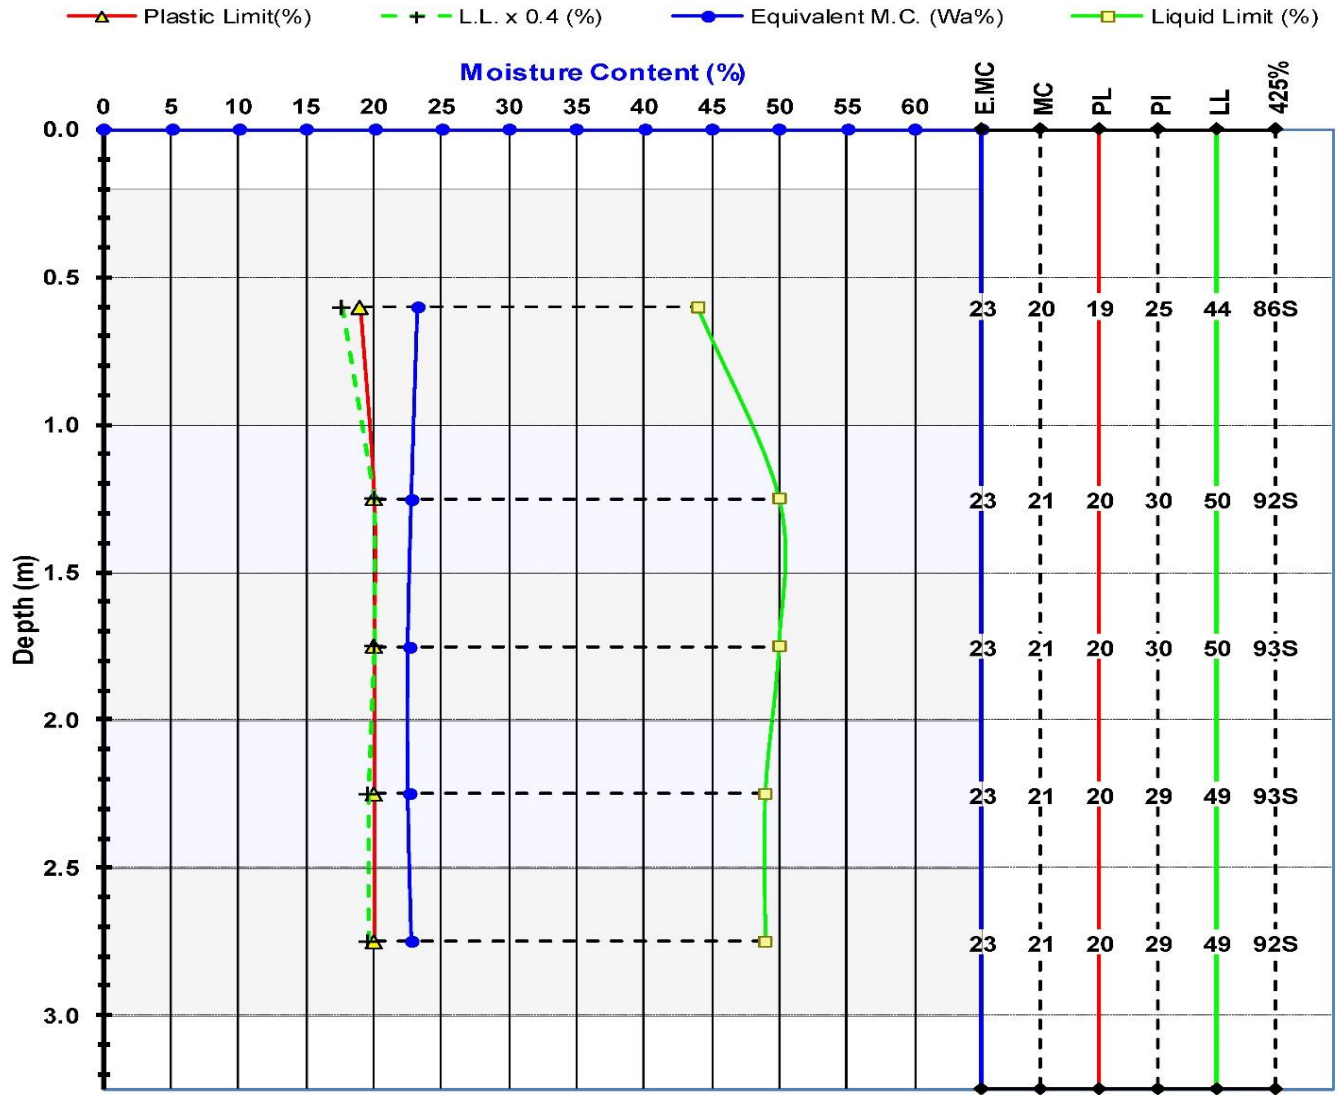
Depth T (m)	Depth B (m)	2 - Rear RHC		Plasticity (BS 5930)	Volume Change (BRE 240)
		Brief Soil Description			
0.2	1	Soft/firm brown slightly sandy CLAY with some medium gravel (inc. brick & chalk)		Intmd. CI	22% Medium
1	1.5	Firm/stiff grey/brown slightly sandy CLAY with some medium gravel (inc. chalk)		Intmd. CI	28% Medium
1.5	2	Firm/stiff grey/brown CLAY with some medium gravel (inc. brick & chalk)		Intmd. CI	28% Medium
2	2.5	Firm/stiff grey/brown CLAY with some medium gravel (inc. chalk)		Intmd. CI	27% Medium
2.5	3	Firm/stiff grey/brown CLAY with some medium gravel (inc. chalk)		Intmd. CI	27% Medium
