INFORMATION SCHEDULE RELATING

LISTED BUILDING CONSENT
REFERENCE 21/0317/LBC
CONVERSION OF AGRICULTURAL BUILDING TO
DWELLING

UNDERDOWN FARM,
RAWRIDGE
UPOTTERY
DEVON
EX14 9QR

February 2024

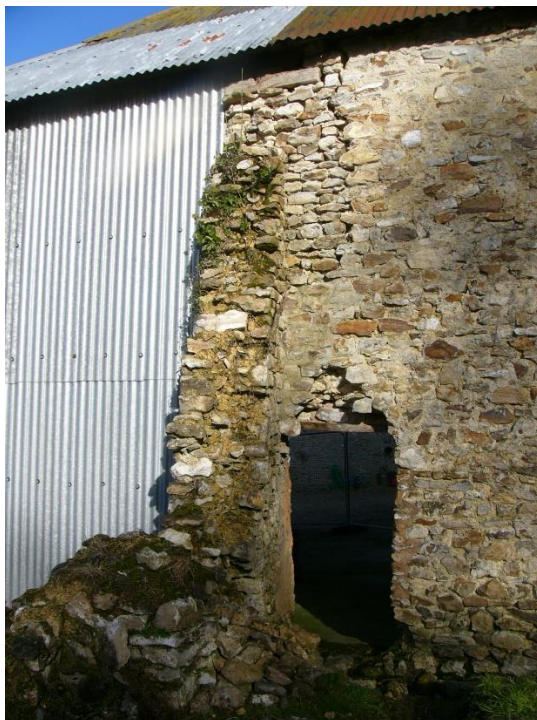
Exterior

1.01 Existing Chert stone wall section above doorway on south west elevation.

Upper section of the existing southwest corner wall adjoining the corrugated sheet section on the south elevation, along with the attached 'buttress sections is suffering significant wash out of the lime mortar joints and bedding through the whole thickness of the wall from ground level to eaves level on the west side of the door opening. A missing lintol, over the doorway has resulted in significant cracking and dropping of the of the section of masonry above.

This eroded wall section is considered to be beyond an insitu repair and is to be carefully taken down and re-built re-using the existing stones bedded and pointed in 1:2.5 putty lime/coarse Chardstock sand/local earth mix. Finish to be flush with stone arises.

New green oak lintols of similar section to the existing are to be fitted over the door opening and the loose masonry re-bedded. The new stone work is to be bonded to the sound remaining section of wall. The existing cement mortar repair section above the door head is to be taken out and rebuilt using lime mortar mix stated above.

The roof is to be propped and supported during the repair works– see details in 1.02 below.

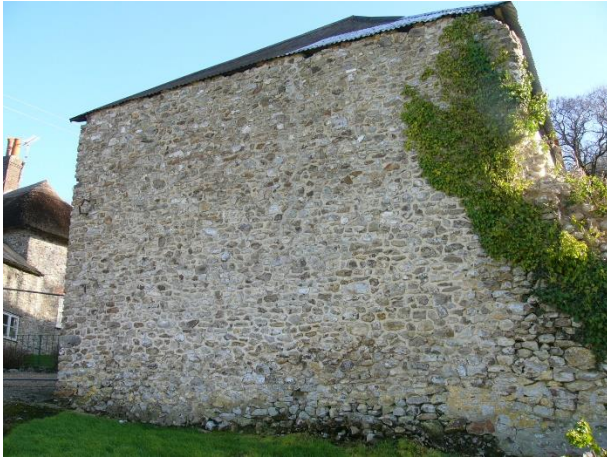
The wall is falling out westwards, from ground level to eaves and exhibits a significant bow outwards along it’s length with a number of vertical full height cracks. An area of masonry has fallen out on the south west corner. There are also stone losses at the base of the wall.

West end wall

The west end masonry wall has moved significantly, circa 150-200mm at the southwest corner. This movement is evidenced by the timber lintel wall plate having remained attached to the opening lintel, and fully exposed from the underside, where the wall has rotated to the west.

It is proposed that the wall is taken down and rebuilt to the following schedule of works:-

- a) Install a designed bird cage scaffold inside the cart shed to support and strap down the existing roof structure. The scaffold is to be sheet wrapped to reduce window uplift on the roof structure and act as a temporary replacement for the wall.

- b) Wall to be braced with vertical planks and raking shores to facilitate a stone by stone demolition of the wall to foundation level. The walling stone are to be cleaned and stacked for reuse, ensuring any quoin stones are identified and set aside for reuse as quoins in the rebuilt wall. The work is to be carried out off the internal scaffold to avoid putting operatives at risk of a wall collapse.

- c) Excavate and cast new concrete foundations, including land drainage system to remove spring water from wall base.
- d) Construct new wall to same dimensions as original, re-using the stones removed in NHL 3.5 hydraulic lime mortar from the foundation to floor level and 1:2.5 putty lime/coarse Chardstock sand/local earth mix to eaves level. Finish to be flush with stone rises, with churn brush compaction.

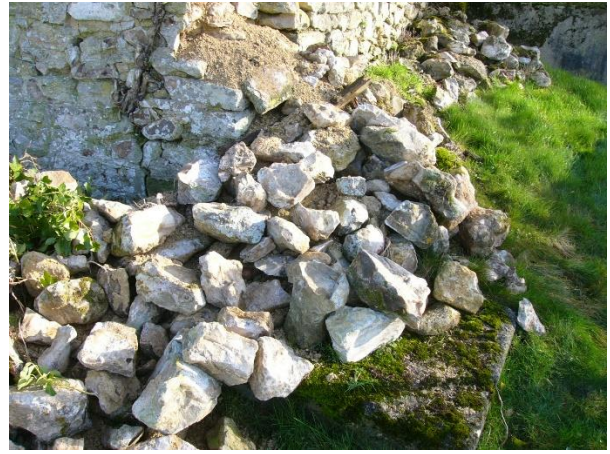
Collapsed masonry

On the southwest corner of the barn, there were visible signs of recent masonry failure. During the visit masonry debris continued to fall from the wall in this area. The wall shows clear signs of failure on the internal and external faces of the wall. Vertical cracks were observed externally, at circa 2500mm spacings along the wall. Internally the cracks ran diagonally towards the top southwest corner of the wall, changing to more vertical alignment by the mid span of the wall.

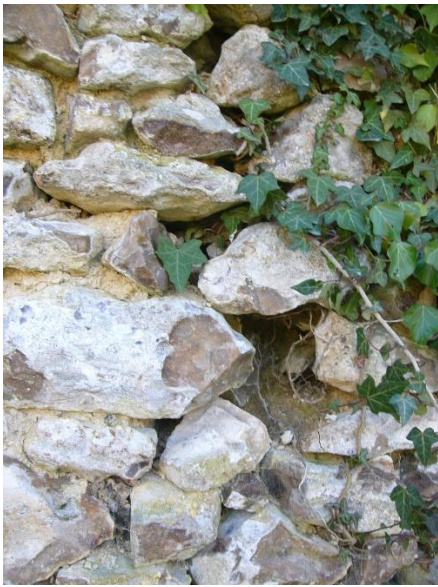
Wash out at base

From outside the west end of the barn, the bottom of the wall indicates typical construction, without a foundation. Two thirds towards the south of this wall, there are signs of a culvert passing under the wall, perhaps serving a natural spring. The culvert was not obvious and was clearly blocked, perhaps collapsed. Subsequently the ground immediately adjoining the wall was saturated and boggy underfoot. Further down slope there were reeds present indicating historical wet ground.

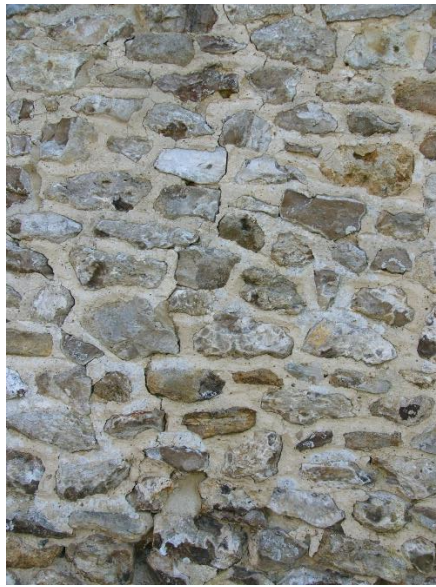
Mid wall movements crack

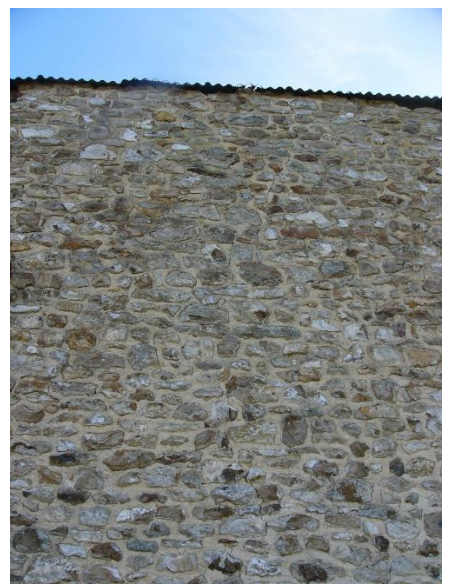
Movement cracks

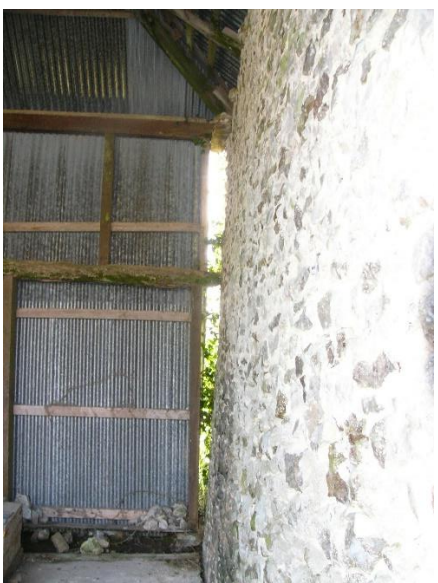
Wall lean out

From the north looking south along the west wall, the wall rotation is easily observed. The wall has hinged failure at the bottom outside of the wall. Further evidenced by the gap between the masonry and concrete floor slab.

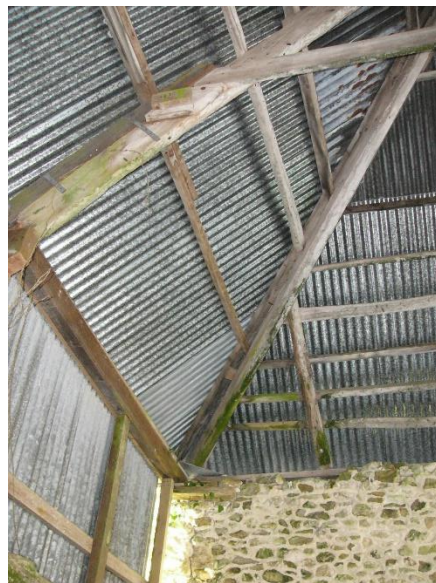
The roof truss support timber bearers are pulling out the wall head with the truss contact with the bearers now very linted.

Hip truss bearing off wall head

- e) Re-bed truss blocks and wallplates.

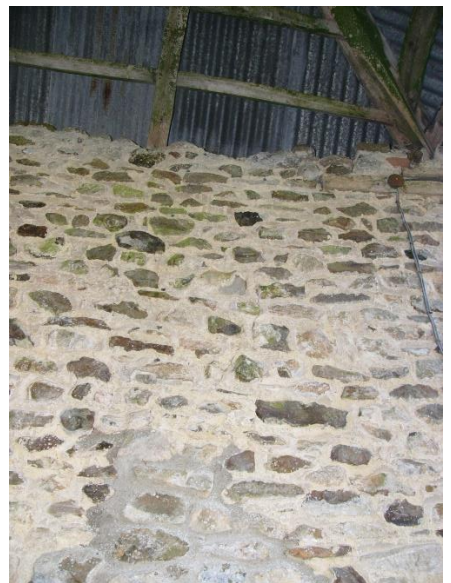
Wall crack and truss bearings.

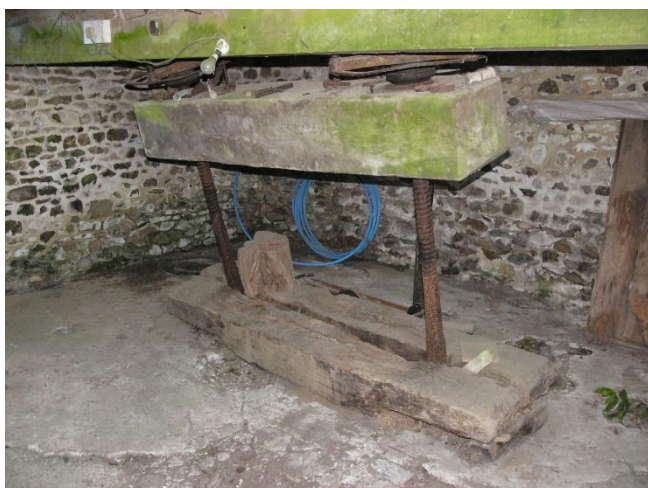
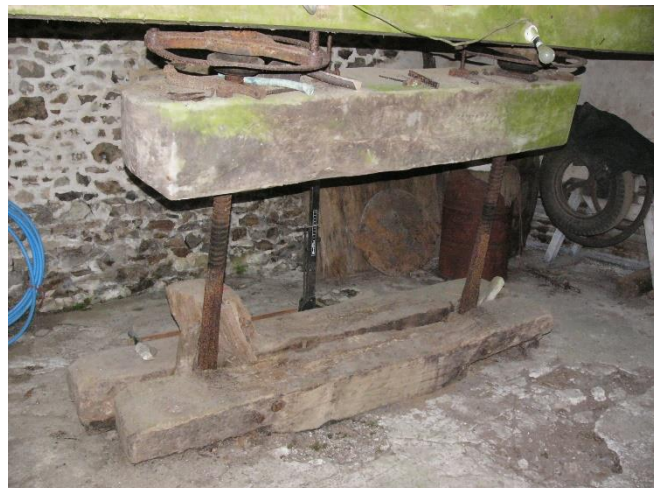
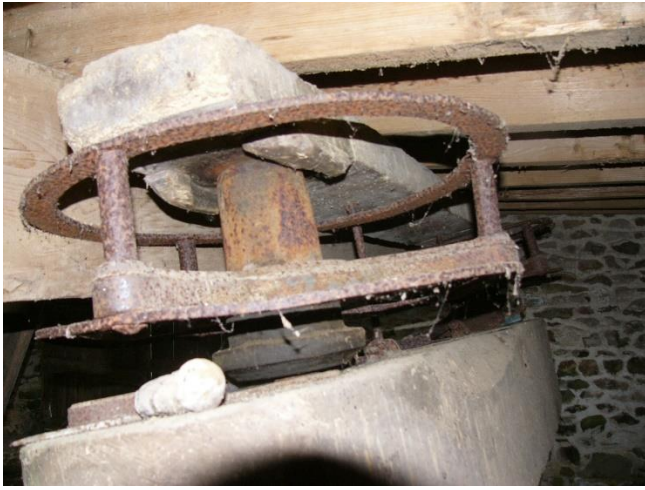
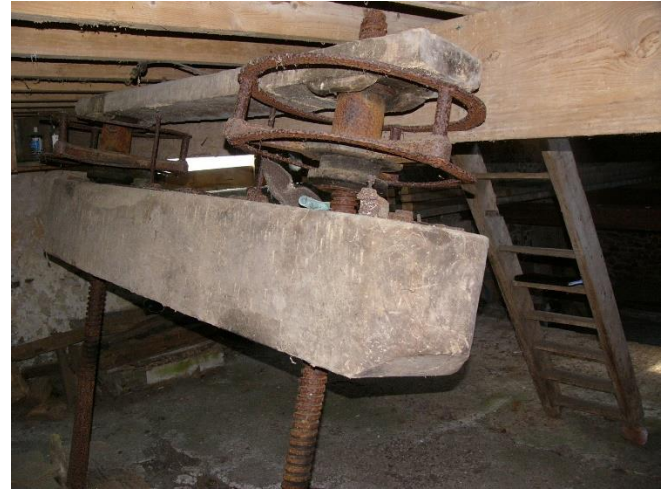
- 4.01 The existing cider press comprises a pair of substantial timber base rails and a single heavy square section timber headstock. A pair of cast iron posts link the head and base timbers, sandwiches between the base rails. The lower parts are square in section, the upper half turned with substantial screw threads.

Iron capstan wheels for timber capstan bars are fitted above the head stock to adjust the clamp pressure of the press. The top bearing of the wheels are attached to the timber cross bar for stability.

Missing pieces are the timber juice collection bed and the cider apple press racks.

Initial holding repairs whilst the press remains insitu are to clean down the timber and apply a woodworm treatment to stop the current common furniture beetle attack and to spray the metalwork with a light oil to reduce further corrosion.

The press is to be boxed in timber cladding to protect from damage and theft.

Restoration will involve the re-bolting of the lower beams to secure the press uprights, clean and oil the metal components. The reinstatement of the missing beds and rack. However, it is not the intention to make to press work, rather one of preserve 'as is' as a relic of the farming past.
