## General structural appraisal report on

Former milking parlour barn

Report reference: 12392\_TF\_23

30.03.23

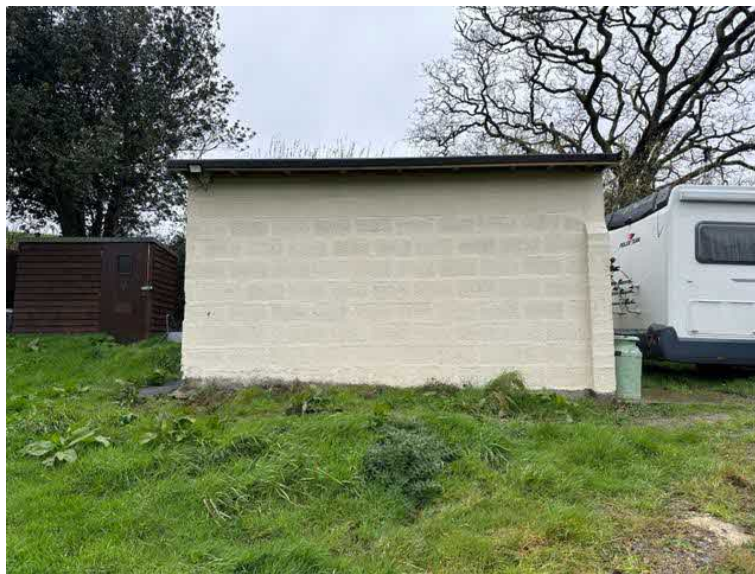
Photograph 1.0 –Eastern flank wall elevation.

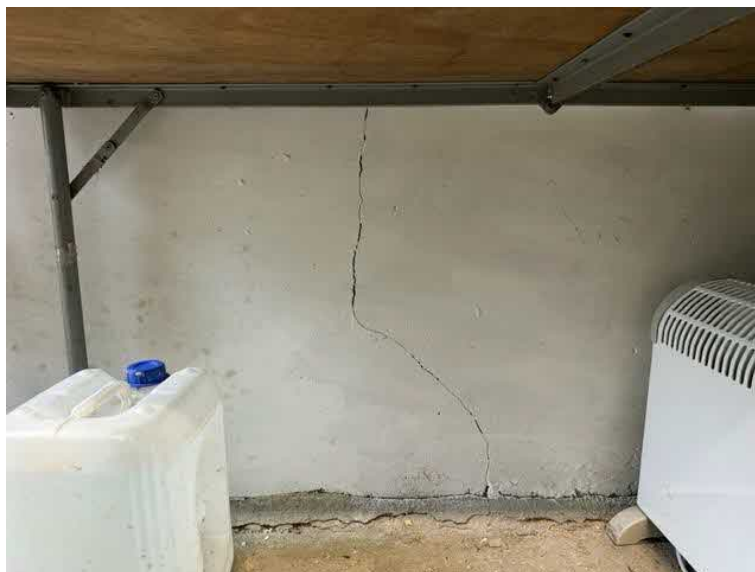
1.1 The four walls of the barn are formed from a mixture of 100mm and 150mm single skin concrete blockwork. The walls present in good general order throughout. There is a small vertical crack in the east wall panel. The crack is not considered to be of significant structural concern. It is suggested the crack may be attributable to historic defects in the roof structure and further movement is considered unlikely. It is suggested upon conversion the crack is stitched up its height using stainless steel helical tie bars as made by Helifix or similar. Further details of such repairs are contained in Appendix A of this report for reference.

Photograph 2.0 – Small crack in blockwork on the inside face of the eastern flank wall.

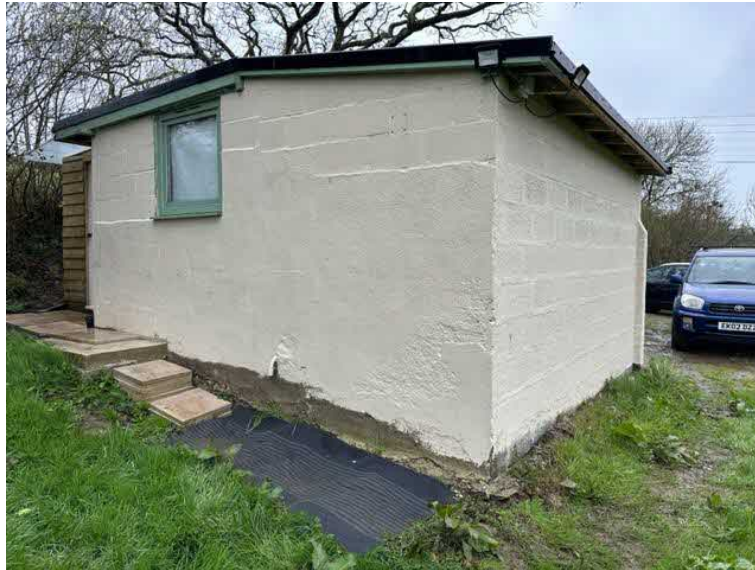
1.2 Due to the ground levels surrounding the barn, the lower extents of the wall panel on the western flank retain ground. No movement was recorded as might be attributable to lateral pressure from the ground in this area. Upon conversion it will naturally be necessary to suitably tank the wall to prevent the ingress of water; unless external levels can be suitably reduced.

Photograph 3.0 –Southern gable wall, with increased ground levels to west end.

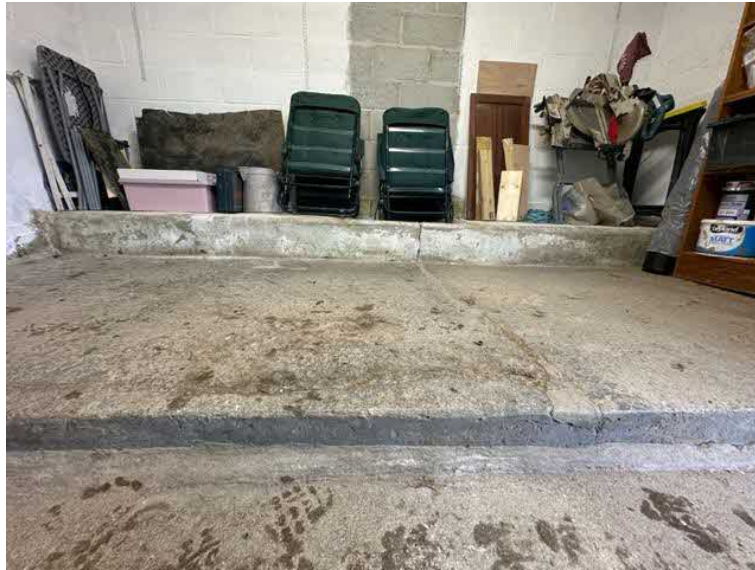
2.1 The ground floor throughout consists of cast concrete. The depth and specification of which is unknown. There is shallow gulley drain cast in the lower slab. There is a step of some 150mm in the slab level within the barn. Against the western flank wall there is also a cast concrete feeding trough present across the width of the building. Upon conversion it is assumed the floor will be leveled and as such it is suggested the at least part of the existing concrete will require breaking up and re-laying. It is likely any new sections of floor may consist of a simple insulated ground bearing concrete slab.

Photograph 4.0 –Internal concrete floor slab, with step (foreground) and trough beyond.

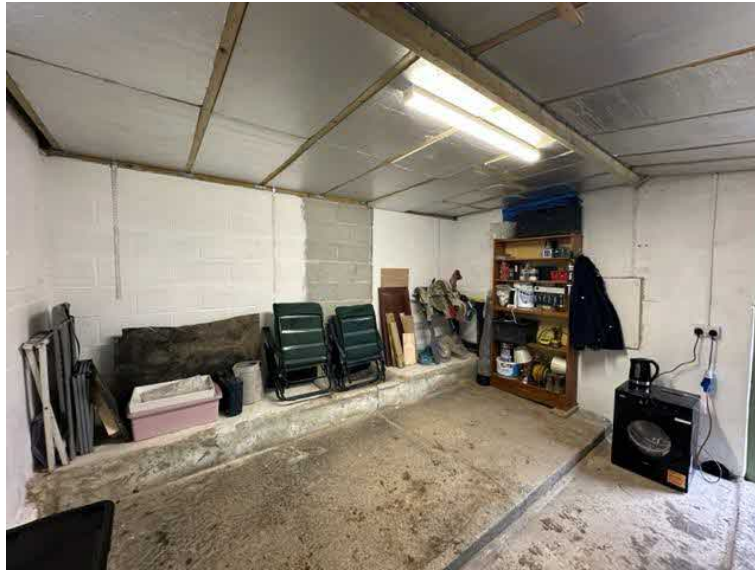
3.1 The roof of the barn has been replaced in the not to distant past. It consists of a 250mm by 50mm timber ridge beam which spans between the front and rear gable walls, and a series of 150mm by 50mm common rafters. The roof is insulated internally and clad with a membrane externally. The rafters are truss clipped to a wall plate which is strapped down to the masonry using proprietary wall plate straps set at 1.2m centers. The roof structure appears robust and is free of structural distress. Upon conversion the size of the timbers forming the roof should be qualified by formal calculation but it is suggested the existing structure is very likely to be suitable to be retained.

Photograph 5.0 –Pitched and vaulted roof structure from ridge beam and common rafters.

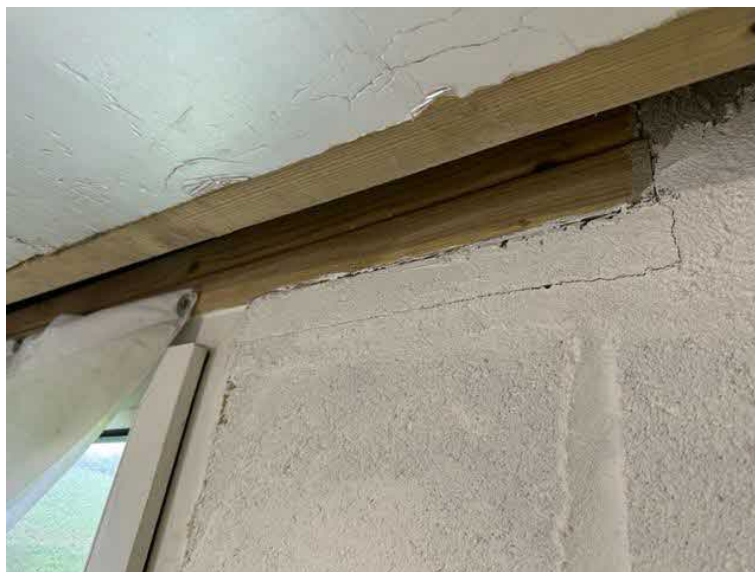
4.2 There is a single window opening in the barn set on the rear south gable elevation. The lintel over this opening appears to be two 50mm by 100mm timbers. These timbers are in good condition and clearly serviceable under their current loading condition.

Photograph 6.0 –Timbers forming lintel over rear window opening.
