Structural Inspection

Inspection of Timber Framed Building for Permitted Development at

Trevenn,
Clubworthy, North Petherwin,
Launceston,
Cornwall,
PL15 8NZ

Reference R230612/SI/00

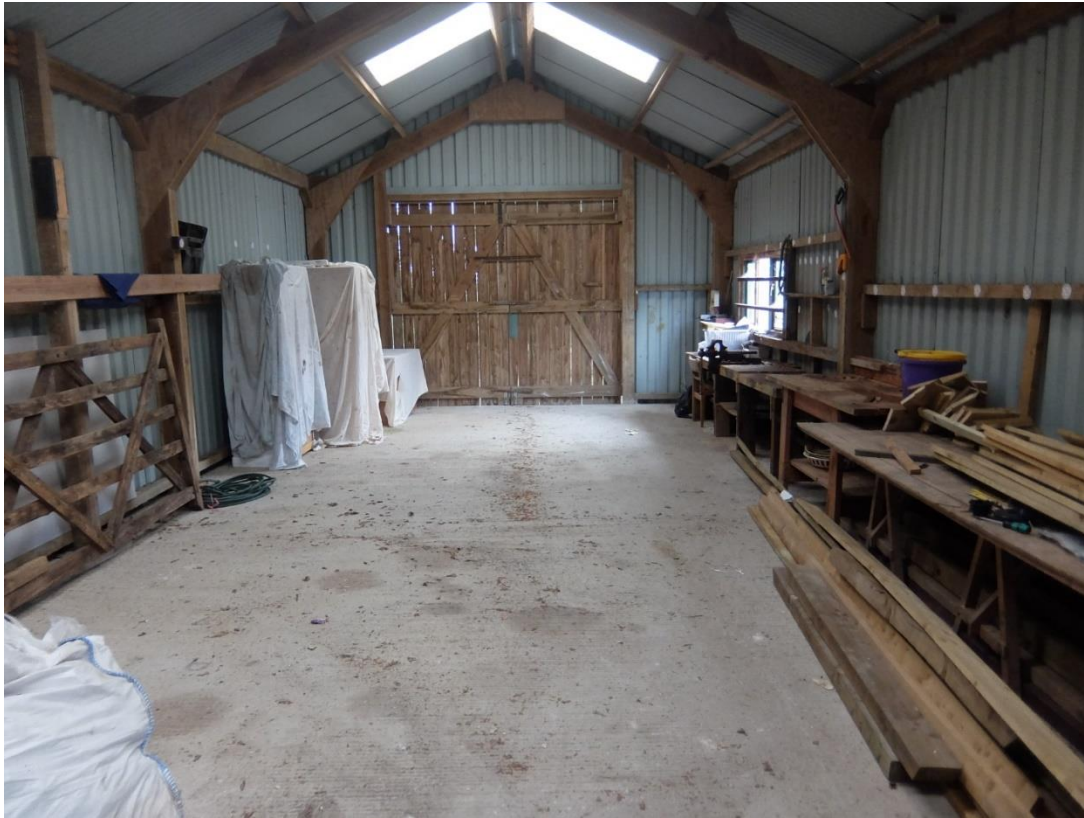
Internal view looking towards front wall

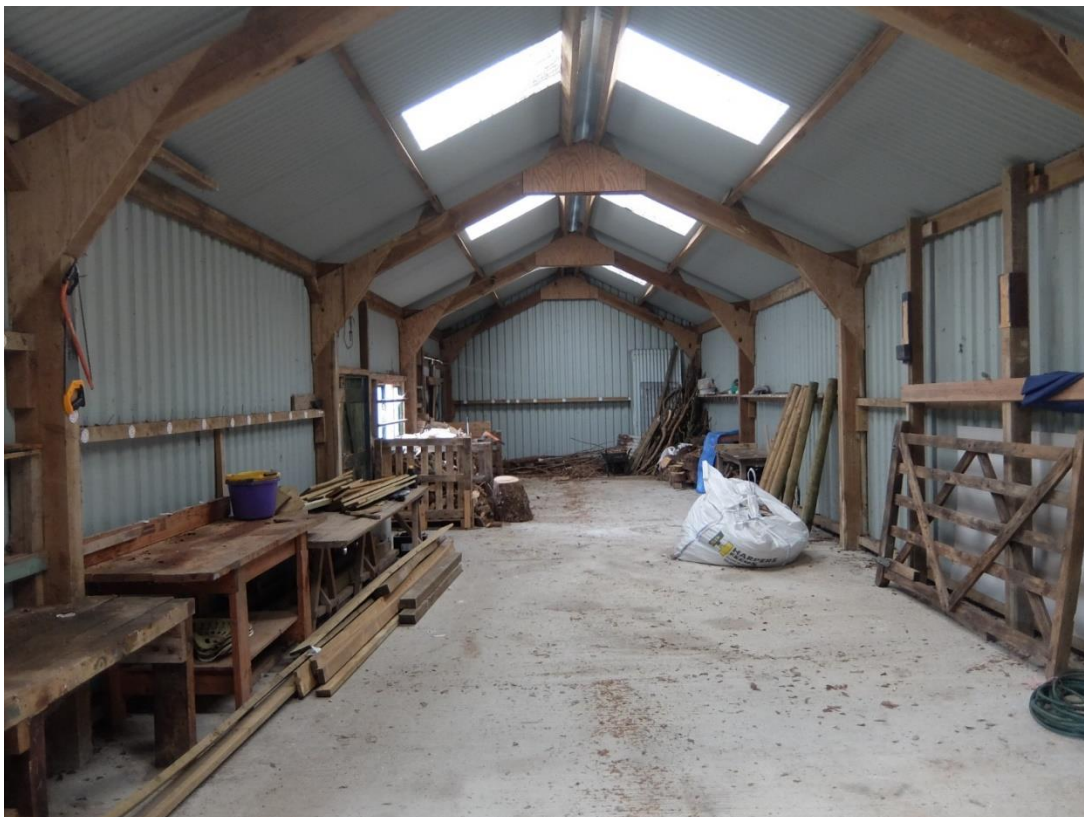
Internal view looking towards rear wall

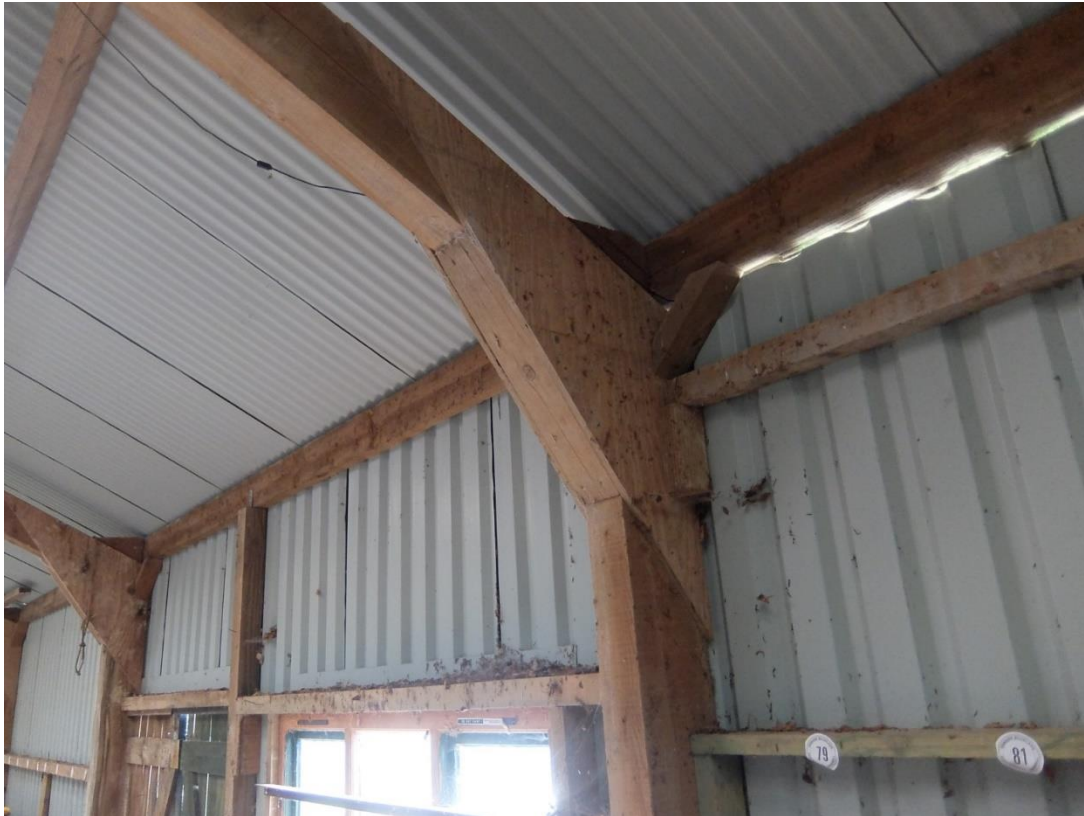
2.1.3 There are haunches at both eaves and apex connections consisting of 18mm thick plywood nailed to each side of the columns and/or rafters, with a diagonal strut infilling the third side. This is a typical portal frame connection detail for a timber framed agricultural building.

Eaves haunch connection

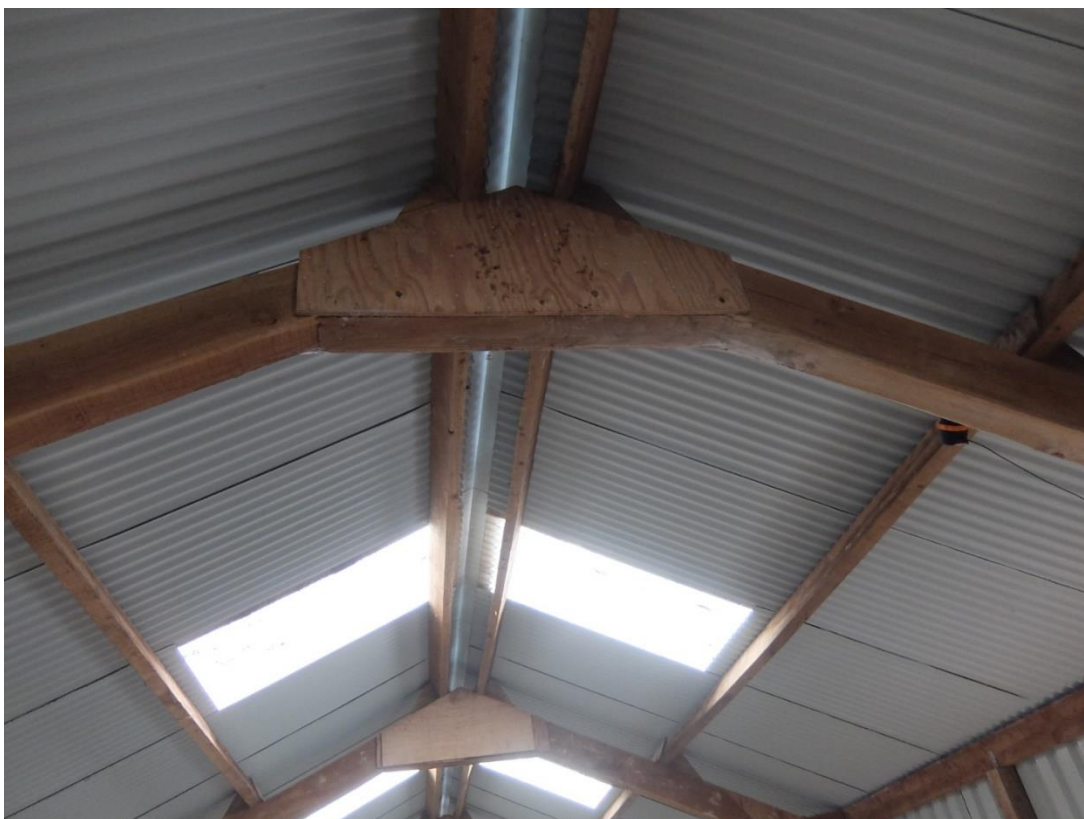
Haunch apex connection

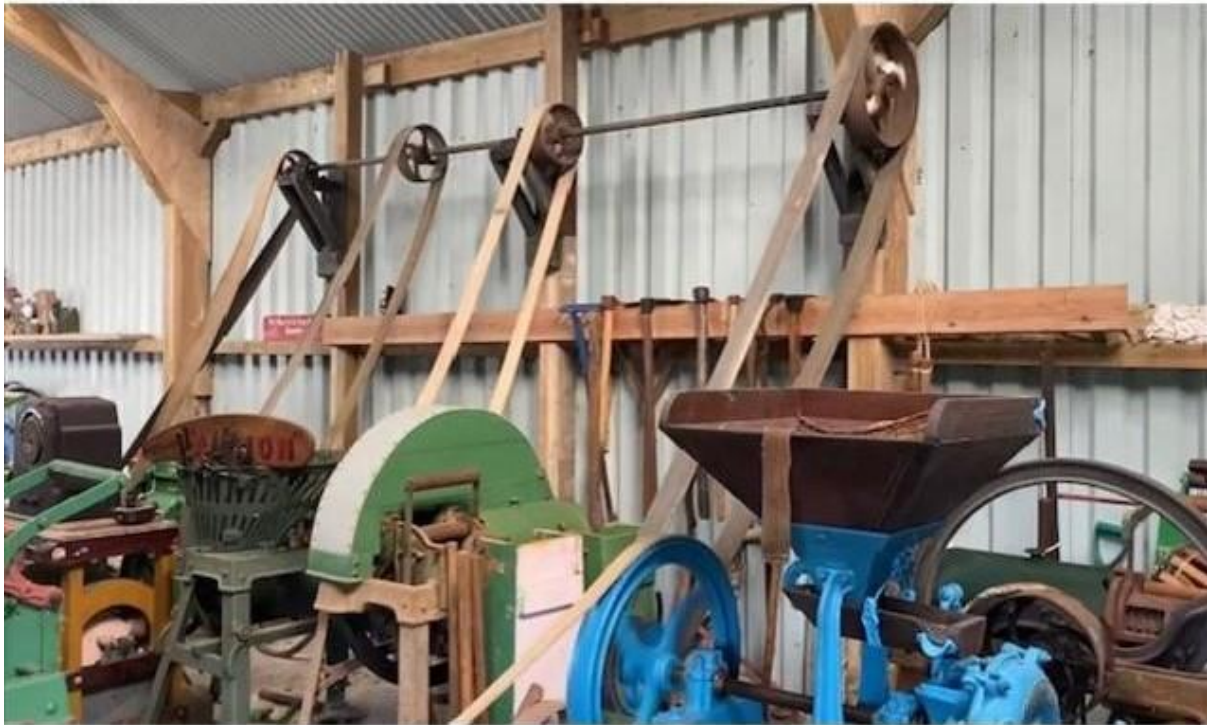
2.1.7 Within the second bay to the right side there are two additional posts that appear to have no function. However, the client provided me with the following photograph showing threshing machine pulleys that were attached to the rails. The forces applied by this mechanism would be in excess of any lateral loading applied by the proposed conversion.

Historical threshing mechanism with pulleys attached to barn, now removed

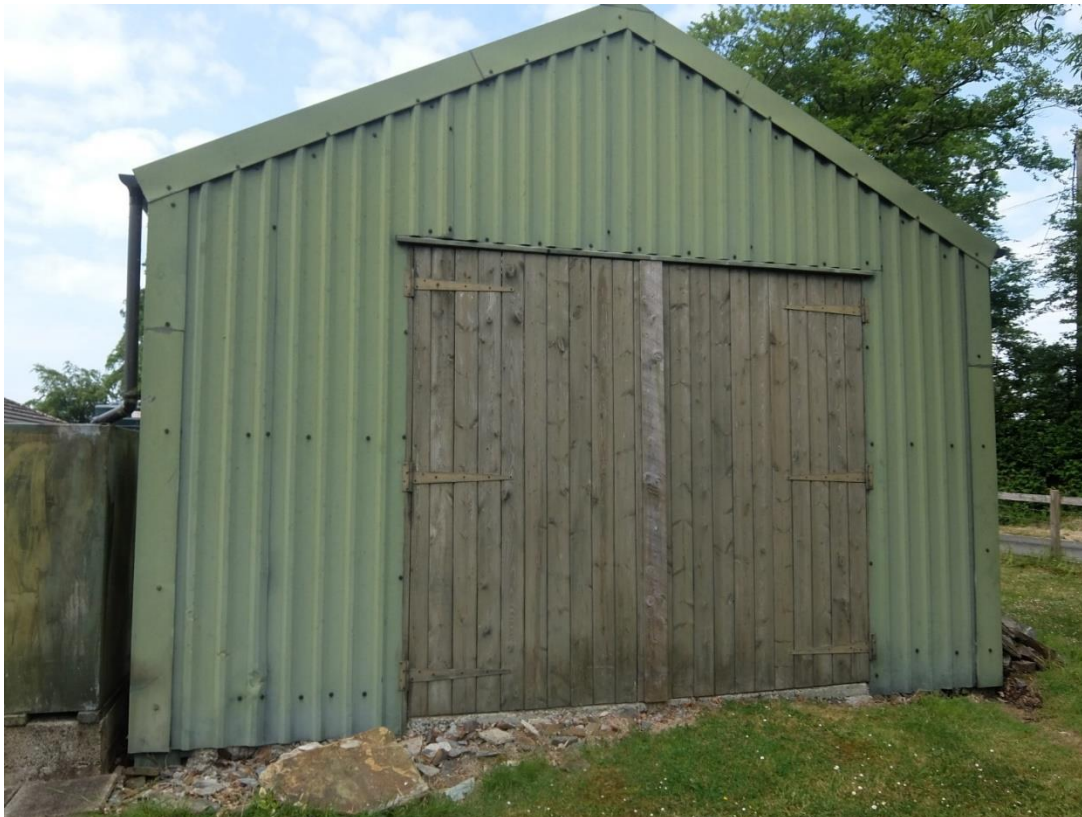
Front wall

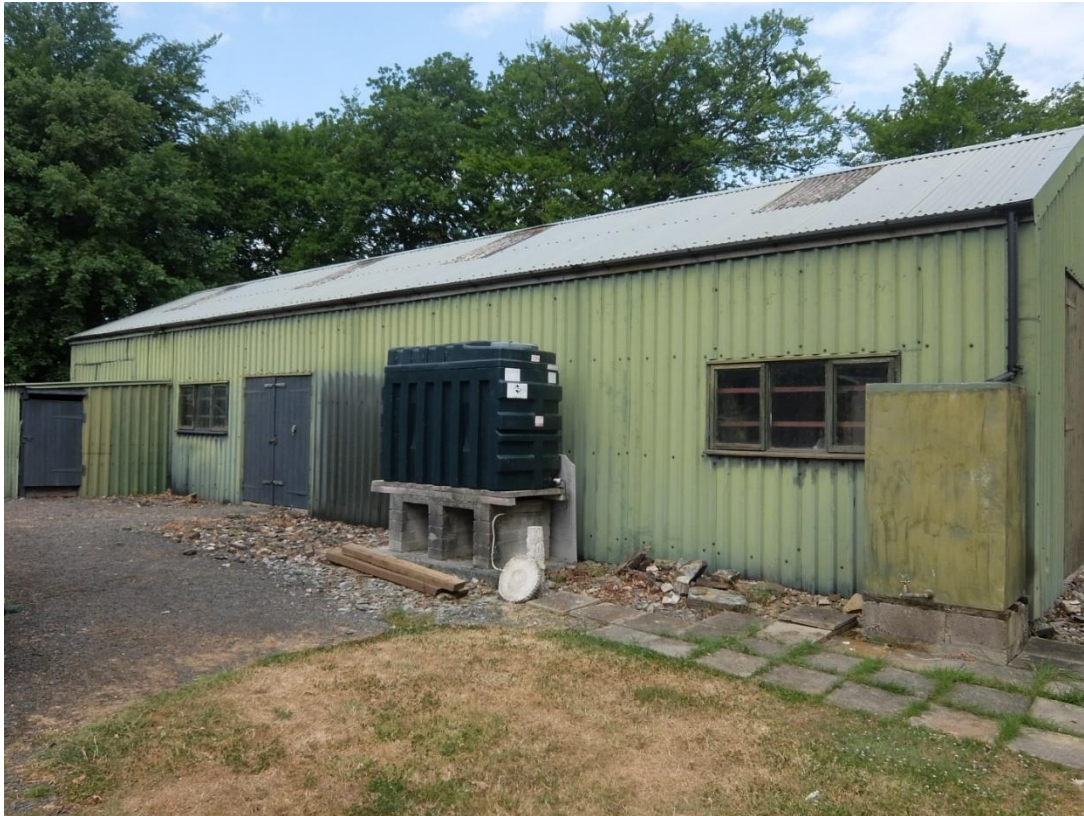
Left side wall from front

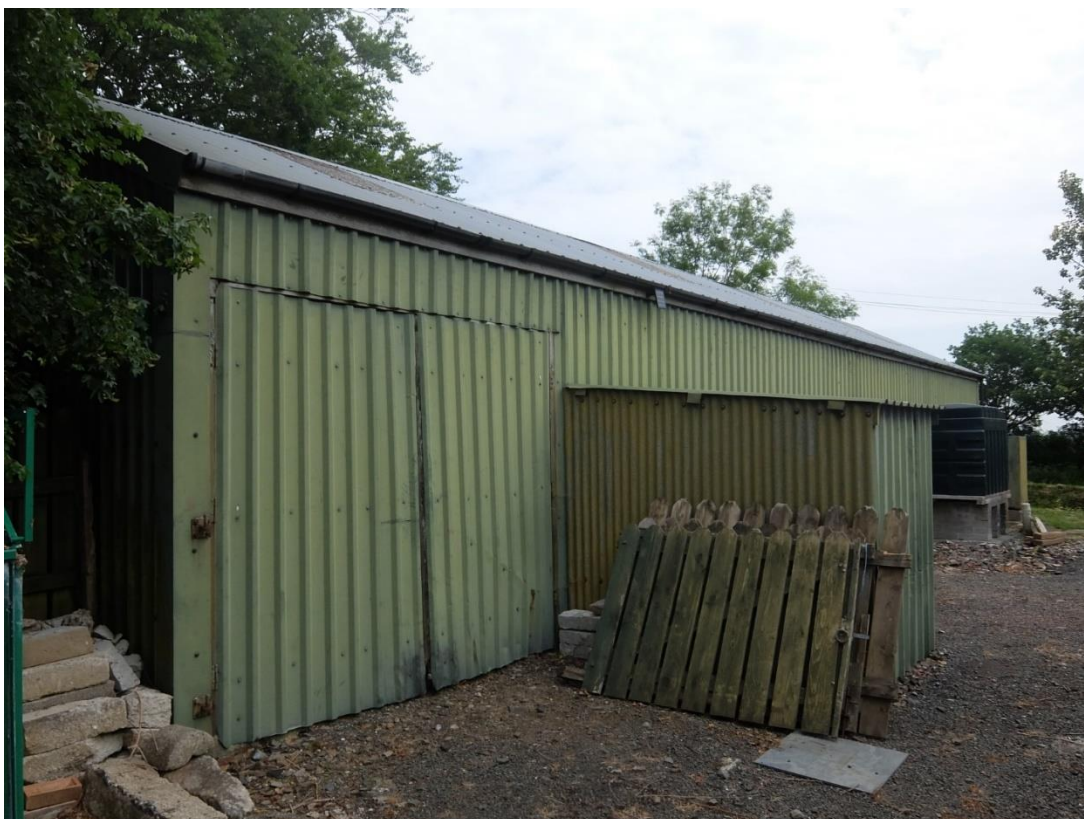
Left side wall from rear

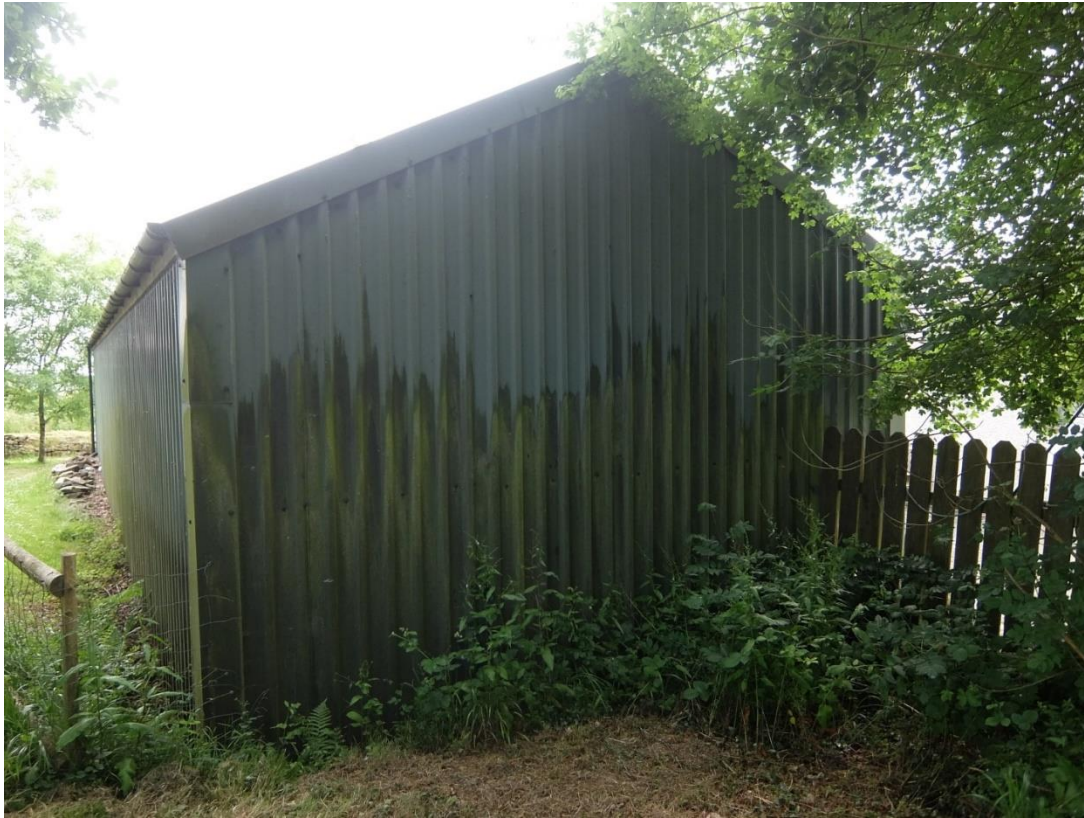
Rear wall

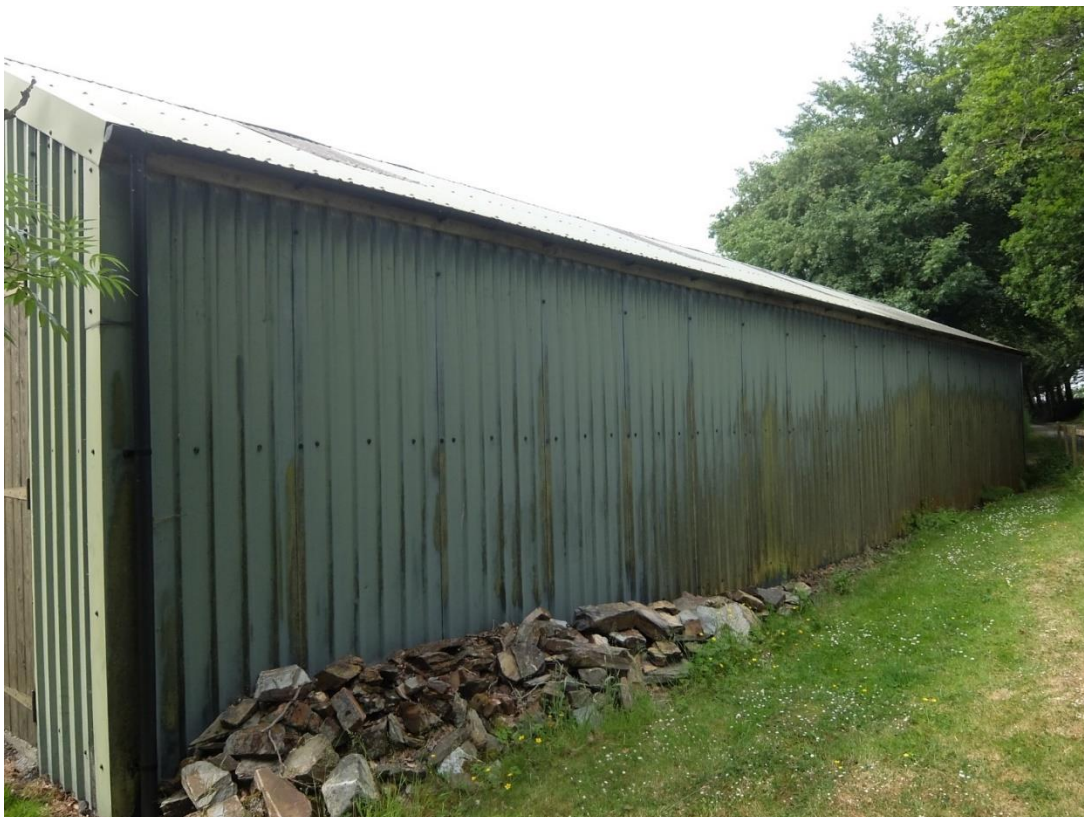
Right side wall
