## **Desk Study Report**

**6 Shore Path  
Gurnard  
Isle of Wight**

Job No. 24061

February 2024

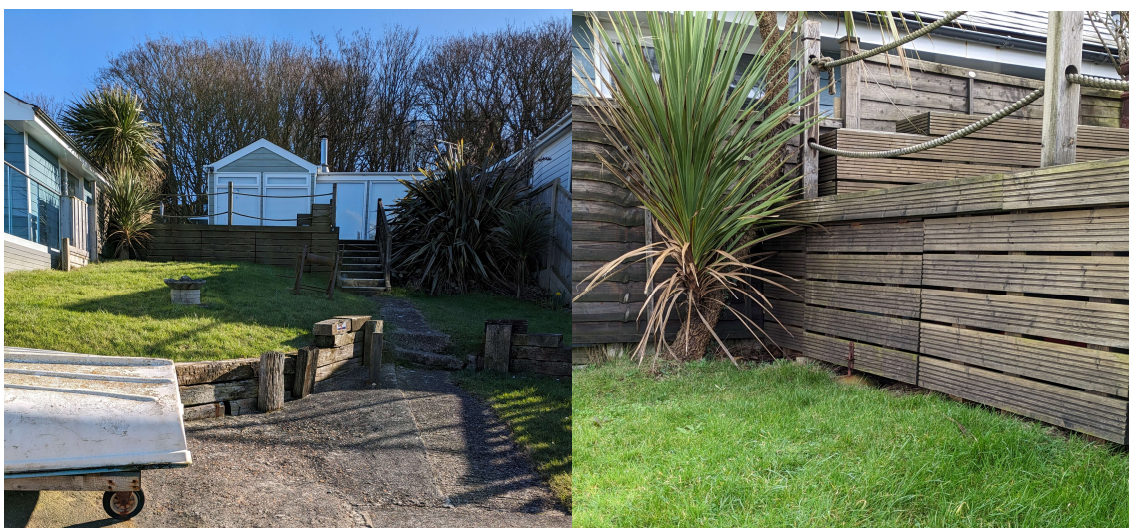
The existing property consists of a detached single storey chalet, of timber frame construction. It has a large raised timber deck, with storage under, to the front. See image below.

It is evident that there is a retaining structure under the footprint of the existing property.

If possible the existing foundations could be re-used for the new front dwelling as the weight of the structures will be similar, the condition will be inspected once the existing building is demolished. If not suitable a reinforced concrete raft will be constructed.

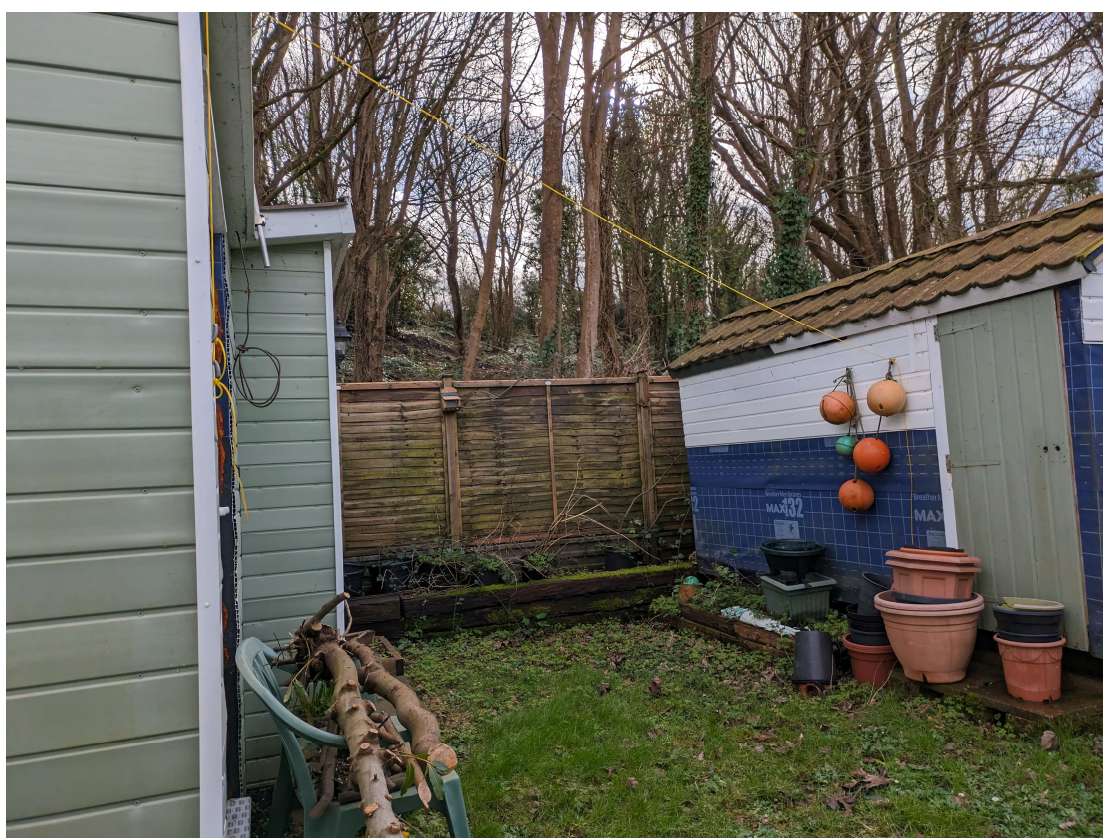
On the upper part of the site is the rear of the existing dwelling and a single storey chalet to the rear left hand corner, refer to Photographs below, with Chalet to the left and shed to the right.

No structural movement was noted to either the existing dwelling or the chalet to the rear.

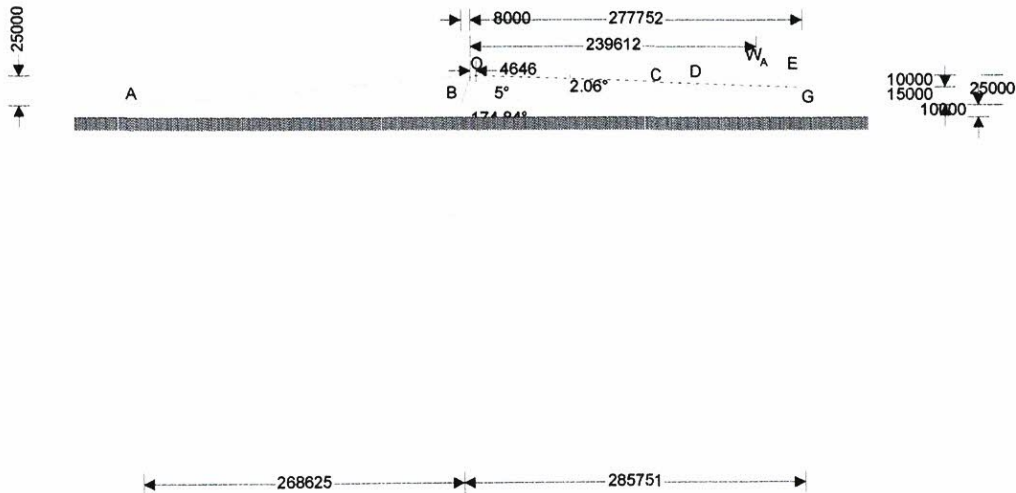
The Slope Analysis gives a factor of safety of 1.43, which is above the required figure.

Angle of slope  $\beta = 5 \text{ deg}$   
 Height of slope  $H = 25000 \text{ mm}$   
 Horizontal length of slope  $L = H / \tan(\beta) = 285751 \text{ mm}$   
 Depth of upper soil layer  $H_A = 10000 \text{ mm}$   
 Depth of lower soil layer  $H_B = 15000 \text{ mm}$   
 Depth of hard layer  $H_L = 10000 \text{ mm}$
