VISUAL STRUCTURAL INSPECTION & SUBSEQUENT ASSESSMENT FOR PLANNING PURPOSES

THE HOME FARMHOUSE BAGENDON CIRENCESTER

Client: Jeremy Rigg
Prepared By: Marcia Figueiredo
Date: March 2024
Reference: 24 / 54906
Revision: 0

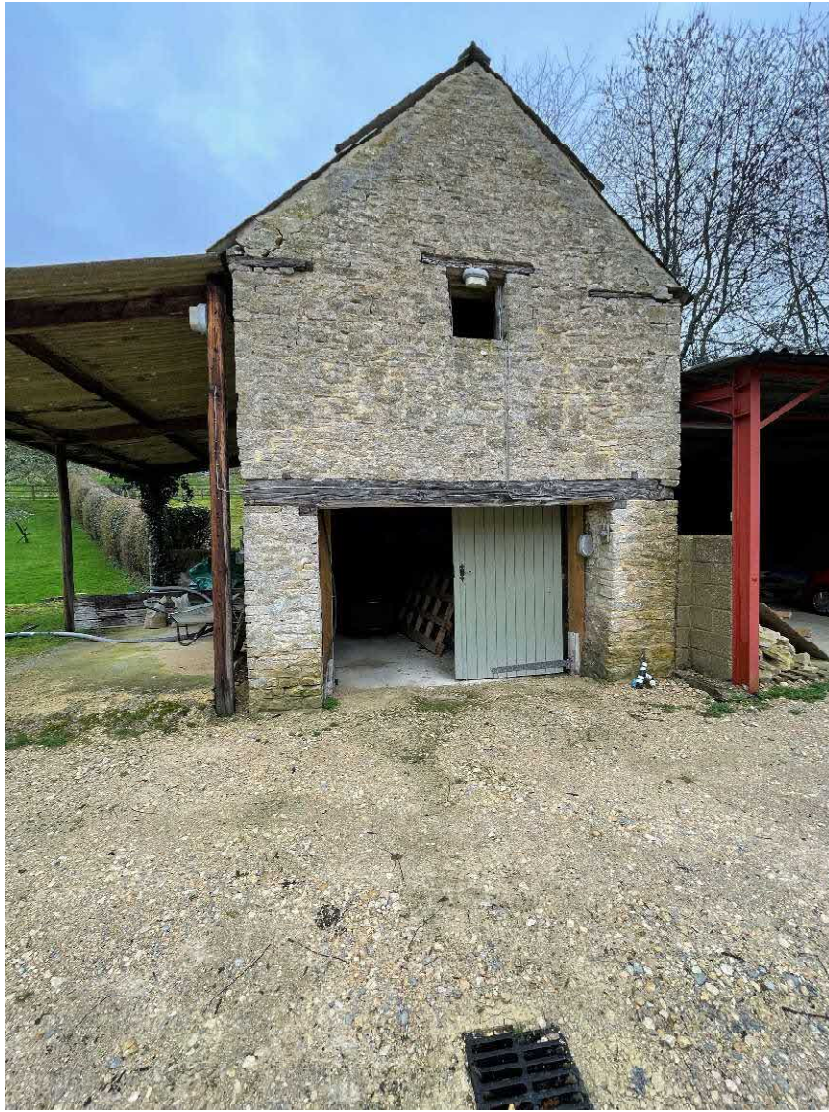
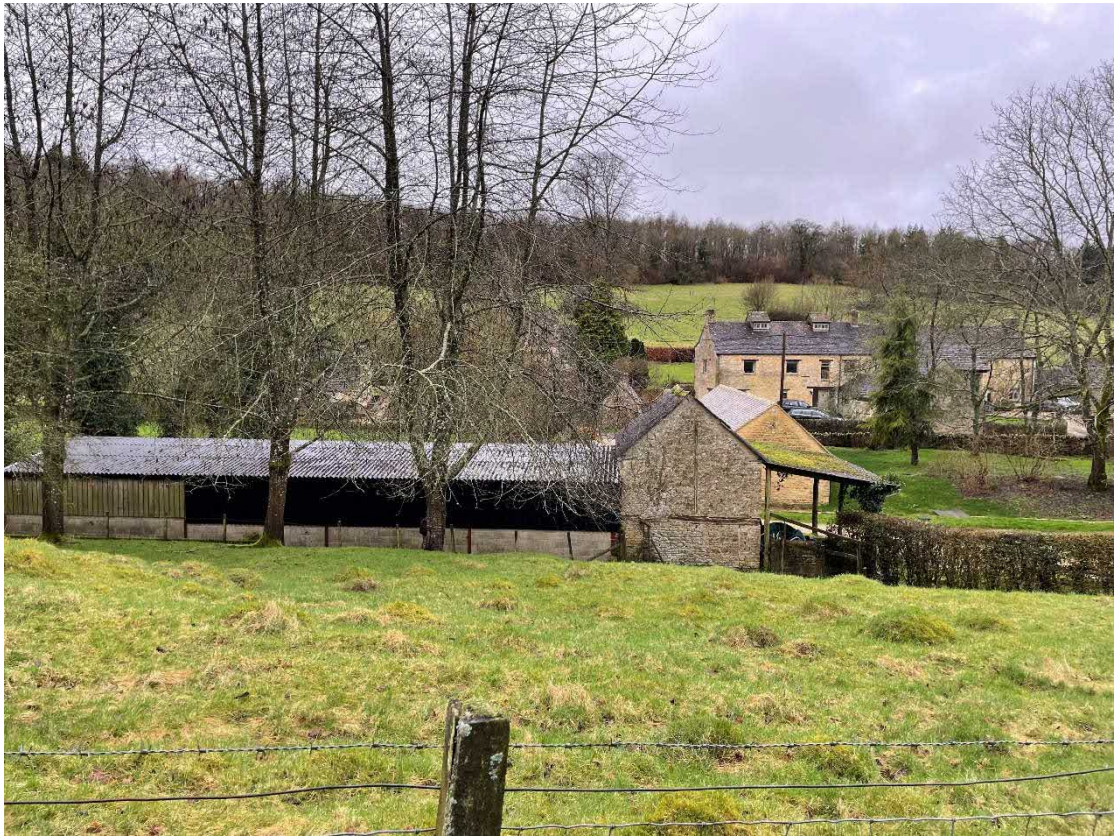
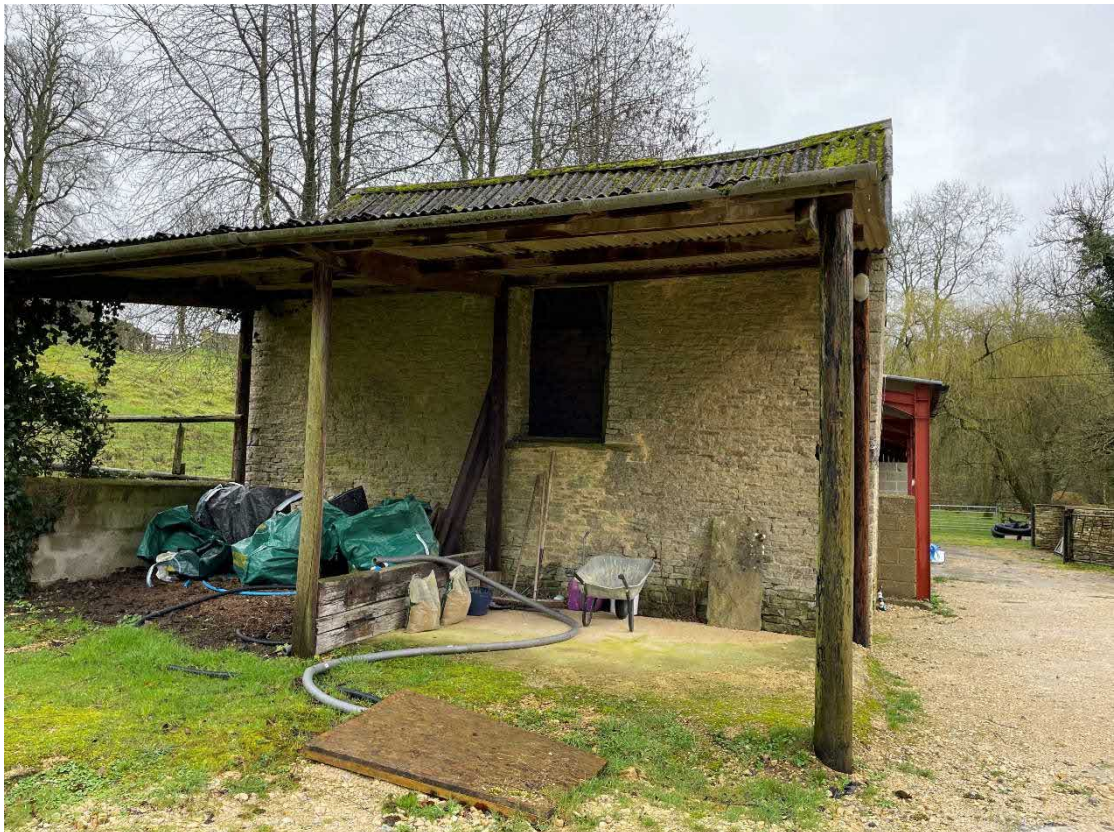
2.2.1 In principle, this is a one storeyed stone-built Barn with a fibre cement sheet duo pitch roof covering. Part of the rear elevation of the Barn is acting as a retaining wall to retain the field, which slopes towards the Barns. Typical details of the external elevations can be seen in Photographs 1 – 3 in Appendix A. Therefore, some form of tanking will be required as part of the change of use to residential accommodation. This is similar to the requirement for Barn B, along the rear elevation as well.

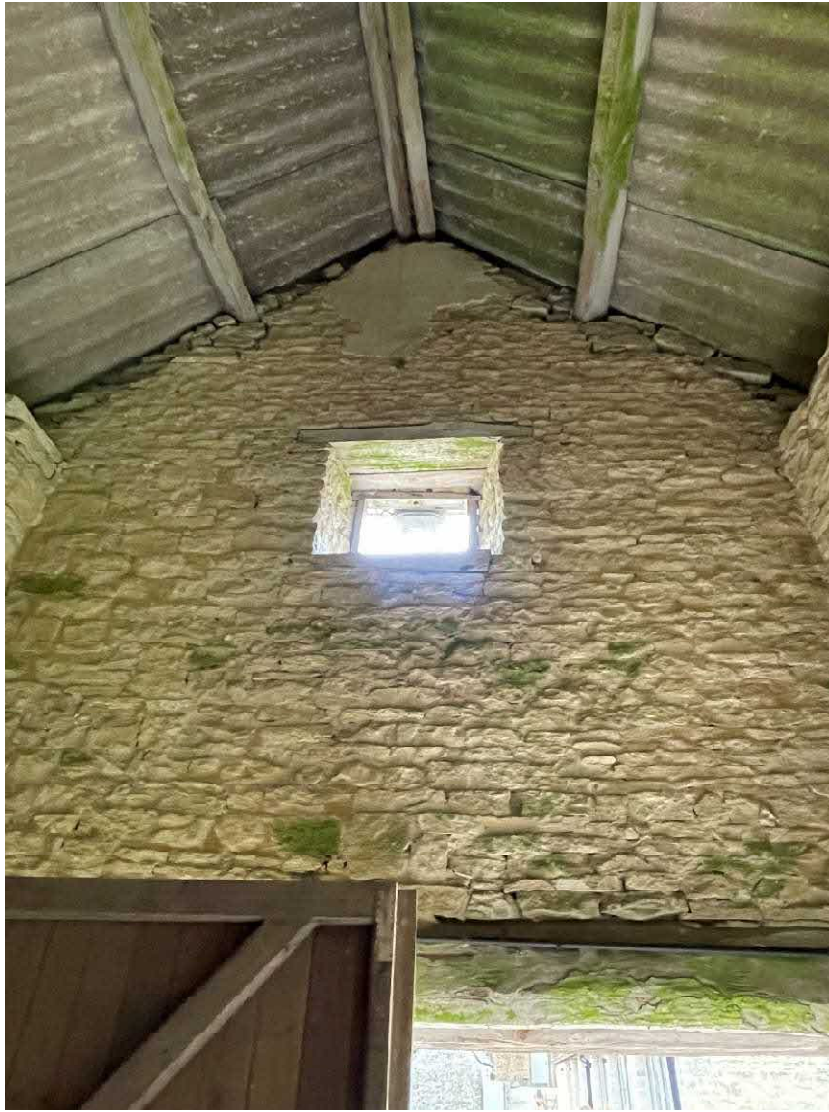
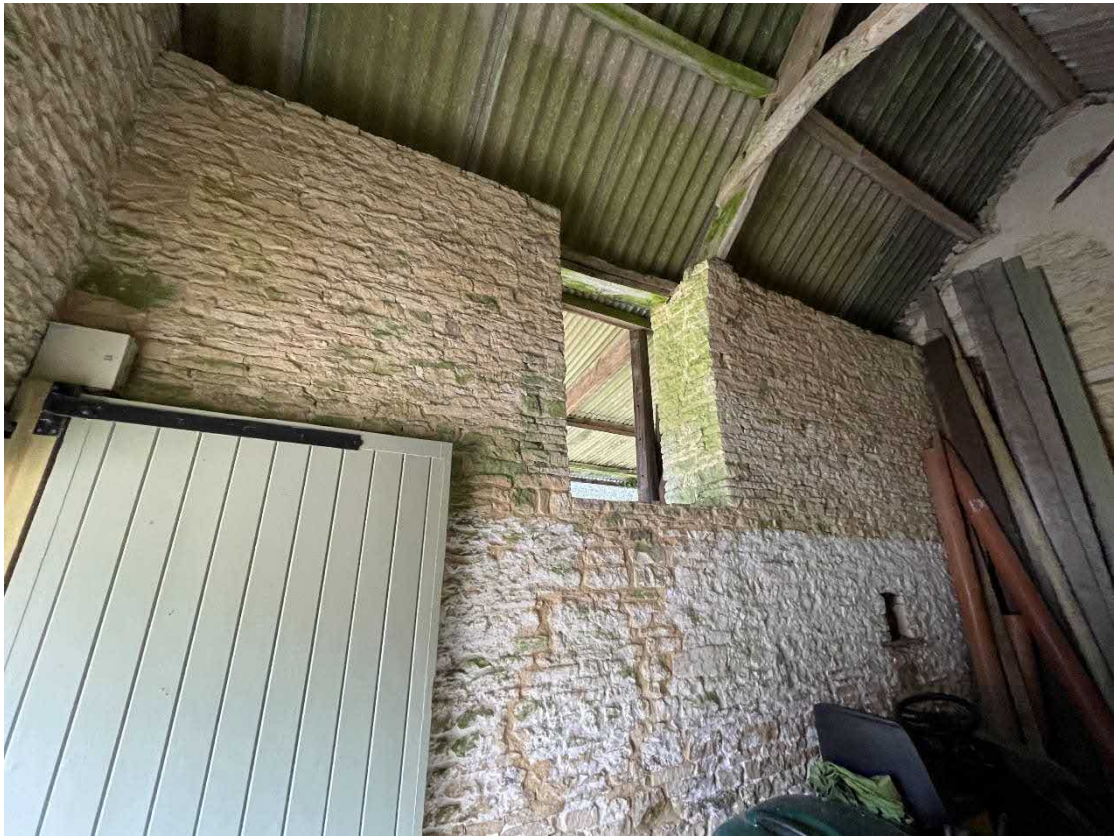
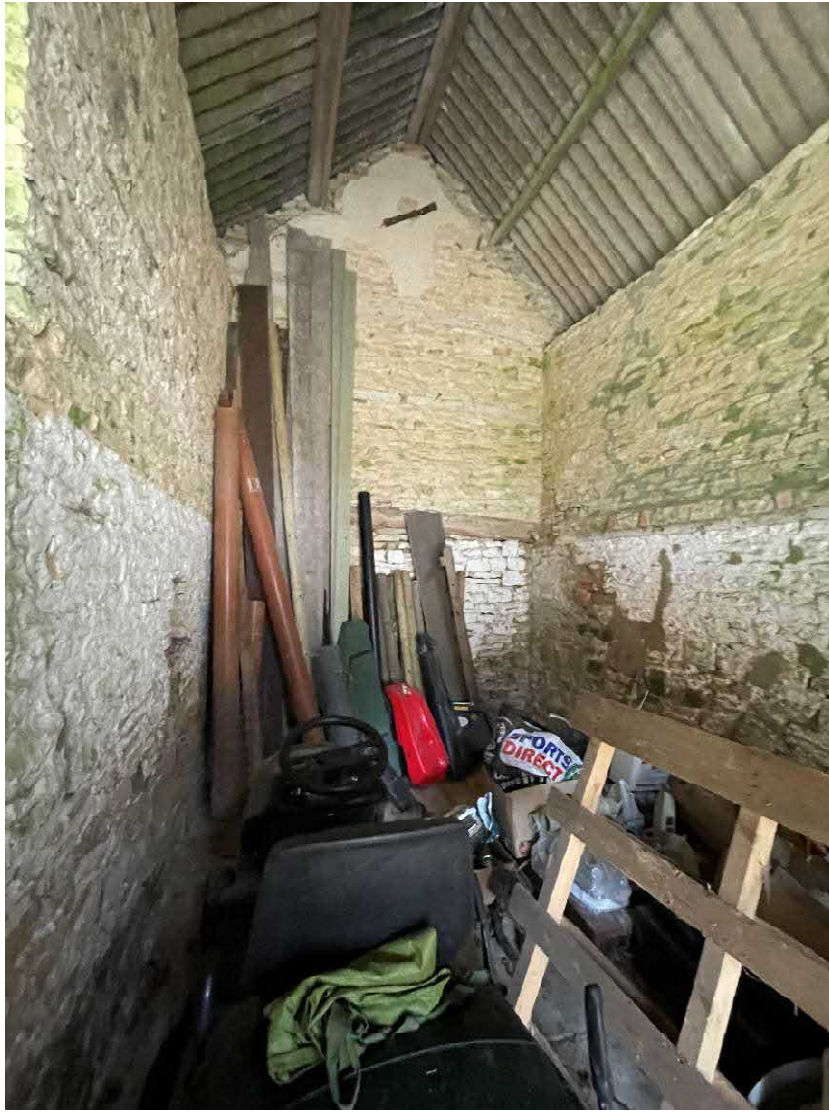
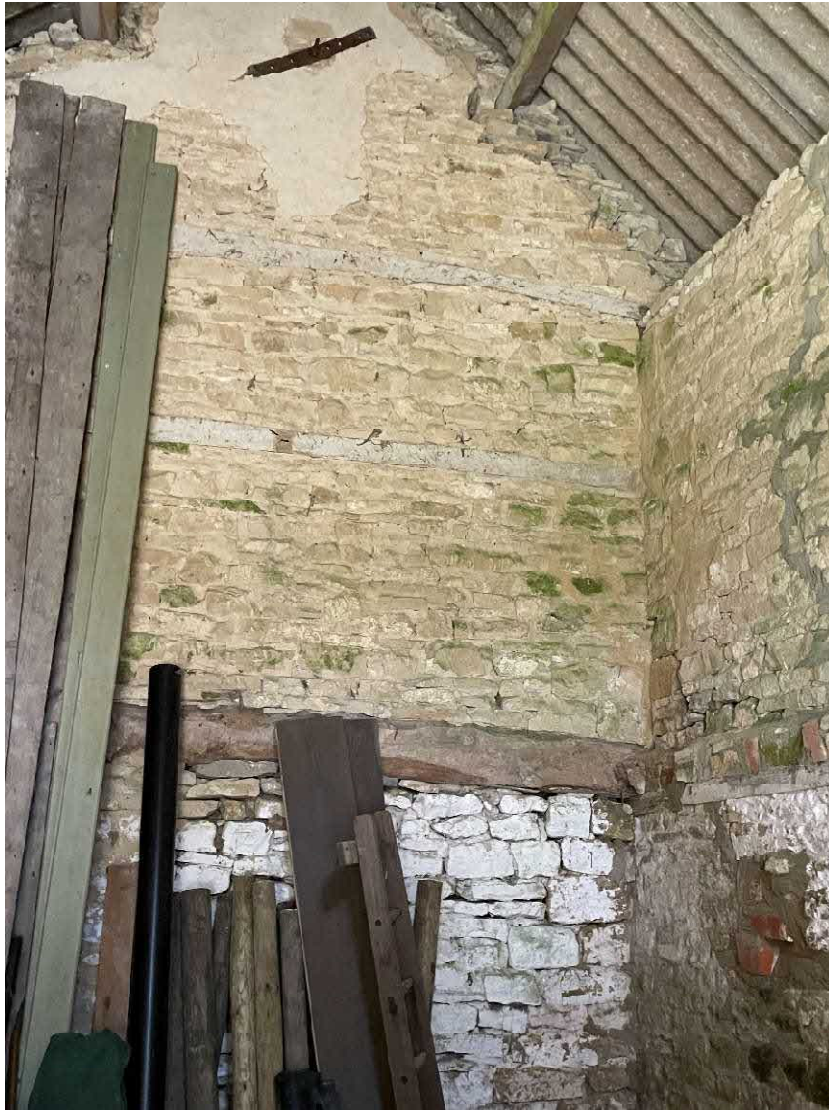
2.2.2 Generally, the stonework to the external elevations is in reasonable condition. However, there are areas where the mortar joints have degraded and localised cracking to the stonework was noted. There will, therefore, be a requirement for the stonework to be repointed with a lime putty mortar mix. Please refer to Photographs 4 – 7 in Appendix A.

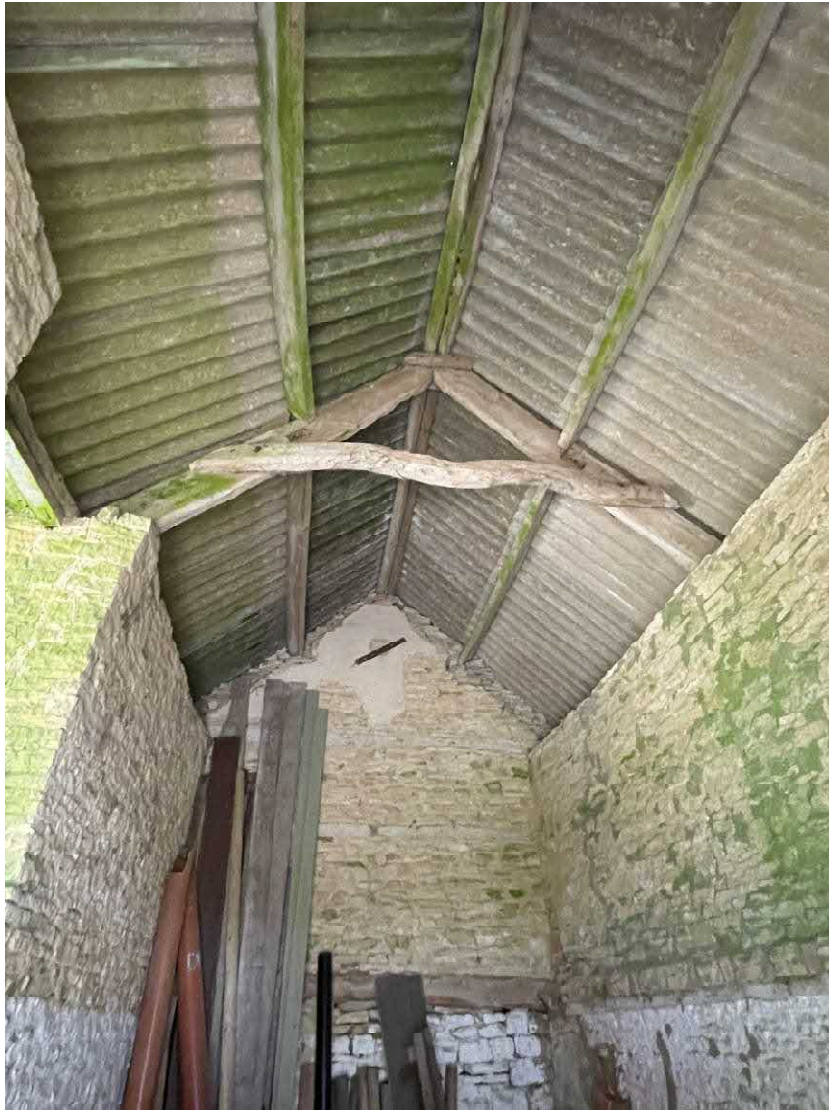
2.2.3 Generally, the roof consists of fibre cement sheets (possibly asbestos) supported off timber purlins which span between ridge board intermediate canted purlins and the external walls. The purlins themselves span between the supporting stonework walls and intermediate timber truss. Please refer to Photograph 8 in Appendix A.

Therefore, as part of any conversion process, there will be a requirement to install ridge beams and rafters to support the new roof structure.

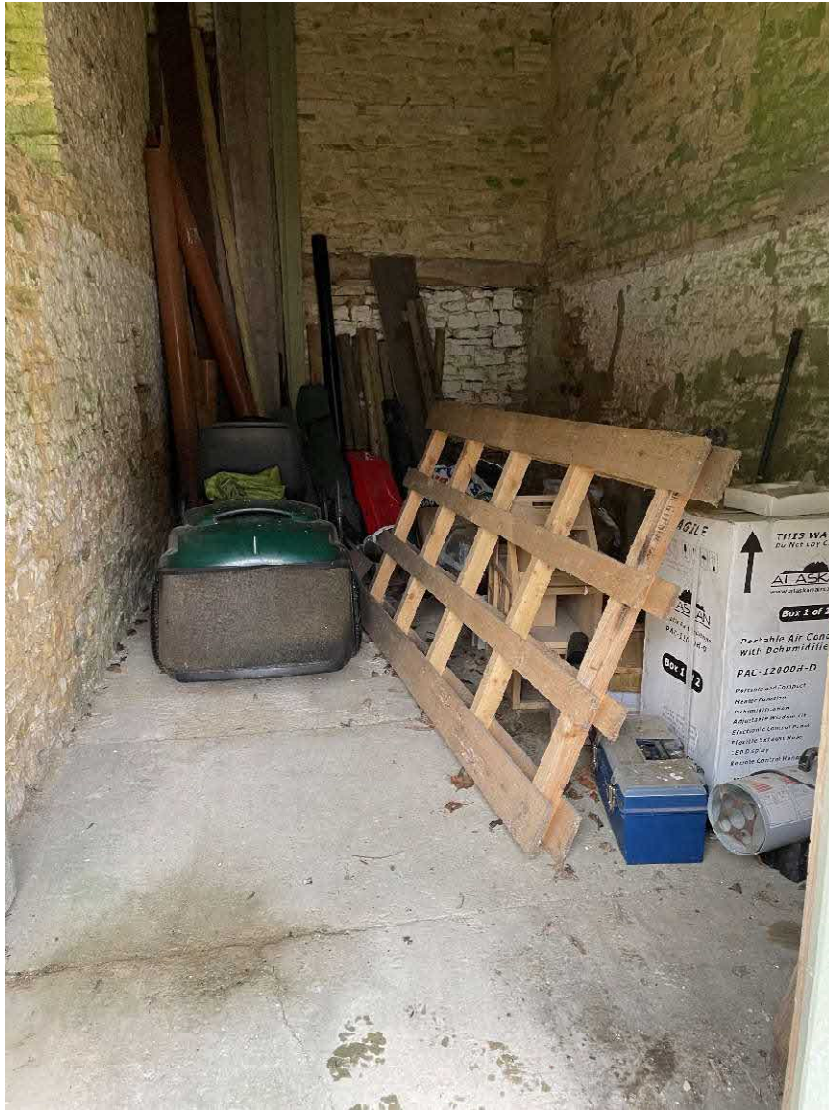
- 2.2.4 The flooring throughout the Barn is a concrete floor which is unlikely to be insulated. Please refer to Photograph 9 in Appendix A. There will, therefore, be a requirement that a damp proof membrane, insulation and a screed be incorporated as part of the Building Regulation process for this Barn as for Barn B. This is not unusual in Barn conversions of this type. This can easily be accommodated at the Building Regulation Application stage.

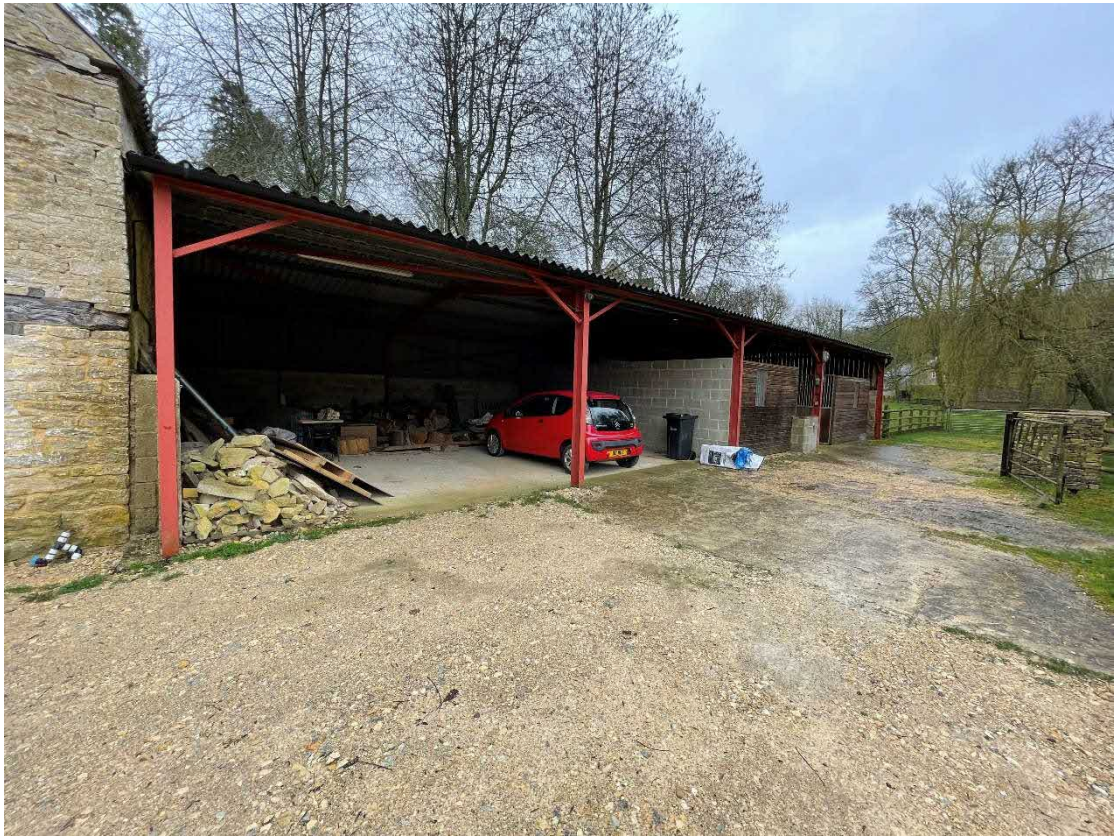
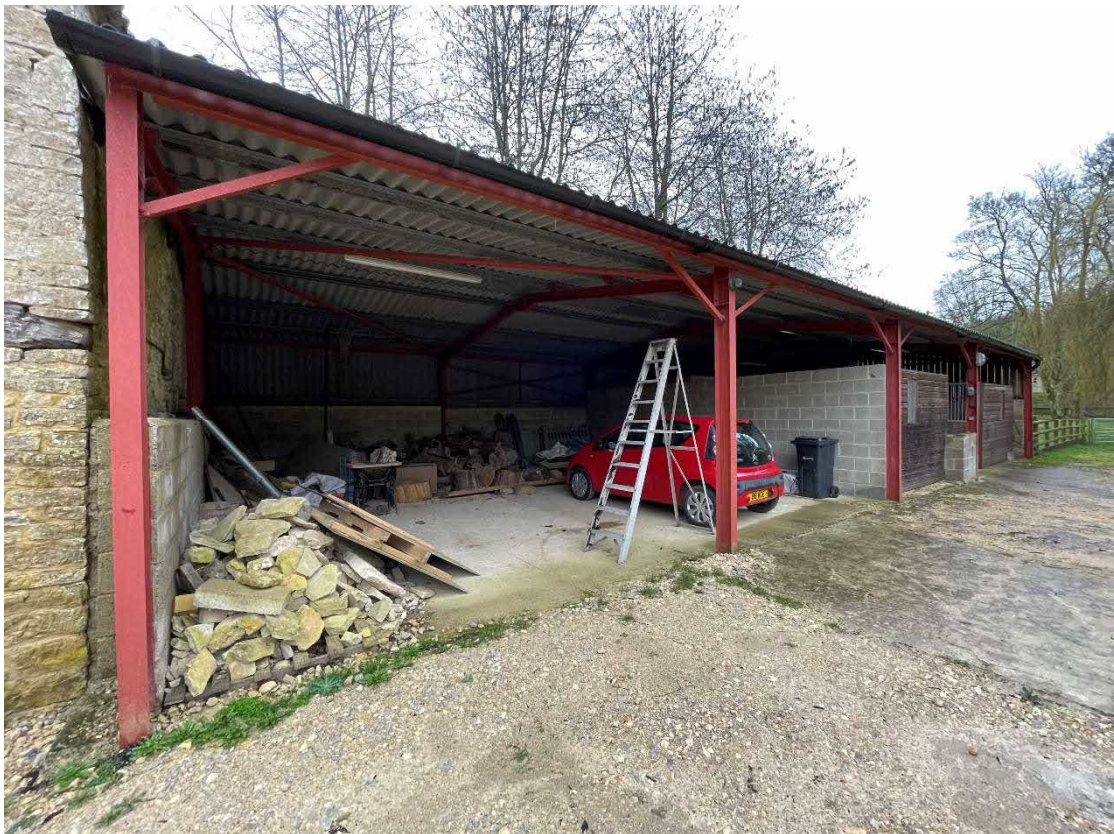
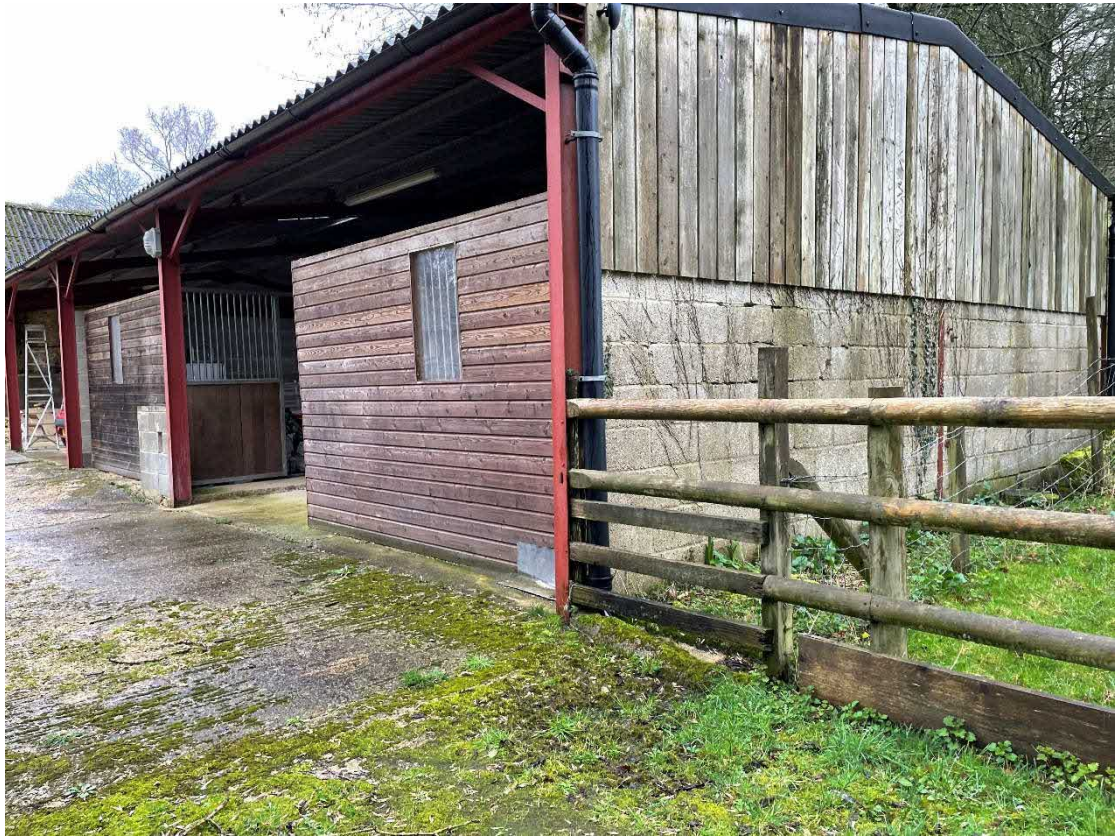
- 2.3.2 The frame structure consists of 4No. bays, 5No. frames spaced at approximately 4.5m. The portal columns / frames span approximately 7.6m. Plan roof CHS bracing was noted to one of the gable ends and vertical CHS bracing at the top middle of the second bay. There is also knee bracing providing longitudinal stability to this structure. Please refer to Photographs 10 – 12 in Appendix A.
