**01 General view of principal entrance to Westonbirt House.** The north east service wing is the low one and two-storey range to the left of the image. The south west corner of the courtyard is denoted by the red arrow (with the taller Belvedere tower visible just to the left).

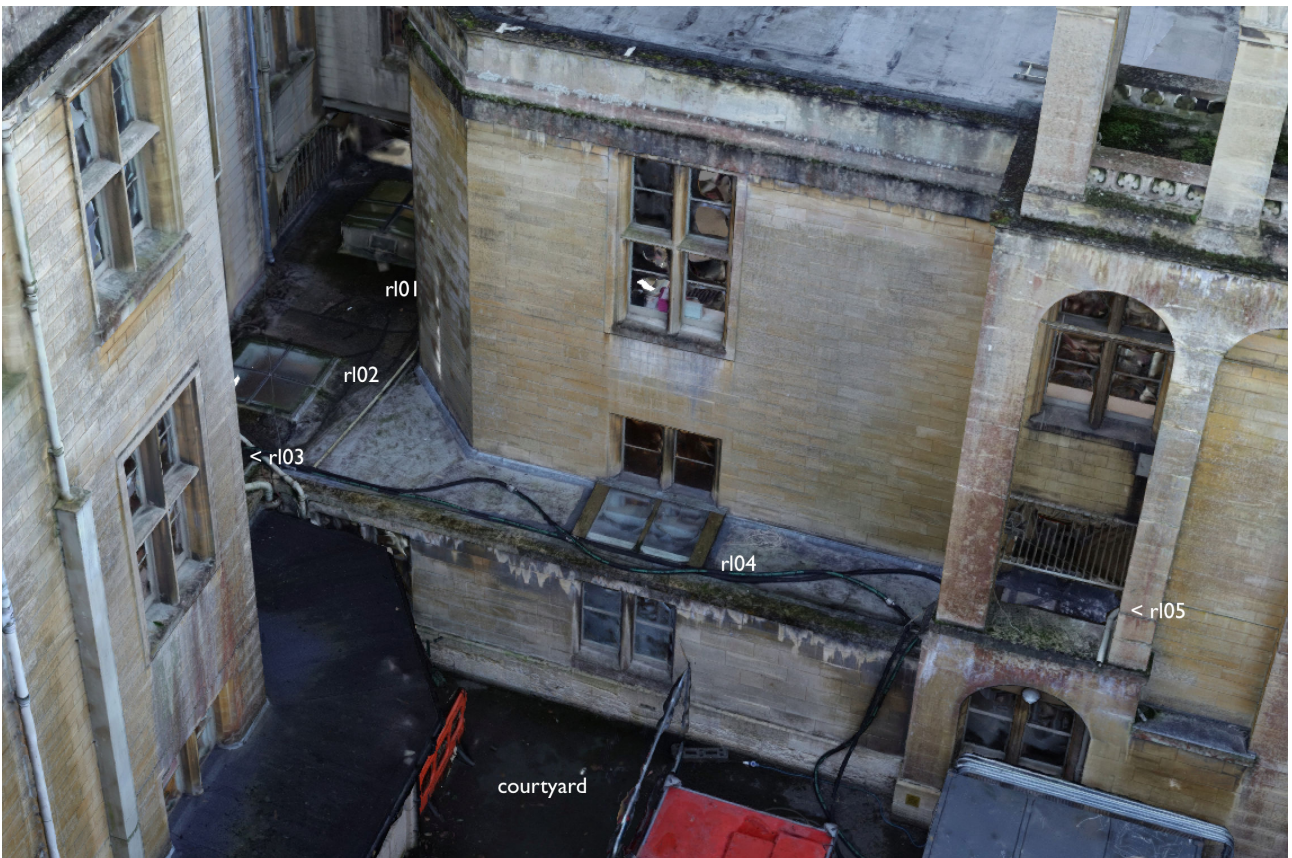
**02 South west corner of north east courtyard** with Belvedere tower visible to right of the image. Single storey flat roof to minimal falls with intermediate rooflights to corridor and service areas at lower ground floor level.

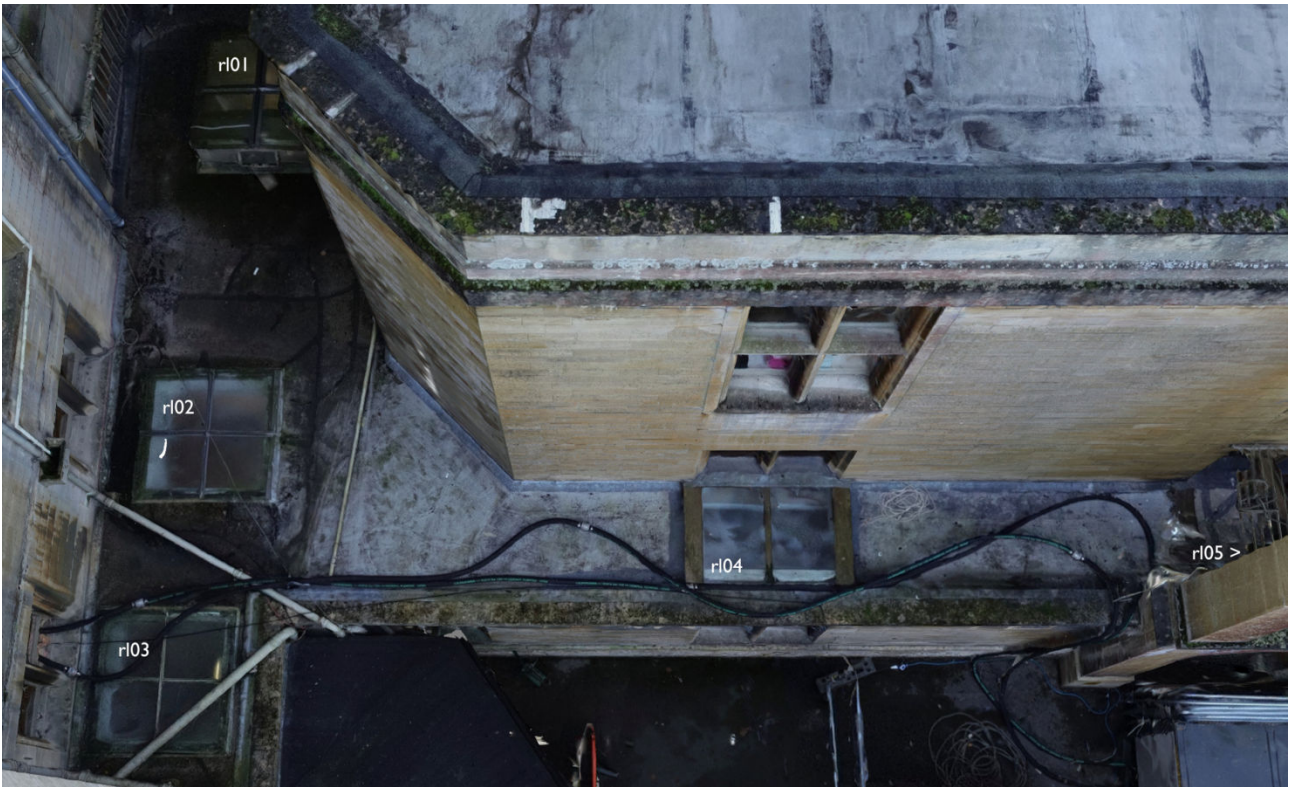
**03** Aerial view of south west corner of north east courtyard highlighting location of concealed rooflights in slot between principal range and north east service court.

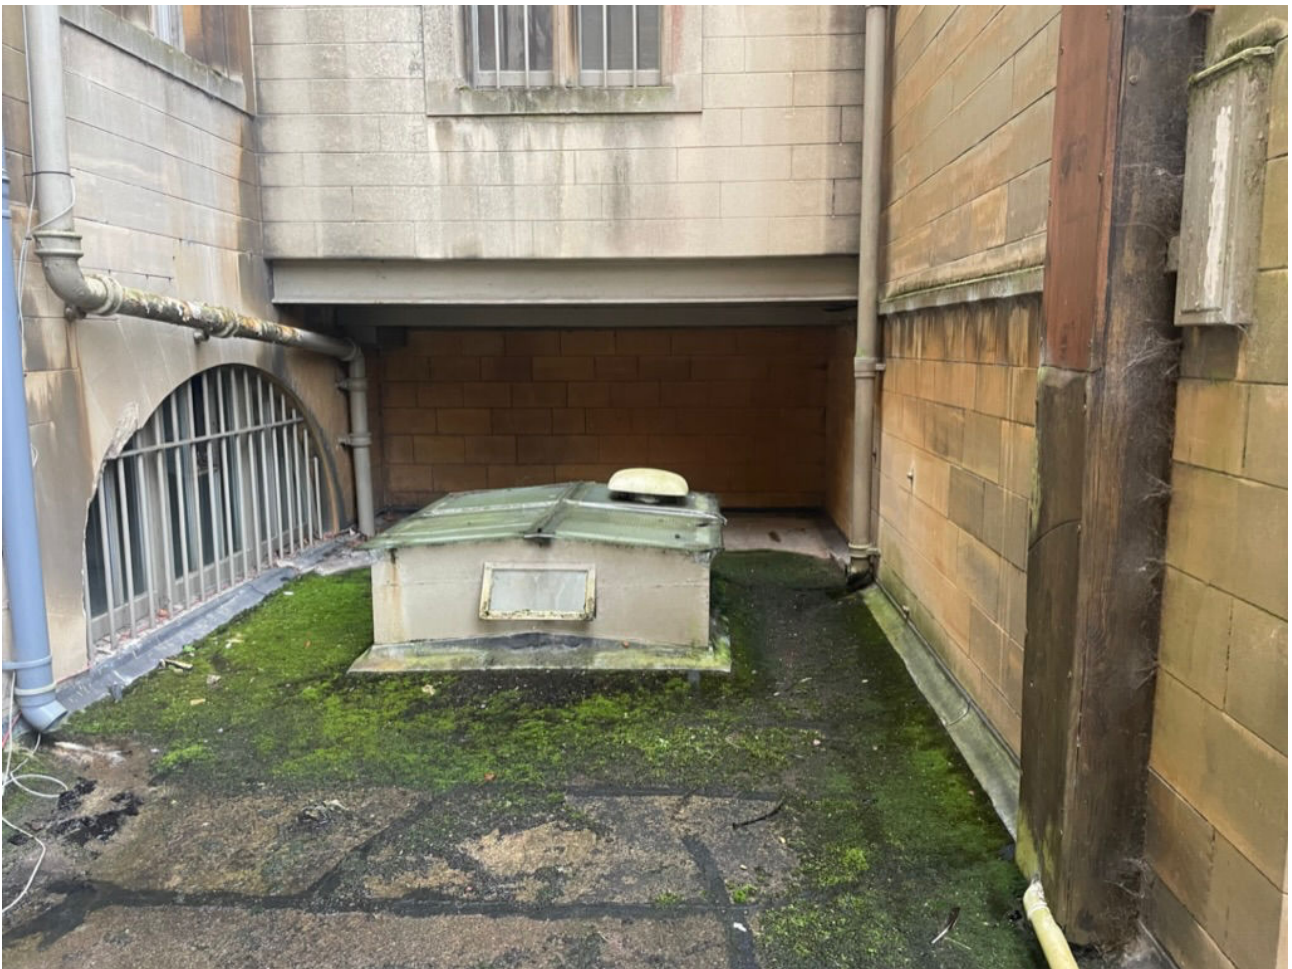
**04** View of rooflight r101 looking west. Replacement Georgian wired glass rooflight with inverted T section iron beams. Much patched with flashband over leaking lead capped joints (itself a remedial detail attempting to improve on the original linseed oil putty weathered joints to glazing bars).

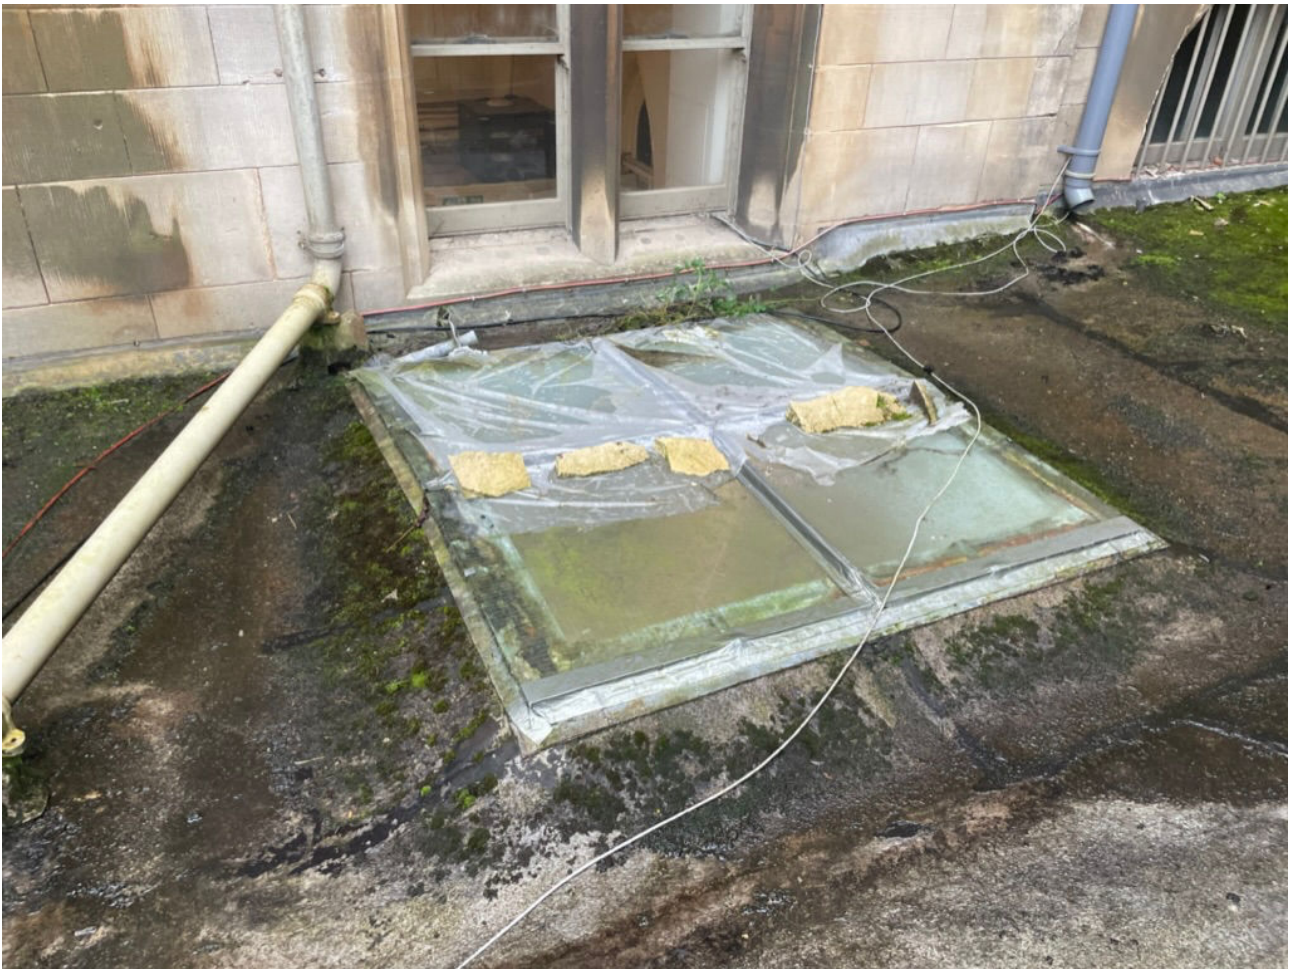
**05 Rooflight r102** looking south towards wn02. Modern Georgian wired glass with inverted T section iron beams, patched with flashband and more recently subject to emergency protection with polythene sheet to resist ongoing water ingress.

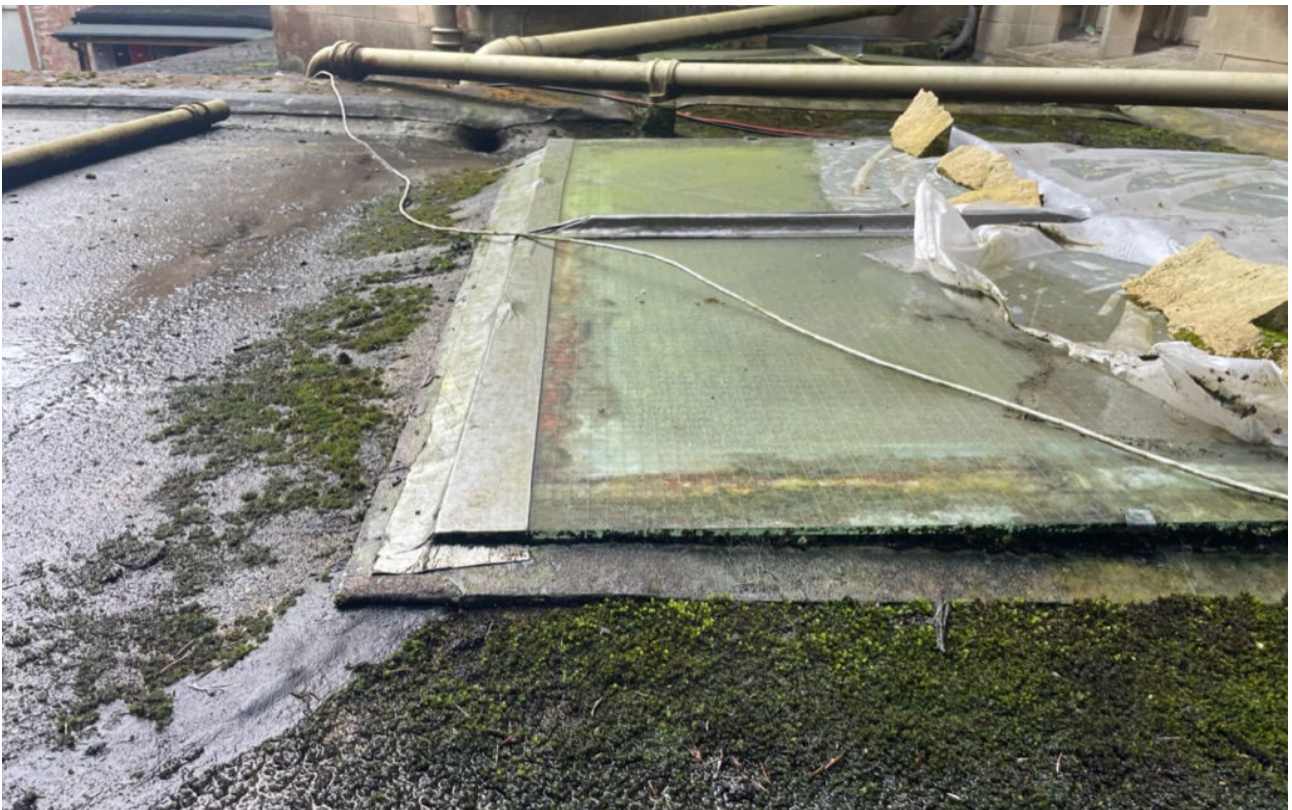
**06 Rooflight r102** looking east. Edge detail is leading to repeated water ingress due to of lack of adequate vertical upstand, especially in storm conditions. Note minimal 40Ø of roof outlet (rw01) which leads to surcharging in storm conditions.

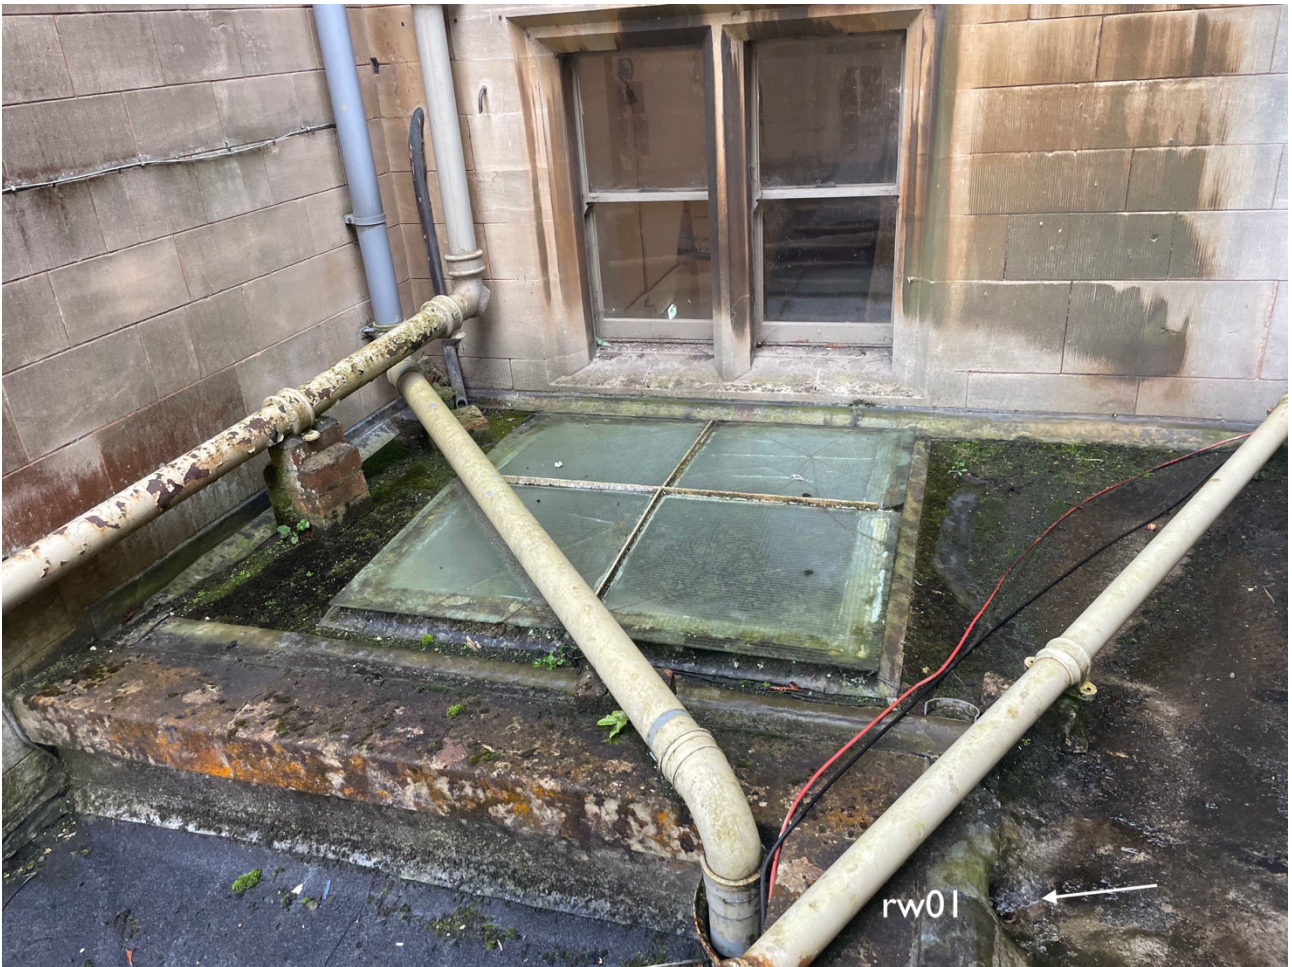
**07 Rooflight r103** looking south towards wn01. Repeat of poorly designed perimeter upstand as r102, which replicates all the defects associated with intermittent water ingress. Note roof outlet (rw01) which tapers to 40ø passing through wall before discharging to hopper beyond coping.

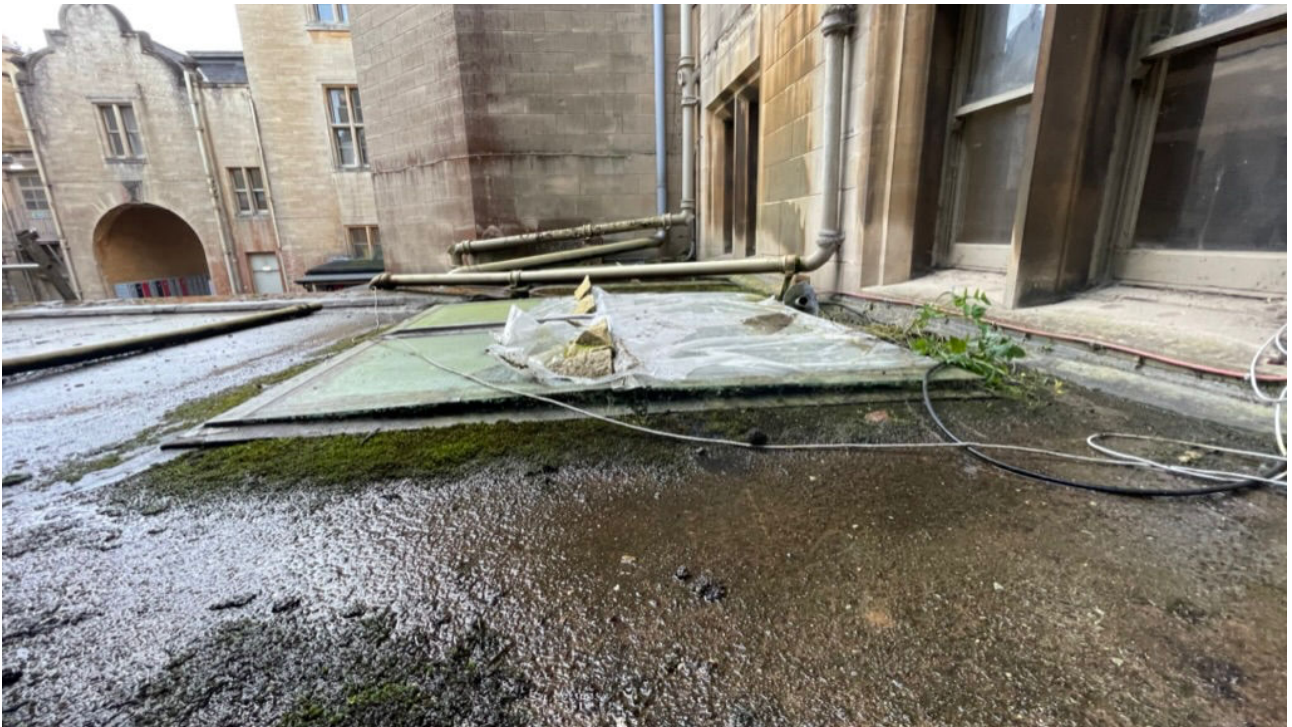
**08 Looking east towards rooflights r102 and r102.** Concrete substrates to minimal falls with asphalt roof covering and solar reflective paint finish, now all in need of replacement. Moss growth is visible where roof retaining water immediately adjacent to rooflight. Roof falls to just 2no outfalls to south west corner of courtyard (rw01) and at north end of roof (rw02) – see roof plan drawing 139/100 for details.

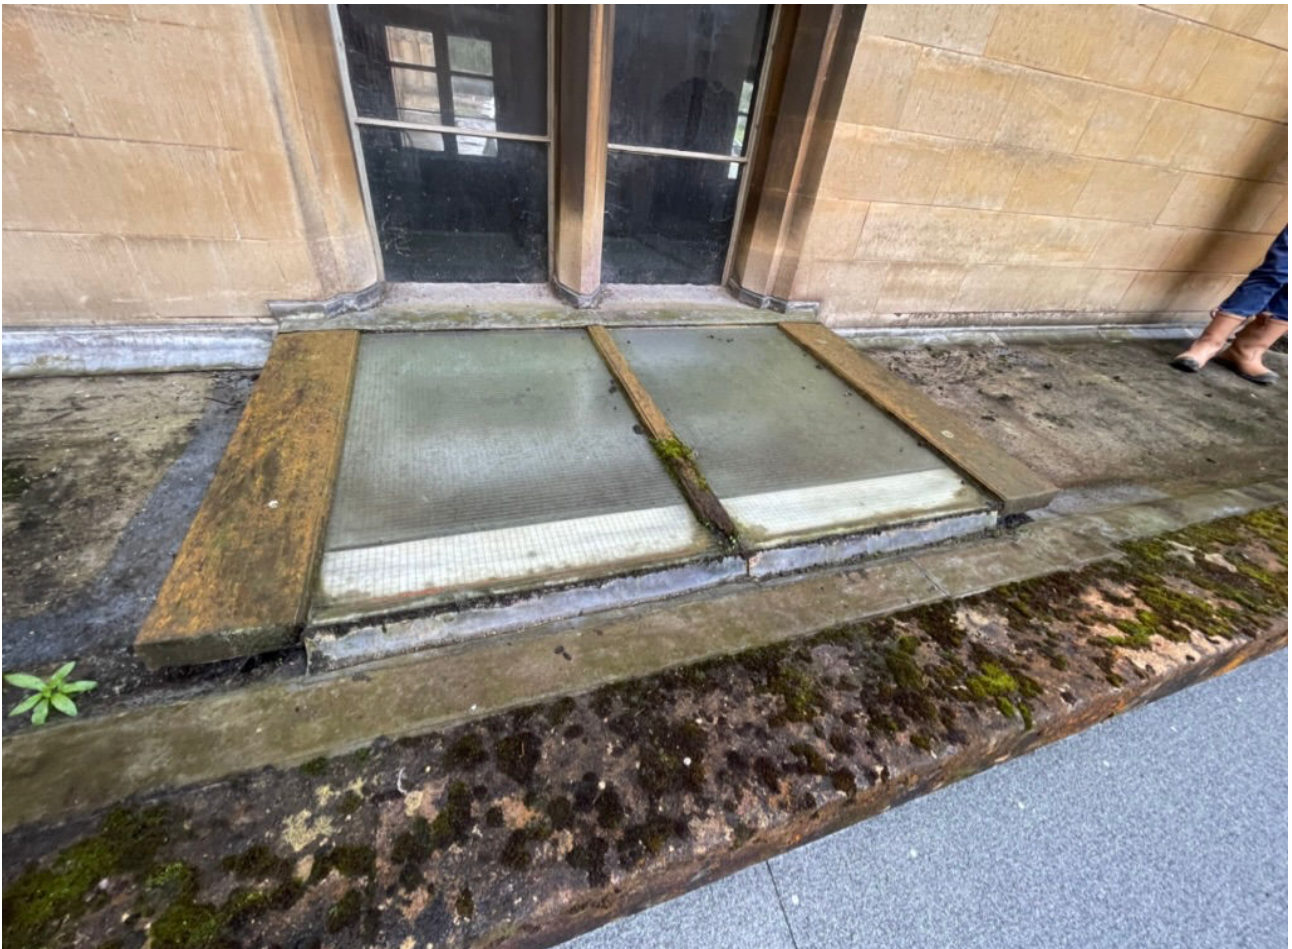
**09** Looking west to rooflight r104. Modified repaired rooflight with timber glazing beads and perimeter frame. Modern Georgian wired glass and lead capped from adjacent window we02. Note very narrow perimeter gutter to eastern edge of r104, subsequently lined with lead flashing.

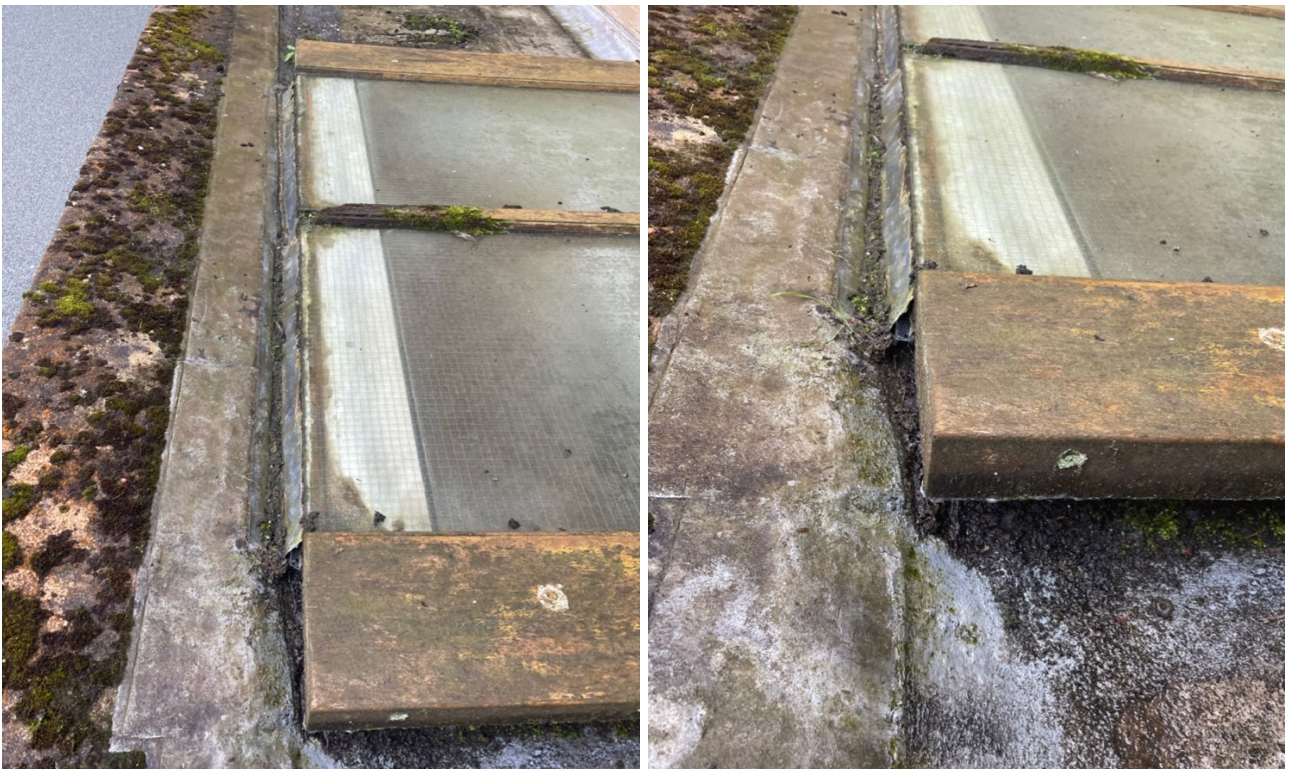
**10-11** Looking north to rooflight r104. Narrow gutter to edge of r104 silts up and due to minimal upstands resulting in regular water penetration internally. Note also decaying moss covered glazing bar in need of replacement.

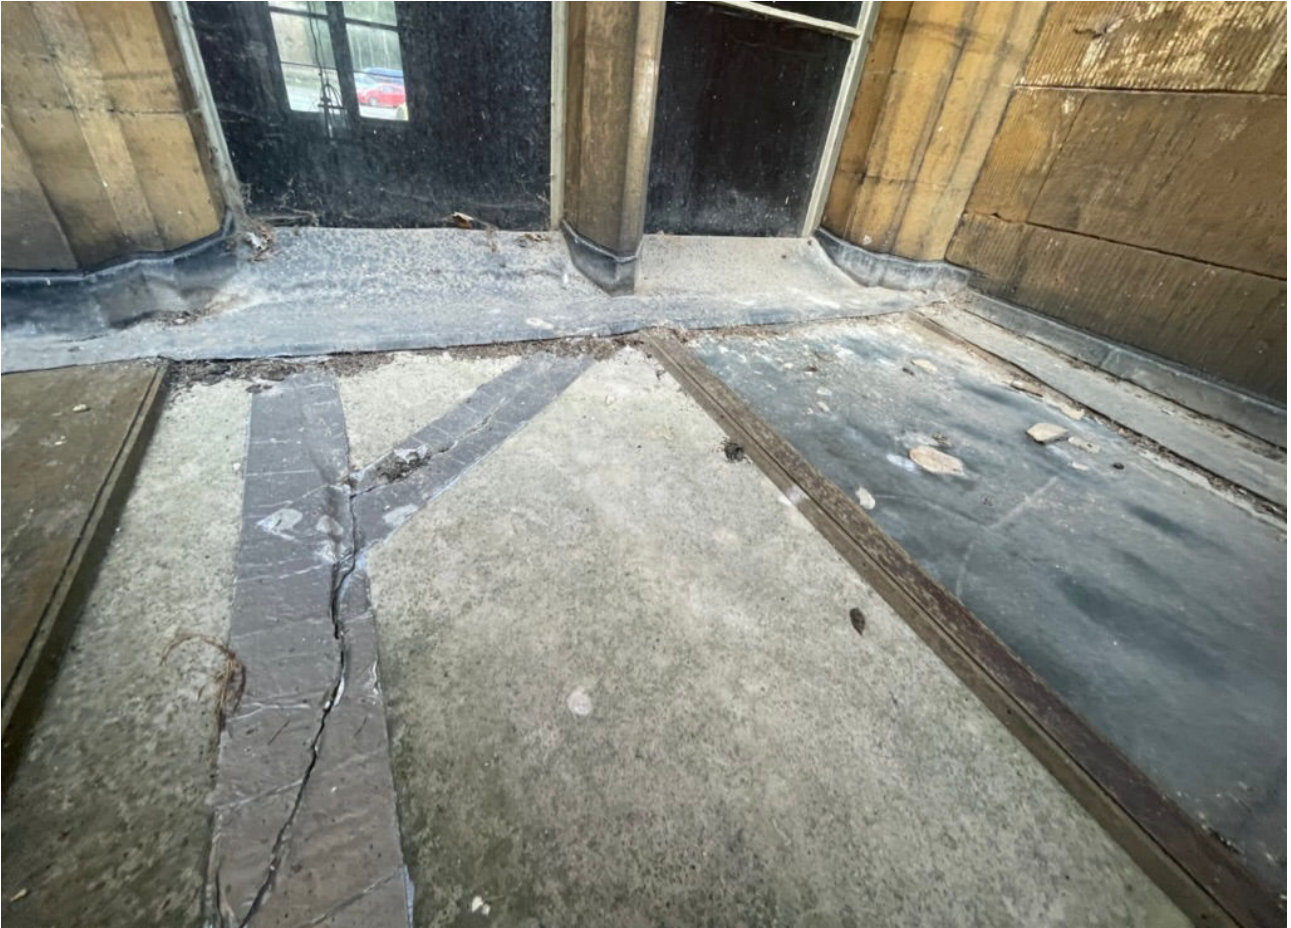
12 Looking west to end rooflight r105. Replacement design similar to r104 with one glazing panel replaced with [damaged] asbestos cement sheet sealed with flashband. Northern edge of rooflight is flashed into adjacent ashlar walling.

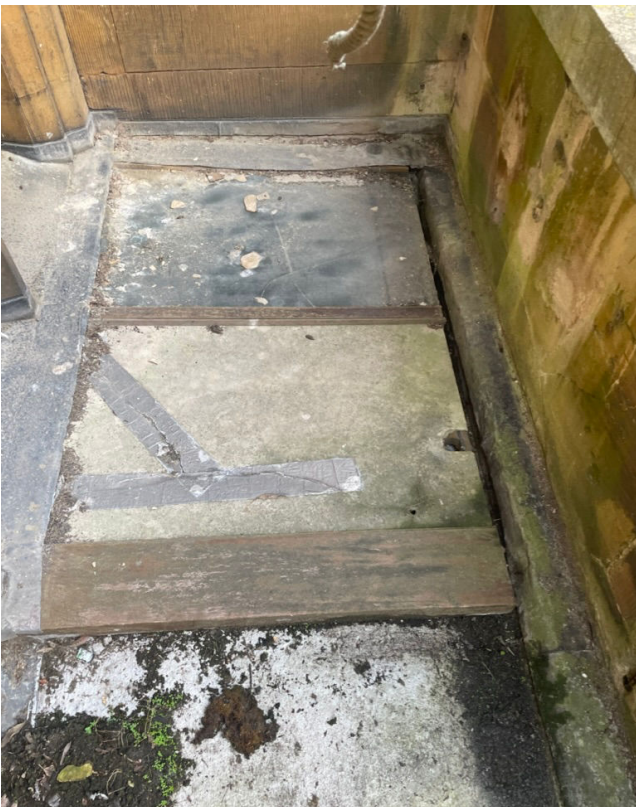
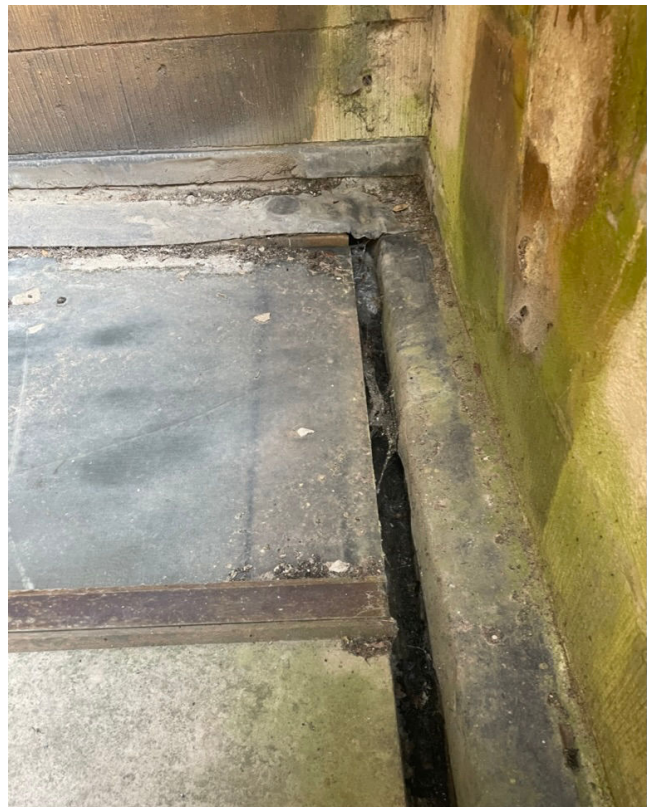
13-14 Looking north to rooflight r105. Roof is very constrained in this area with very narrow, c.60mm wide deep gutter leading to outfall at north end of roof – through outlet reduced to 40ø as it passes through wall to hopper. Proposal is to diamond core drill to allow provision of 100ø pipe through wall.
