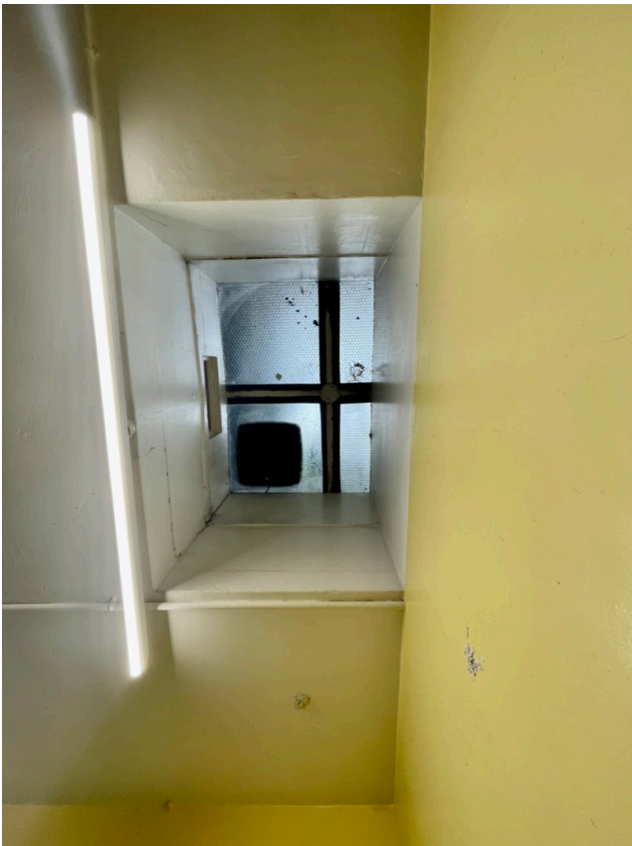
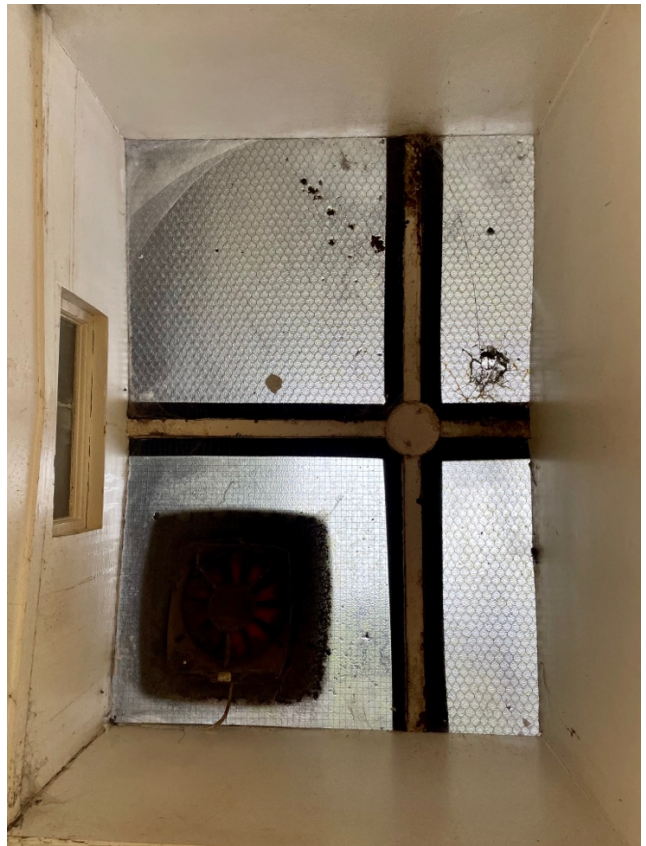
15-16 Looking north below rooflight r101. Rooflight only partly visible within male students wc, having been obscured by later internal blockwork wall to east. Note water penetration to sides of lantern, redundant extract fan and variety of replacement Georgian wired glass (and damage). Glazing bars appear wider and more significant as a result of flashband repairs externally and electrical conduit installation internally.

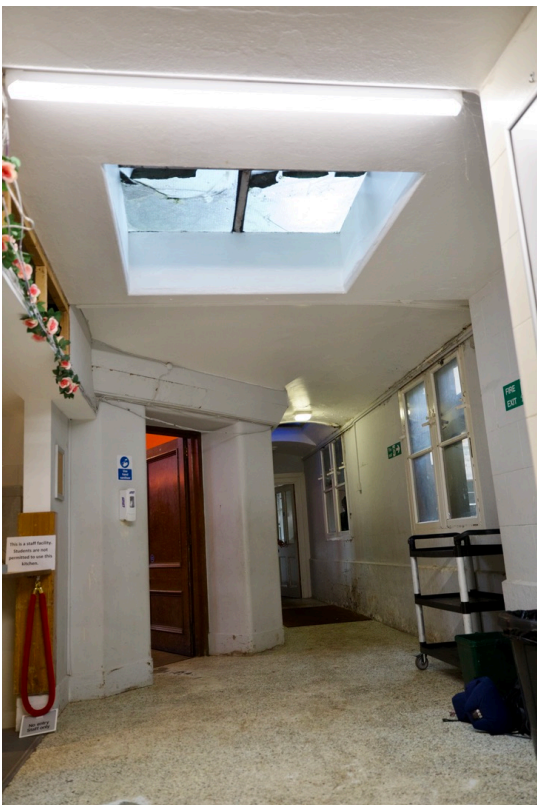
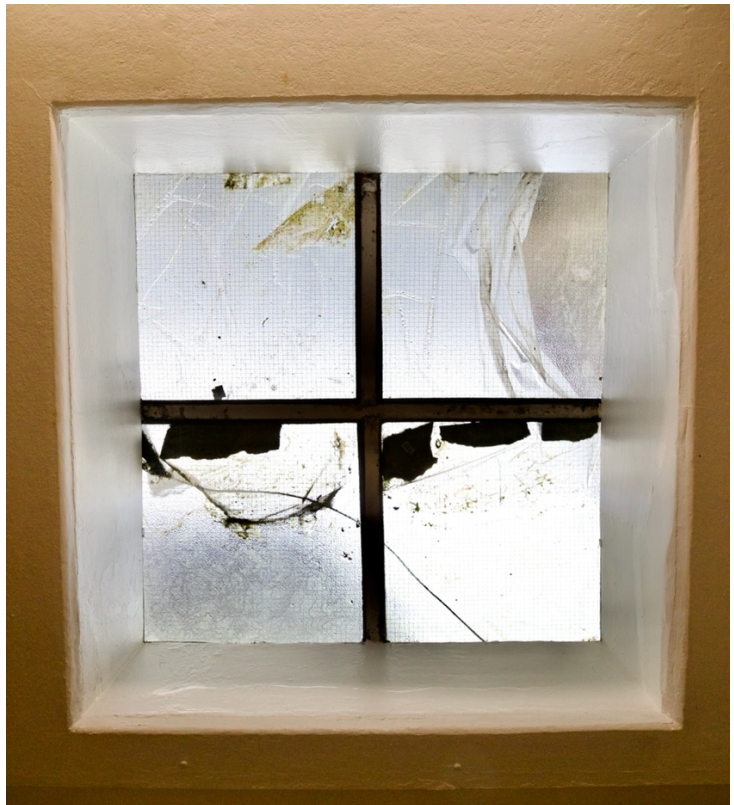
17-18 Looking north below rooflight r102. Rooflight is at south end of the access corridor to the service wing, adjacent to the entrance to the refectory. Existing rooflight suffers repeated water penetration and algal growth following damage [cracks] to 2no replacement Georgian wired glass lights.

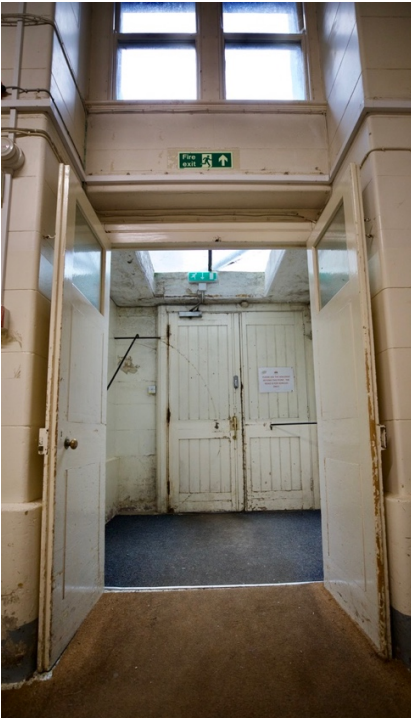
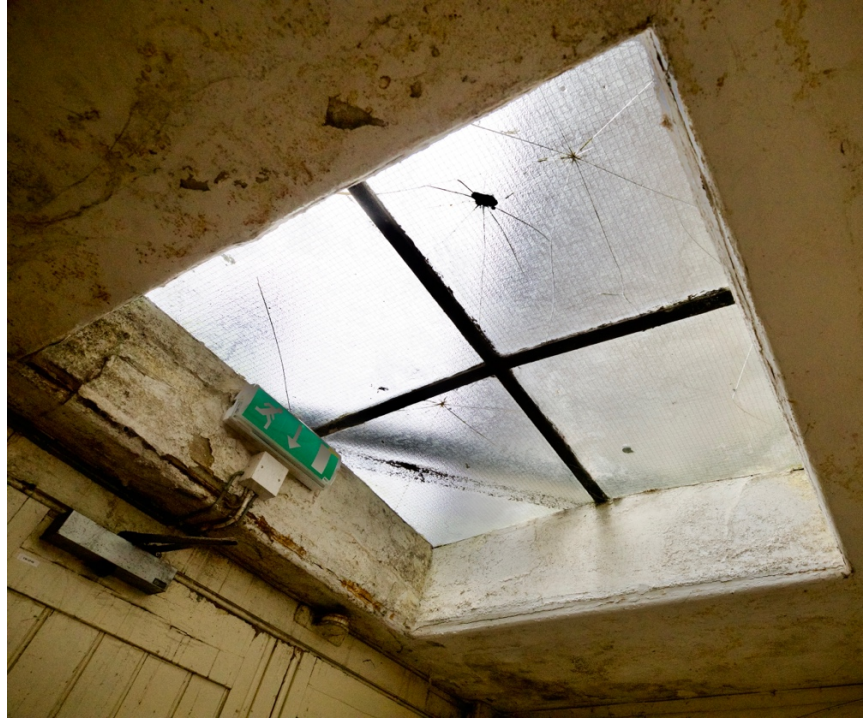
19-20 Looking north below rooflight r103. Rooflight is above the entrance porch to the south west corner of the courtyard. Significant repeated water penetration to all edges of roof and through glazing bars. Damaged to Georgian wired glass.

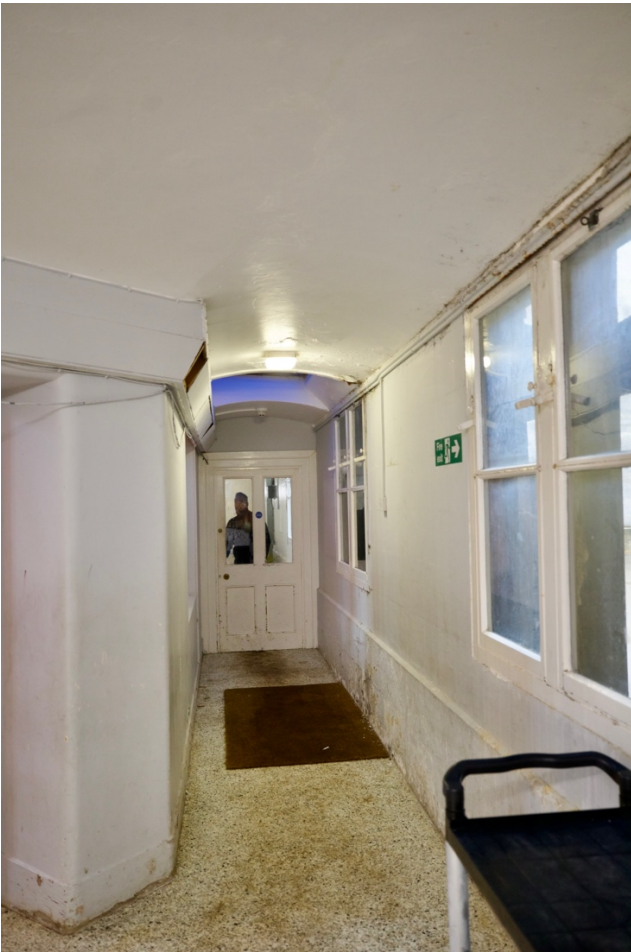
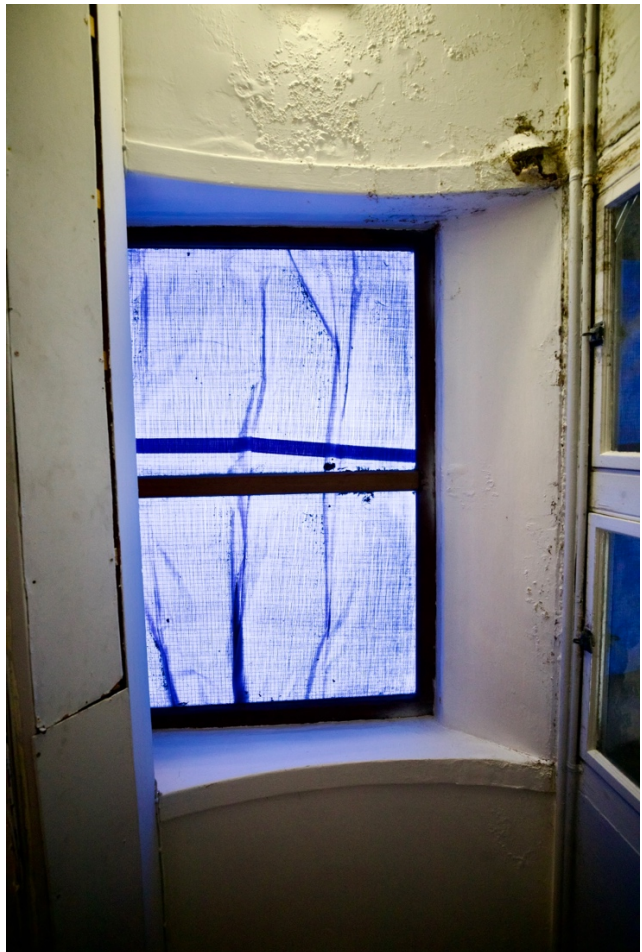
21-22 Looking north towards and below rooflight r104. Rooflight towards south end of the west corridor. Repeated water penetration throughout this area, with mould and algal growth to trimmed roof structure. Mat laid below rooflight to collect drips and reduce trip hazard in corridors [nb: rooflight covered with blue tarpaulin to prevent severe water ingress since photographs 09-11 taken externally].

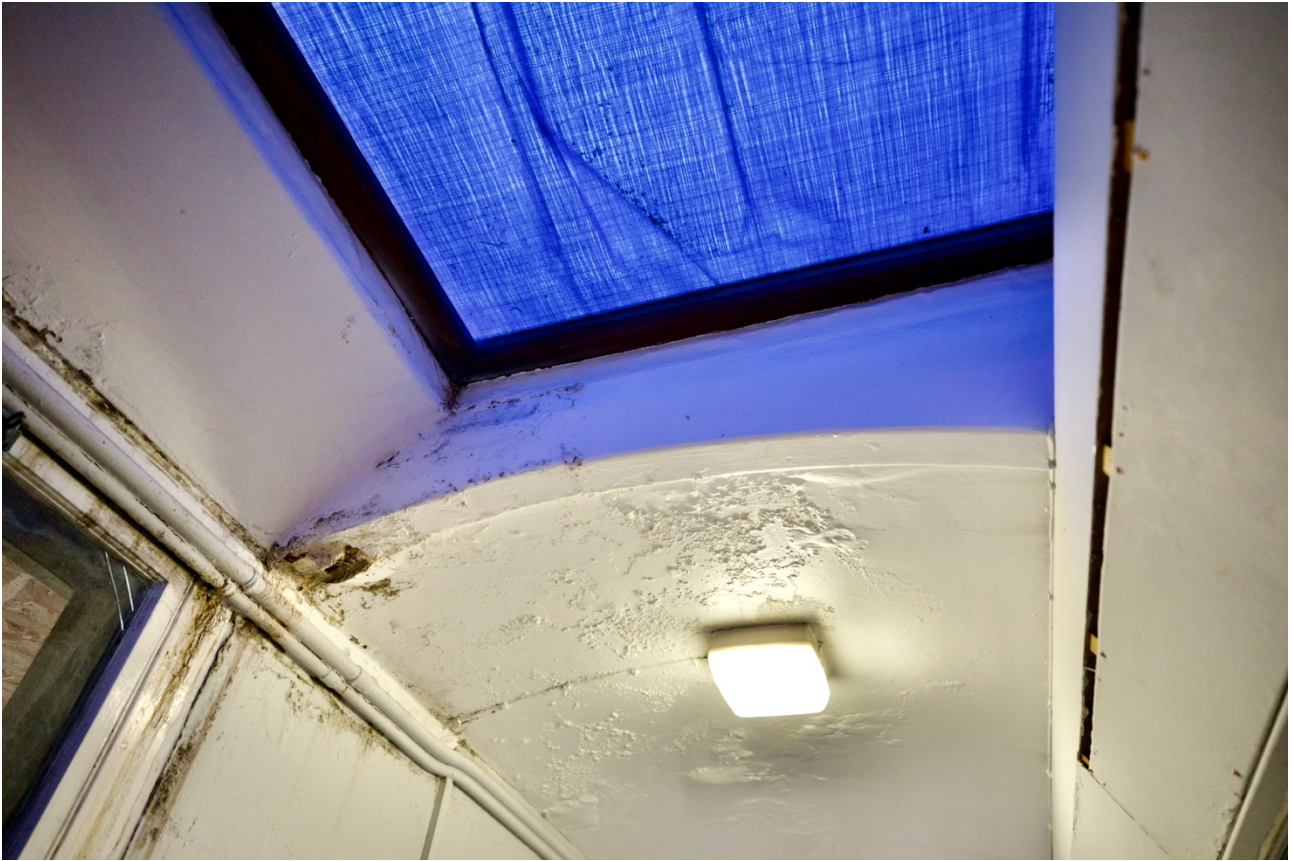
23 Detail of r104 looking south. Water penetration and algal/mould growth to south west corner of rooflight.

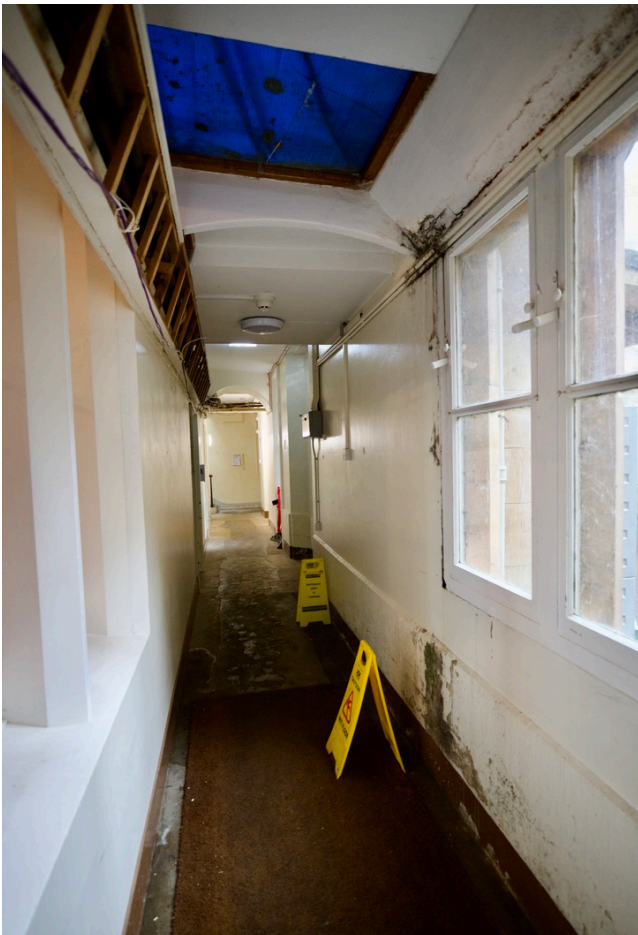
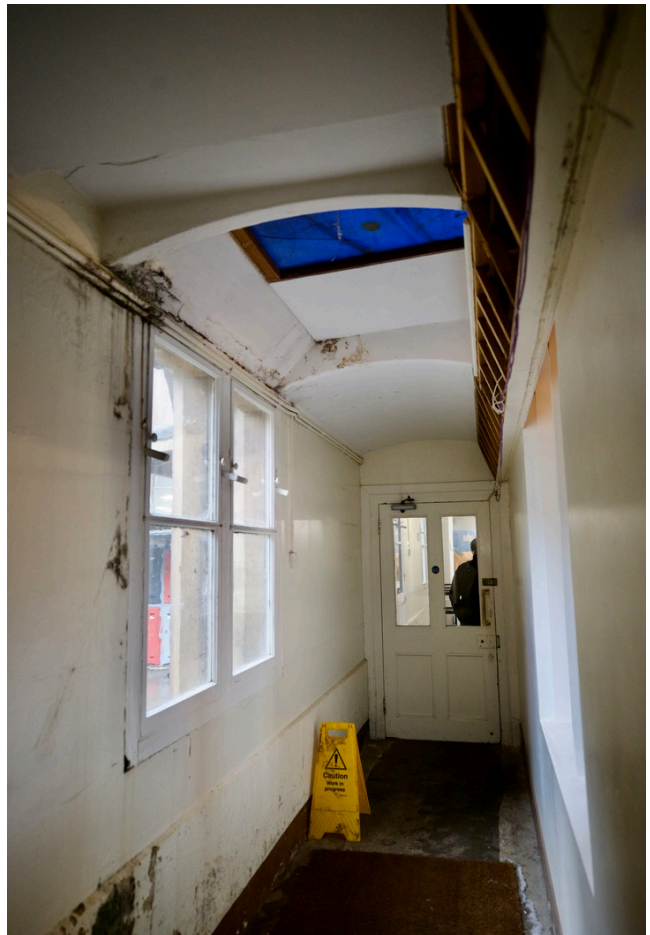
24-25 Looking north and south from r105. With evidence of water penetration throughout north end of corridor.

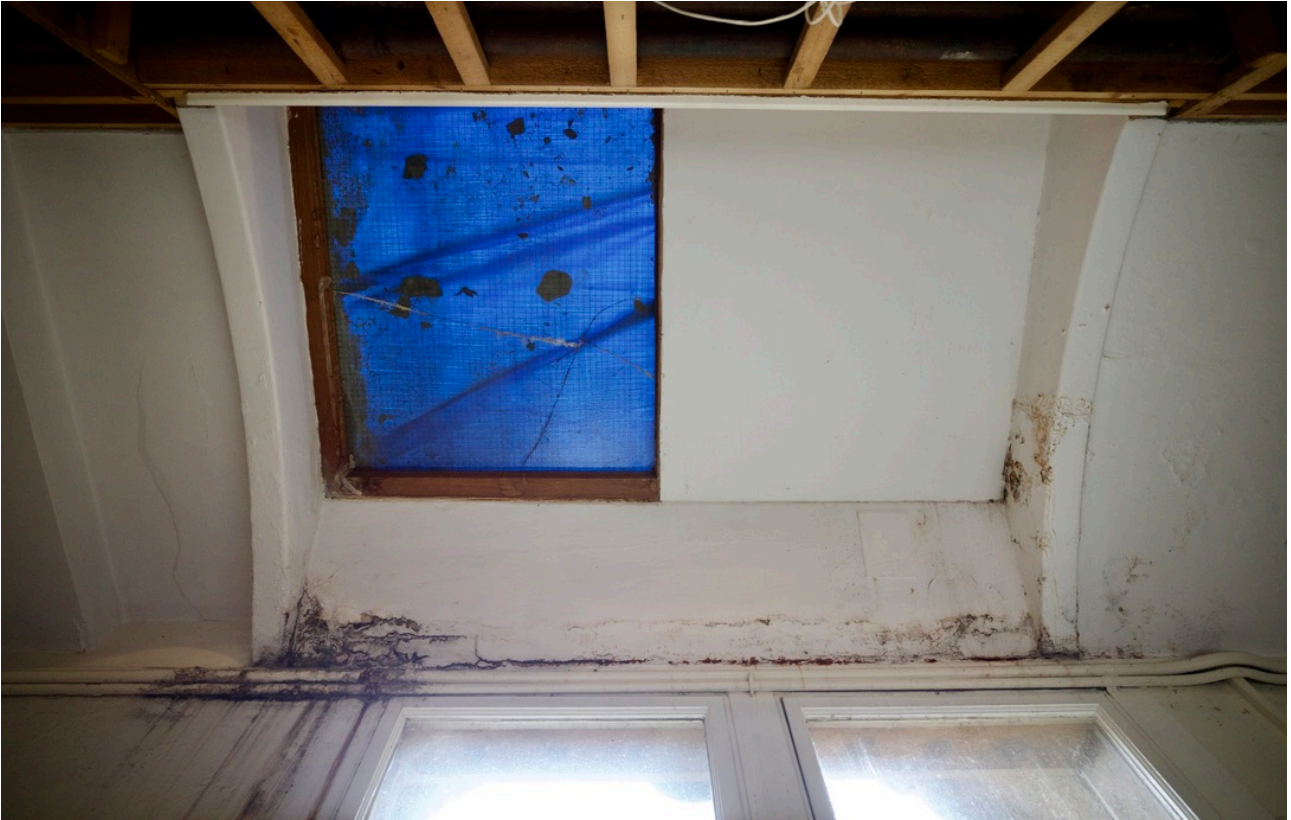
26 Looking east below r105. With significant repeated water penetration to trimmed reveals. Right hand side of rooflight has been boarded-in internally with plywood and asbestos cement board externally – see 12-14. Main source of water penetration to north east corner of rooflight is constrained (and debris filled) narrow gutter to roof outlet.

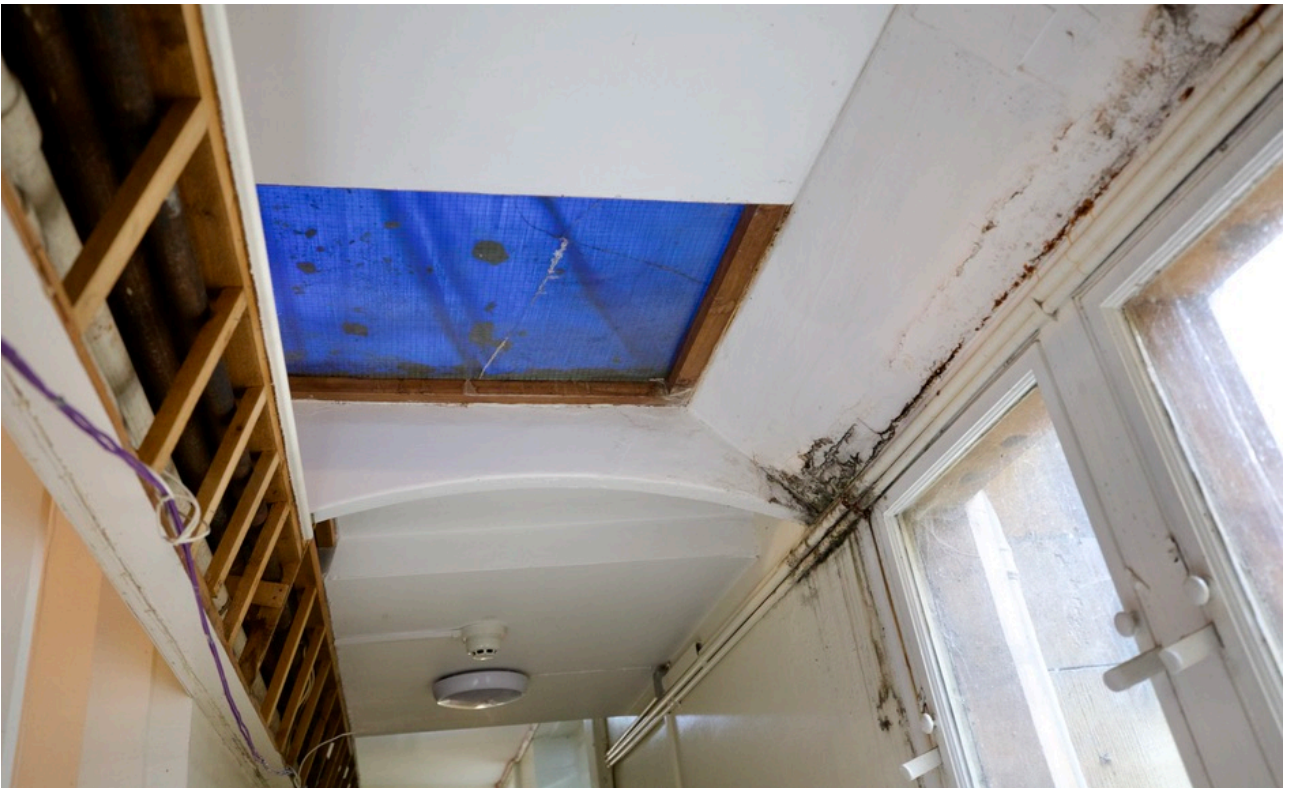
27 Looking north below r105. Mould growth to right hand corner of rooflight corresponds with adjacent 40ø roof outfall to downpipe to external face of wall. Proposal to introduce new rooflight with narrower perimeter kerb will allow install of wider gutter and enlarge core drilled outfall through wall (that is capable of maintenance to mitigate build-up of silt).
