**Grange Farm Barns
Wiseton**

**Structural Inspection Report
For
MD Langley & Sons Ltd**

PC/6772
July 2022

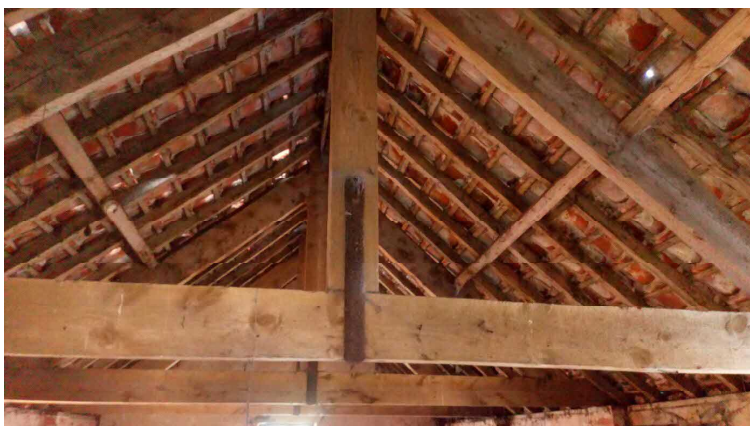
Photograph 1

The roof consists of tiling supported by timber rafters, purlins and trusses [Photograph 1].

The timbers appear to be in good structural condition and there is no evidence of any significant distortion or distress. Strengthening work is not considered to be necessary.

Once the tiles are removed the timbers can be checked for any deterioration and localised repairs undertaken as necessary.

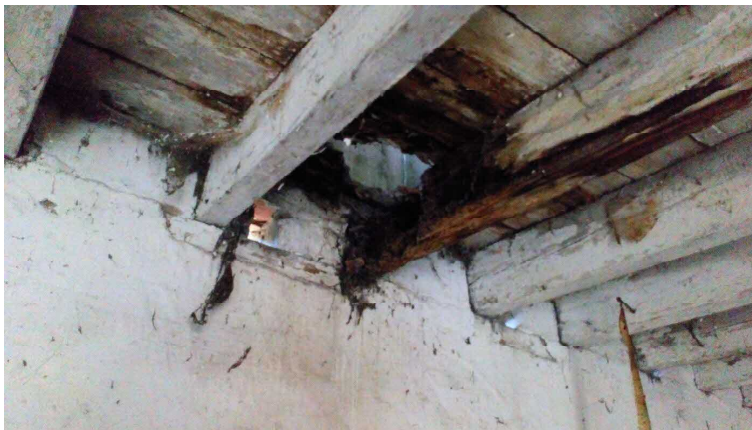
Photograph 2

The first floor consists of 175x63mm floor joists at 400mm centres supported at midspan by a 270x100mm timber beam spanning between walls with an internal timber support post. The joists are of adequate size for domestic loading and can be retained provided there is sufficient headroom. However there has been some rot at the ends of two joists and they will require replacement or repair [Photograph 2]. The main timber beam is

undersized for domestic loading and will require strengthening or replacement. In view of the headroom under the beam it is probable that replacement with a shallower steel beam in the depth of the joists would be preferable to replacement with a larger timber beam. The timber post would also require replacement with a steel post or cross beam.

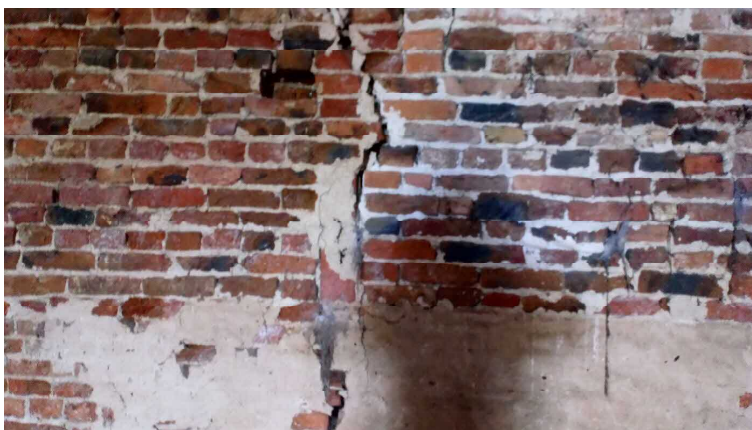
Photograph 3

There is a 10mm wide vertical crack in the party wall with unit B [Photograph 3-view from unit B]. This is due to historic foundation movement combined with a lack of bond in the

brickwork and is not structurally significant. The crack can be repointed but it would be prudent to strengthen it with 1m long Helifix bars in the bedjoints at 225mm vertical centres.

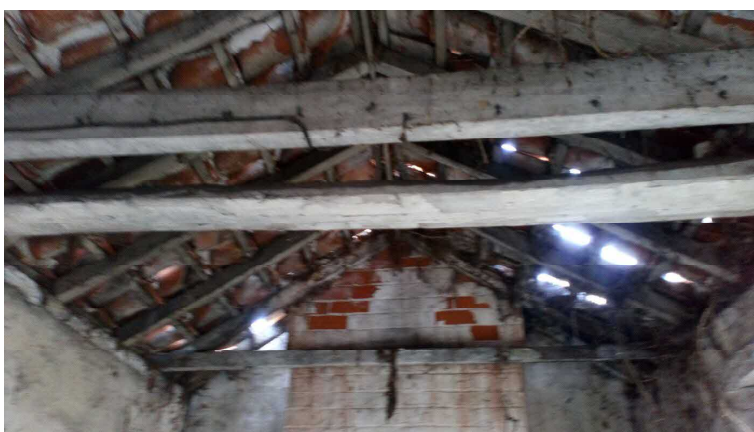
Photograph 4

The roof consists of tiling supported by timber rafters. There are no purlins or ridge beam and roof spread has occurred. Some timber ties have been introduced at eaves level but it is unlikely that they are fully effective and further roof spread will probably occur during times of heavy snow loading [Photograph 4]. In addition there has been some

deterioration of rafters due to water ingress. It will be necessary to replace the affected timbers and to strengthen the roof by installing a timber or steel beam under the ridge. In view of the extent of repairs and strengthening work required to this roof it is recommended that it is fully replaced.

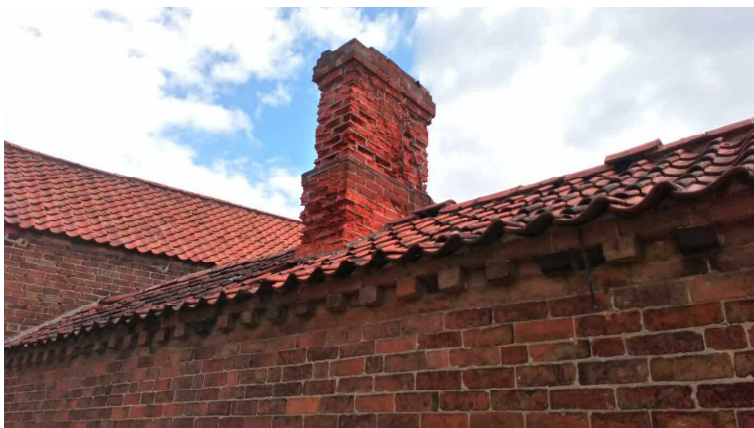
Photograph 5

The remainder of the brickwork to the walls is in reasonable condition. Some localised repointing of eroded joints and some localised replacement of frost damaged or missing bricks will be required particularly on the west elevation. All repointing should be in a suitable lime mortar. However the chimney stack has suffered from extensive erosion and is beyond practical repair [Photograph 5]. If a chimney is required in the final

refurbishment scheme then it will have to be rebuilt in matching masonry.

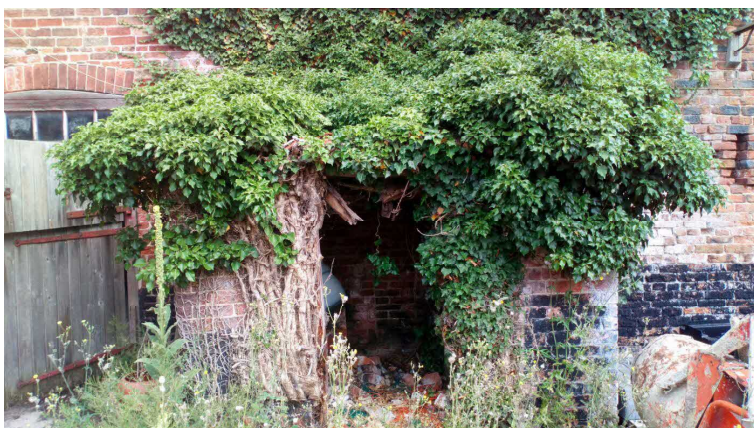
Photograph 6

The walls of the small store are obscured by ivy but are likely to be in poor condition and require extensive rebuilding [Photograph 6].

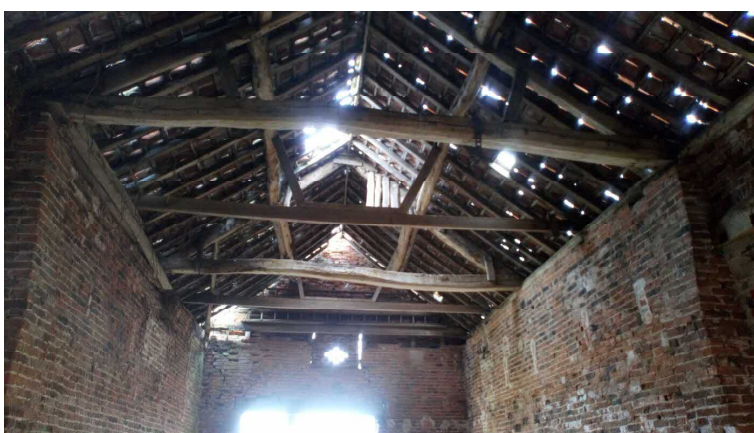
Photograph 7

The roof consists of tiling supported by timber rafters and large, rough cut, purlins. The purlins are supported by a mixture of timber frames and timber props off timber beams [Photograph 7]. There is evidence of deterioration due to water ingress of one purlin

and of the wallplate to the north elevation which will require localised repair with additional timbers or dowels and resin subject to detailed survey. Once the tiles are removed all timbers can be checked for any deterioration and localised repairs undertaken as necessary.

The rafters, purlins and frames appear to be of adequate size and there is no evidence of any significant distortion or distress. Strengthening work to these elements is not considered to be necessary. However the timber beams supporting the purlin props are inadequate and appear to have sagged. It will be necessary to strengthen these elements by either replacing them with a timber frame or bolting steel to the sides.

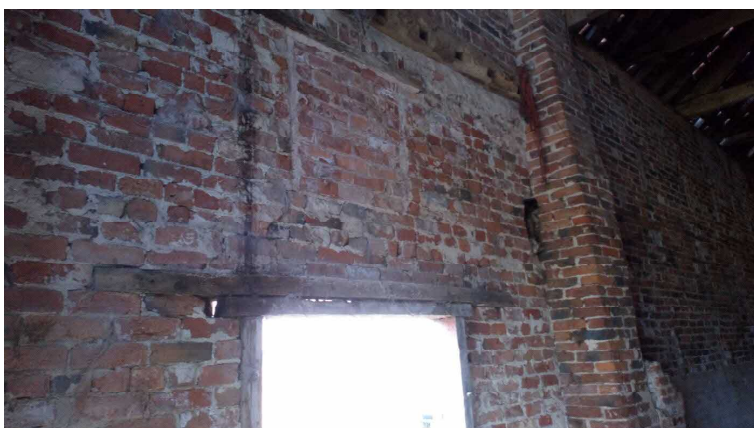
Photograph 8

The external walls consist of solid brickwork. There are internal brickwork piers either side of the original openings in the north and south elevation. These piers reduce in size towards the roof [Photograph 8]. There are also a few internal brick piers that have either

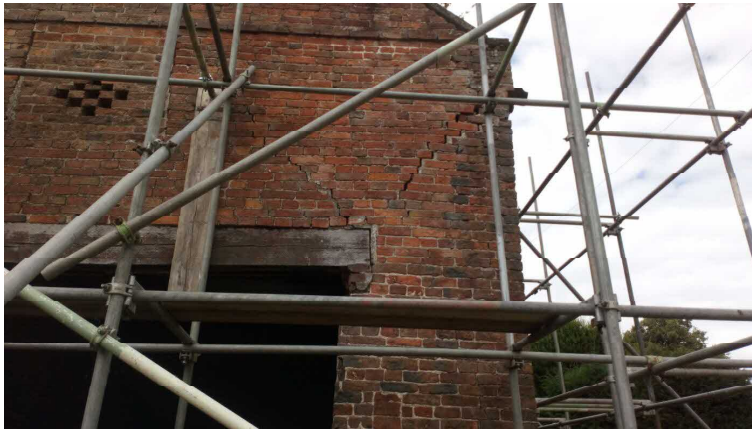
Photograph 9

been terminated at midheight of the external wall or have been removed. The north wall leans outwards by up to 75mm in a 900mm wide height. The south wall leans inwards by up to 50mm in a 900mm height. There is diagonal and vertical cracking up to 50mm wide in the east gable wall some of which has been repointed in the past and has re-opened [Photograph 9]. The timber lintel over the main door in the gable sags and the brickwork

The movement of this section of the building is extensive and appears to be due to a combination of inadequate buttressing, lack of roof bracing, position of openings reducing the strength of the walls and increasing foundation bearing pressures, foundation movement and undersized timber lintels. The movement has been ongoing for a considerable time and appears to be progressive. The gable wall is in very poor condition and would require a replacement galvanised steel lintel over the main doors and rebuilding of the worst cracks incorporating Helifix bars for additional strength. In view of the current stability of this wall it would be safer and more practical to take it down completely except where attached to the outbuilding and rebuild it. The new brickwork can be bonded into the infill brickwork of the north elevation in order to enhance the stability of this area. The north wall does not require rebuilding provided further

movement is prevented by installing roof bracing, tying it back to a new first floor and introducing buttressing in the form of either internal walls or steel portal frames. The temporary shoring will have to be retained until the wall is stabilised.

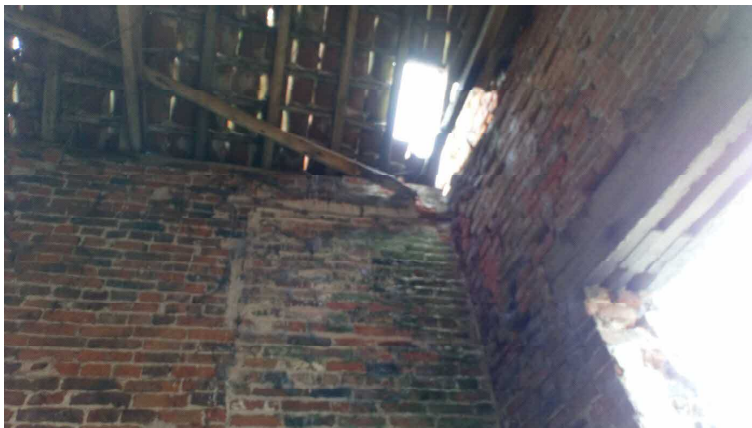
Photograph 10

coursing adjacent to the door dips towards the north east corner. The brickwork in the north elevation near the gable wall appears to be newer indicating that it may have been rebuilt or that openings may have been filled in [Photograph 10]. There was an additional

doorway in the gable wall into the single storey outbuilding which would have resulted in high bearing pressures under the section of pier between the openings although this opening has now been partially infilled.

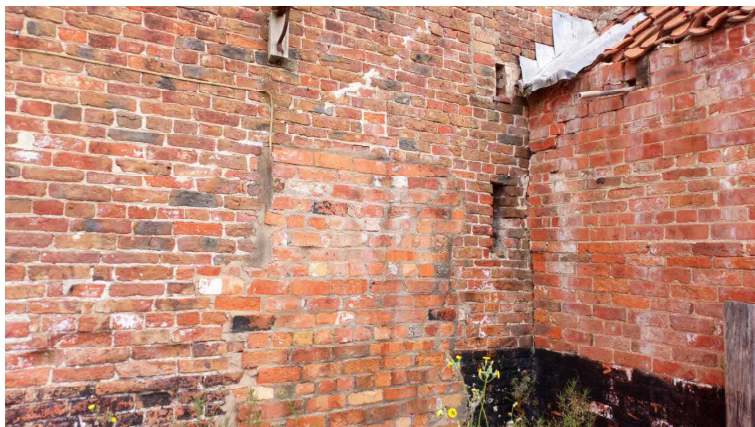
Photograph 11

The remainder of the external walls are in relatively good condition although some openings have been infilled with brick in an unsympathetic manner and may require rebuilding for appearance [Photograph 11]. Some localised repointing of eroded joints

and some localised replacement of frost damaged or missing and loose bricks will be required. All repointing should be in a suitable lime mortar. The crack in the party wall with unit A will require repair.

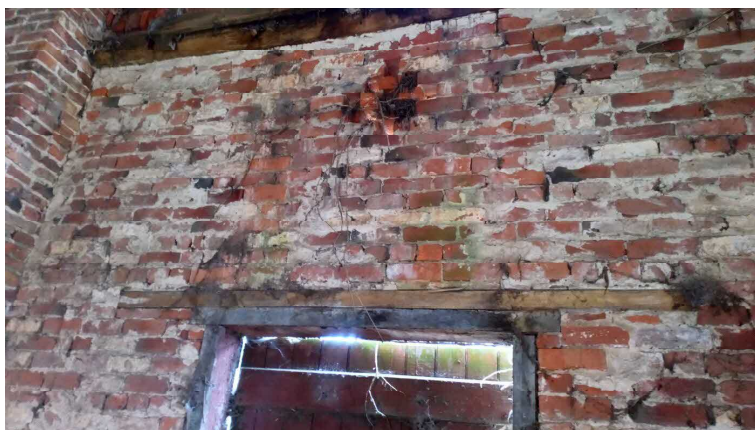
Photograph 12

The timber lintels over the original large openings on the north and south elevations have been rendered over although sections of this have fallen off. It will be necessary to remove all the render to check the condition of the lintels and cut out and replace any sections of rotten timber. The remainder of the timber lintels are inadequate in size [Photograph 12]. New galvanised steel or concrete lintels should be installed.

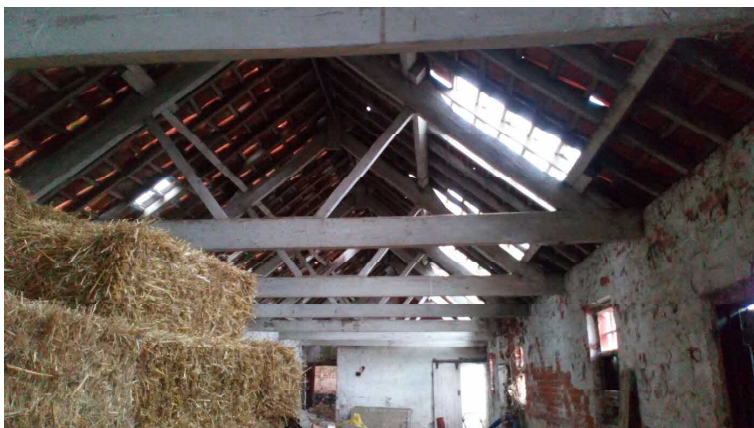
Photograph 13

The roof of the single storey outbuilding consists of timber rafters and purlins supported by timber trusses [Photograph 13-view in unit C]. Although the purlins and elements of the trusses appear to be undersized there is no evidence of any significant distortion or distress. Strengthening work to these elements is not considered to be necessary.

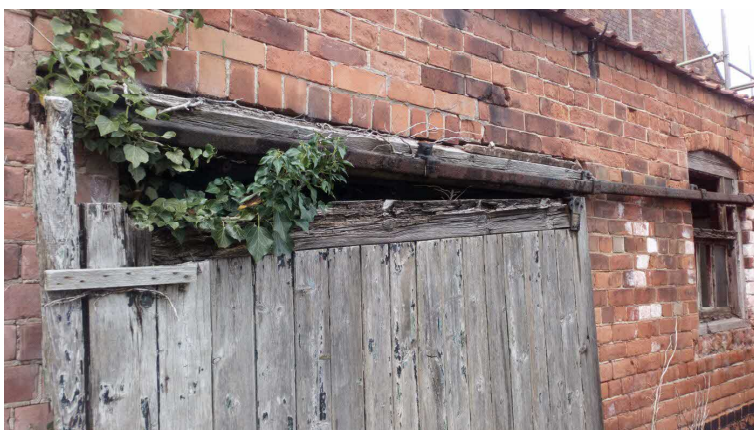
Photograph 14

The brick arch lintels and the timber lintels are in good condition and can be retained. However there is evidence of sagging to the timber lintel to the doorway on the east elevation [Photograph 14]. A new galvanised steel lintel should be installed.

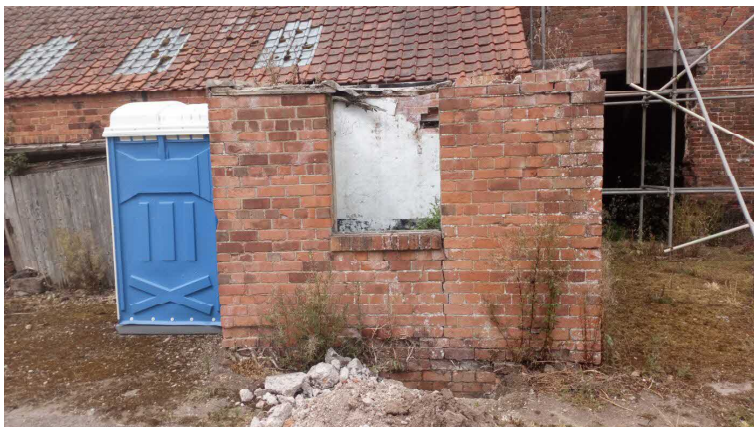
Photograph 15

The external walls consist of solid brickwork and are in poor condition with cracked and displaced brickwork and brickwork sagging where it is built off door frames [Photograph 15]. Extensive rebuilding of brickwork and installation of lintels will be required and it will be more practical to demolish and rebuild the store.

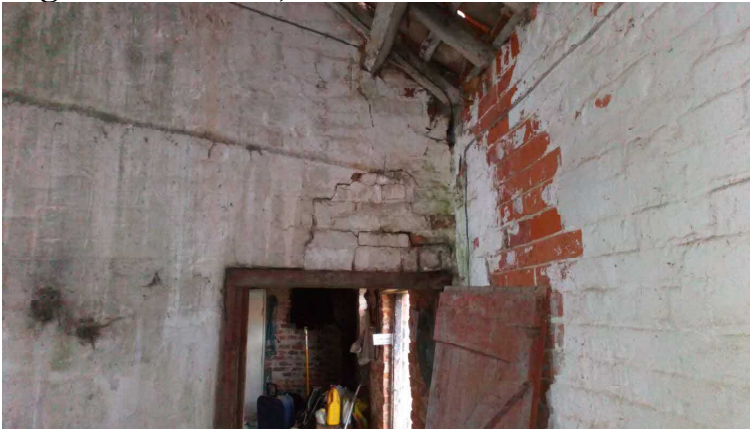
Photograph 16

The brick arch lintels and the timber lintels are in good condition and can be retained. However there is evidence of unsupported brickwork over internal doors [Photograph 16]. New galvanised steel or concrete lintels should be installed.

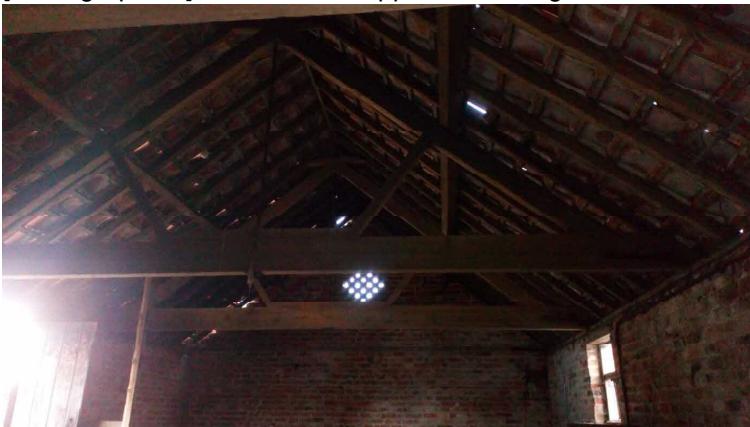
Photograph 17

The roof consists of tiling supported by timber rafters, purlins and timber/steel trusses [Photograph 17]. The timbers appear to be in good structural condition and, although the

purlins appear to be undersized, there is no evidence of any significant distortion or distress. Strengthening work is not considered to be necessary.

Once the tiles are removed the timbers can be checked for any deterioration and localised repairs undertaken as necessary.

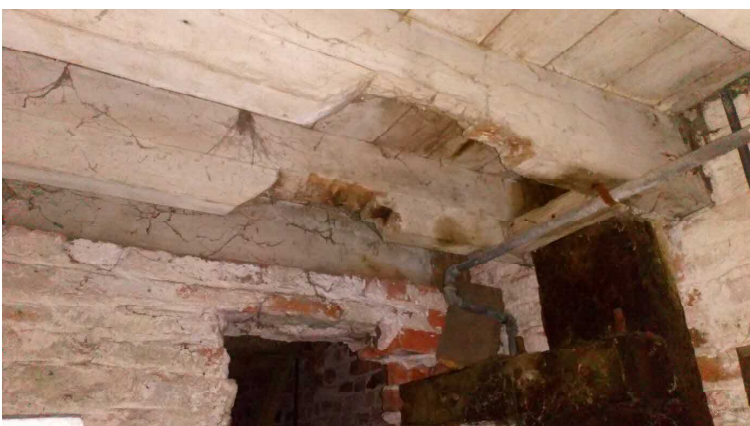
Photograph 18

The first floor consists of 220x75mm floor joists at 400mm centres spanning between walls. The joists are of adequate size for domestic loading and can be retained. However there has been some excessive notching of four joists and one joist has split [Photograph 18]. These joists will require replacement or repair with additional timbers

bolted to the side.
