Our Ref: 200-493 Report R3

7th January 2024

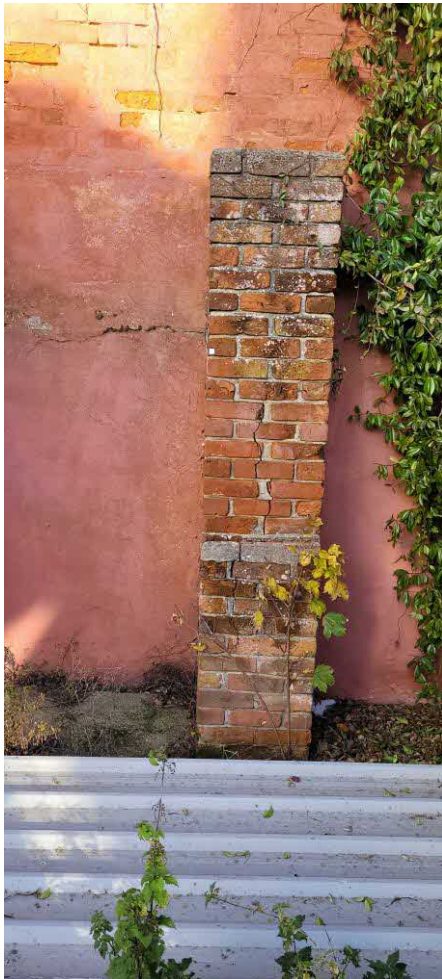
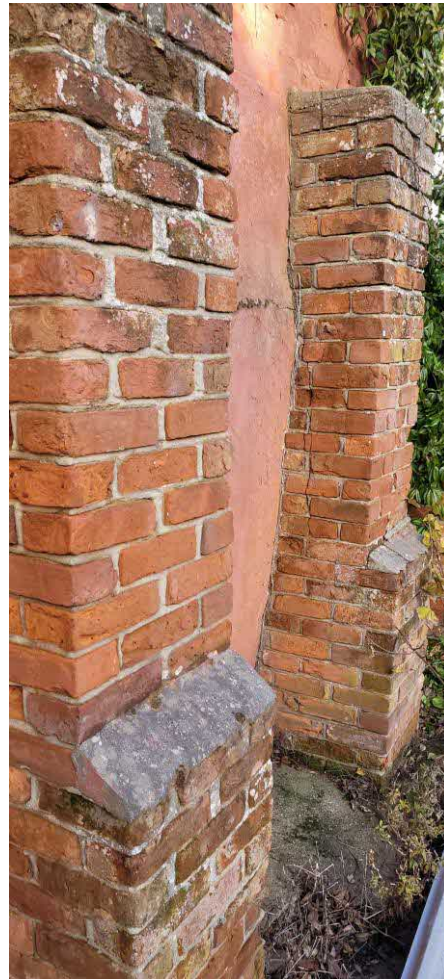
Photograph 3A & 3B
Showing damage to buttresses in Southeast Elevation

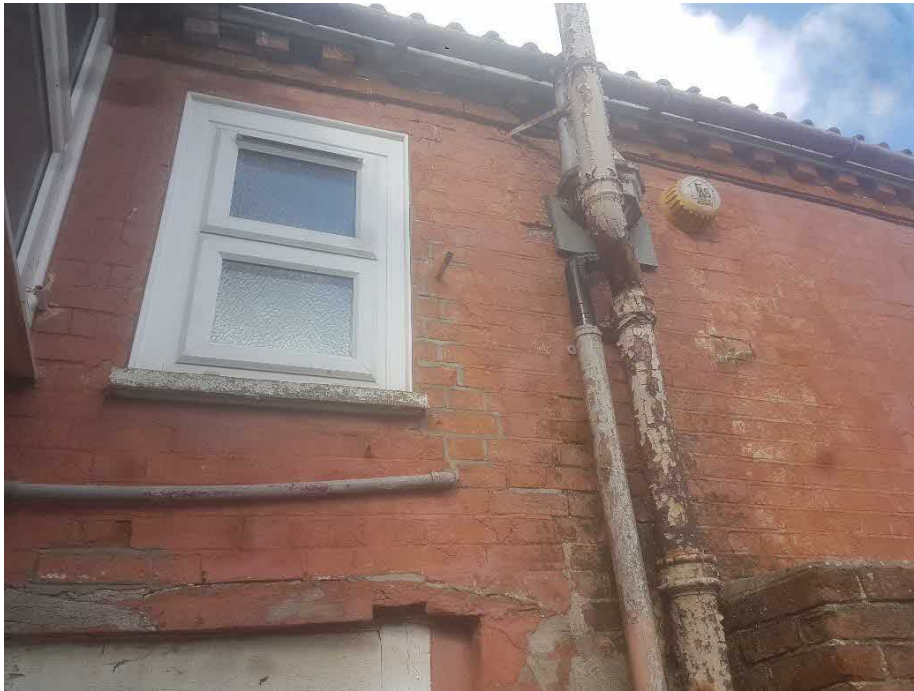
Historic wall damage and repairs are evident to middle section of the Southeastern wall. Distortion and movement are evident above the door at this location. The timber lintel over the door appears to be rotten and suffered decay. A notch is evident in the bottom of the lintel. See Photograph 4.

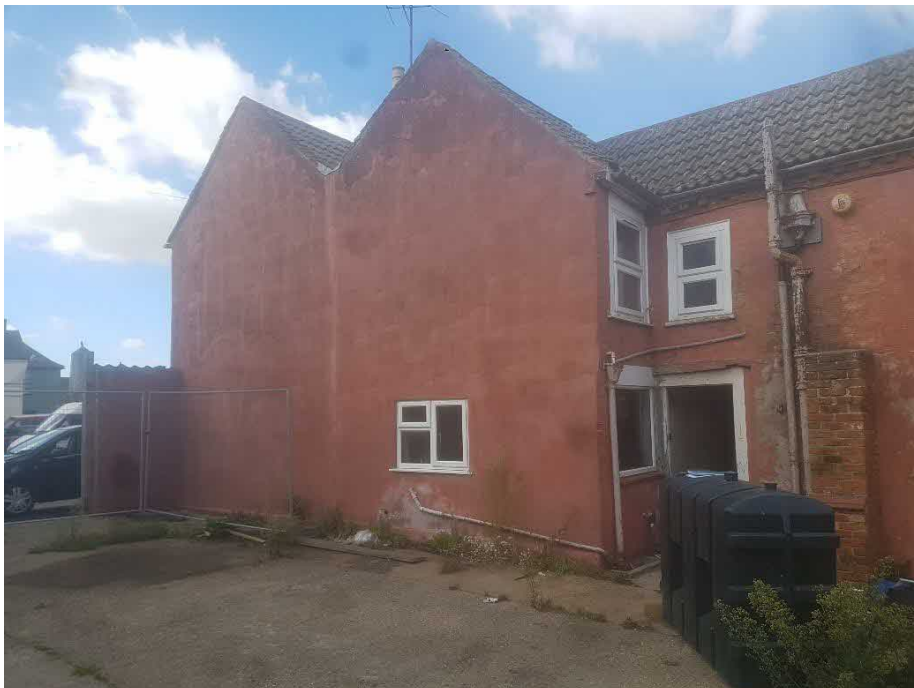
Showing Distortion and historic damage around window on Southeast elevation

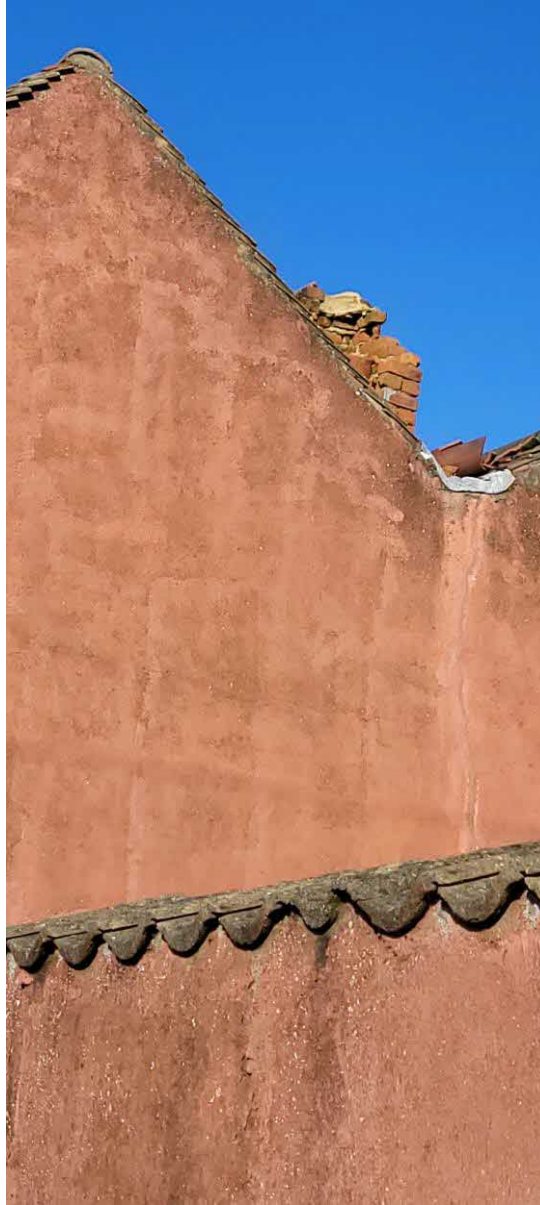
Photograph 5B
Showing partially collapsed chimney in valley.

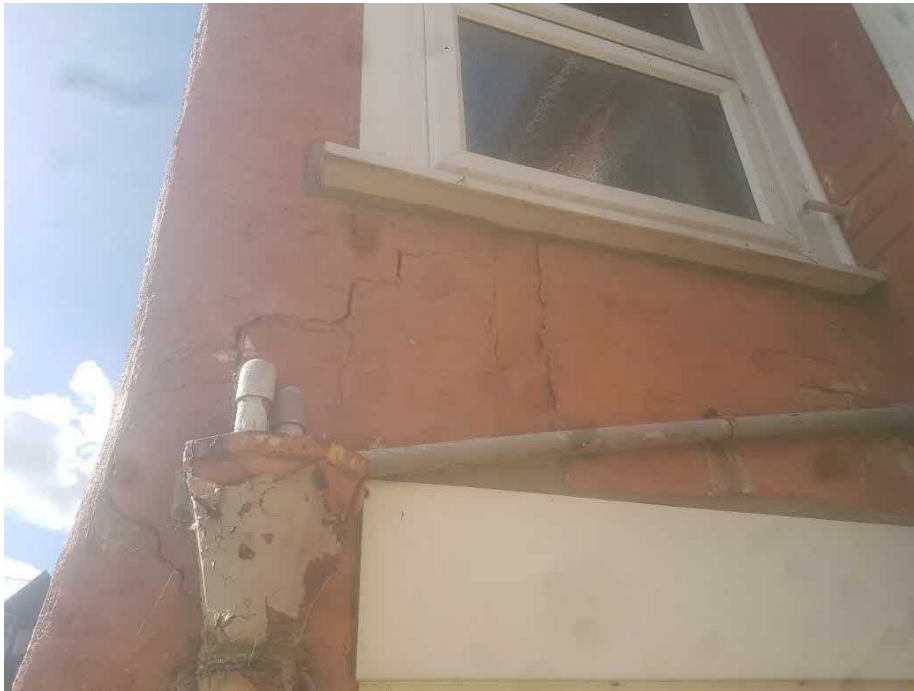
Photograph 6
Showing wall damage on Northeast Elevation

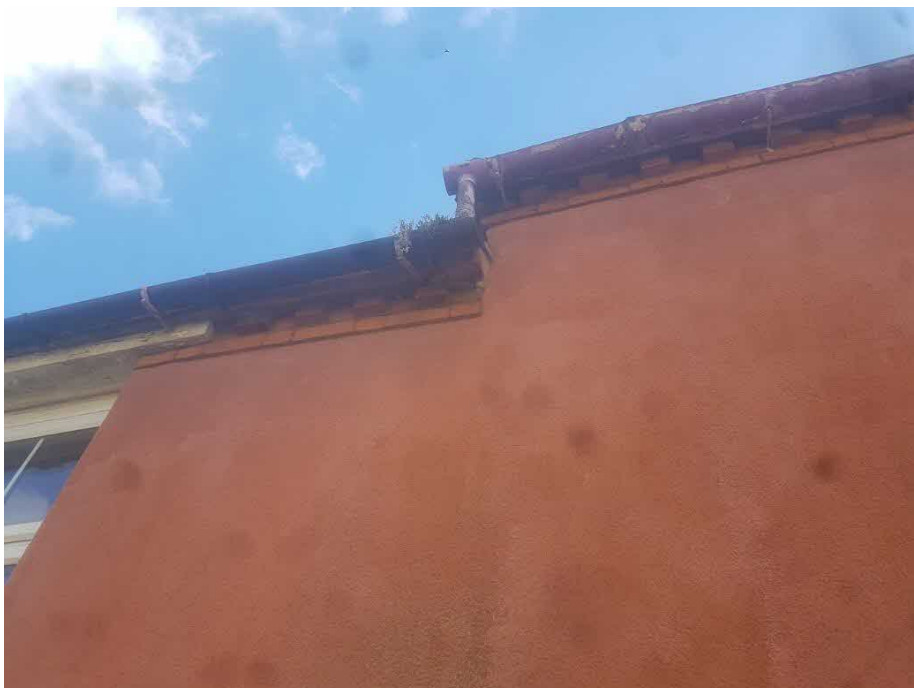
The cracking appears to be vertical and stepped diagonal in profile and would appear to be the result of structural movement. See Photograph 6 above.

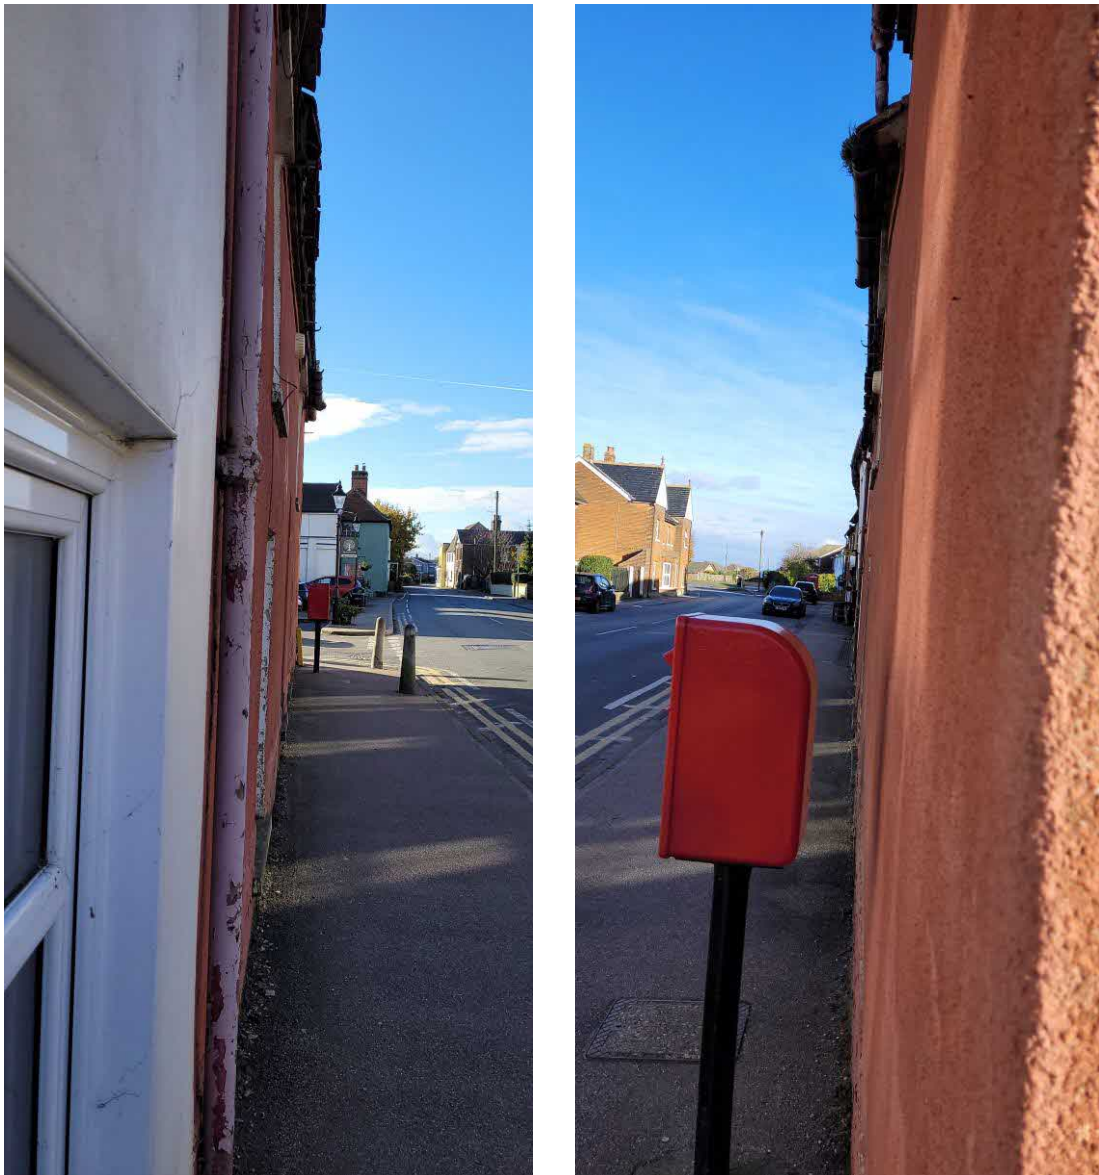
Photograph 7B & 7C
Showing leaning and bulging external wall.

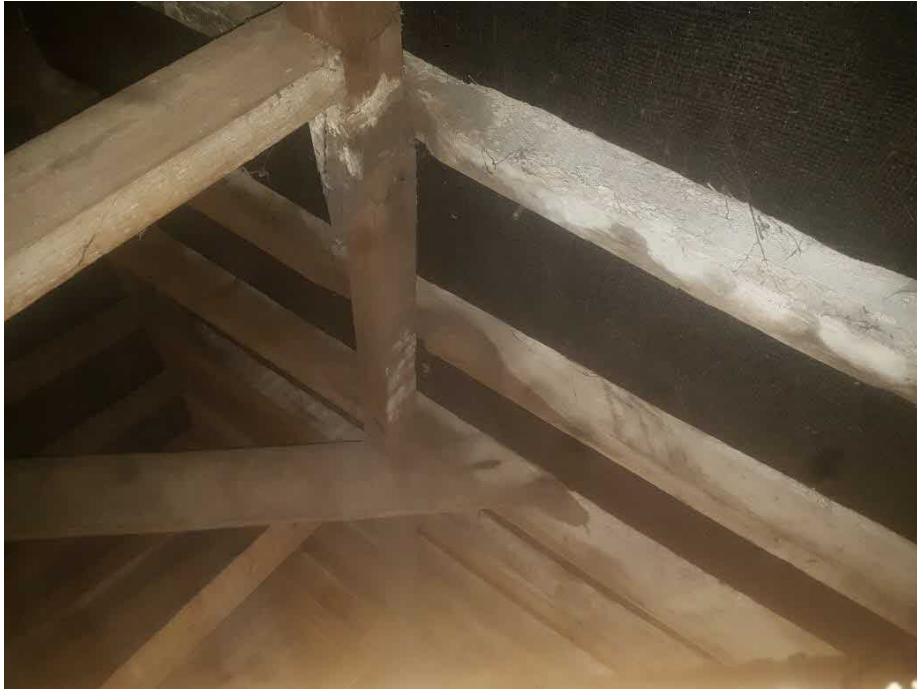
Photograph 8
Showing decaying rafters.

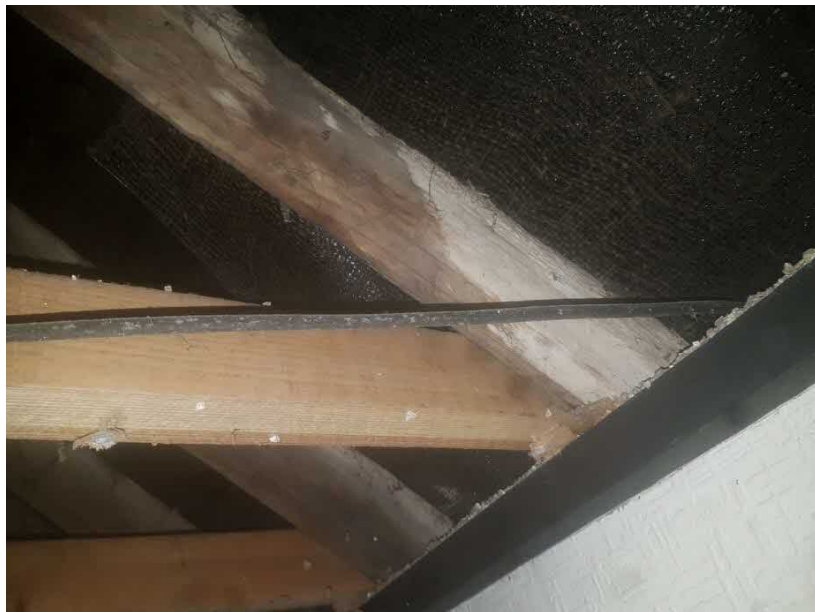
Photograph 9
Showing decaying rafters

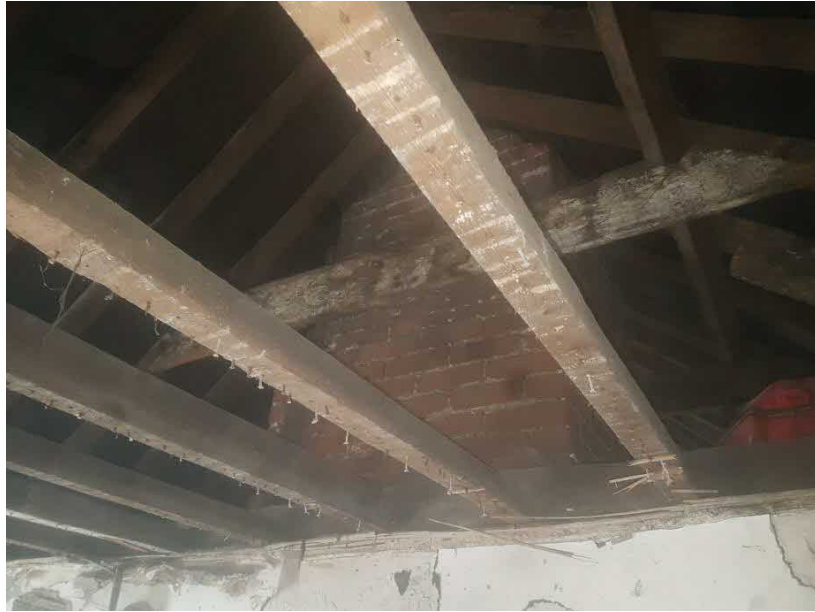
Photograph 11 A
Showing roof over Bedroom 3 & high level collar tie.

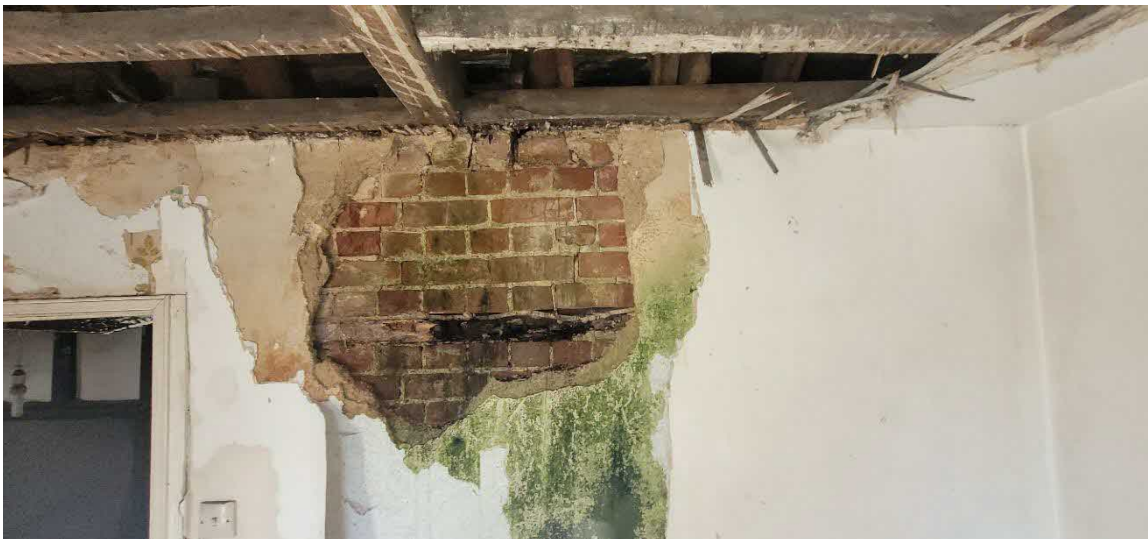
Photograph 11 B
Showing wall cracking and moisture Ingress

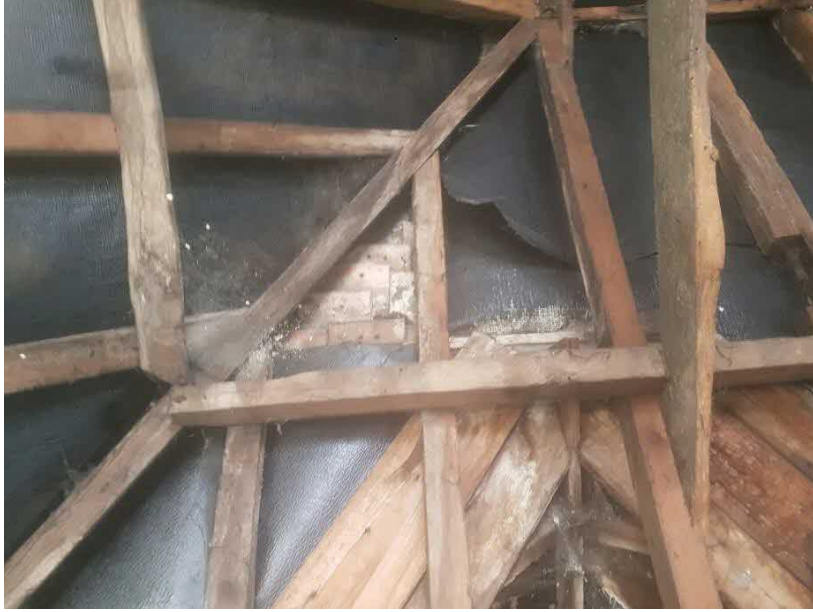
Photograph 12
Showing missing felt and rotten timbers.

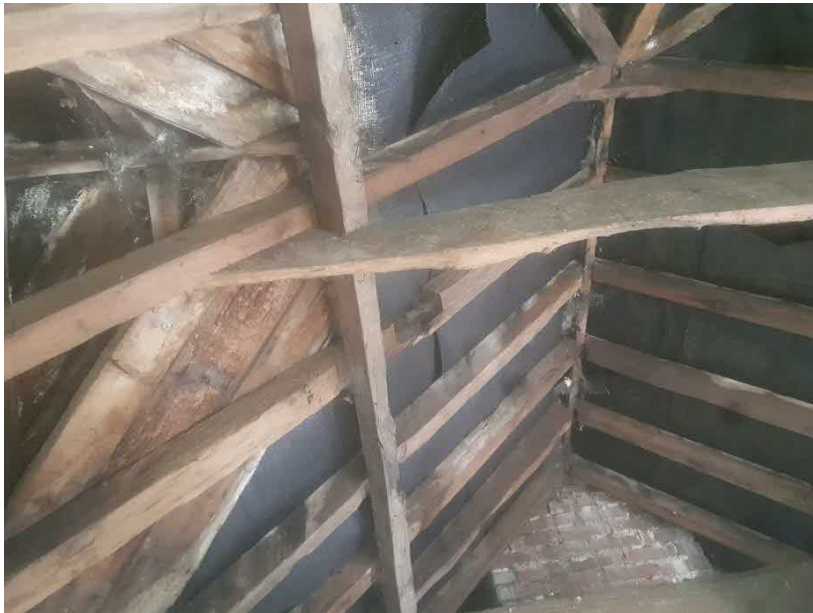
Photograph 13
Showing sagging rafters & collars

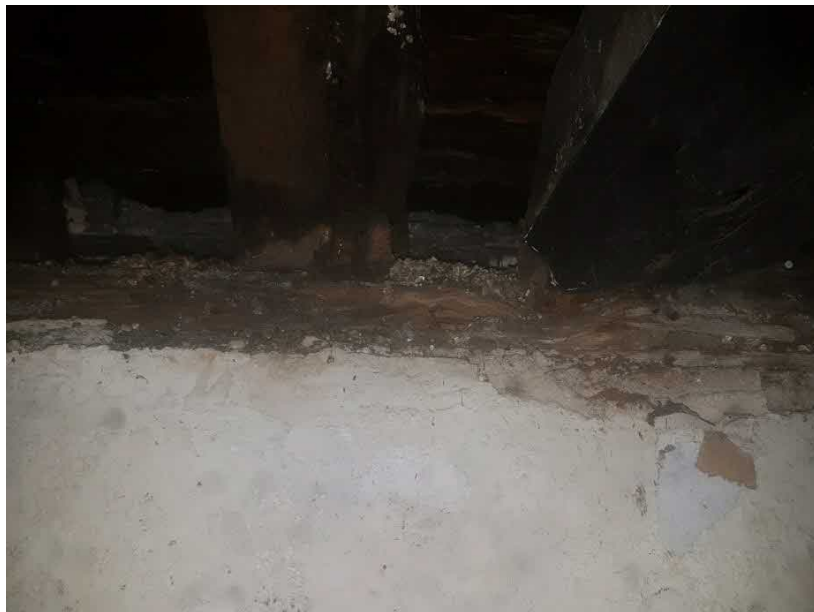
Photograph 14
Showing rotten wall plate.

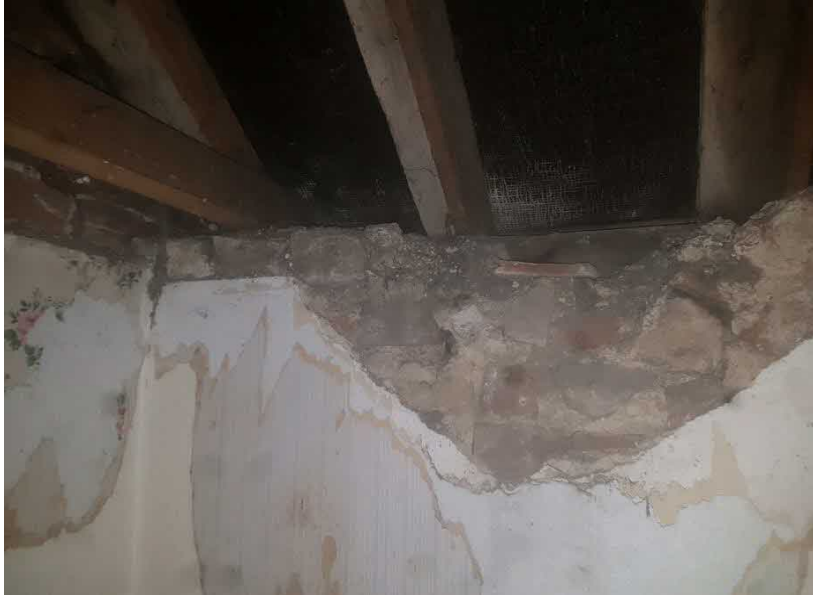
Photograph 15
Showing rotten wall plate and loose masonry.

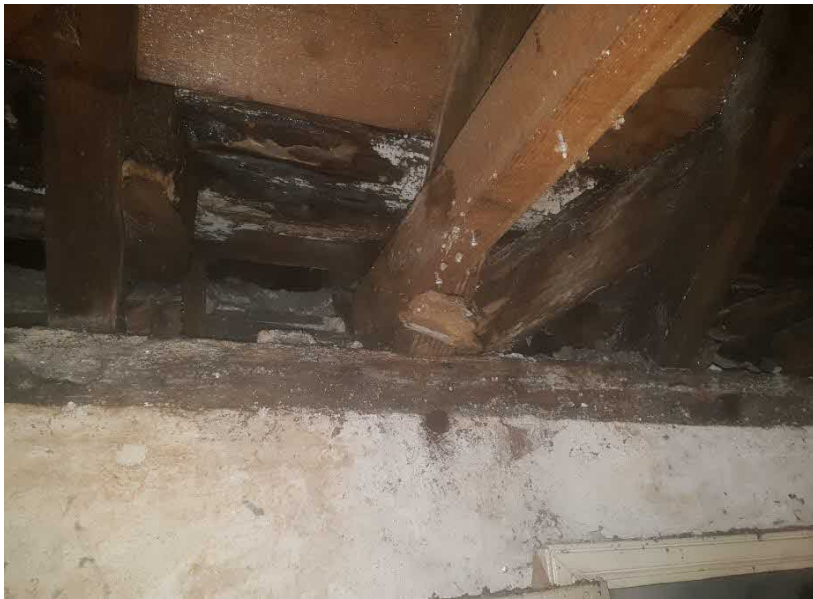
Photograph 16
Showing rotten valley boards and wall plate.

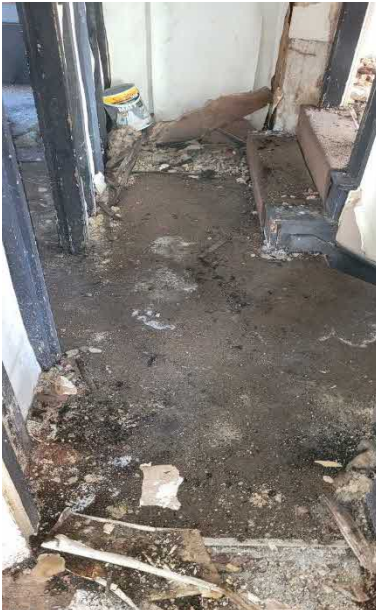
Photograph 18A.
Showing area where
Floor appears potentially
Unsafe.

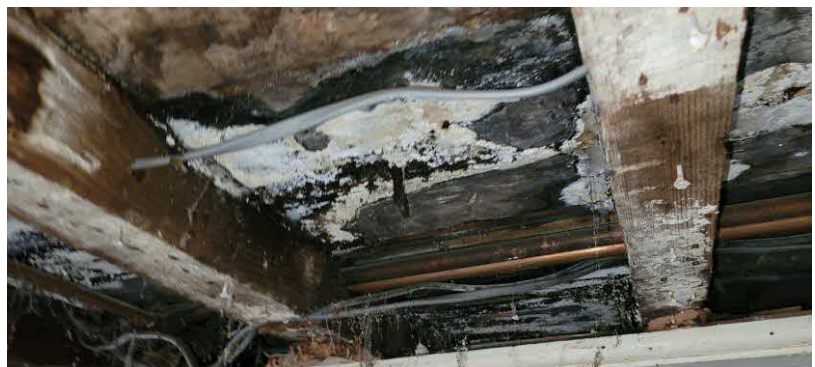
Photograph 18B.
Showing view on underside of floor joists and boards.

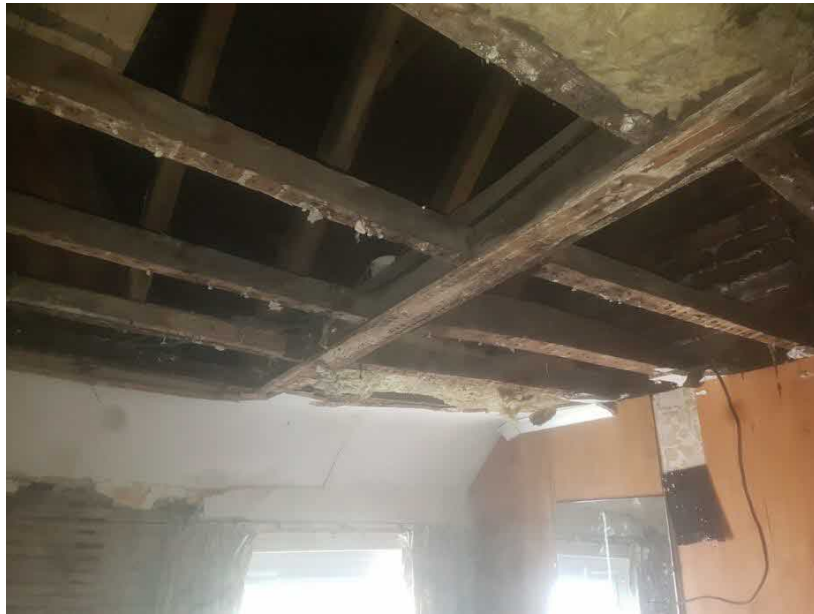
Photograph 19
Showing ceiling structure above bathroom.

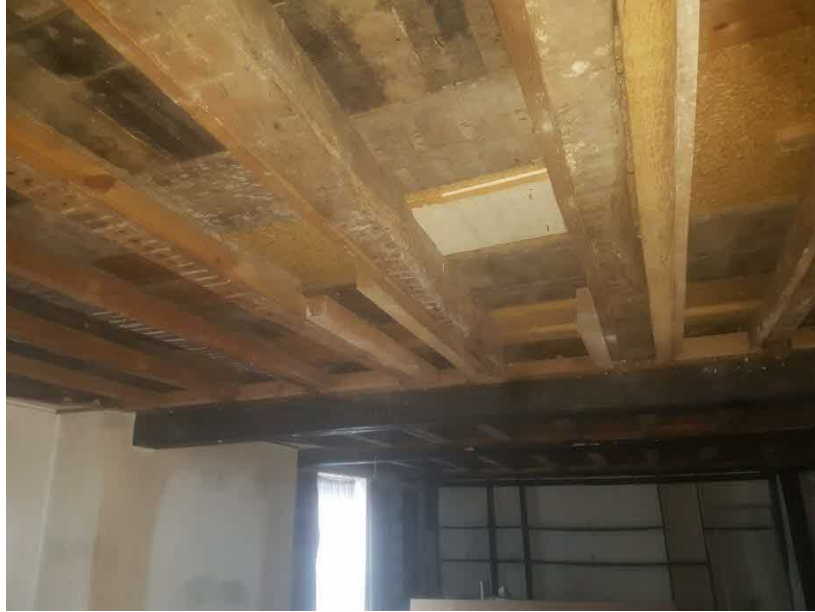
See Photographs 22A, 22B & 23.

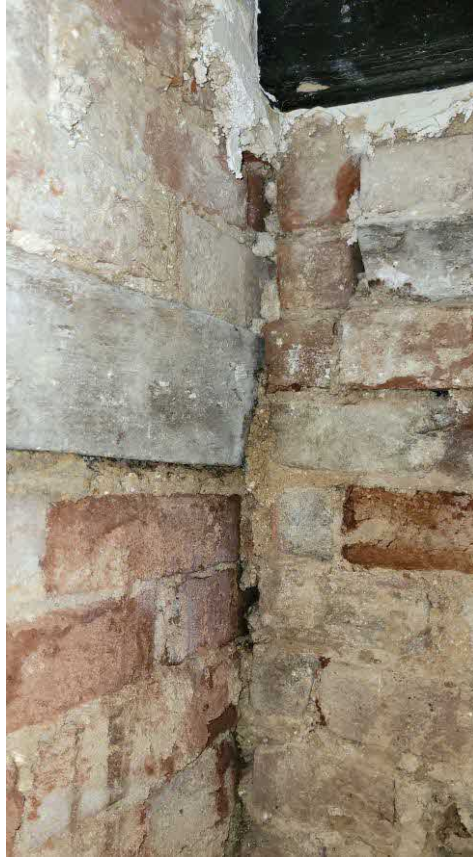
Photograph 27
Showing de-bonded masonry at internal wall junction

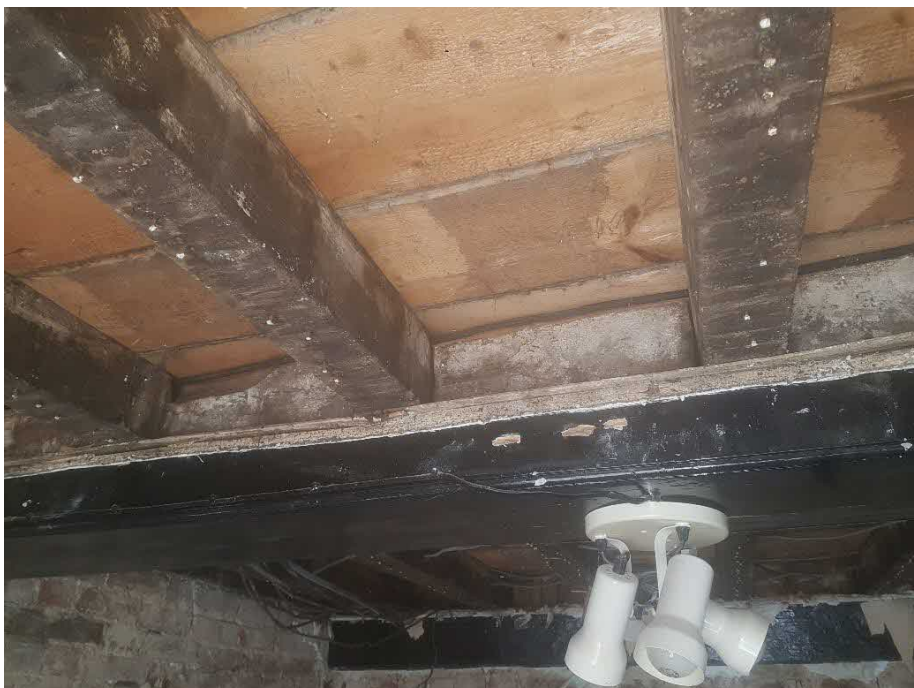
Photograph 29
Showing floor joists and central beam.

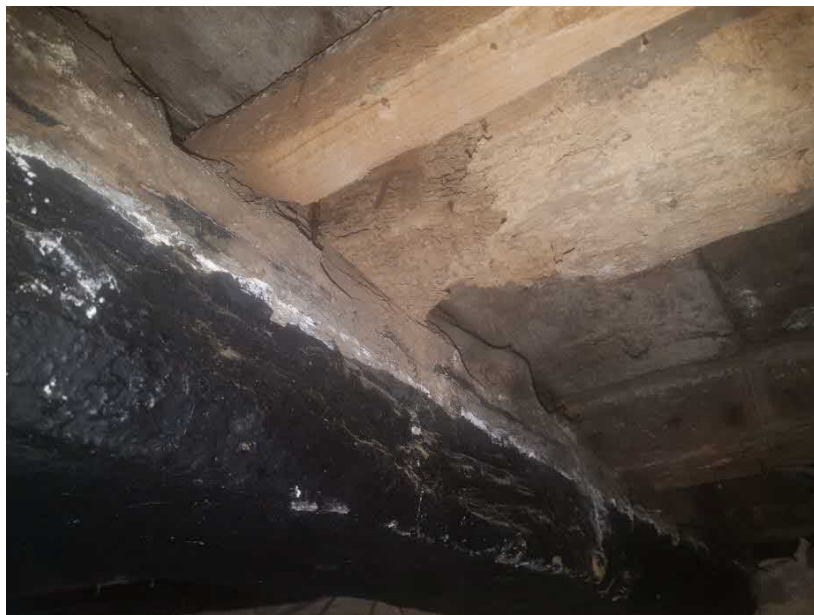
Photograph 30
Showing badly deteriorated joist and timber beam over kitchen

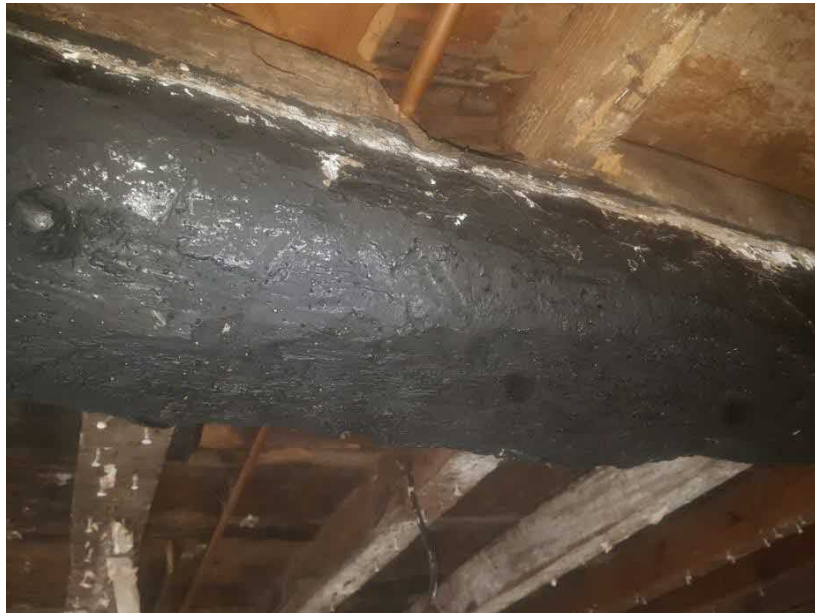
Photograph 31
Showing deep notch in timber beam
that supports the floor over the kitchen.

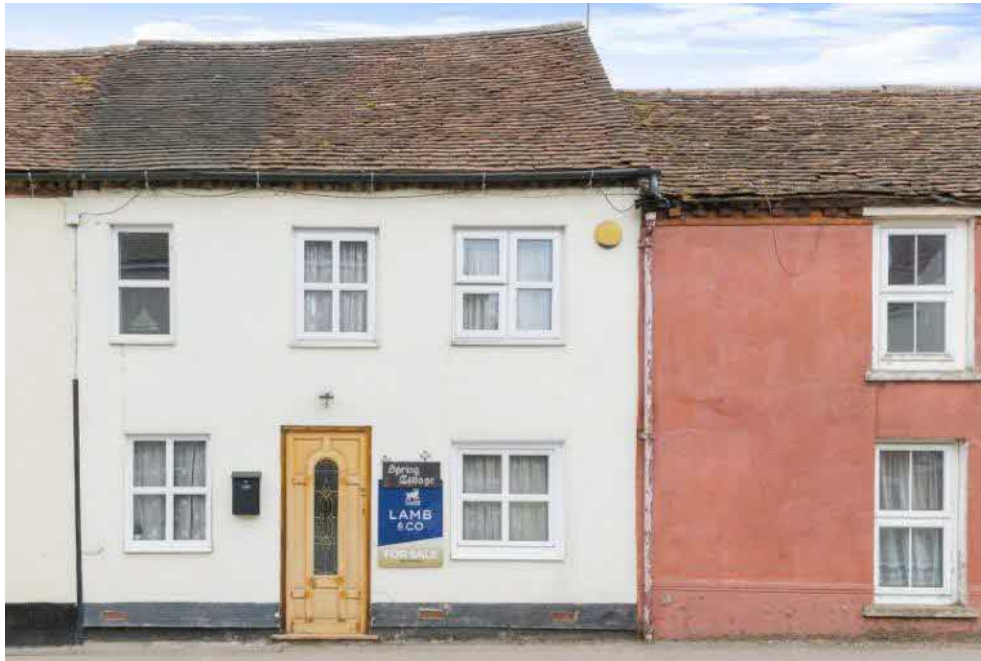
A geotechnical and foundation investigation were conducted in August 2022. This revealed that the existing building, as expected, is construction on little or no foundation. The soil conditions were found to comprise of weak, loose, and disturbed soils down to around 2.3 meters where firmer Sandy Silty clay was encountered. Any scheme of involving the retention of the building would likely require relatively deep foundations for the new and replacement elements, and this would also result in the requirement to underpin much of the existing structure, deem viable for retention. The execution of such works would be very difficult and in our opinion of high risk in terms of the stability of the existing structure and those adjacent.
