Sash Window Surveys Edinburgh

Condition Survey Report

Address:
22B Upper Gray Street
Edinburgh
EH9 1SW

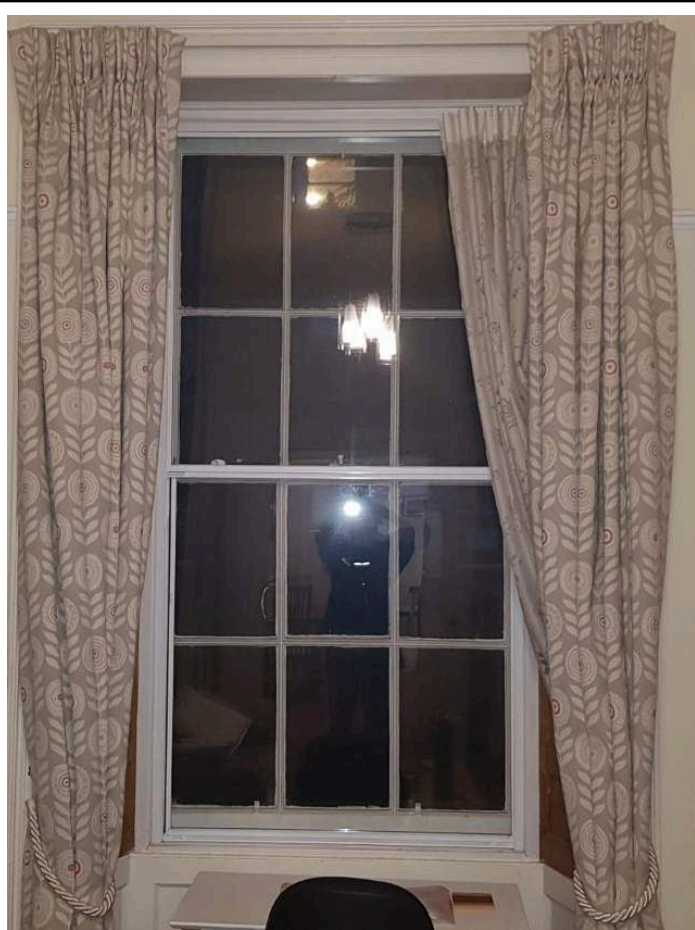
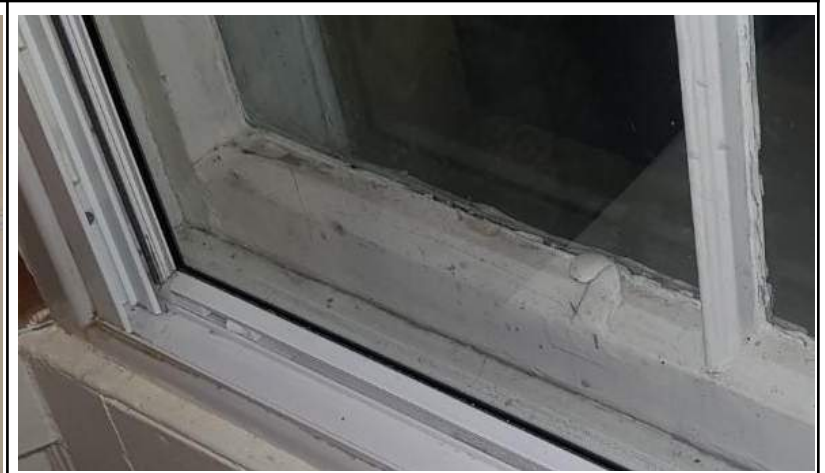
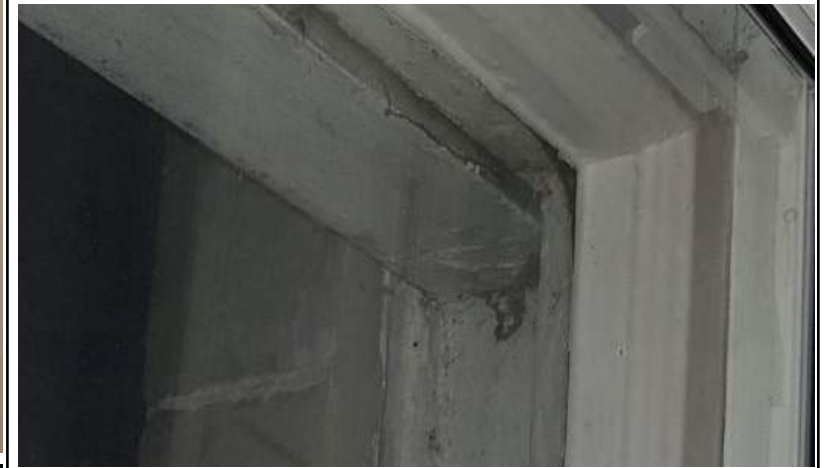
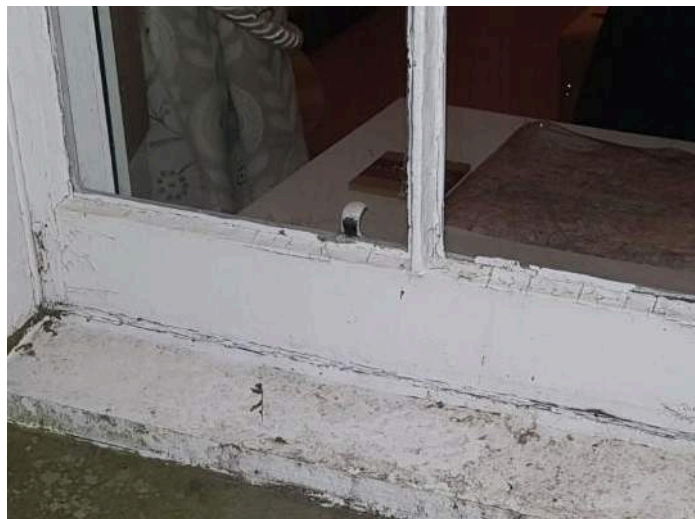
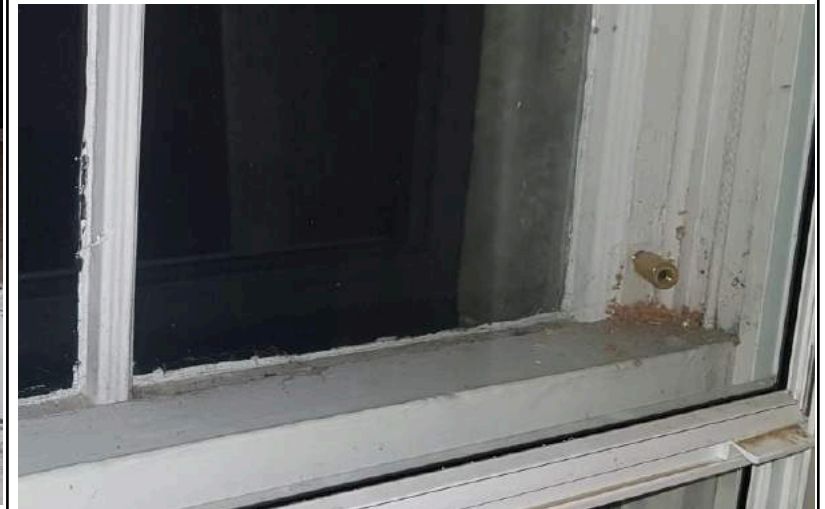
Elevation	Floor	No.	Room
Front	GF	W1	Lounge

- Windows are heavily overpainted with significant loss of internal moulding detail.
- Previous patch repairs work visible under the paint coatings
- Compromised exterior paint and putty have allowed water ingress and moisture to permeate the timbers.
- Condensation damage to the interior horizontal lying timbers with areas that have been chipped out, backfilled with putty and painted over.
- Moisture permeation of the horizontal rails and extending to the lower stiles.
- Cracking of paint along the joins is indicative of shrinkage/swelling and a weakening of the structure.
- Likely compromised join to upper sash meeting rail

Like-for-like replacement custom-fitted with Vacuum-Sealed IGUs. Replacement timber is to be Accoya.

*Case to be replaced in Accoya Timber

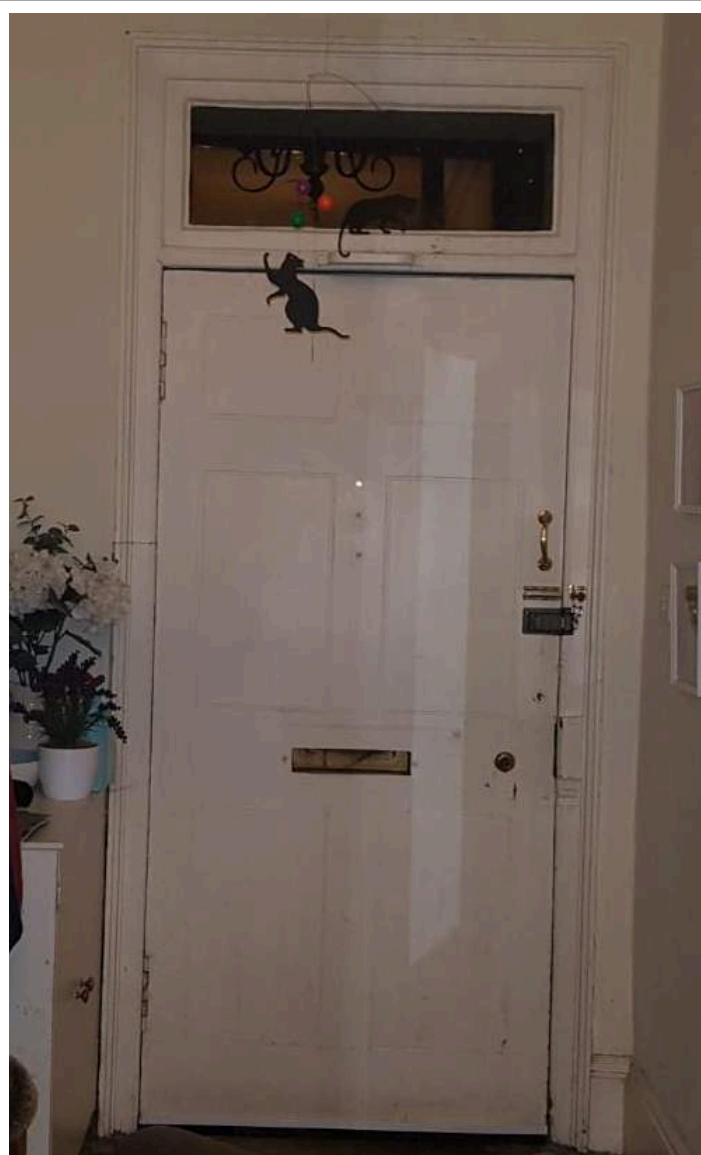
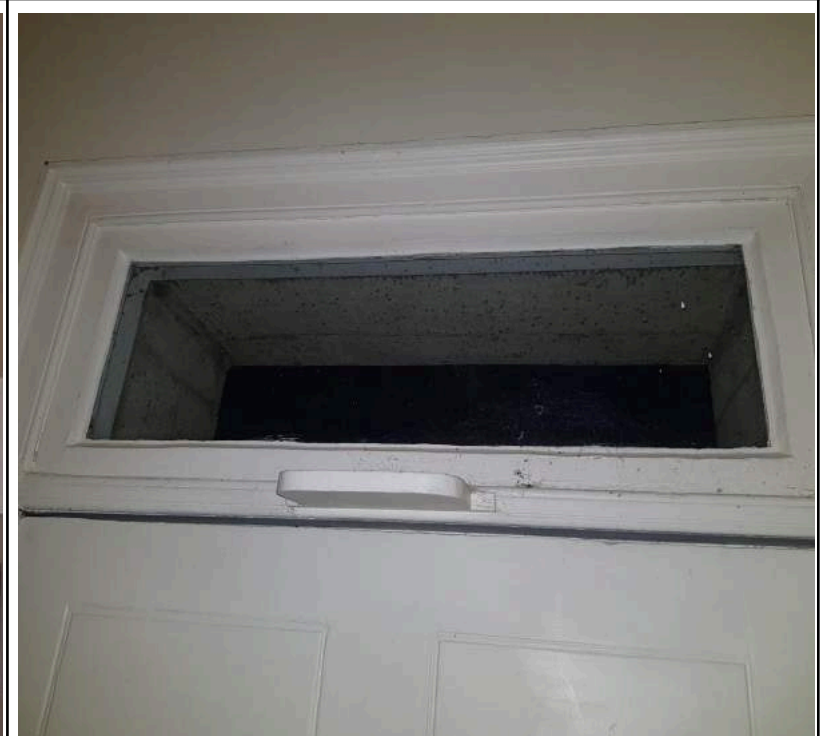
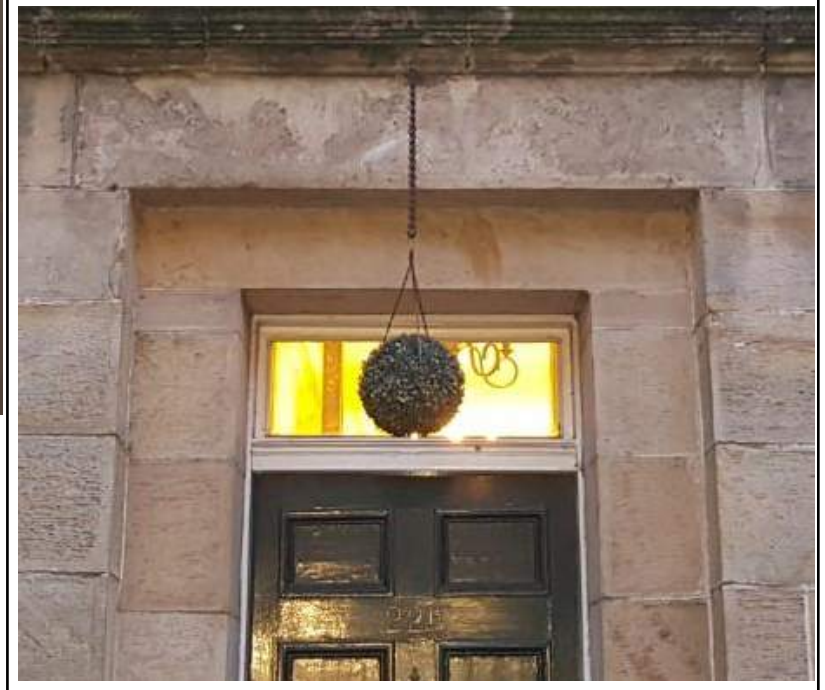
Elevation	Floor	No.	Room
Front	GF	W2	Hallway

Single Pane Fanlight

Refurbishment and Re-Glaze with Vacuum-Sealed IGUs

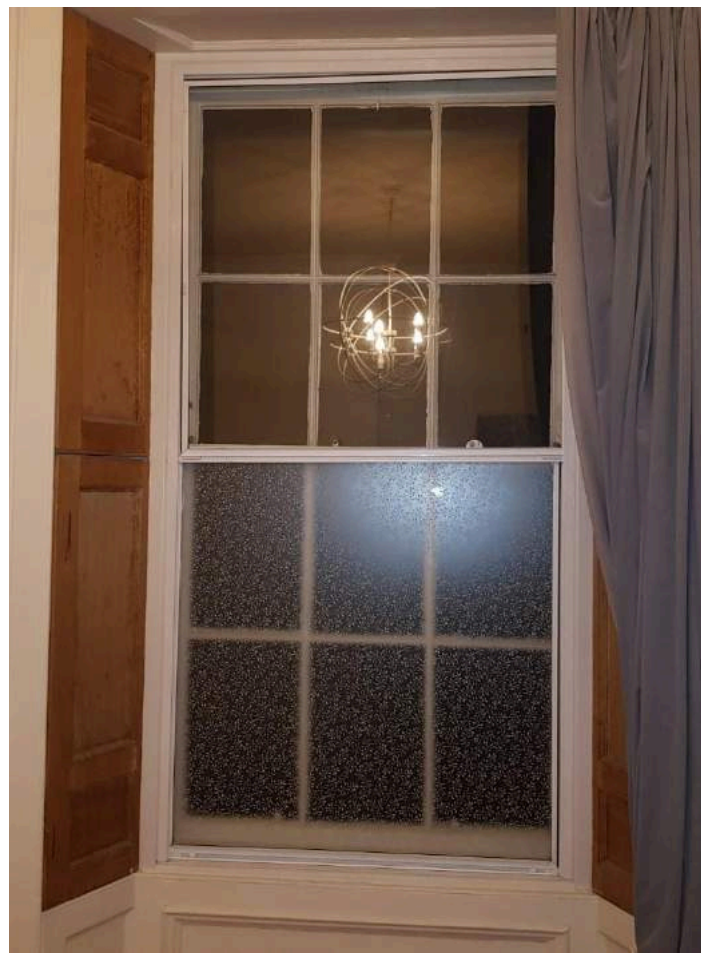
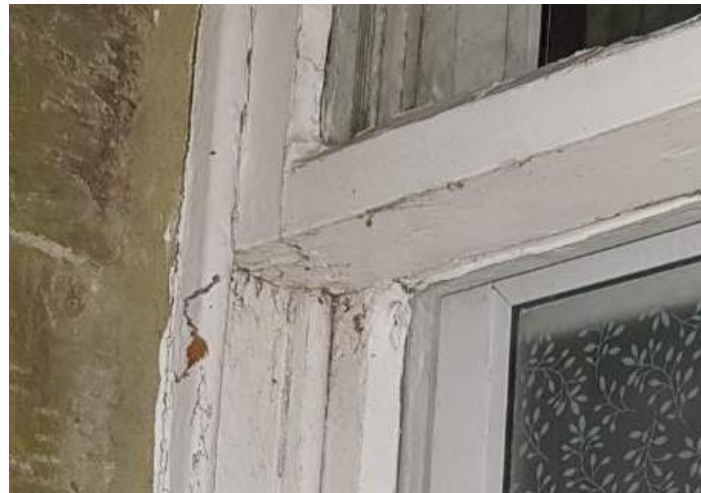
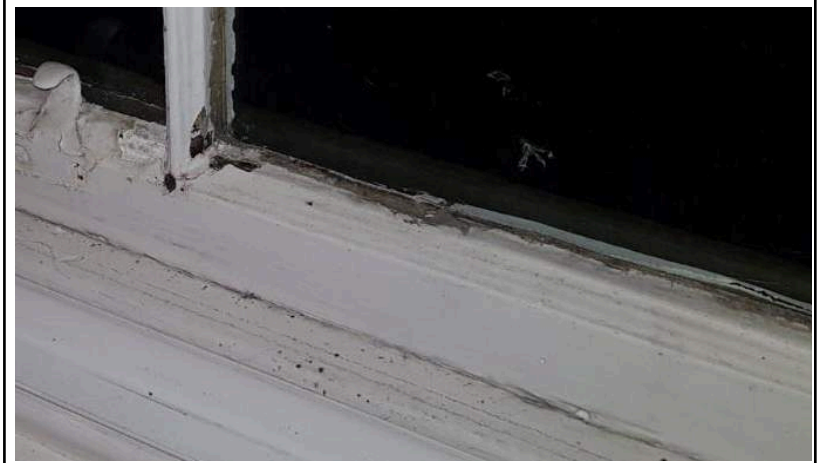
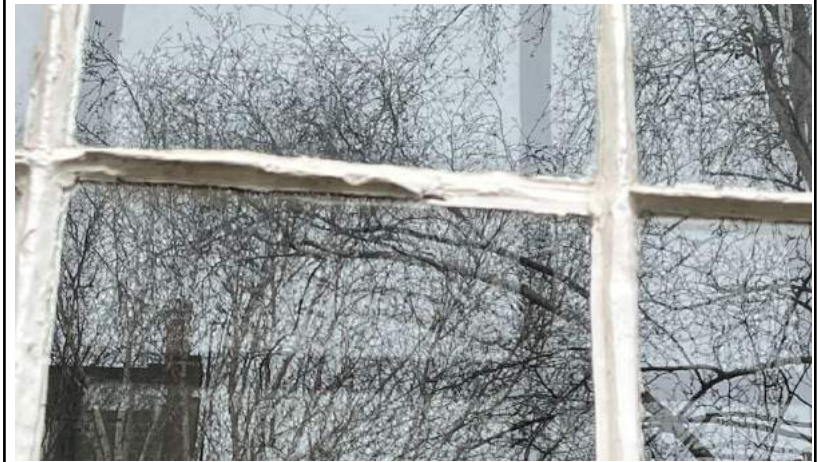
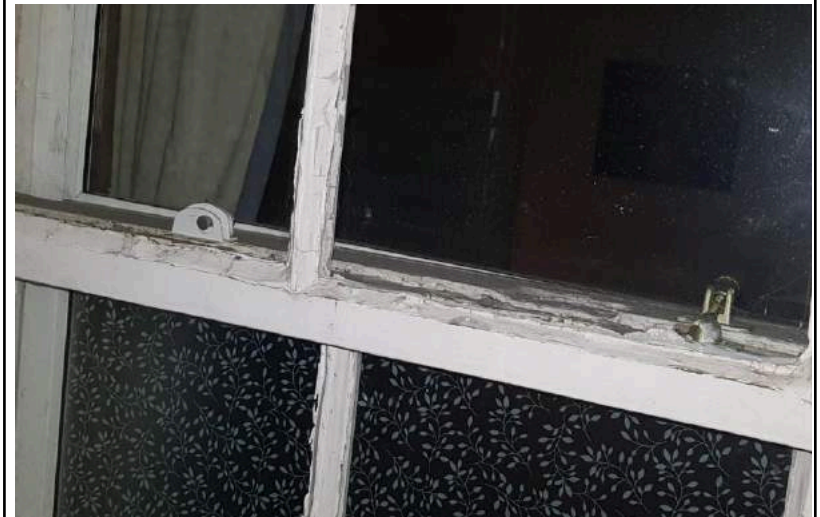
Elevation	Floor	No.	Room
Front	GF	W3	Front Bed

- Windows are heavily overpainted with significant loss of internal moulding detail.
- Previous patch repairs work visible under the paint coatings
- Compromised exterior paint and putty have allowed water ingress and moisture to permeate the timbers.
- Heavy condensation damage to the interior horizontal lying timbers with areas that have been chipped out, backfilled with putty and painted over.
- Previous re-glazing work has been undertaken. This is a destructive process which often leads to timber portions breaking off from the astragals. See photo to the right
- Moisture permeation of the horizontal rails and extending to the lower stiles.
- Cracking of paint along the joints is indicative of shrinkage/swelling and a weakening of the structure.
- Likely compromised joint to upper sash meeting rail

Like-for-like replacement custom-fitted with Vacuum-Sealed IGUs. Replacement timber is to be Accoya.

*Case to be replaced in Accoya Timber

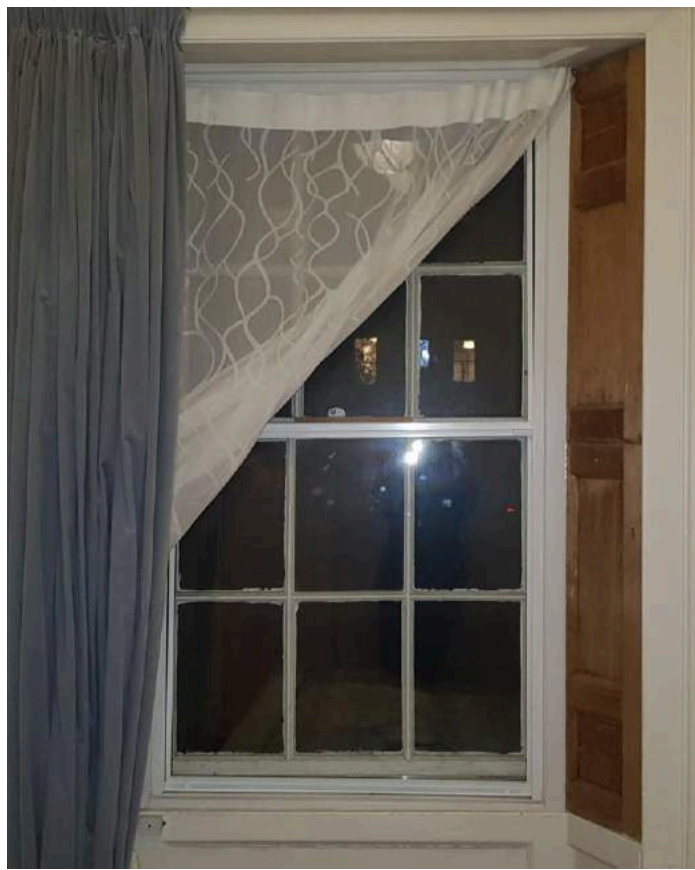
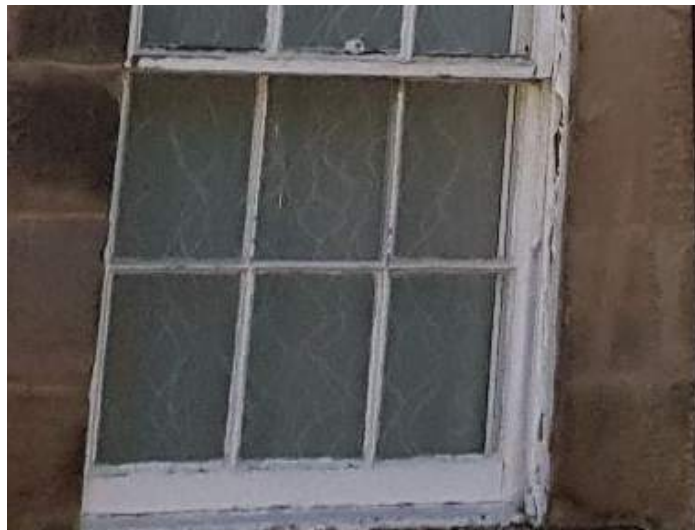
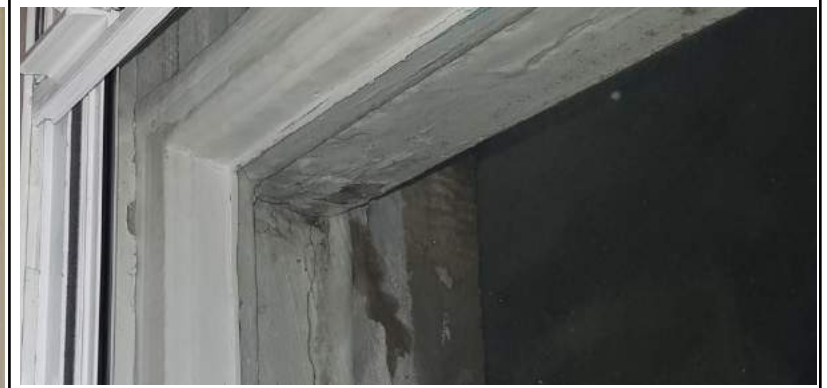
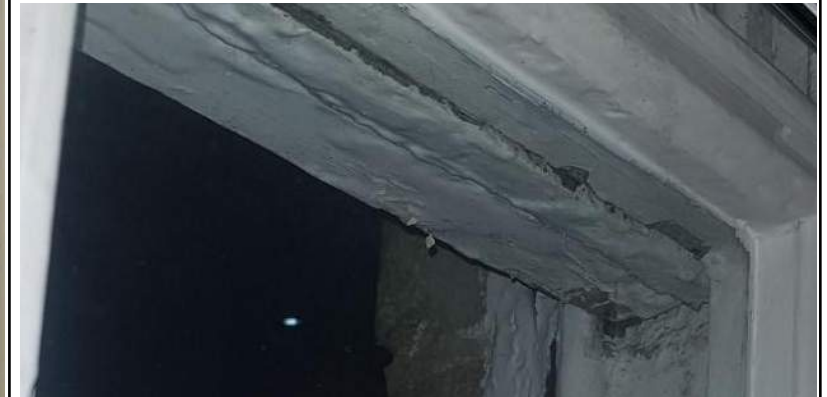
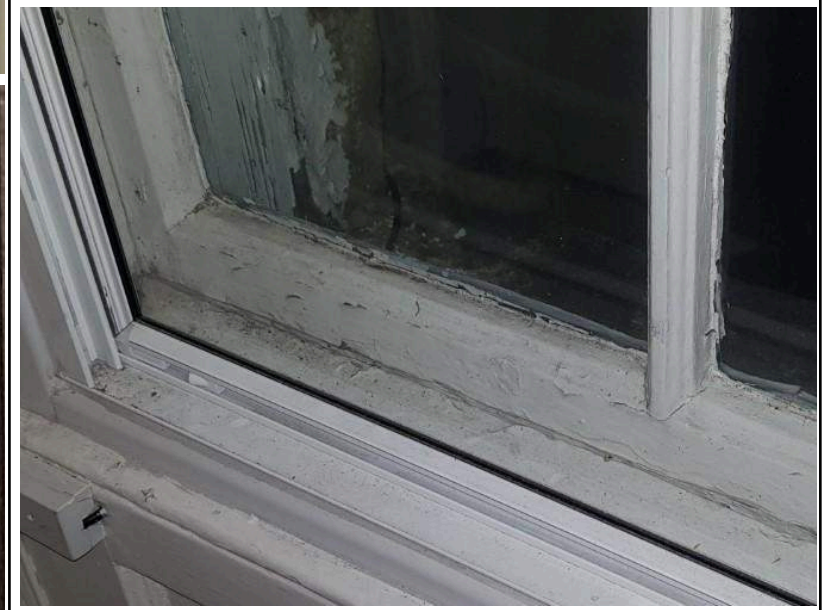
Elevation	Floor	No.	Room
Rear	GF	W4	Rear Bed

- Windows are heavily overpainted with significant loss of internal moulding detail.
- Previous patch repairs work visible under the paint coatings
- Compromised exterior paint and putty have allowed water ingress and moisture to permeate the timbers.
- Heavy condensation damage to the interior horizontal lying timbers with areas that have been chipped out, backfilled with putty and painted over.
- All lower-lying horizontal rails have been fully saturated with moisture.
- Both upper sash meeting rail joints are compromised.
- Cracking of paint along the joins is indicative of shrinkage/swelling and a weakening of the structure.
- External sand mastic has been painted over, trapping moisture towards the case timbers, and hastening deterioration.

Like-for-like replacement custom-fitted with Vacuum-Sealed IGUs. Replacement timber is to be Accoya.

*Case to be replaced in Accoya Timber

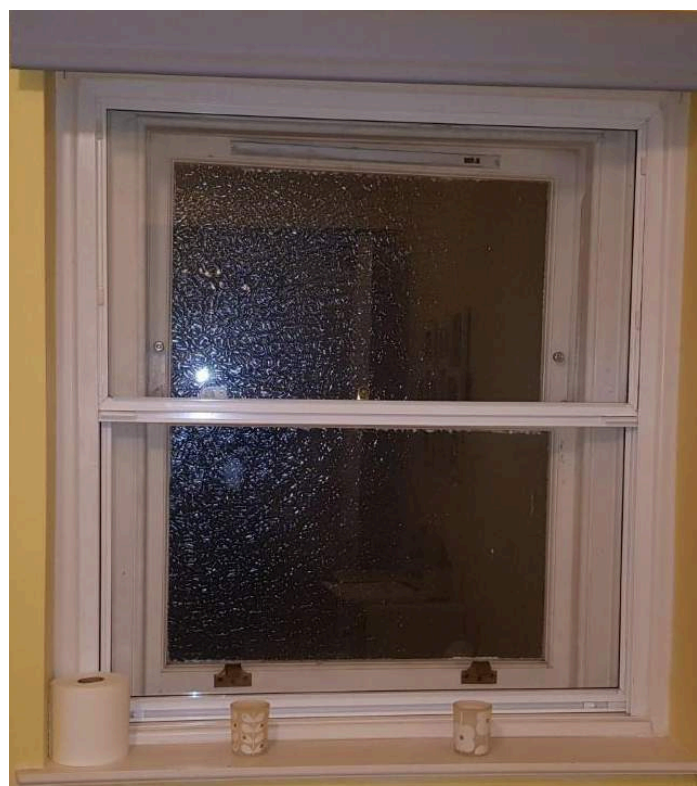
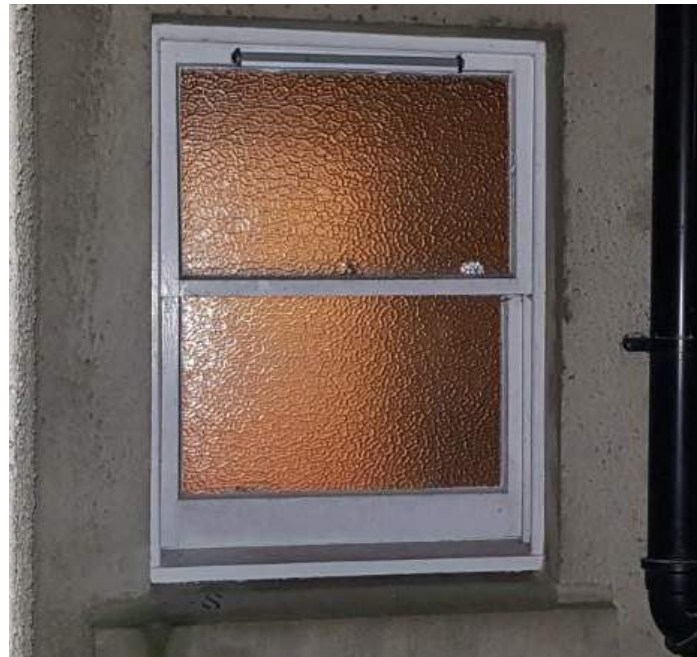
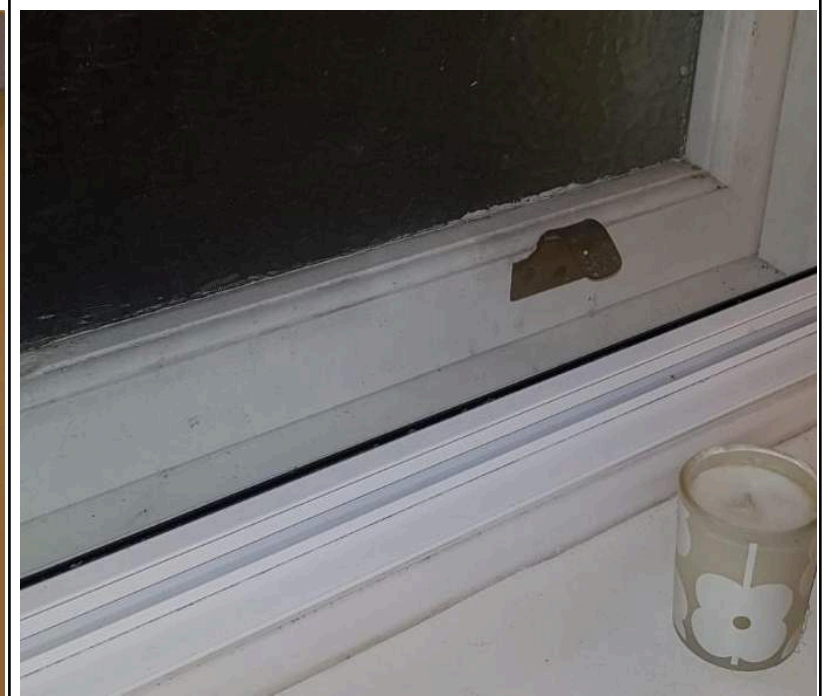
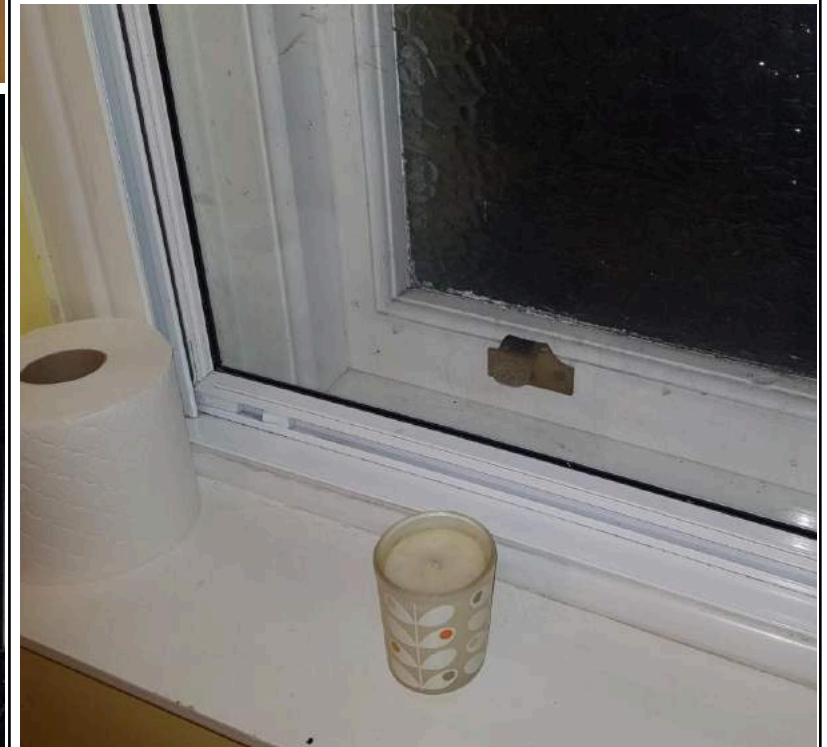
Elevation	Floor	No.	Room
Rear	GF	W5	Bathroom

- Sashes are Non-Historical and of more recent construction, likely fitted during renovation works
- The bathroom area is part of a 20th Century extension.
- Moulding detail is sharp and well-defined, indicative of fewer paint coatings
- Lack of general wear-and-tear indicates newer sashes

Refurbishment and Re-Glaze with Vacuum-Sealed IGUs

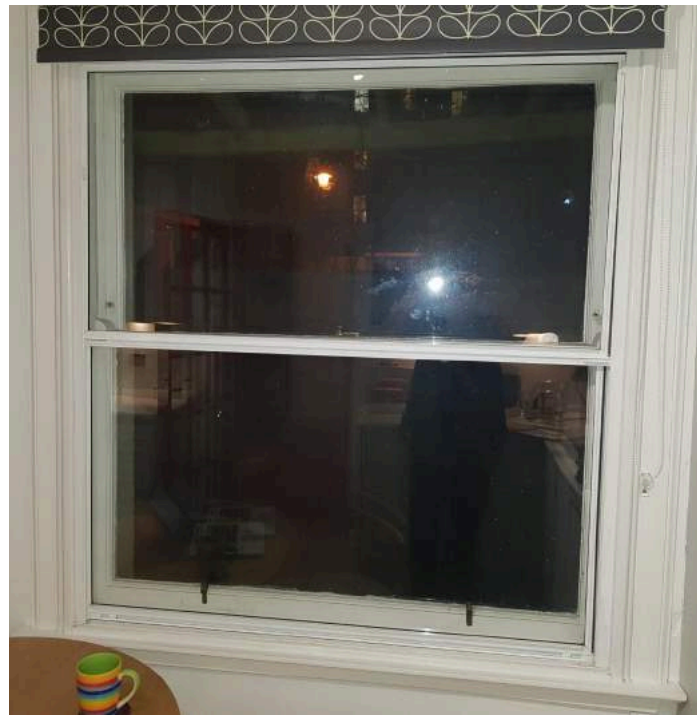
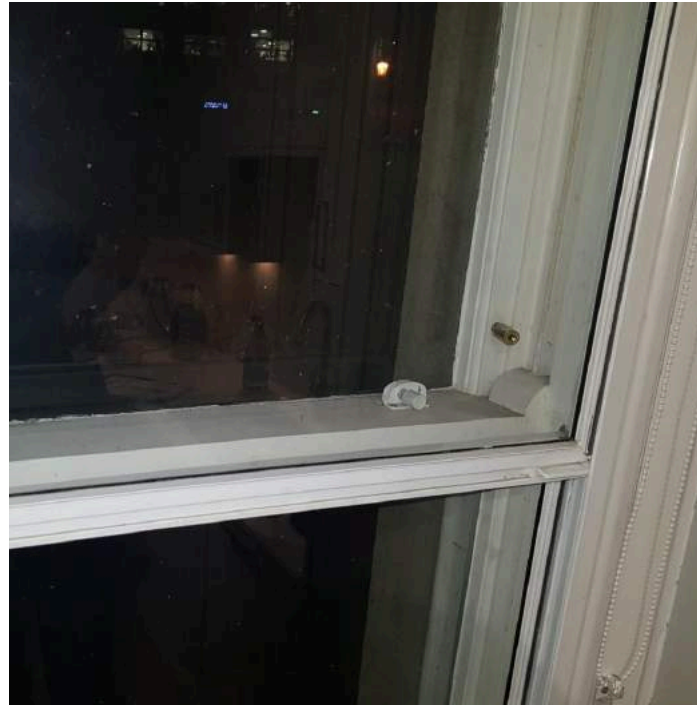
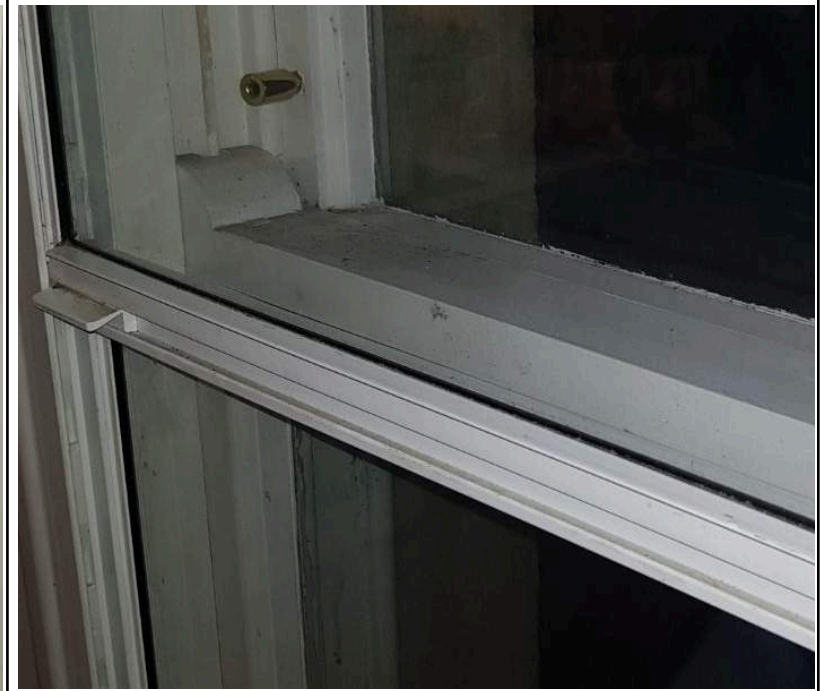
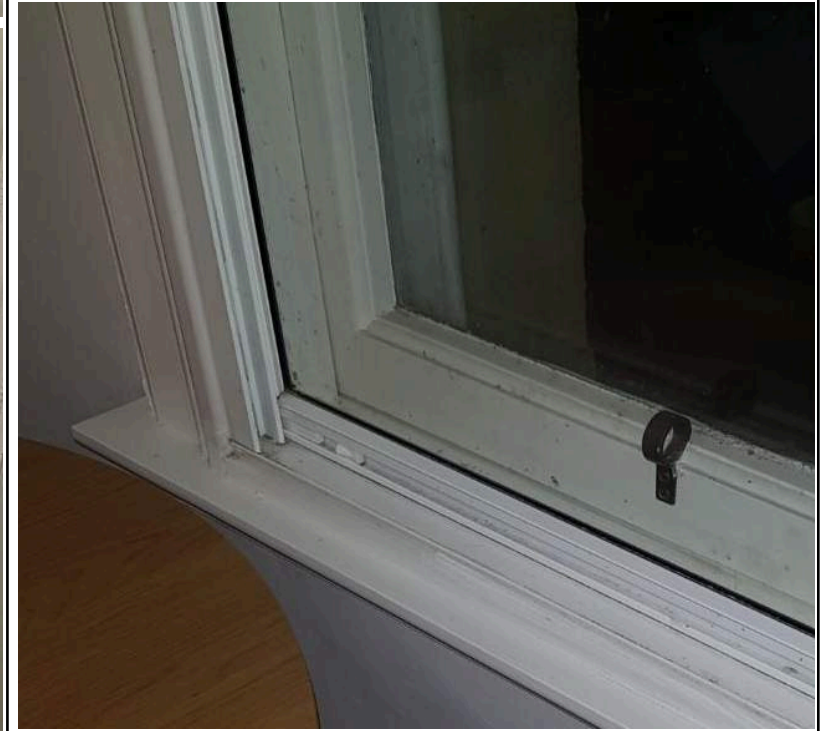
Elevation	Floor	No.	Room
Rear	GF	W6	Kitchen

- Sashes are Non-Historical and of more recent construction, likely fitted during renovation works
- The kitchen area is part of a 20th Century extension.
- Moulding detail is sharp and well-defined, indicative of fewer paint coatings
- Lack of general wear-and-tear indicates newer sashes

Refurbishment and Re-Glaze with Vacuum-Sealed IGUs

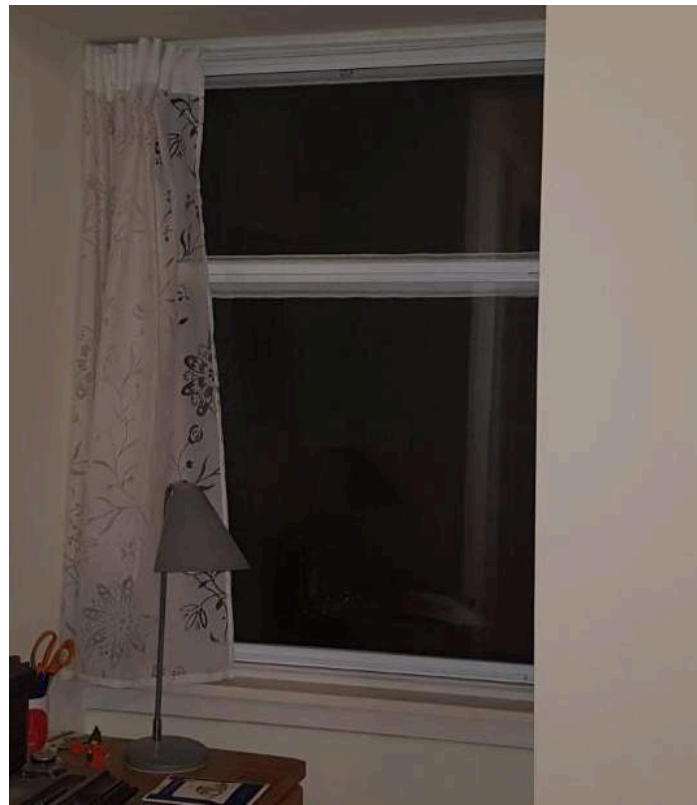
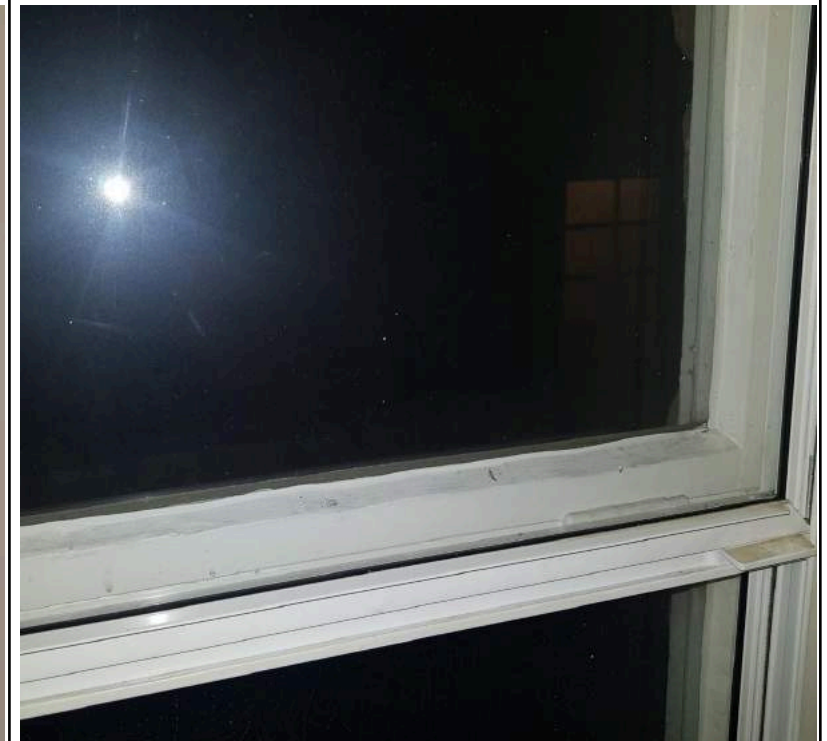
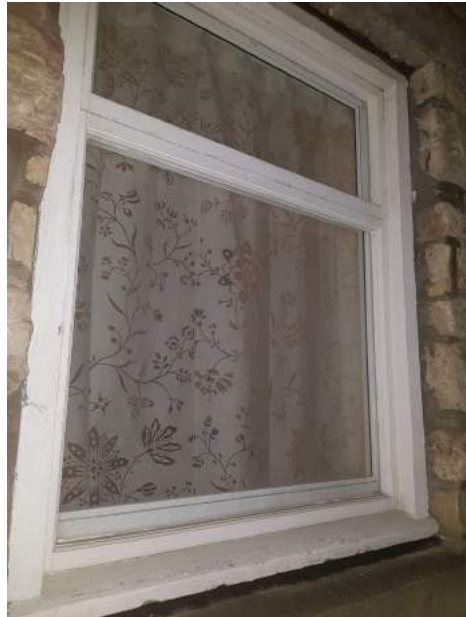
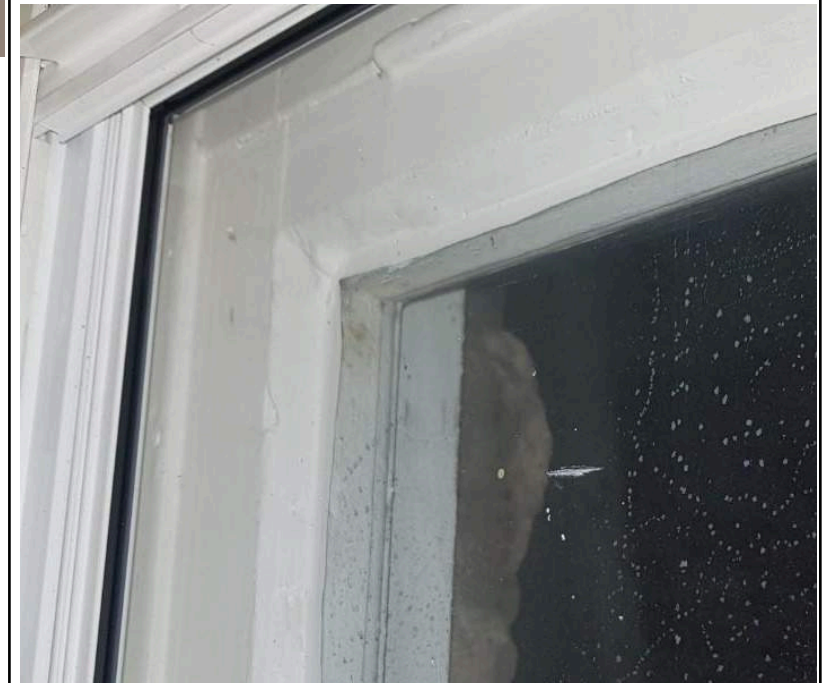
Elevation	Floor	No.	Room
Side	GF	W7	Dining Room

- Sashes are Non-Historical and of more recent construction, likely fitted during renovation works
- Moulding detail is sharp and well-defined, indicative of fewer paint coatings
- Lack of general wear-and-tear indicates newer sashes

*NOTE: This window appears to have been fitted with the putty to the inside. I recommend that the contractor explore options to reverse the window at the time of work.

Like-for-like replacement custom-fitted with
Vacuum-Sealed IGUs

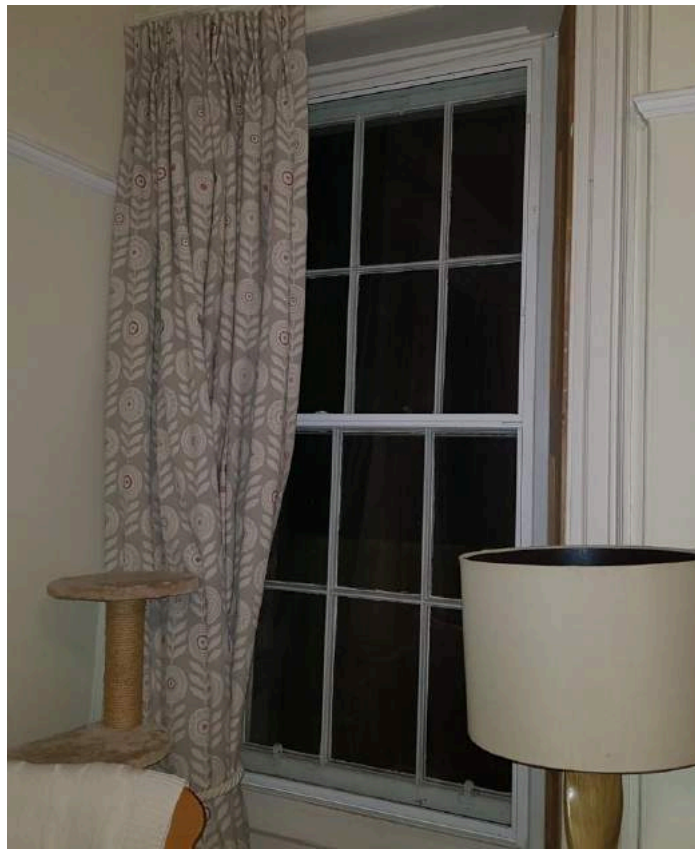
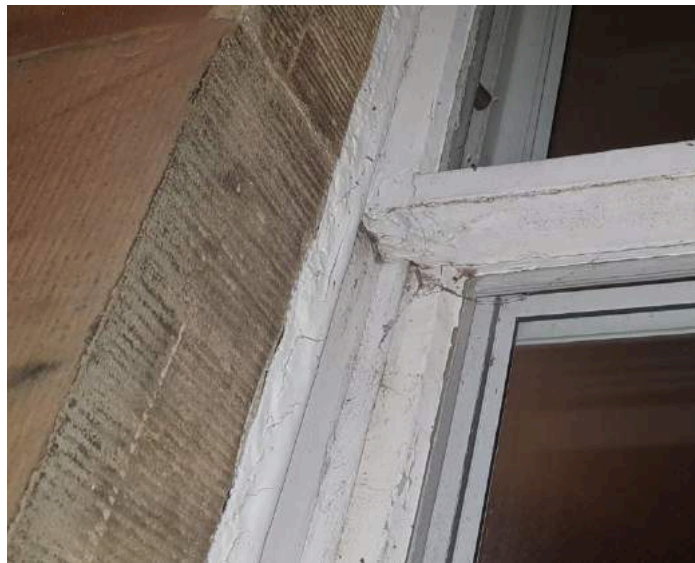
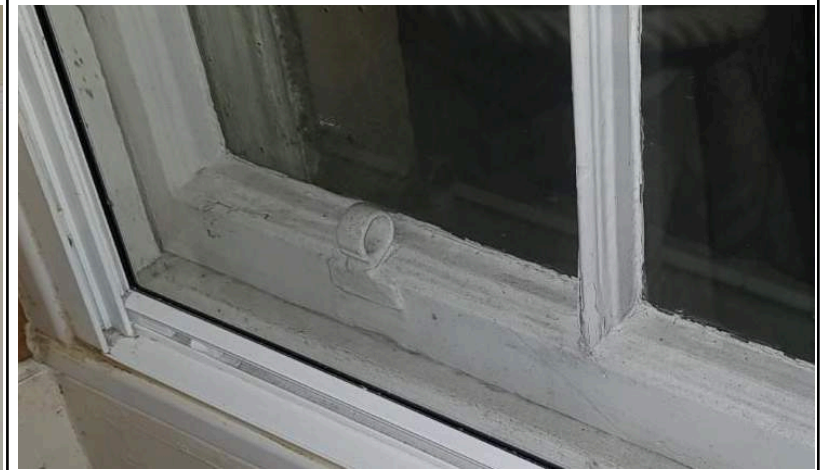
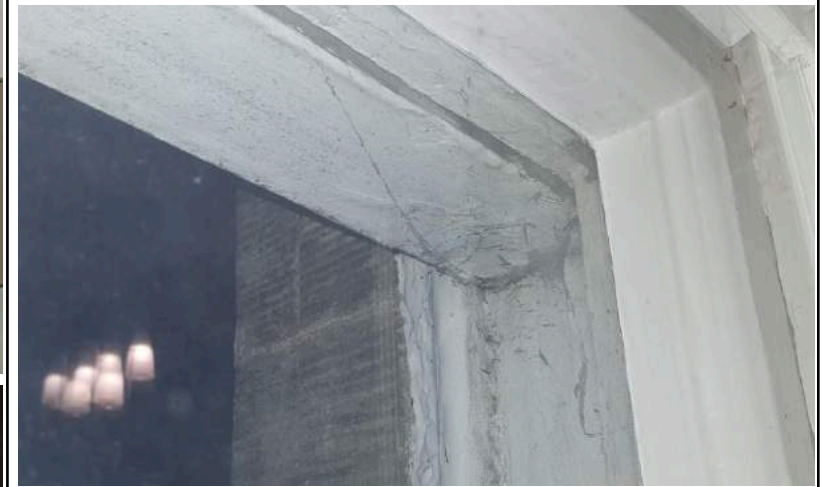
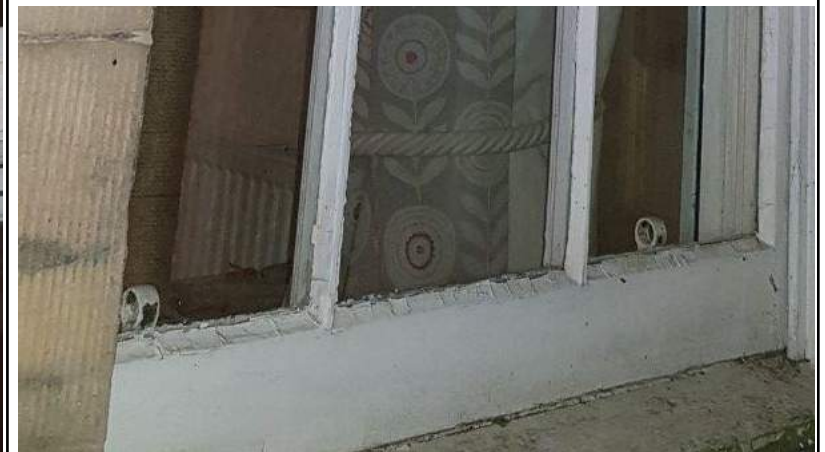
Elevation	Floor	No.	Room
Side	GF	W8	Lounge

- Windows are heavily overpainted with significant loss of internal moulding detail.
- Previous patch repairs work visible under the paint coatings
- Compromised exterior paint and putty have allowed water ingress and moisture to permeate the timbers.
- Heavy condensation damage to the interior horizontal lying timbers with areas that have been chipped out, backfilled with putty and painted over.
- Moisture permeation of the horizontal rails and extending to the lower stiles.
- Cracking of paint along the joins is indicative of shrinkage/swelling and a weakening of the structure.
- Compromised join to upper sash meeting rail.
- External sand mastic has been painted over, trapping moisture towards the case timbers, and hastening deterioration.

Like-for-like replacement custom-fitted with Vacuum-Sealed IGUs

*Case to be replaced in Accoya Timber
