**Tree Condition Report
Arboricultural Impact Assessment
Tree Protection Plan and Method Statement**

Land at Aston Hall, Aston Munslow, Shropshire

AIA Full (4th Iteration) 12.12.2022 (Change to development boundary and drive construction method)

16.2.2024 Revision to realign the new driveway corner section.

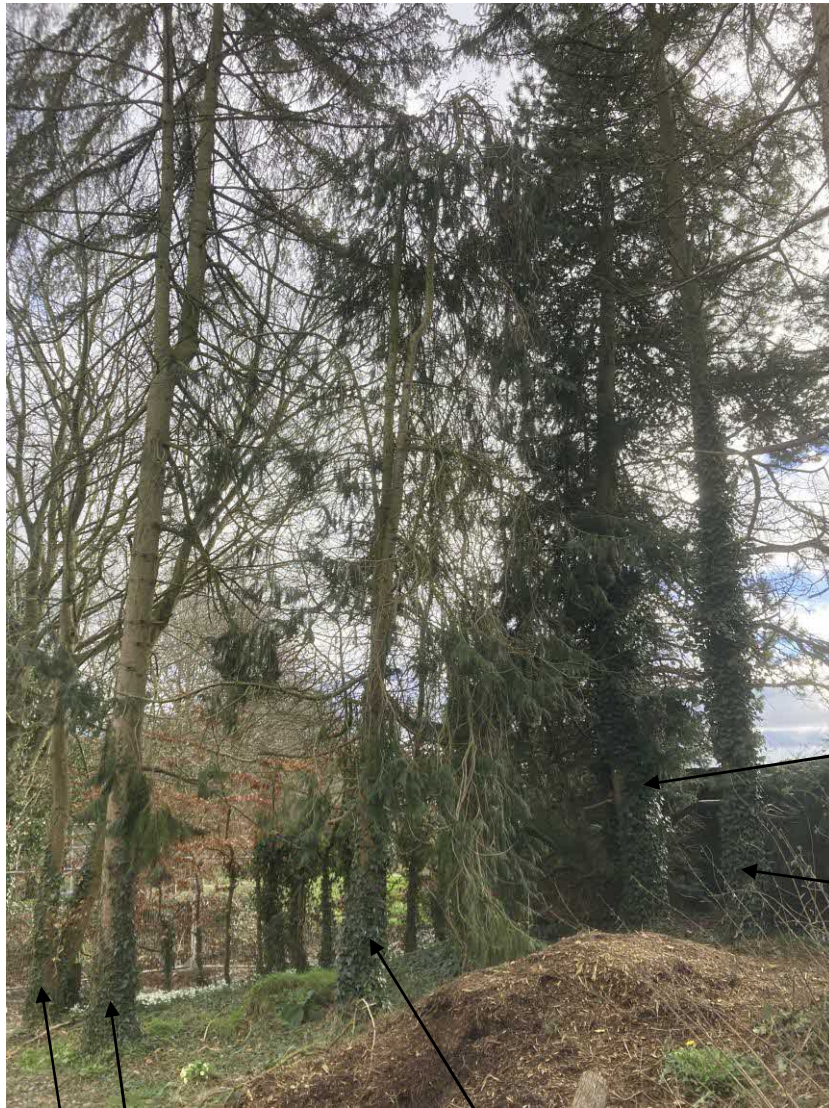
T248

Identification No.	New Tag 248 (16.2.24)
Species	Lodgepole pine <i>Pinus contorta</i> Doug.
Current Height (M)	14m
Ultimate Height (M)	20m
Current Stem Dia (cm) at 1.5m	35cm
Crown clearance	3m
Crown Spread (M)	Radius N = 1m; E = 2m; S = 2m; W = 4m
Growth stage	Early-Mature
<p>Tree Condition: Root: No evidence of soil movement Stem: no evidence of stem bleeds Crown: No evidence of recent breakouts or dieback Evaluation: adequate annual shoot extension, foliage retention, colour and density are indicative of the tree maintaining vitality to grow in the prevailing conditions Tree Quality Assessment: Ref.BS5837 (2012) 4.5.1 Category B2: 'trees occurring as collectives but situated as to make little visual contribution to the wider locality Safe, Useful, Life expectancy >20 years Water Demand NHBC 4.2-B: Moderate Root Protection Area RPA: for tree of 35cm diameter at 1.5m (0.35 x 12) = 4.2m Radius Total RPA required at current stage of growth = 55m² Arboricultural Impact Assessment AIA: The proposed new drainage system falls outside the RPA. The proposed new driveway <u>re-aligned</u> driveway corner section falls within the RPA perimeter by 1m at the widest point. No further excavation for conventional foundation is proposed within the RPA as the drive level will be raised at this point and surfaced with porous material. The tree provides shelter for T546 Norway spruce from the prevailing wind. RPA. 'BS 7.7.2.1: <i>The design should not require excavation into the soil, including the lowering of levels and/or scraping, other than the removal, using hand tools, of any turf layer or other surface vegetation</i>'. Method Statement: Construction of new driveway Install section of Heras fence set back within the RPA as indicated on Tree Protection plan. Specification as recommended in BS5837 (2012) Fig 3 appended.</p>
