41-43 Hay's Mews
Photographs
December 2023
Not to scale

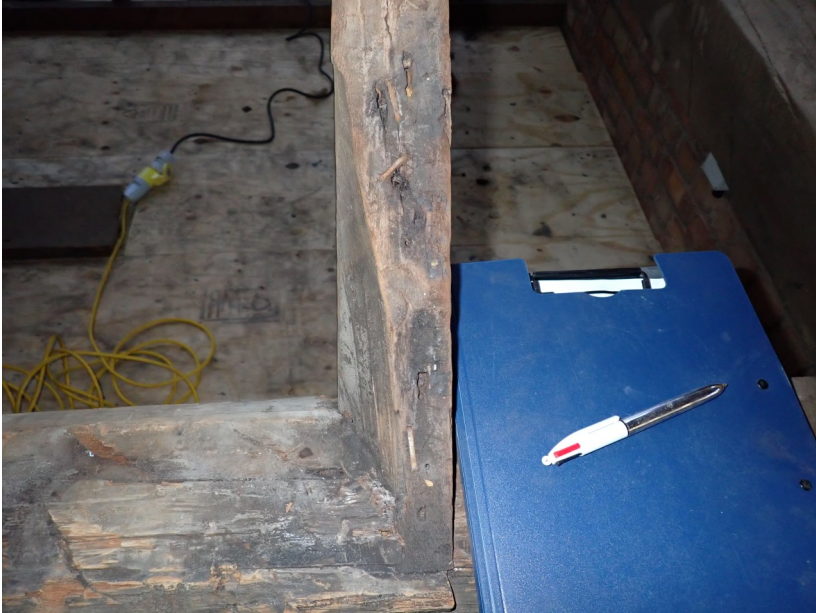
Fig 33:

Roof 6, south pitch; showing loss of cross section to foot of upper common rafter

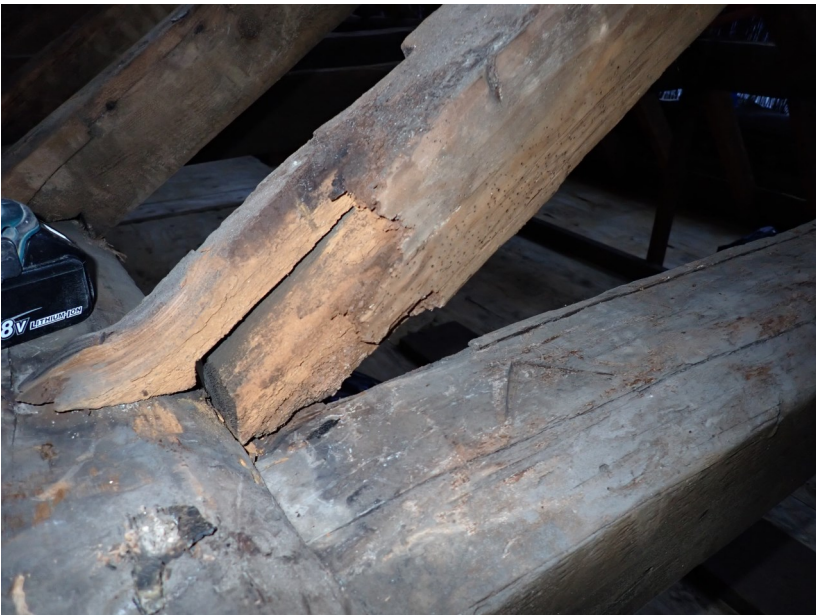
Fig 34:

Roof 6, south pitch; showing decay and damage to base of upper rafter

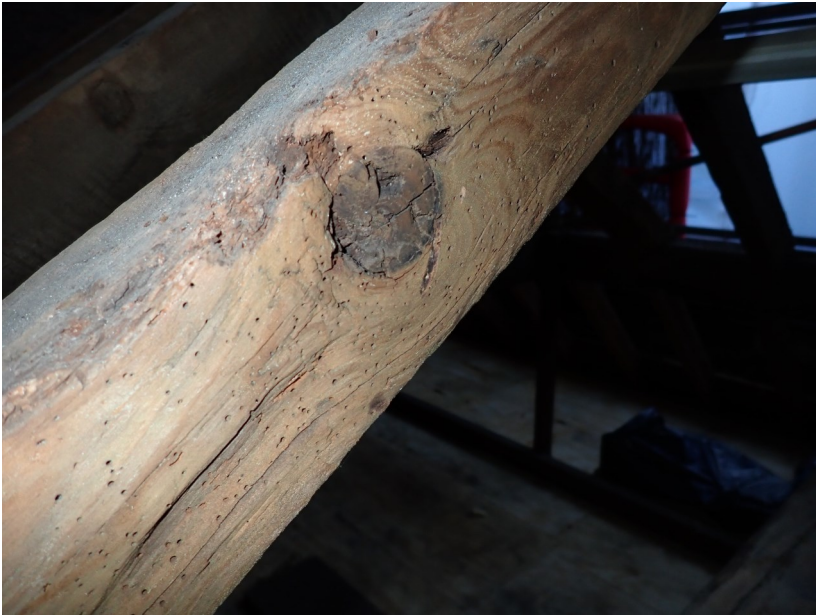
Fig 35:

Roof 6, south pitch; showing distribution of woodboring beetle flight holes to east face of rafter shown in previous image

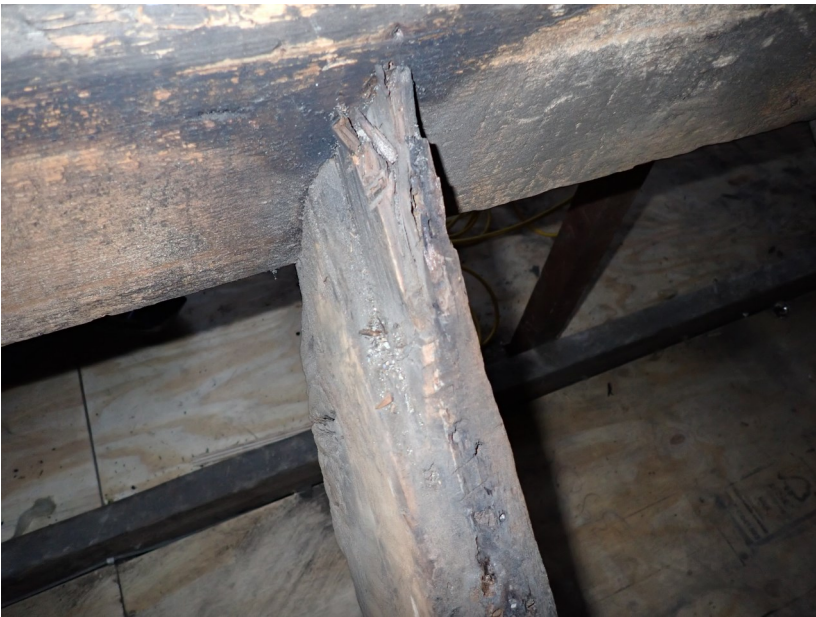
Fig 36:

Roof 6, south pitch; showing damage and loss of cross section to head of lower common rafter at approximate mid-point

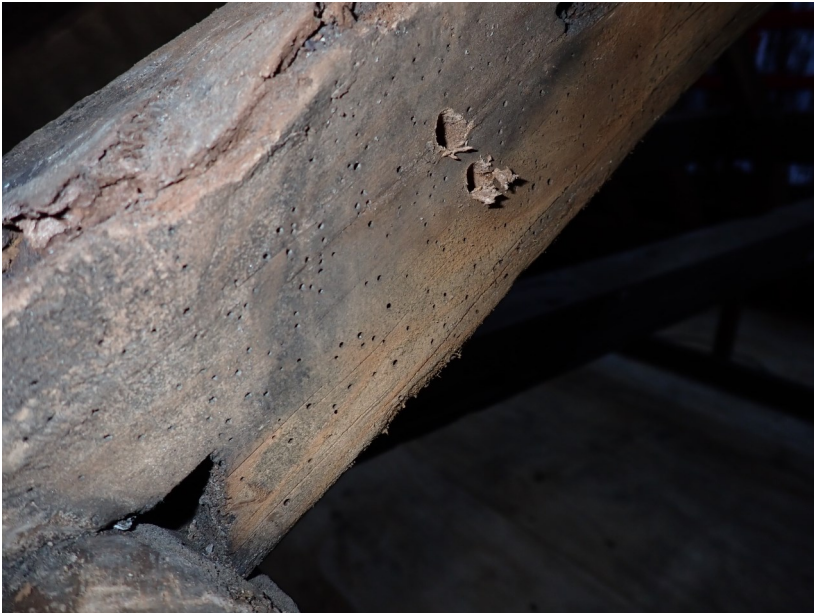
Fig 37:

Roof 6, south pitch; showing upper common rafter with concentrated distribution of woodboring beetle flight holes. Diameter of flight holes consistent with common furniture beetle (*Anobium punctatum*)

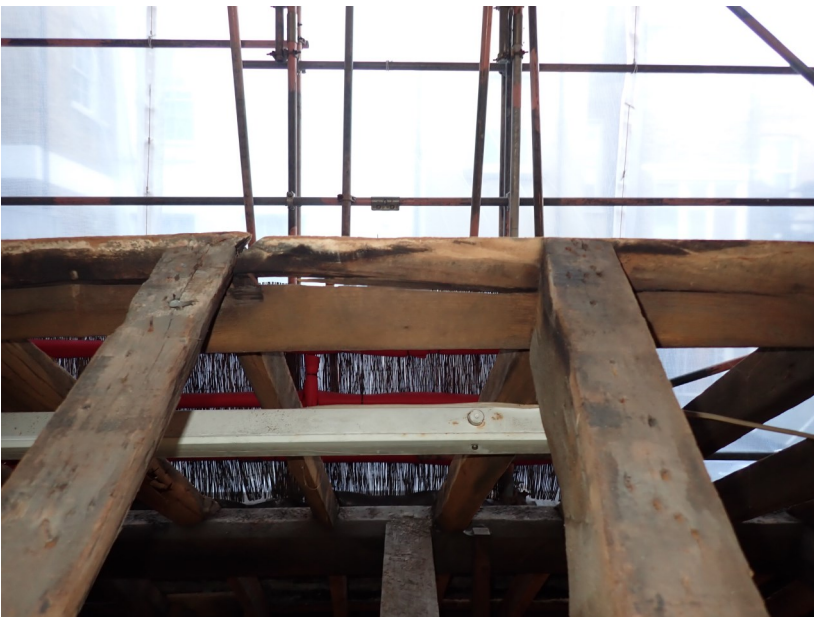
Fig 38:

Roof 6; showing large split in ridge board towards western end

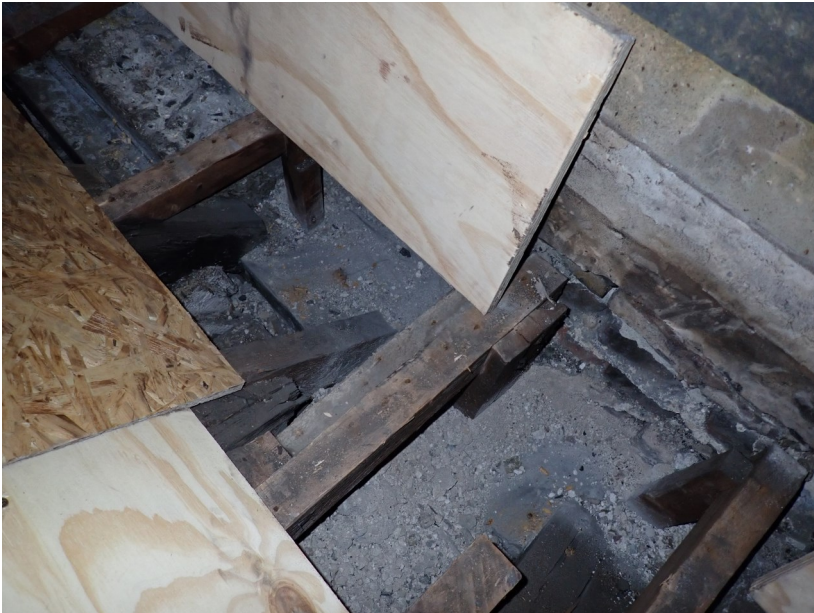
Fig 39:

Roof 6, south pitch; showing lower common rafters supported onto plate between two section of poured concrete. No decay detected to plate. Moisture content readings well within dry parameters

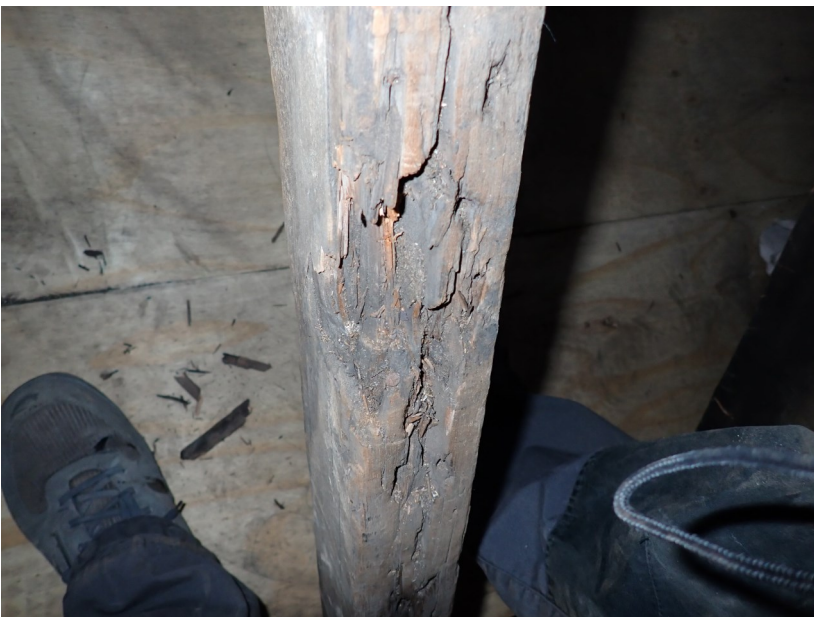
Fig 40:

Roof 6, south pitch; showing localised decay damage to mid-span of lower rafter

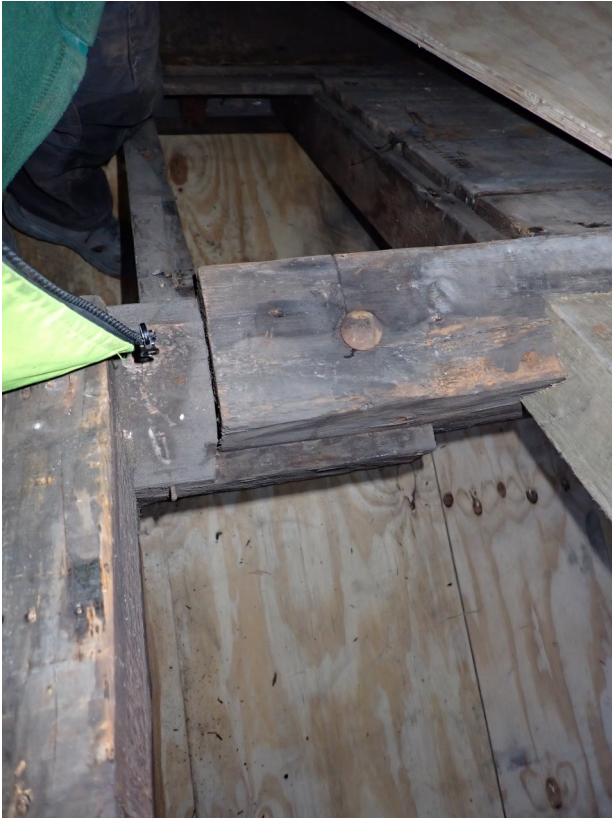
Fig 41:

Roof 6, south pitch; showing purlin connection to joint at western end. Width discrepancy between purlin dimensions. However, bolt appears stable. Potentially inadequate support to purlin joint on north pitch, south pitch supported by double post

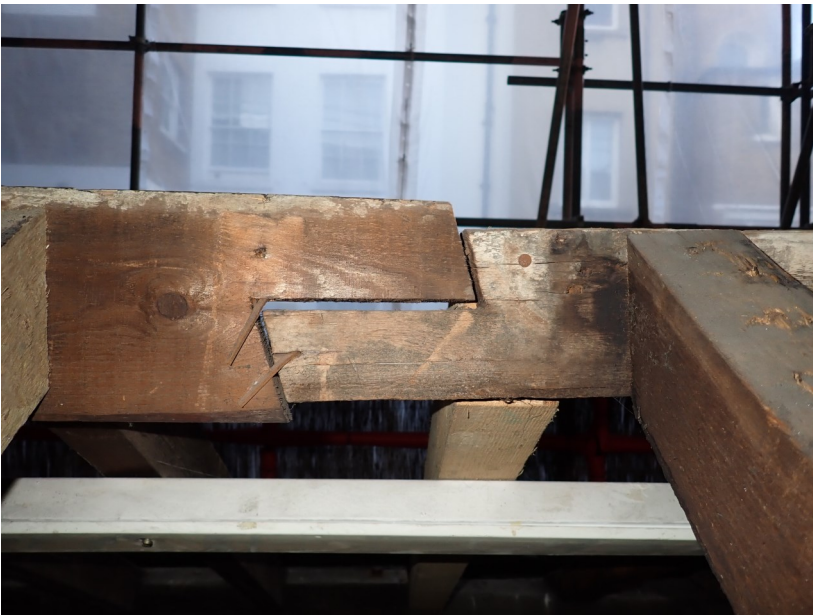
Fig 42:

Roof 6, south pitch; showing discrepancy between board width of ridge board at western end. Note gap between half lap bevel joint

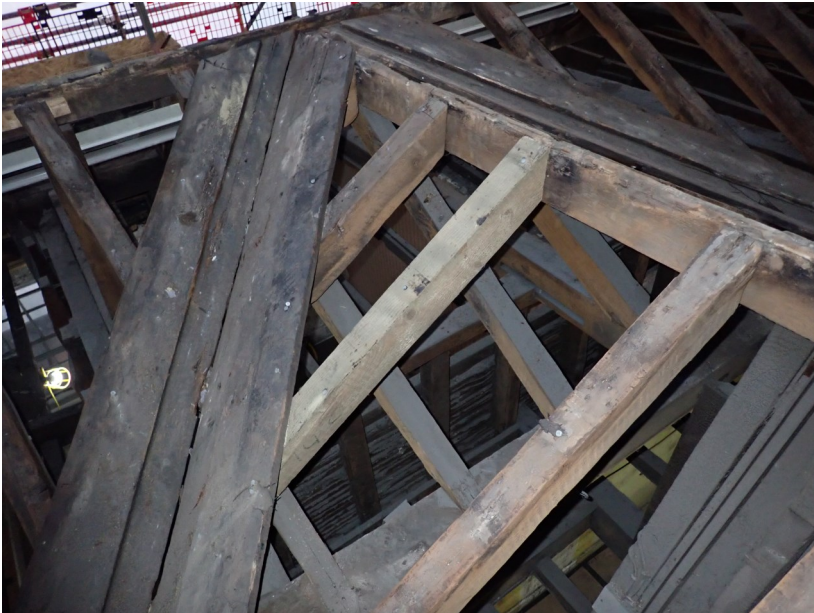
Fig 43:

Roof 6, north pitch; showing a general view of jack rafters at the east end. Note that one had been recently replaced in contemporary softwood and fixed with galvanised mechanical fixings

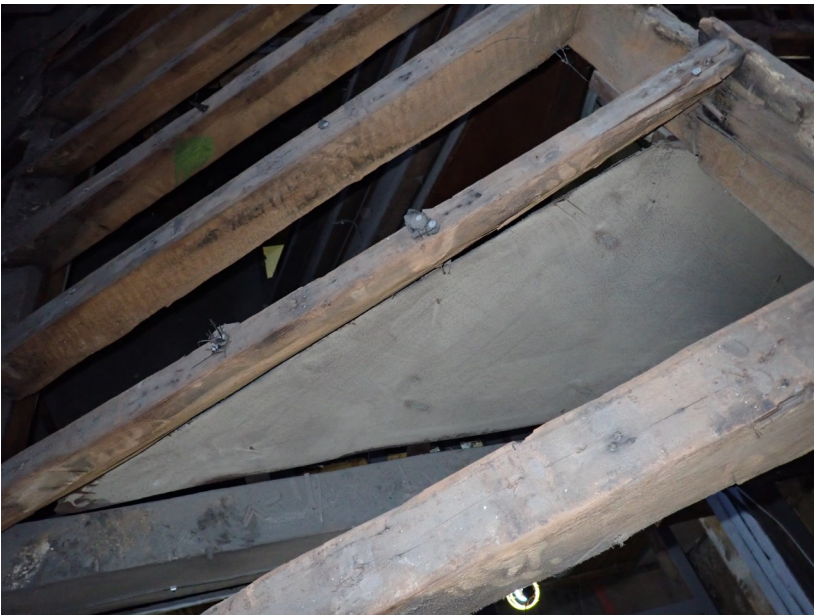
Fig 44:

Roof 6, north pitch; showing upper common rafter 9 which had suffered significant section loss particularly at the top end. This had jeopardised the connection with the ridge board. Also note that splitting had occurred further reducing the structural integrity of the joint and significantly corroded mechanical fixings were also identified

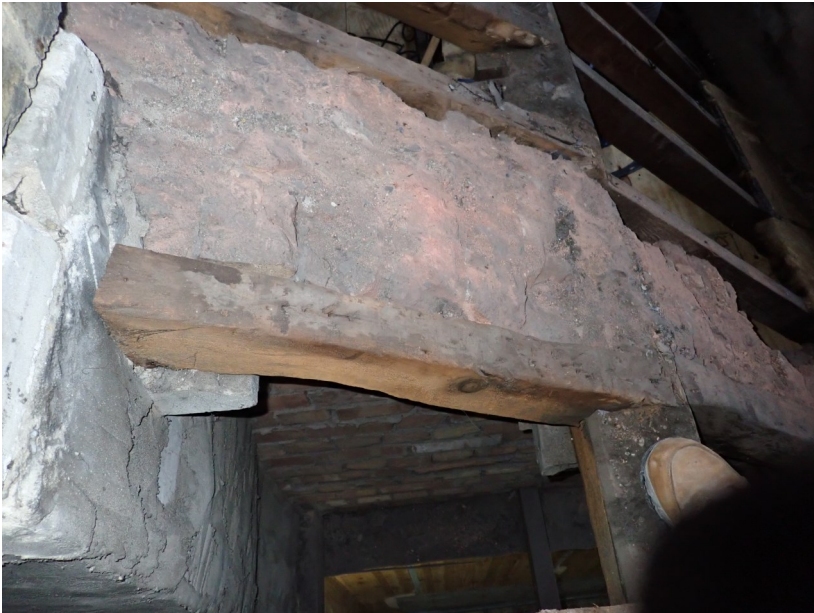
Fig 45:

Roof 6, north pitch; showing a focussed view of upper common rafter 14 which had a poor connection to the masonry corbel supporting it against the chimneystack. Note that the entire rafter was loose at the time of survey

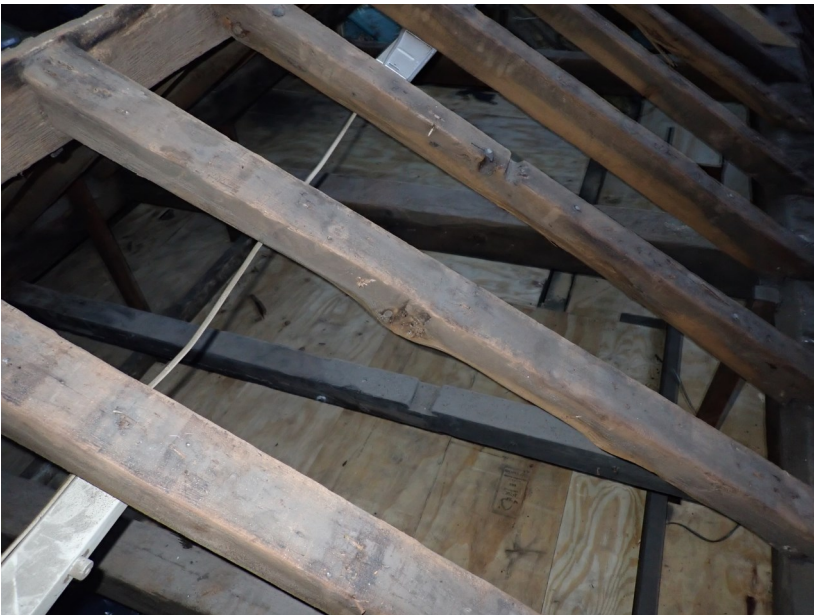
Fig 46:

Roof 6, north pitch; showing upper common rafter 23 which had a large knot in the vertical face. This would likely be a significant strength reducing characteristic

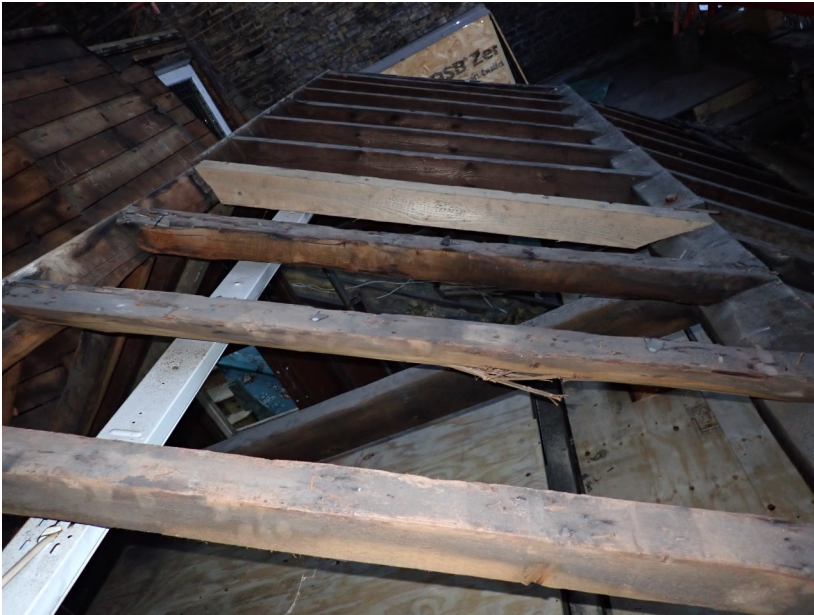
Fig 47:

Roof 6, north pitch; showing a general view of upper common rafter 27 which had been subjected to significant section loss due to historic decay. note that further decay to heartwood was noted

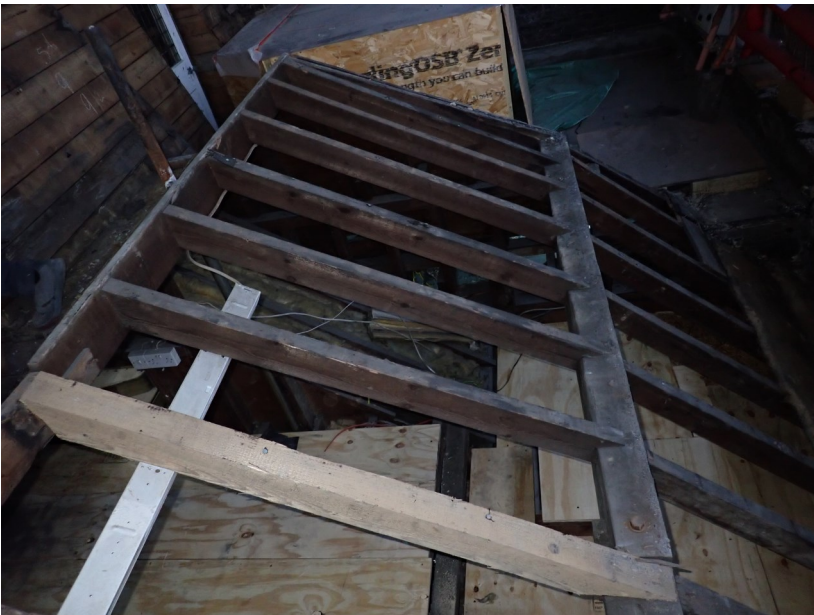
Fig 48:

Roof 6, north pitch; showing a series of upper common rafters at the west end comprising of rafters 29 to 36 which were deemed to be later softwood replacements. No defects were identified to these elements at the time of survey

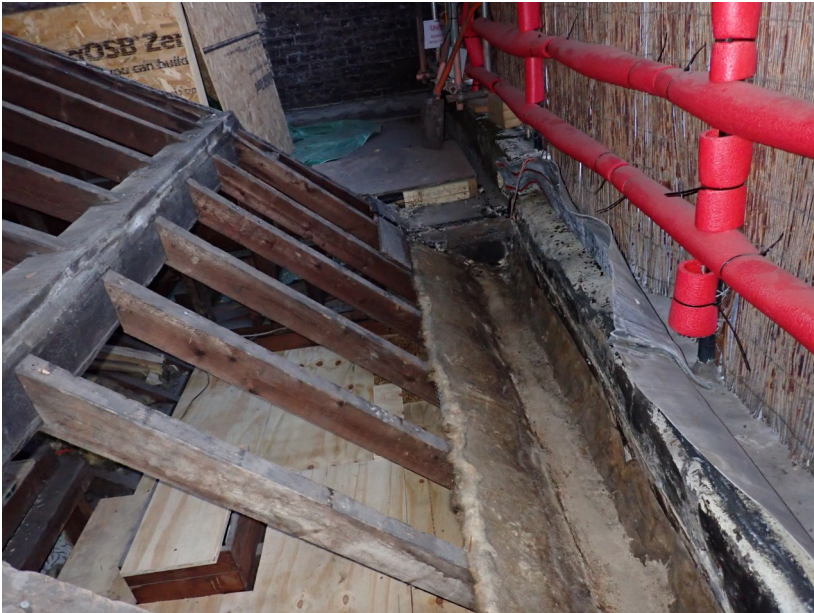
Fig 49:

Roof 6, north pitch; showing a general view of the lower common rafters at the west end. Note that several of these were later softwood replacements. No structural defects were identified to these elements at the time of survey

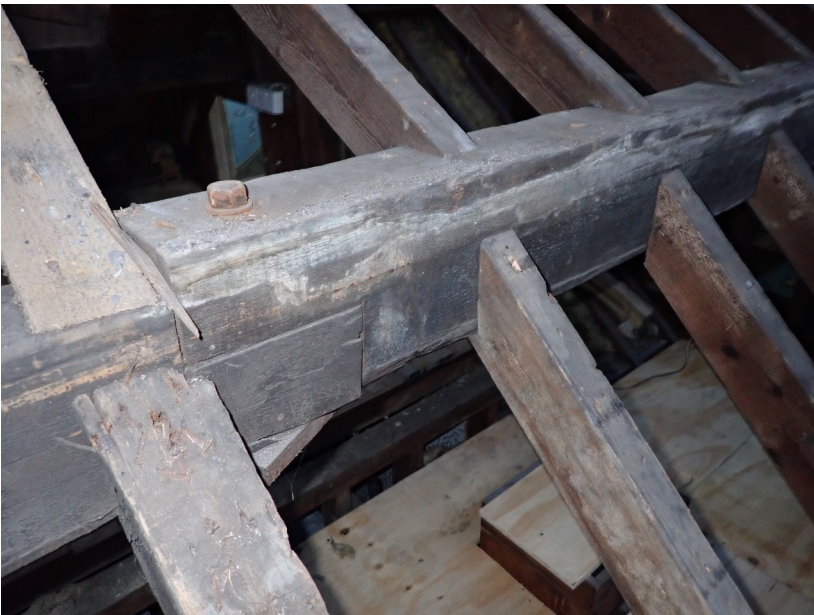
Fig 50:

Roof 6, north pitch; showing a focussed view of the lap scarf joints connecting purlin members at the west of the roof. The joint dimensions and presence of only a single fixing were considered to be possibly inadequate. Structural Engineer to comment

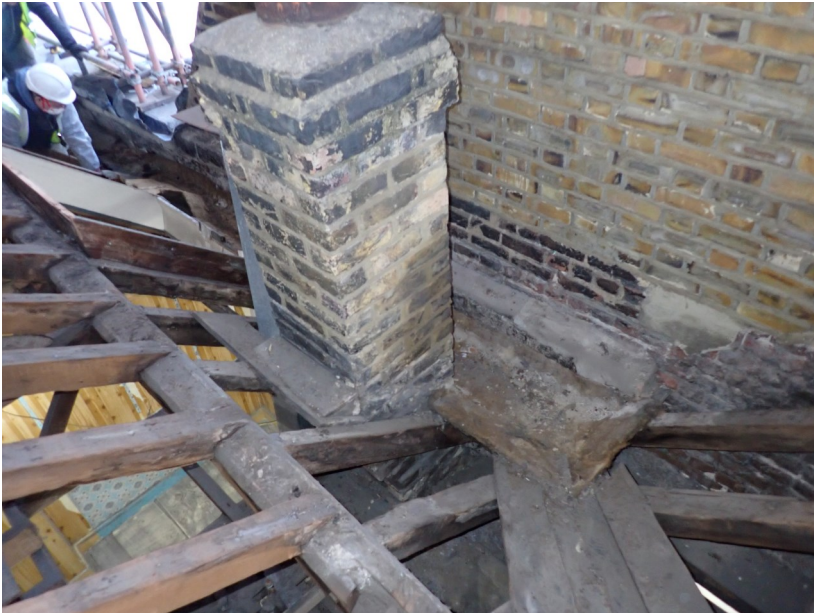
Fig 51:

Roof 6, north pitch; showing a general view of the lower common and jack rafters at the east end of the roof structure. Note that these were formed of softwood. Investigations were limited due to the presence of additional roof materials. However, no evidence of critical issues were identified at the time of survey

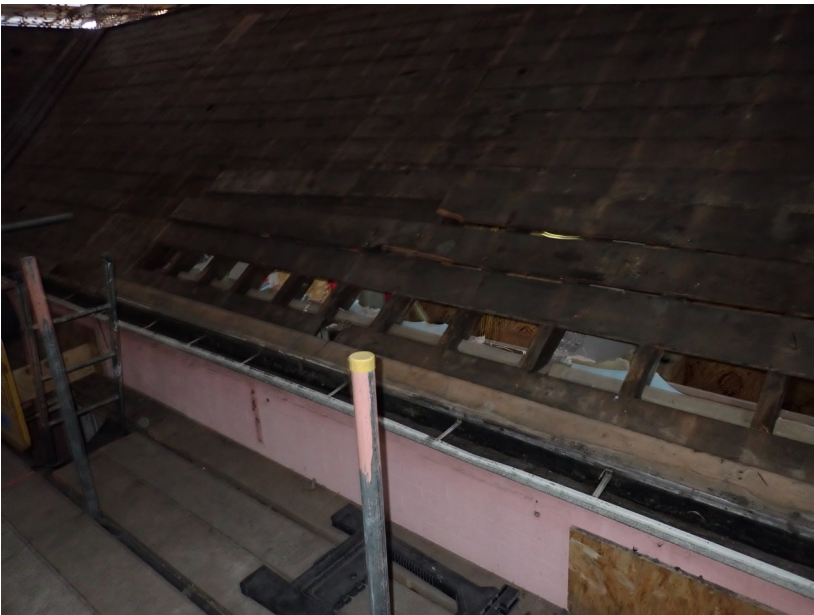
Fig 52:

Roof 2; showing west side view of eaves location
