41-43 Hay's Mews
Photographs
December 2023
Not to scale

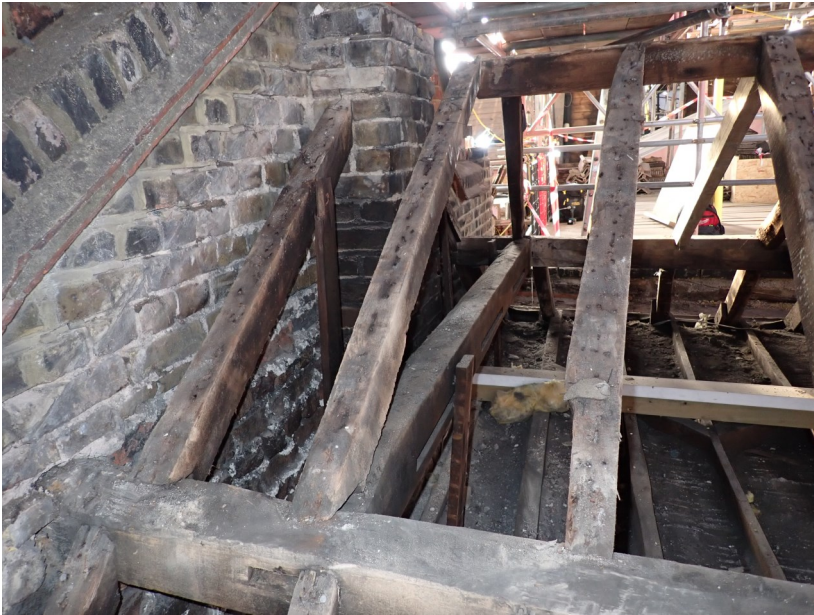
Fig 17:

Roof 5; showing a general view of upper common rafters 1 and 2. Note that common rafter 2 had a poor connection at the top joint to the ridge board and the bottom birdsmouth joint was separated from the purlin

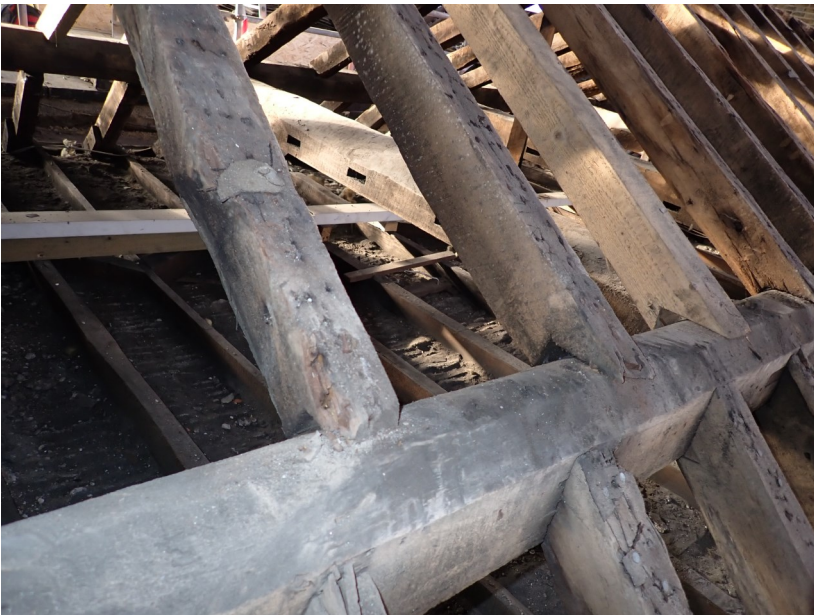
Fig 18:

Roof 5; showing the feet of upper common rafters 3 and 4 which had been poorly scribed to the purlin. The positioning and condition of mechanical fixings securing these joints was also deemed to be inadequate

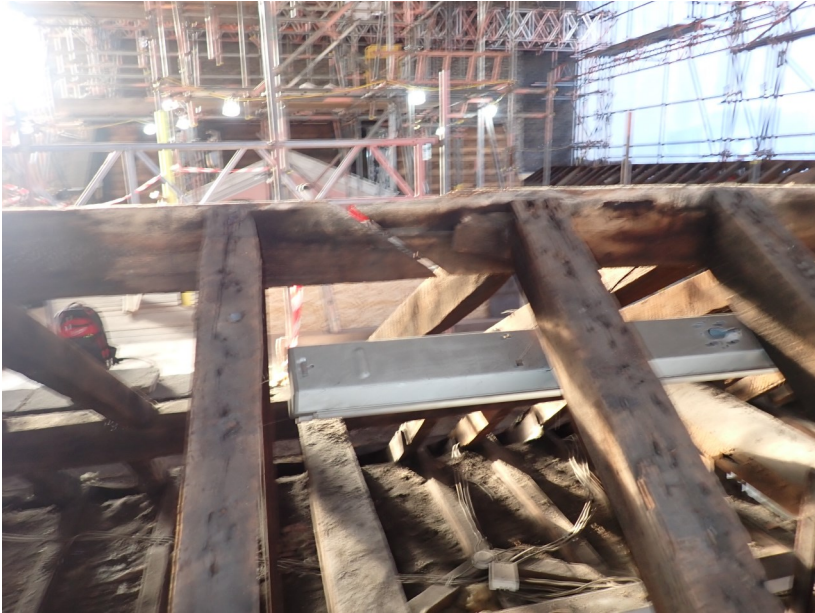
Fig 19:

Roof 5; showing the separated splay scarf connecting two lengths of ridge board between upper common rafters 8 and 9 showing a focussed view of the birdsmouth joint of upper common rafter 13. Note that this joint was deemed to be inadequate due to multiple splits and the poor condition and positioning of mechanical fixings

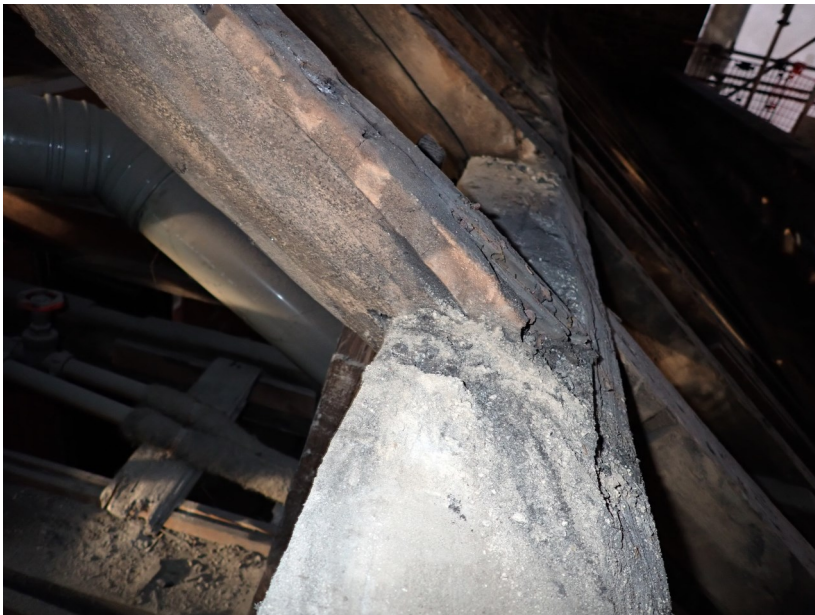
Fig 20:

Roof 5; showing a focused view of the foot of an upper common rafter that had degraded due to superficial decay, excessive splitting and corrosion of mechanical fixings

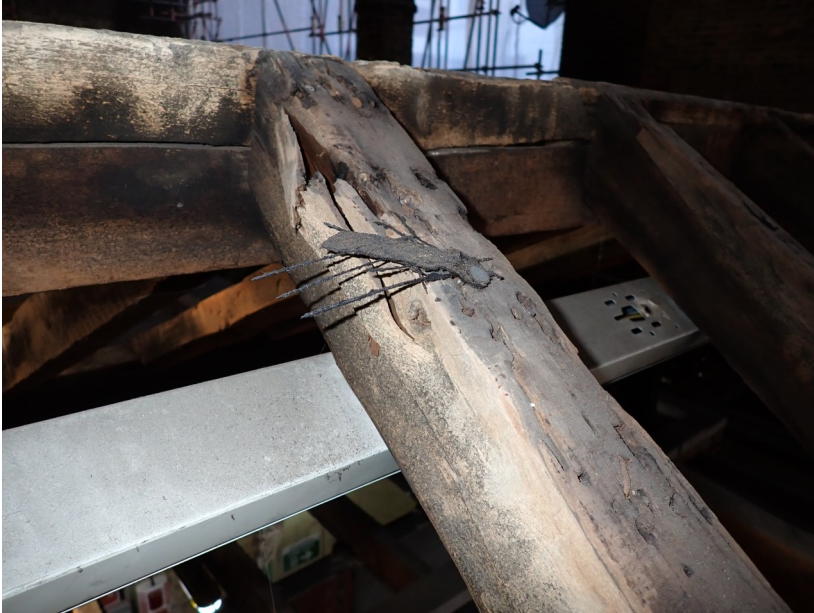
Fig 21:

Roof 5; showing a focussed view of the top of the upper common rafter 16. Note that a localised incidence of mechanical damage had resulted in significant section loss at this location resulting in the common rafter being deemed as inadequate

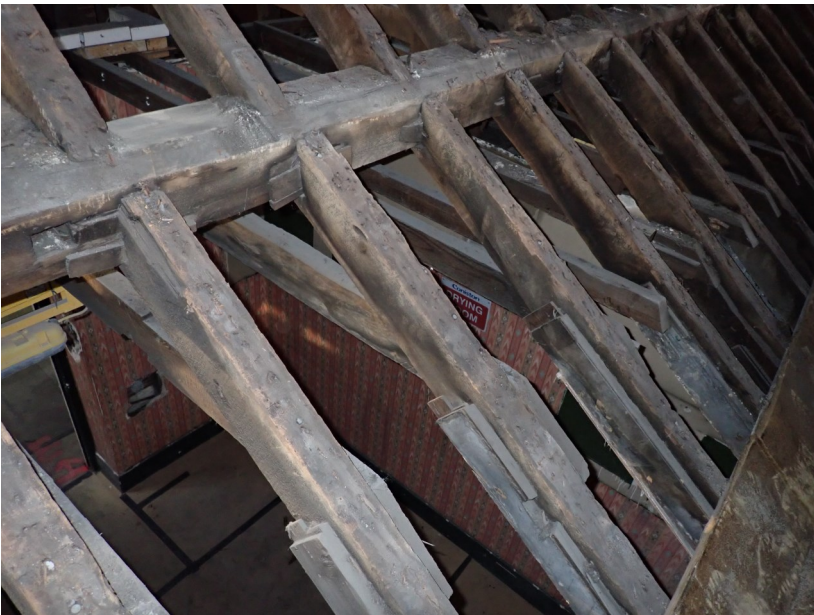
Fig 22:

Roof 5; showing a series of joints connecting the lower common rafters to the purlin. Note that these had wedges inserted to improve joint connection. However, these may be considered inappropriate by modern standards. Structural Engineer to comment

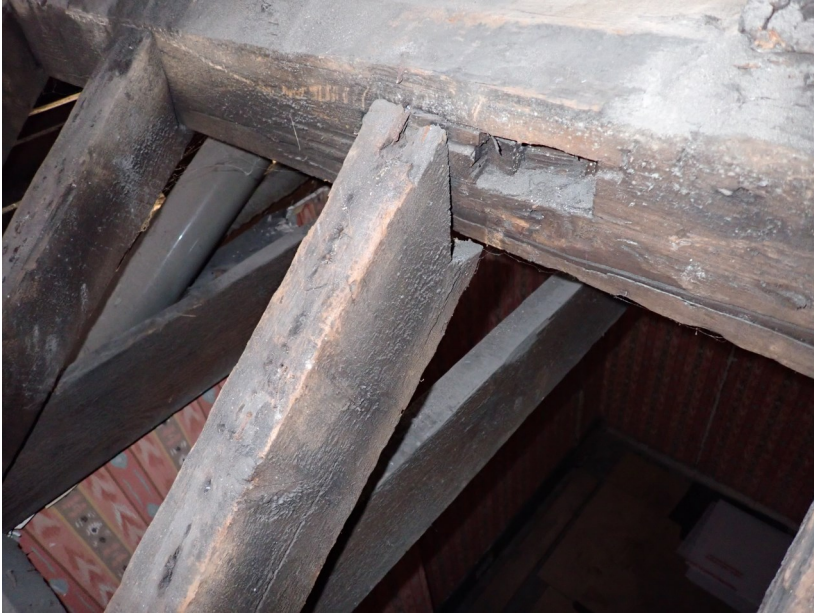
Fig 23:

Roof 5; showing the top birdsmouth joint connecting the lower common rafter 16 to the purlin. This had become separated by approximately 25mm. Joint was deemed to be inadequate

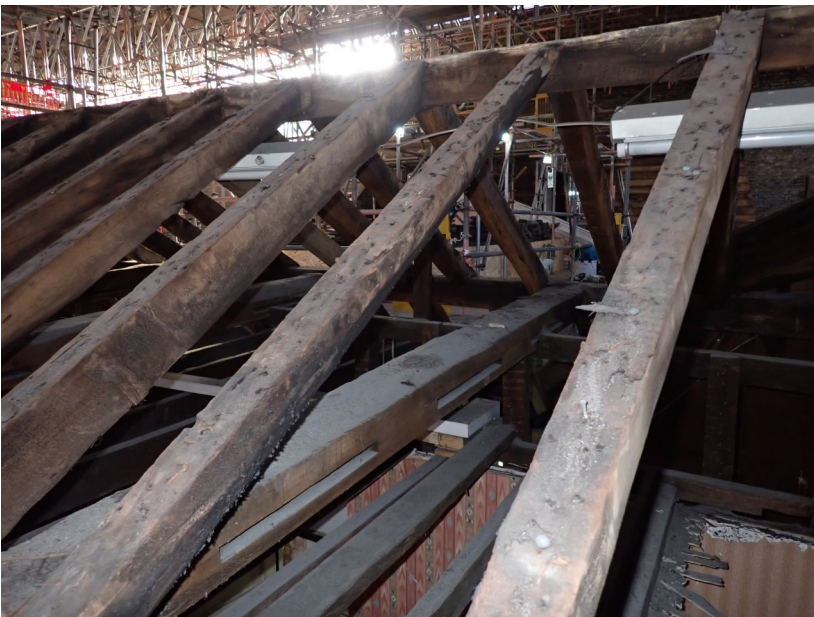
Fig 24:

Roof 5; showing a general view of the upper common rafter 23 which had been subjected to significant section loss due to the historic infestation of woodboring beetle consuming the sapwood. Also note that the joint connecting the top end to the ridge board was deemed to be highly inadequate due to the section loss and the poor quality of fixings as well as significant splitting

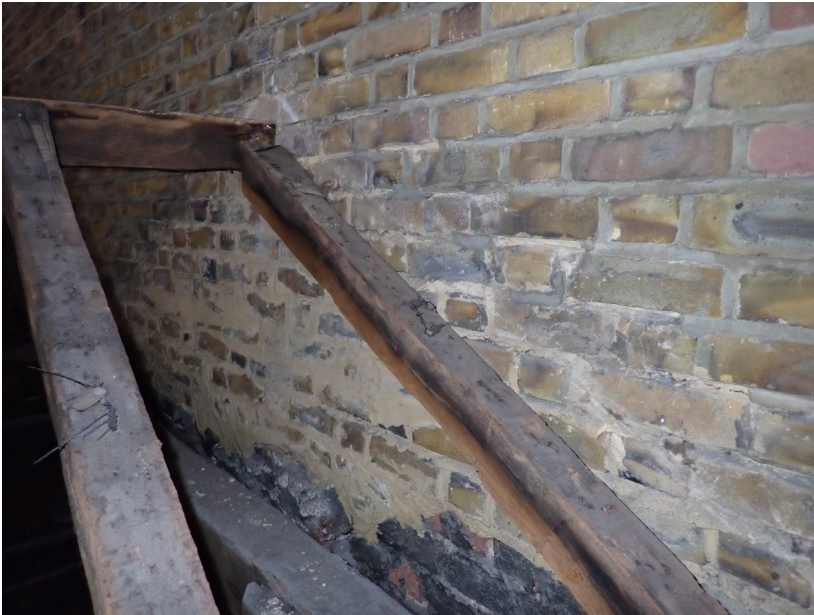
Fig 25:

Roof 5; showing a general view of upper common rafter 33. Note that the rafter had slipped from its original position resulting in a poor connection at the top interface with the ridge board. Additionally, the bottom birdsmouth joint connecting the rafter to the purlin was deemed to be inadequate due to significant splitting

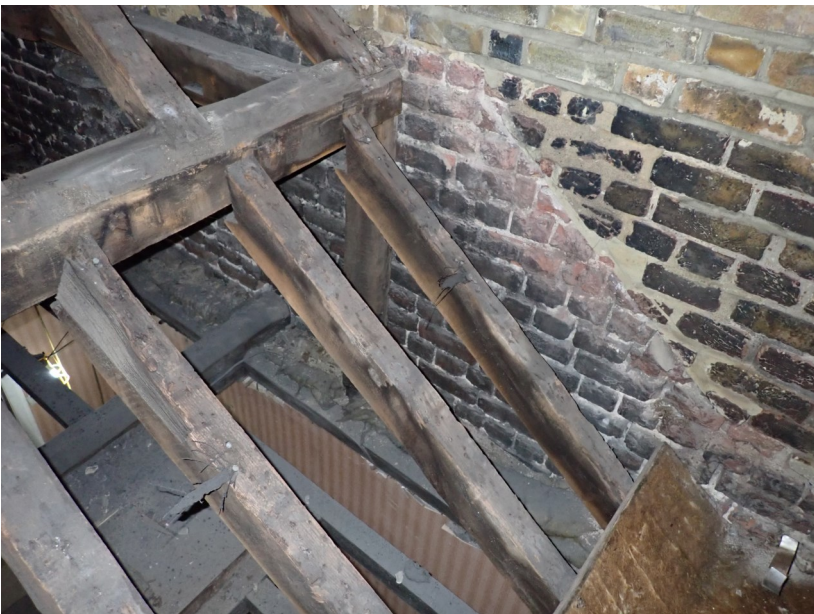
Fig 26:

Roof 5; showing a general view of lower common rafters 33, 34 and 35. Note that 33 had been subjected to significant mechanical damage at its upper end resulting in large section loss and poor connection to the purlin. Common rafters 34 and 35 appear to have slipped from their original positions before being re-fixed. Upper birdsmouth joints were therefore deemed to be inadequate and further strengthening or additional replacements or repairs would be necessary

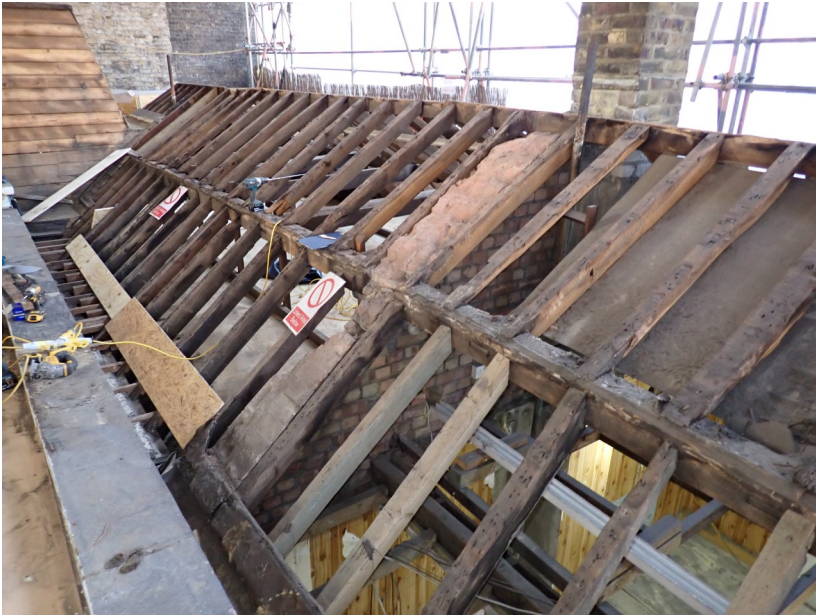
Fig 27:

Roof 6, south pitch; showing a general view towards west end

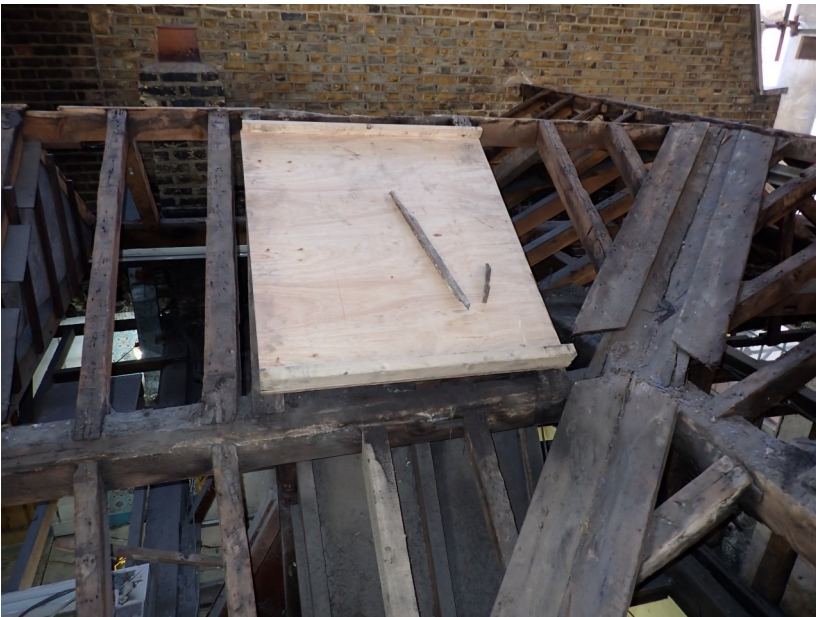
Fig 28:

Roof 6, south pitch; showing boarded over area at east end for previous rooflight location

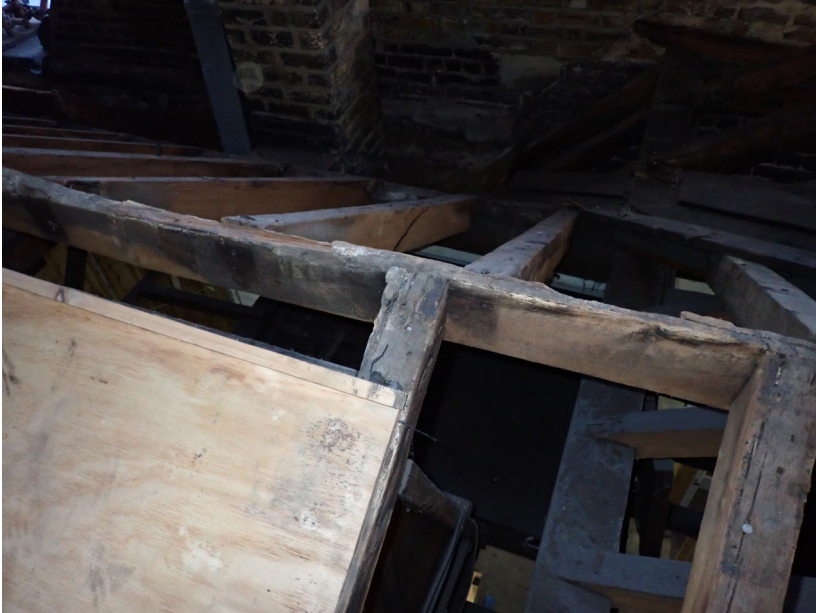
Fig 29:

Roof 6; showing general degradation of ridge board at east end

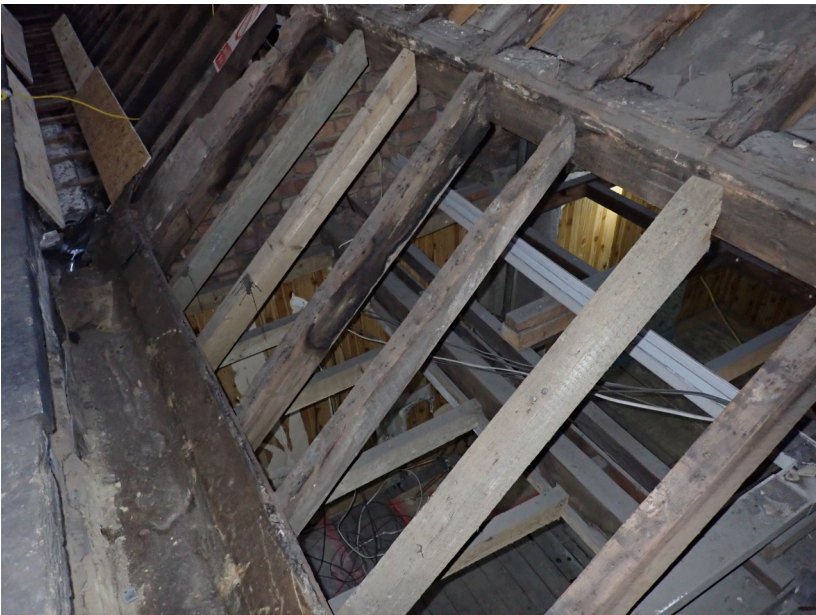
Fig 30:

Roof 6, south pitch; showing occasional replacement of historic rafters with new softwood timber

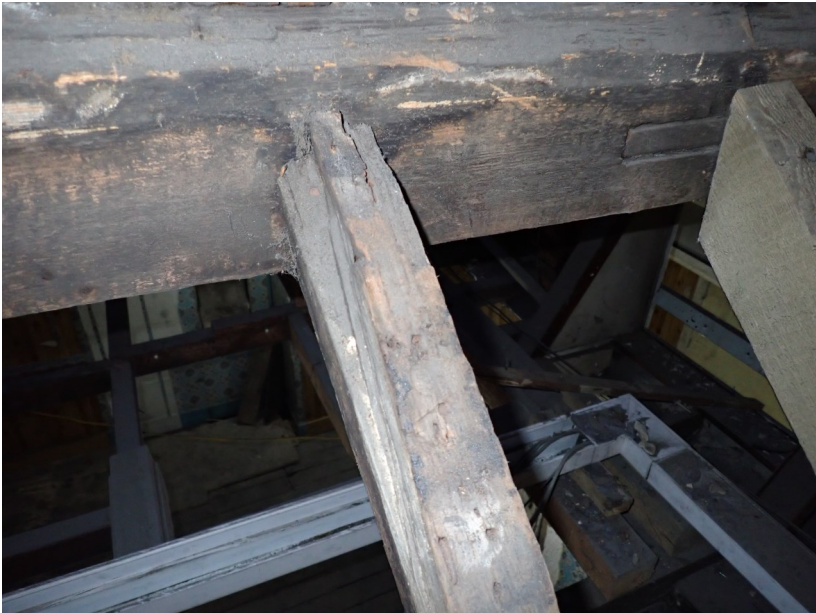
Fig 31:

Roof 6, south pitch; showing slight damage to head of lower common rafter at east end

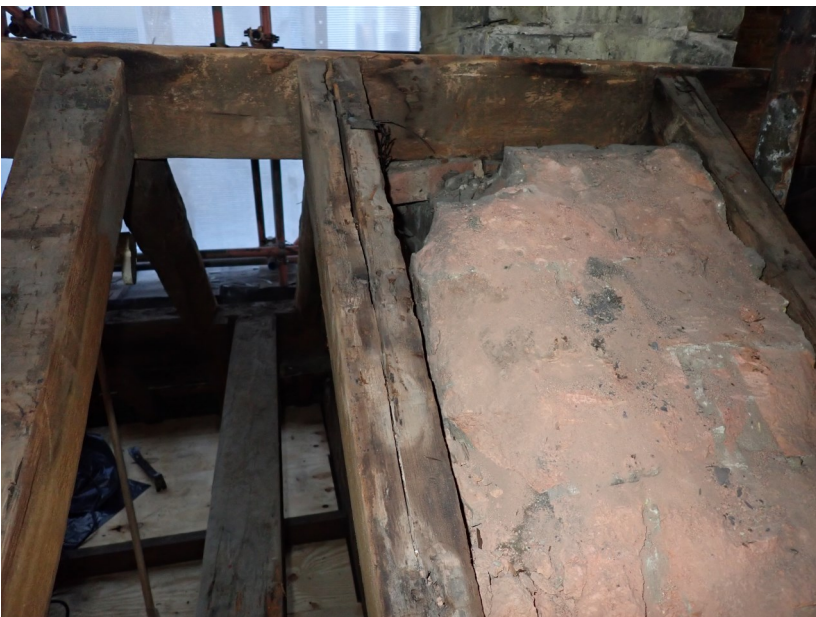
Fig 32:

Roof 6, south pitch; showing long split to head of upper rafter
