DESIGN STATEMENT  
ROOFS 5 & 6

41 - 43 HAY'S MEWS, LONDON

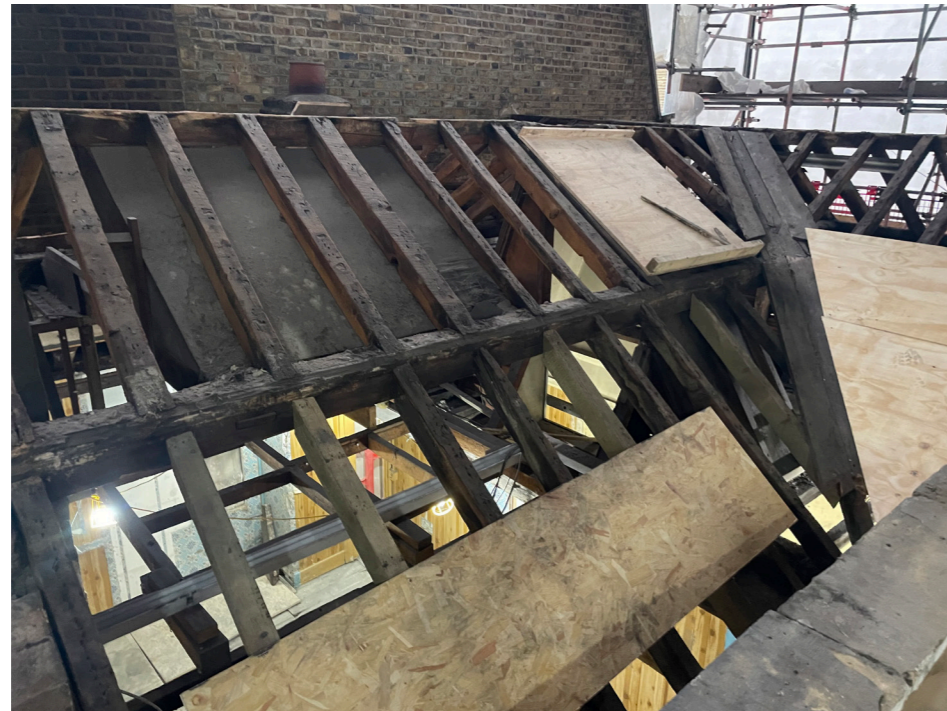
There is evidence of historic rafters previously being replaced, assumed to be due to poor condition of the original rafters. This is mainly seen to the lower rafters in roof 6, but is also evident within roof 5.

Historic rafters previously replaced, mainly to lower rafters in roof 6

- Lower rafters are to be retained/repared, with partner/ intermediate rafters to be installed where required. Where ceilings are retained below, the rafters will be repaired in position to maintain soffit support. Any salvaged lower rafters removed will be numbered and re-positioned.

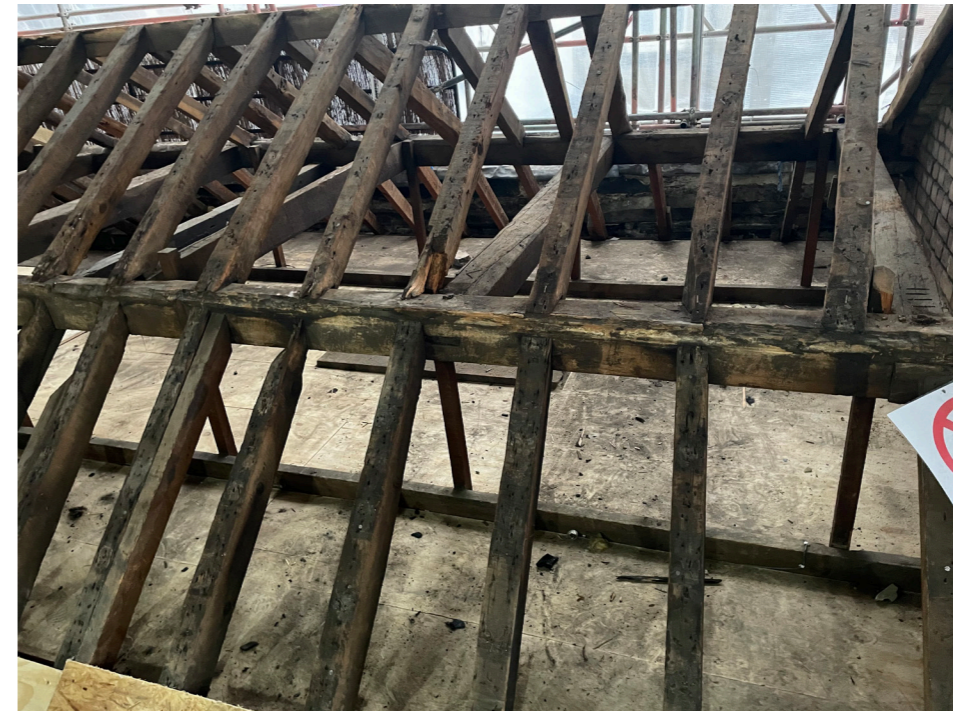
Significant issues to both the upper and lower rafters in both roof 5 and 6 were noted by Hutton + Rostron following their survey in December 2023, once the roof had been fully exposed. This includes loose and defected rafter ends, loss of cross sections and splitting.

Defected and splitting rafter ends, seen throughout roofs 5 & 6

- Upper rafters are generally in a very poor condition, widespread replacement of rafters will be required. Any new timber rafters will be of Pinus Sylvestris to match existing timber.

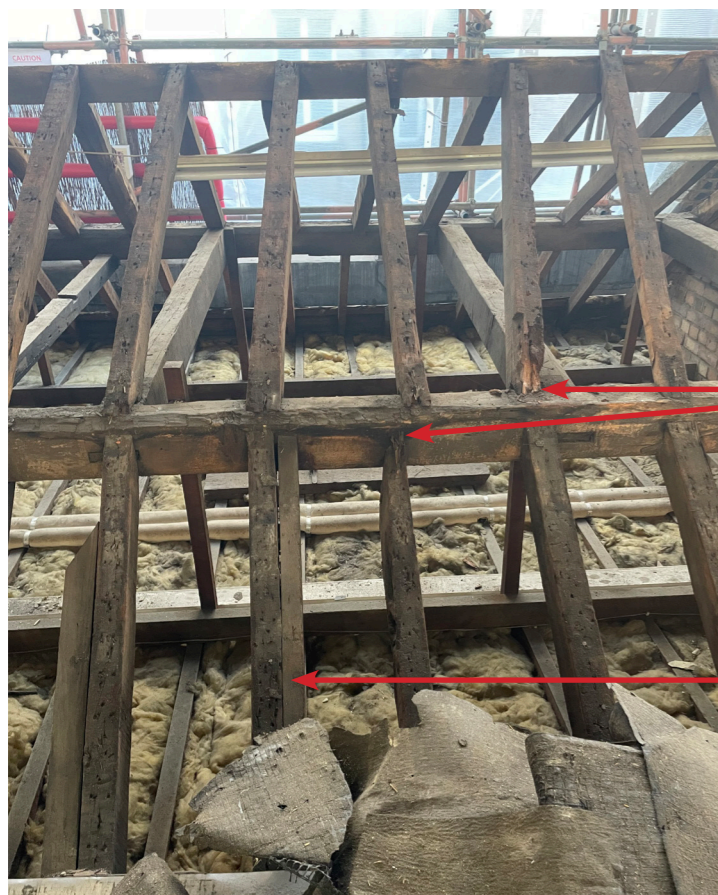
Bearing ends of the rafters have decayed in many areas, this is seen in rafters above and below purlins.

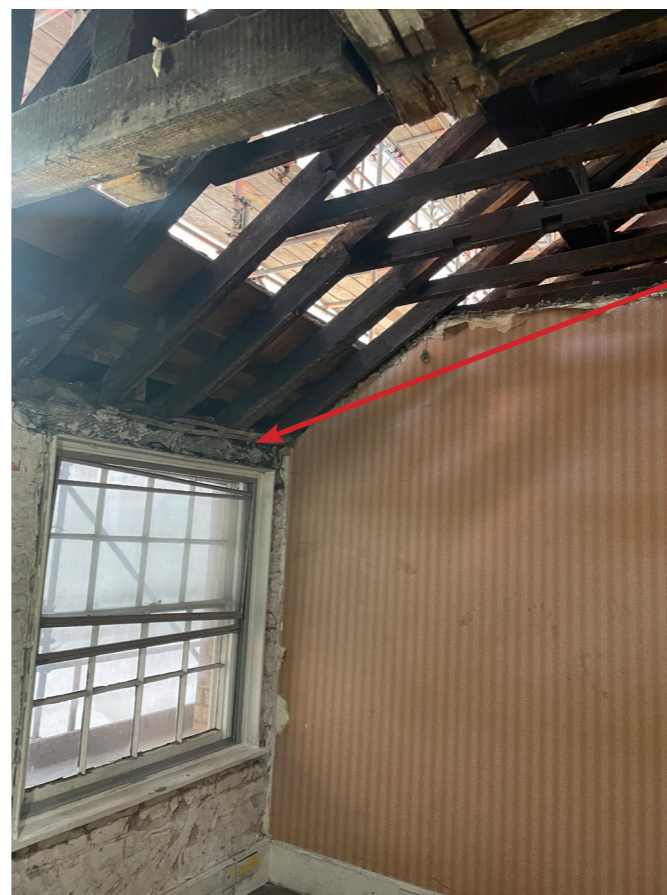
Historic partner repairs to rafters

Historic alterations to the roof, including ceiling raising and layout alterations

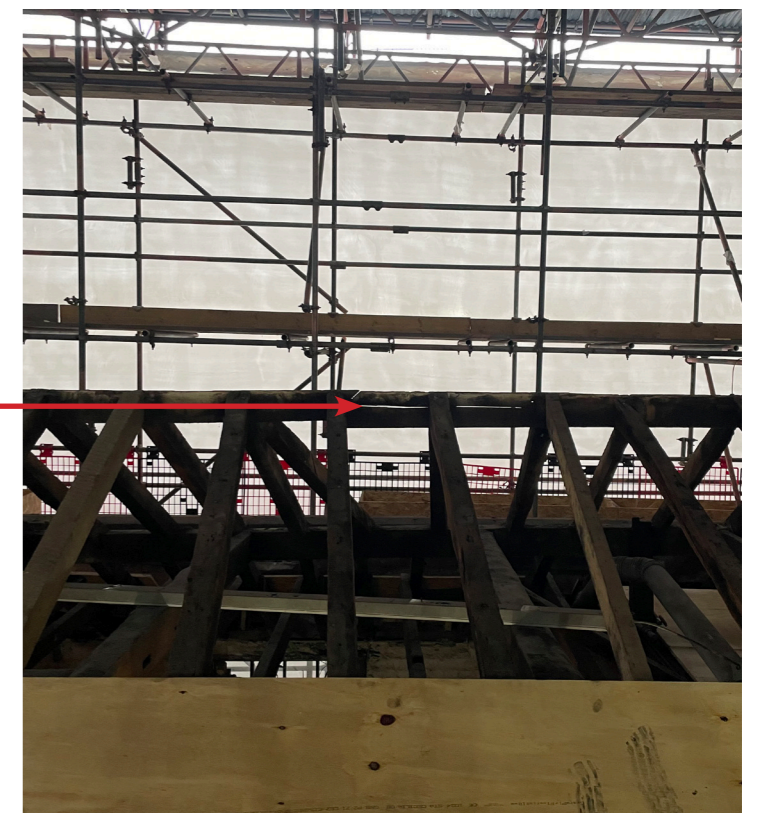
Ridge beam is in very poor condition and requires replacement.

- The existing ridge board is in a very poor condition with areas of splitting and disconnection recorded, the ridge board is also under sized which is potentially causing structural issues. It is proposed to replace the ridge board with an increased thickness to better support the re-instated roof coverings. The ridge beam thickness is to be to structural engineers calculations and details.

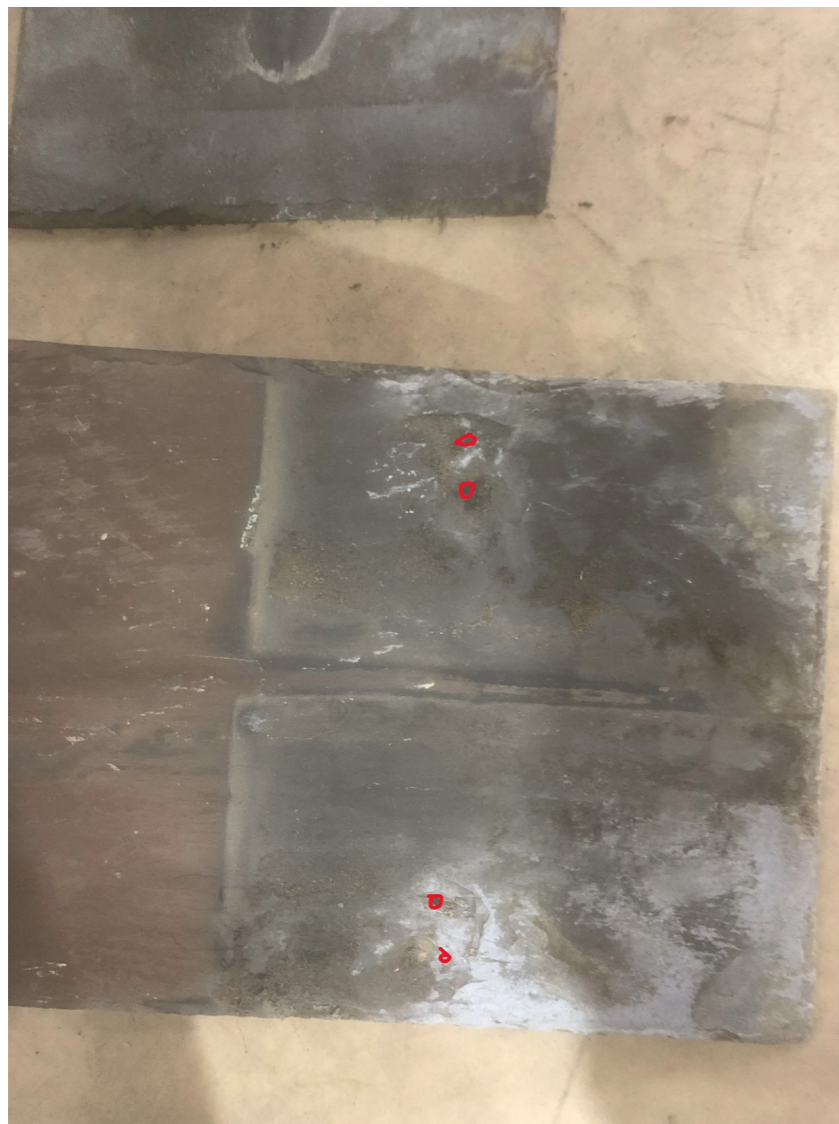
The existing slate tiles have been carefully removed from all roofs and are being stored on site. The majority of the existing slates have 4-5 holes up to 6mm diameter indicating that these have been reused multiple times already. These are no longer suitable for reuse as that would introduce further holes weakening slates to the extent they would snap and leak.

- Most slates are seen to have 3-4 holes, indicating they have been reused multiple times already
- Delamination and fracturing is evident on the majority of the slate tiles around the holes
- Some slates have significant damage and are no longer full slate tiles.

Existing Welsh slates with multiple holes

- New Penryhn Welsh slate tiles to be installed to all slate roofs to match existing, Penryhn Welsh slates.
