**41-43 Hay's Mews**  
Photographs  
December 2023  
Not to scale

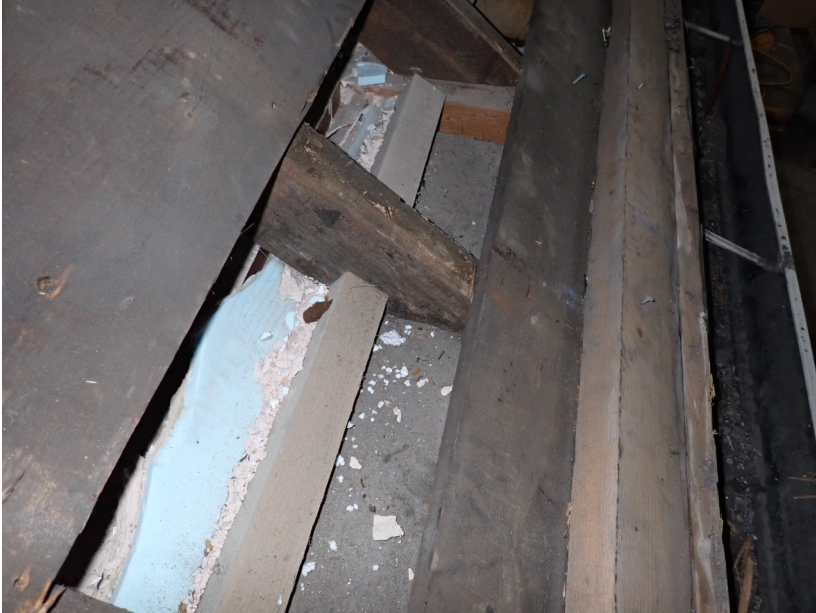
**Fig 53:**

Roof 2; showing plate at base of rafters on east side after localised exposure. No decay detected on drilling. Moisture content readings well below decay threshold

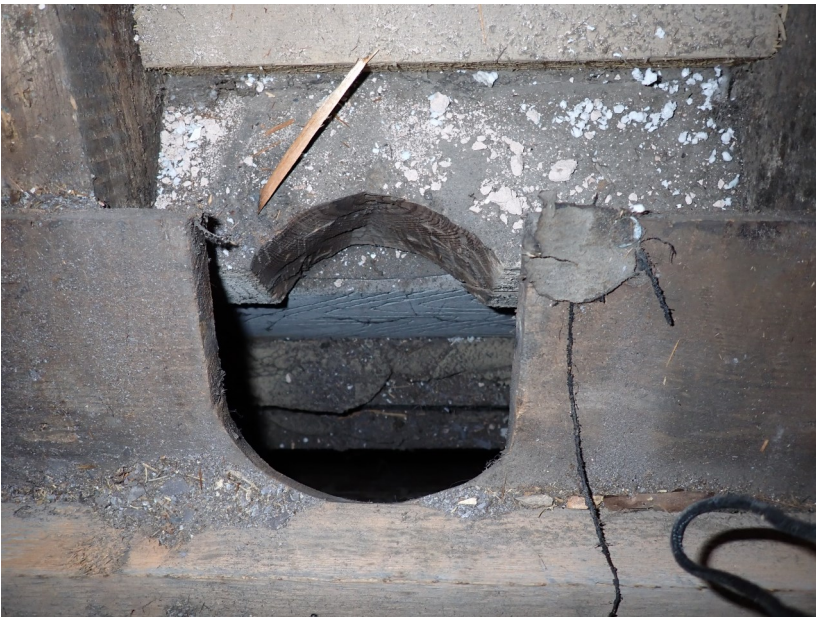
**Fig 54:**

Roof 2; showing cavity wall construction on east side and plate. Plate isolated from masonry using bituminous layer

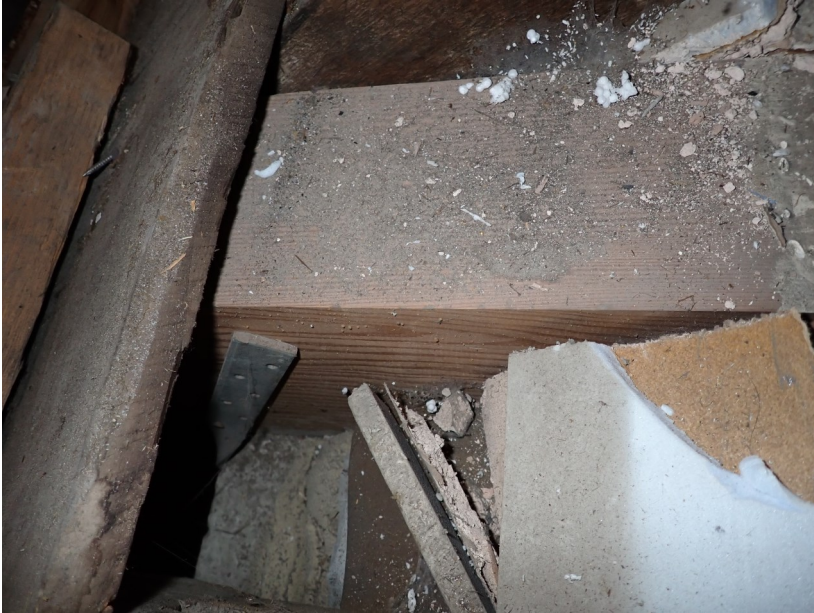
**Fig 55:**

Roof 2; showing east bearing end of southern truss. Timber condition and general patina consistent with late C20th installation and manufacture

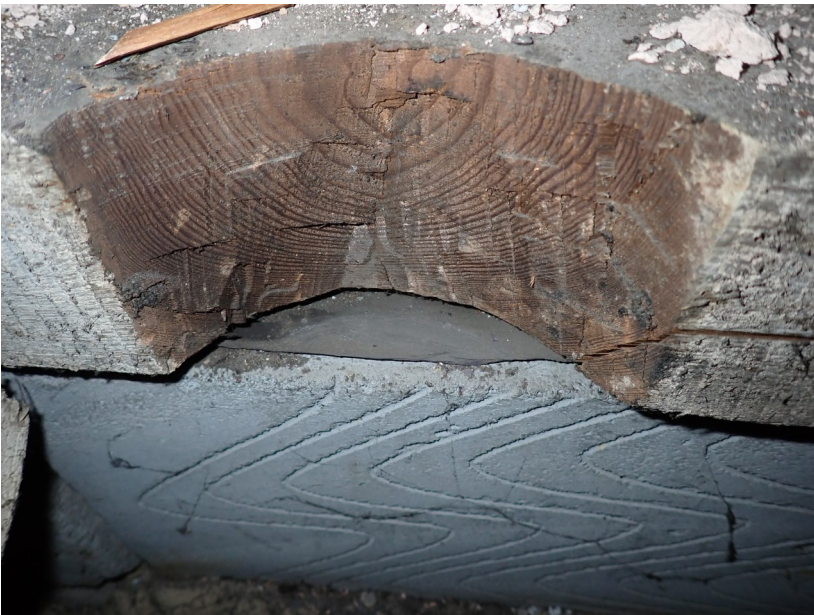
**Fig 56:**

Roof 2; showing plate isolation with bituminous material

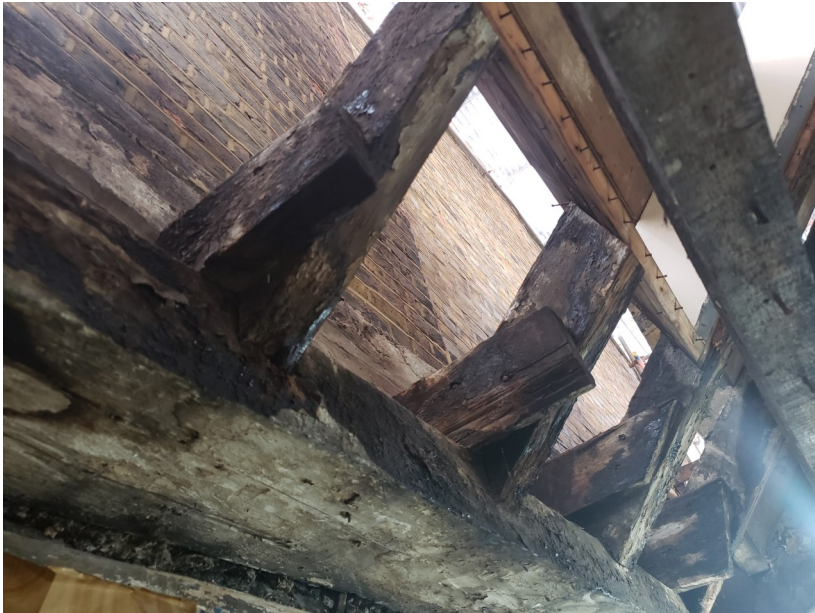
**Fig 57:**

Roof 6; showing a focused view common rafters 5-10 in the north pitch that had poor quality birdsmouth joints due to decay, as well as superficial decay to the plate and corrosion to mechanical fixings

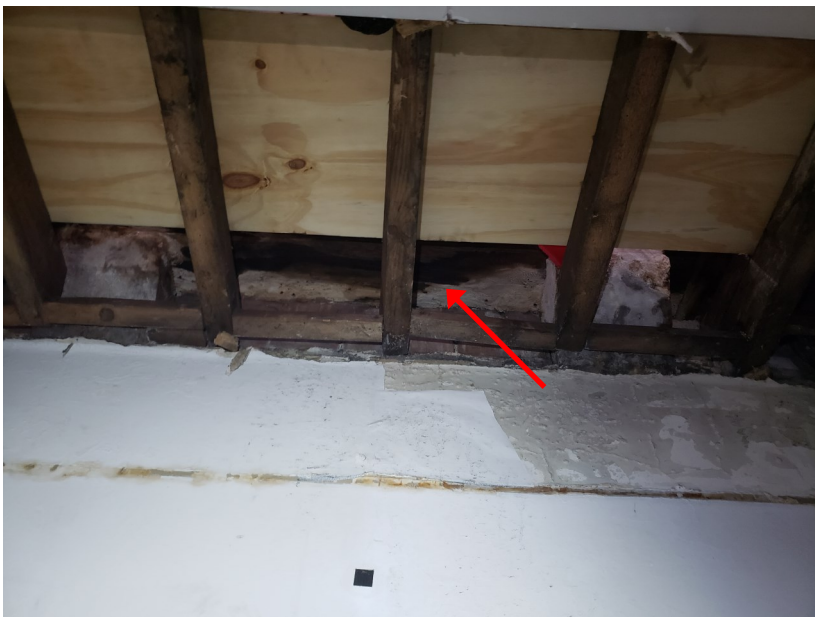
**Fig 58:**

Roof 6; showing a general view of a section of rafter plate in the north pitch that was supported by masonry corbels. This showed signs of partial decay for ~1m

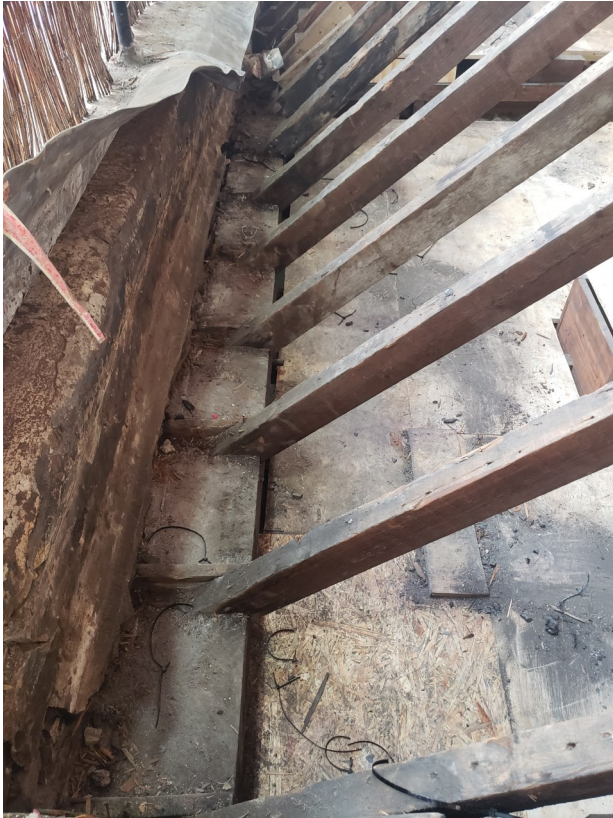
**Fig 59:**

Roof 6; showing a section of the eaves of the north pitch that been previously hidden underneath the leadwork of the parapet gutter. Note that minor decay had occurred to the small joists/upstands adjacent to each rafter

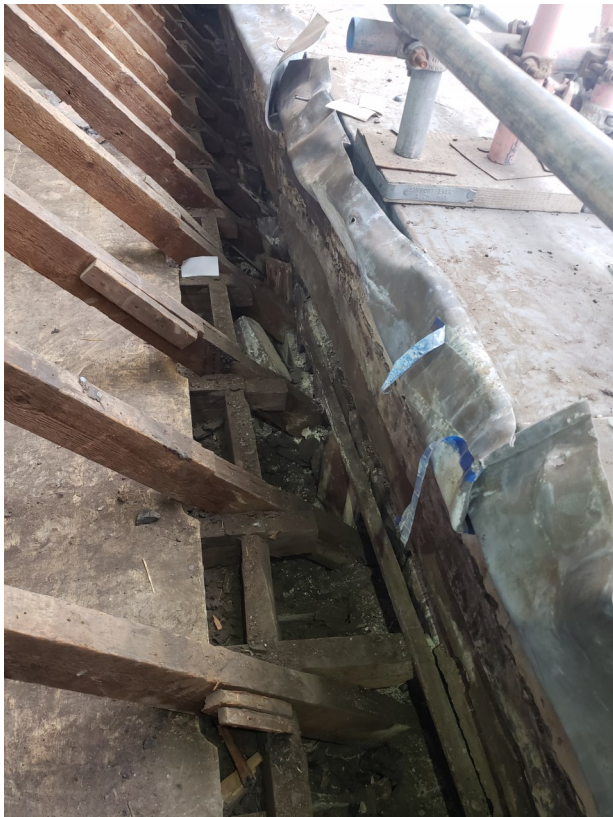
**Fig 60:**

Roof 6; showing the exposed embedded rafter plate within the north pitch, that had previously been encapsulated within the brickwork and leadwork over the parapet wall and gutter. Note the brickwork was seen to be highly unstable at this location

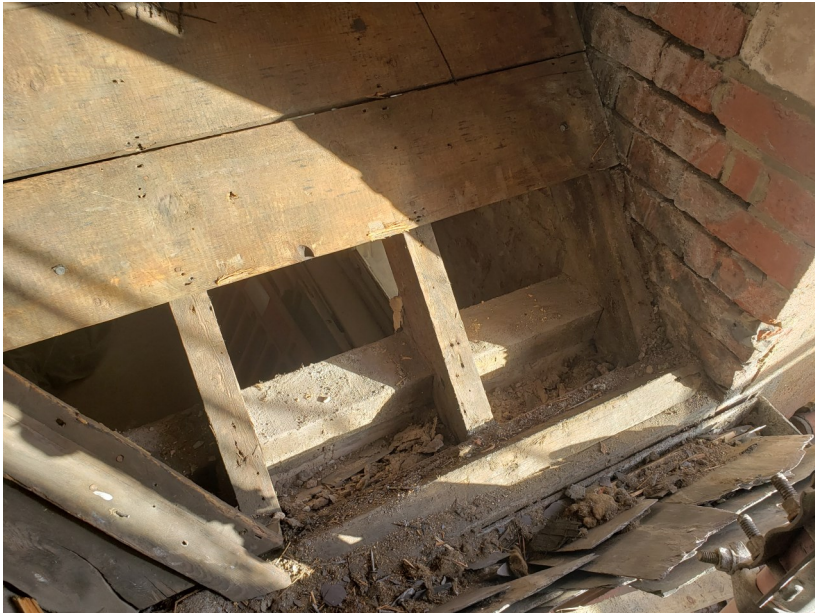
**Fig 61:**

Roof 3; showing a general view of the condition of the exposed rafter plate and the feet of the adjoining common rafters within the south pitch. No decay was detected, however excessive levels of debris were identified

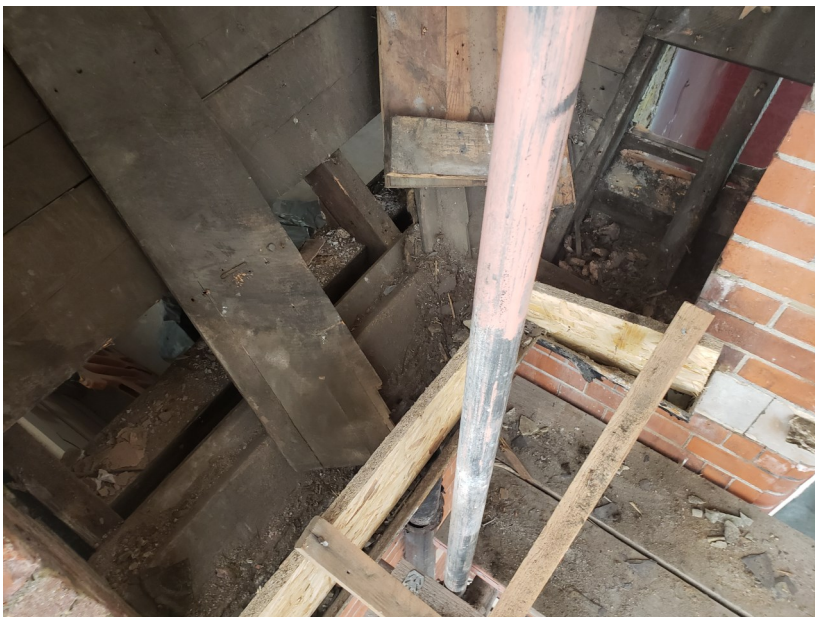
**Fig 62:**

Roof 3; showing a further general view of the condition of the rafter plate and common rafter feet. No decay was detected upon investigation using deep drilling and probing techniques

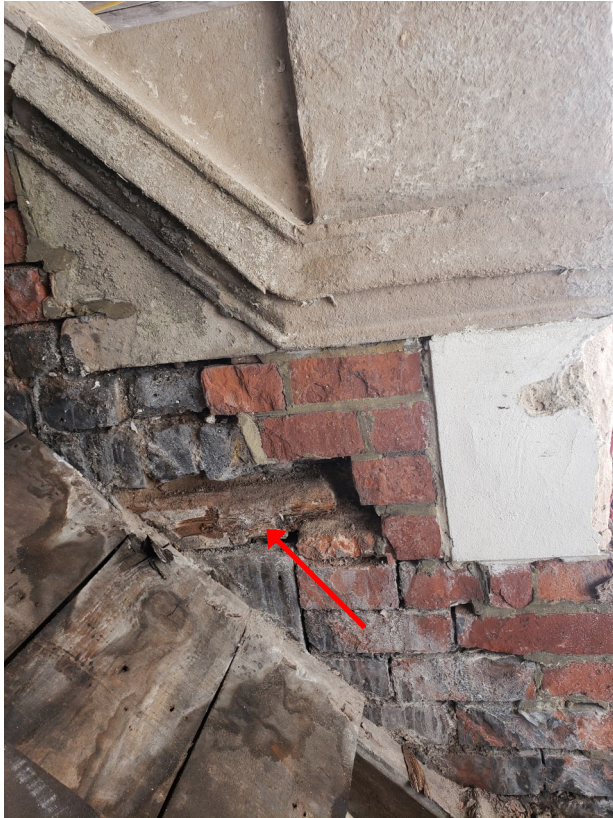
**Fig 63:**

Roof 3; showing 1 no. embedded lintel within the east gable wall. The lintel had been affected by a fungal decay organism, which could also affect structural roof timbers that were in close contact with the brickwork should their internal moisture levels become raised above the threshold

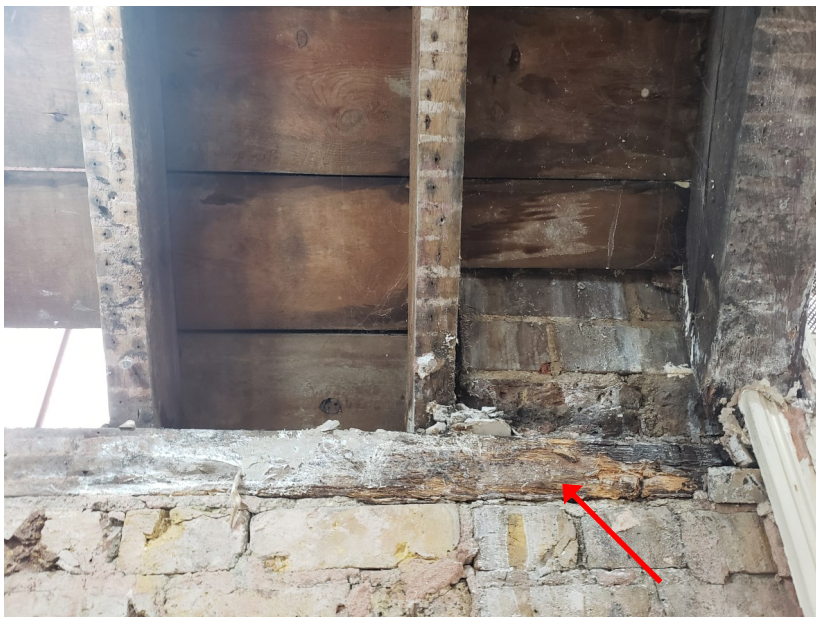
**Fig 64:**

Roof 4; showing a focused view of a section of rafter plate at the south – east. Note that the plate was structurally decayed for ~400mm

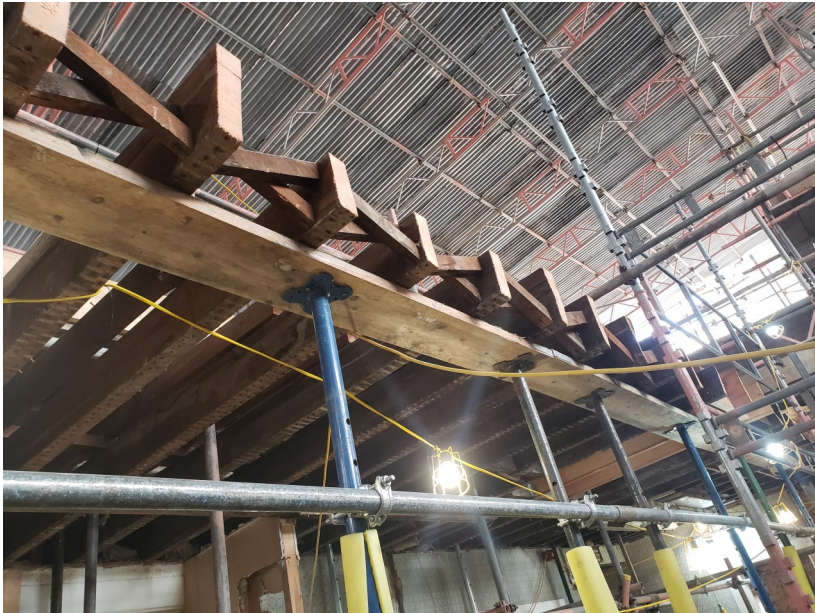
**Fig 65:**

Roof 7; showing a general view of the docked flat roof joists that previously formed the roof. No issues were identified at the time of survey

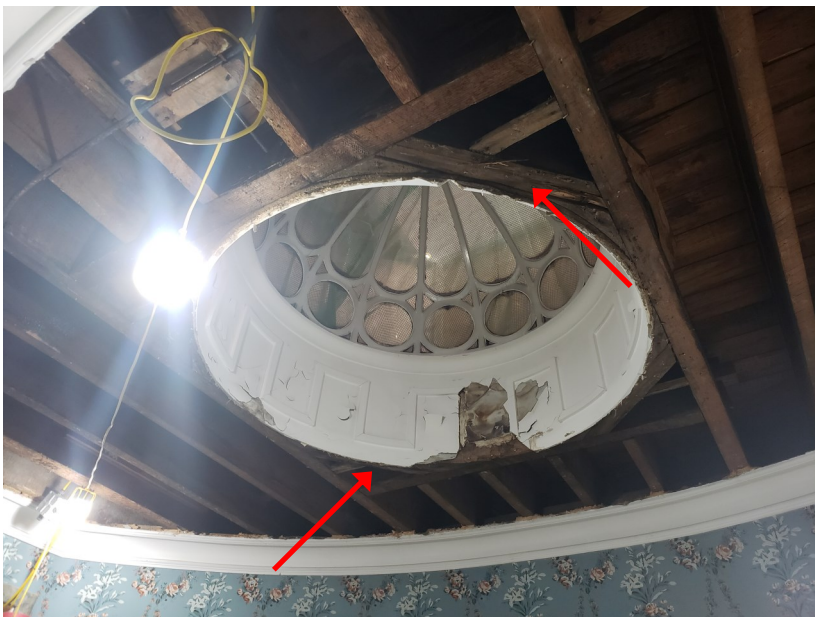
**Fig 66:**

Roof 8; showing a general view of the exposed joist forming the roof structure that supported the domed lightwell. Note the 2 no. diagonal noggings had been decayed
