## 41-43 Hay's Mews: Re-visit to reassess roof timber condition investigation (revised)

Site note 9 for December 2023, job no. 159-31

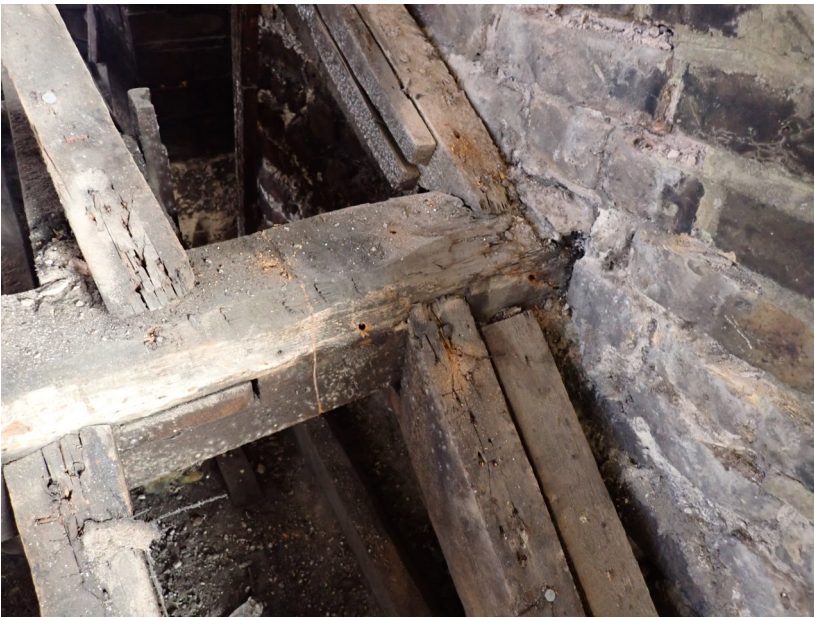
**Fig 2:**

Roof 5, west pitch; showing area of decay to purlin at south end

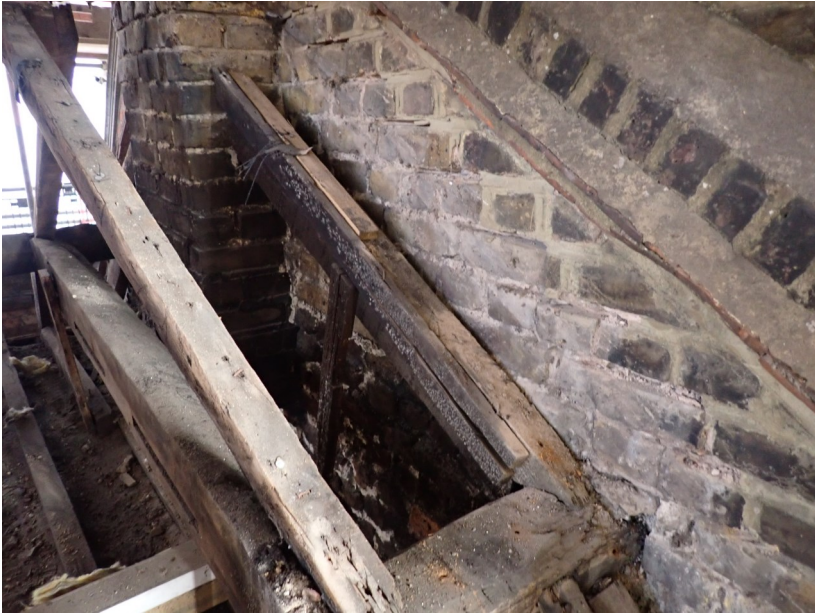
**Fig 3:**

Roof 5, west pitch; showing perimeter upper rafter at extreme south end unfixed to timber or masonry at head

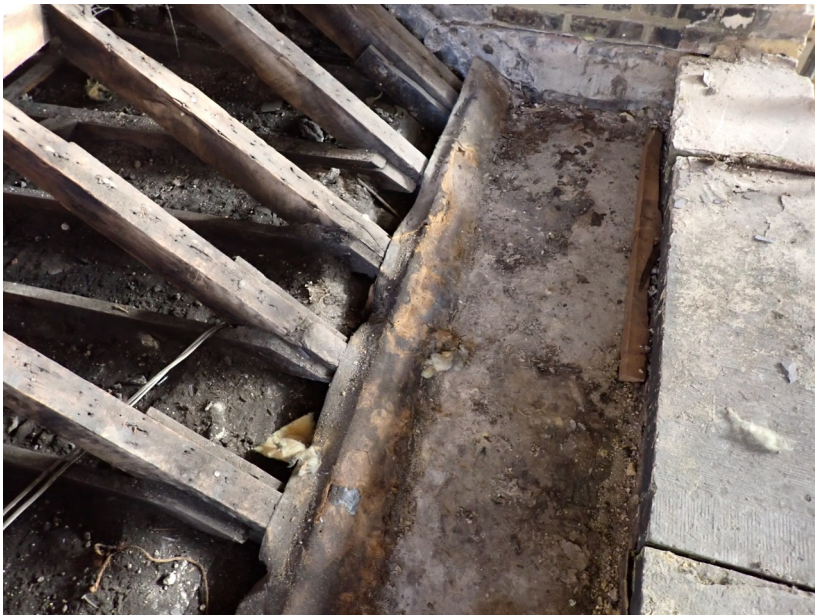
**Fig 4:**

Roof 5, west pitch; showing no access to drill or probe wall plate along west side

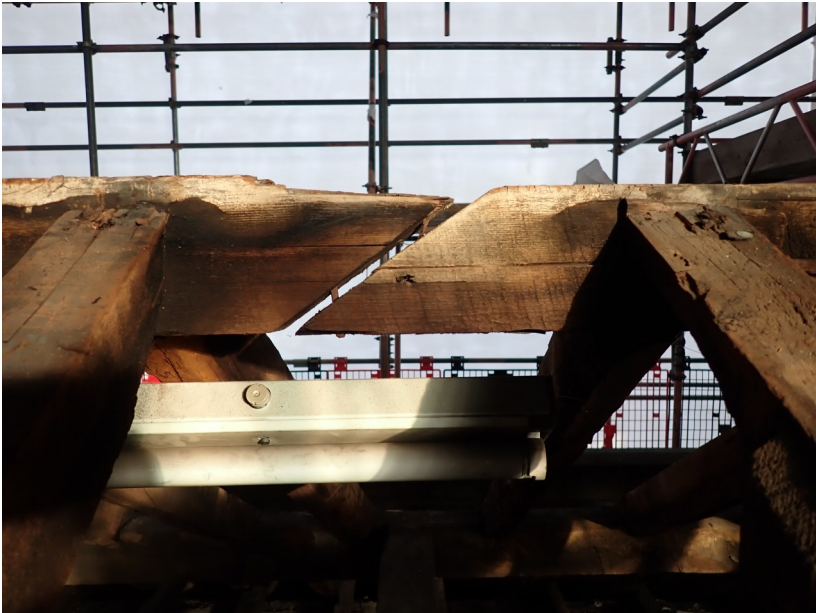
**Fig 5:**

Roof 5; showing disconnection between ridge board sections at southern end

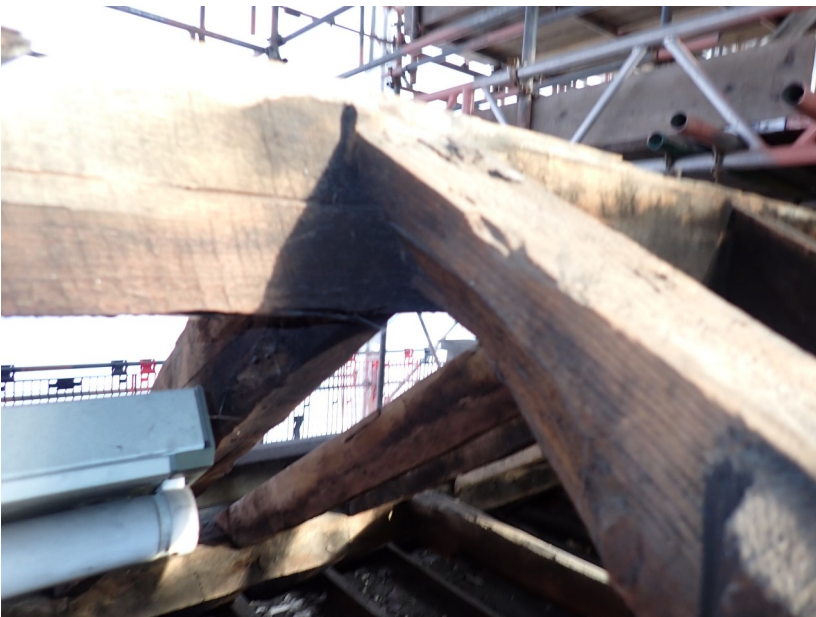
**Fig 6:**

- Damage/splitting to rafter feet and heads (roofs 5 and 6): Where rafters were damaged at heads and feet, the splitting and degradation of the timber was almost certainly due to the repeated re-fixing of the timbers to the ridge/plate after past refurbishment works as original holes were likely deemed unsuitable for new fixings or through the change in nail sizing. This had resulted in loss of fixing between the underlying plates/ridges and movement, and in some instances complete detachment, of the rafters in-situ

Roof 5, west pitch; showing loss of cross section to head of upper common rafter

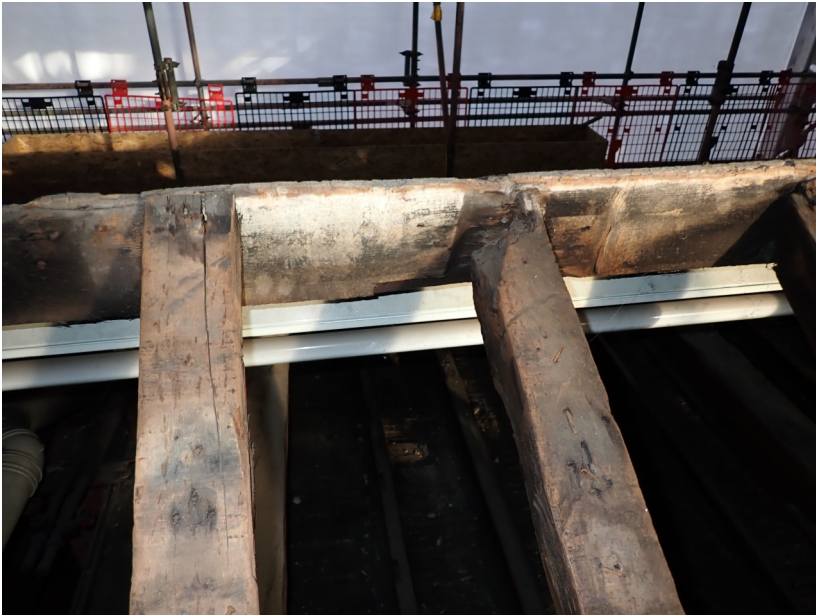
**Fig 7:**

Roof 5, west pitch; showing localised loss of cross section to head of upper common rafter and also split to adjacent rafter at head

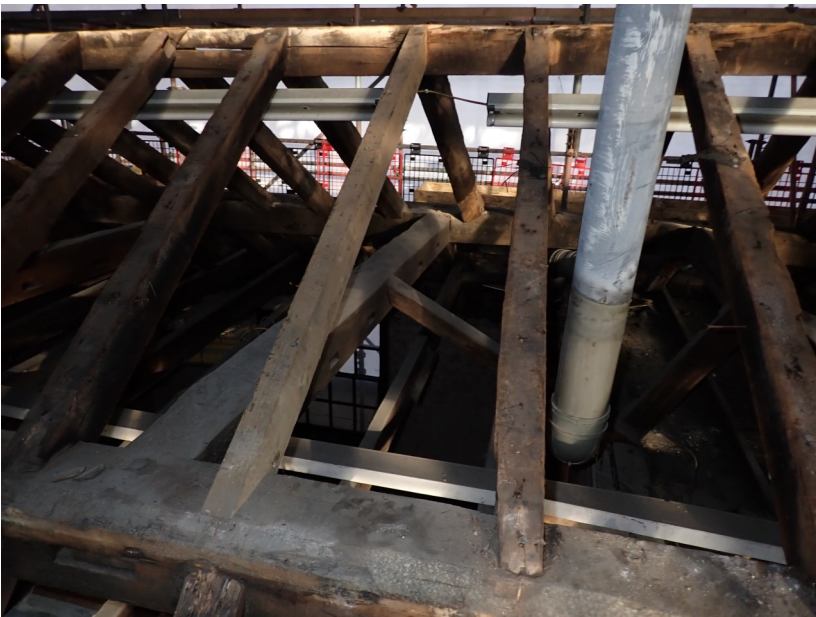
**Fig 8:**

Roof 5, west pitch; showing occasional use of softwood replacement rafters

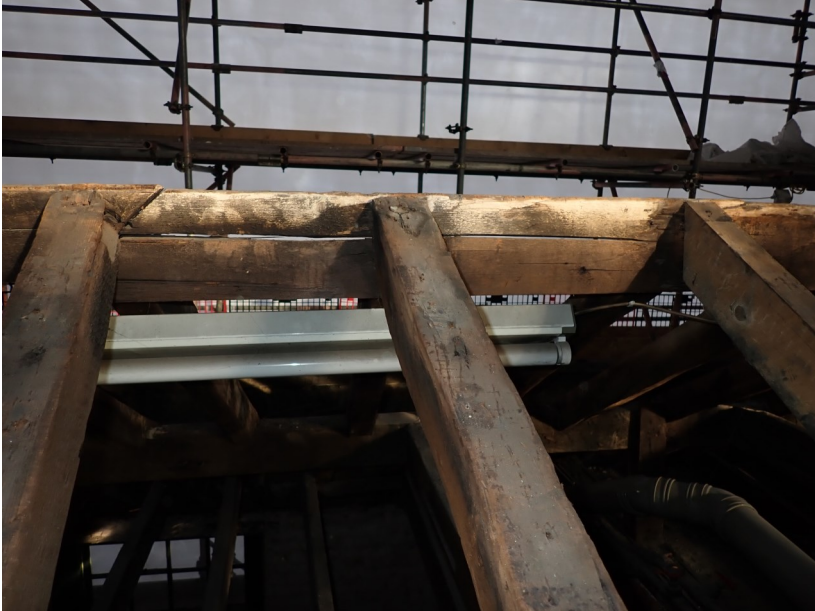
**Fig 9:**

Roof 5; showing large longitudinal split to ridge board at jointing location at approximate mid-span of roof

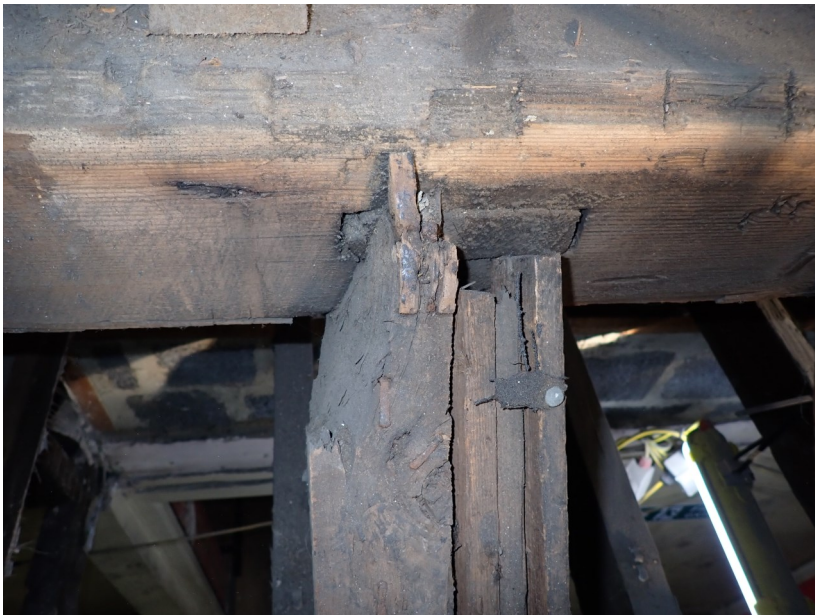
**Fig 10:**

Roof 5, west pitch; showing typical damage to head of lower rafter

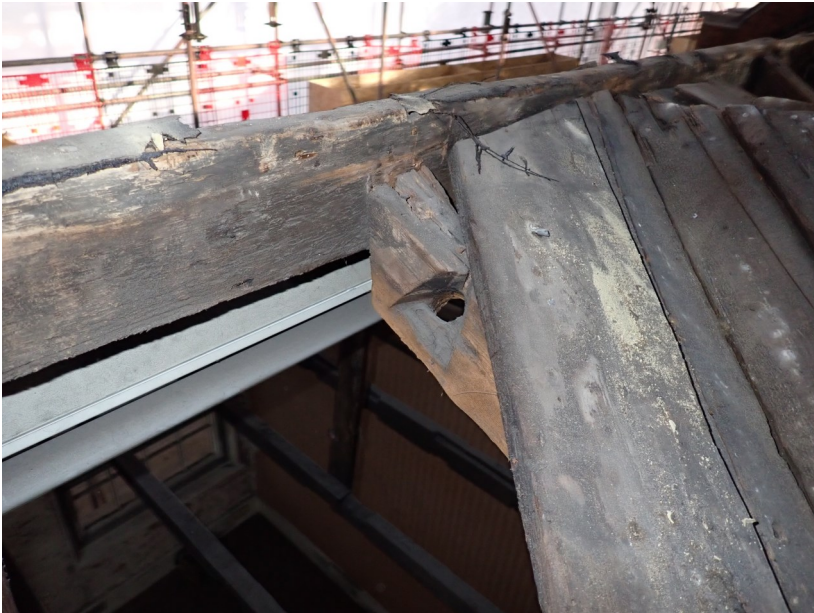
**Fig 11:**

Roof 5, north end, west pitch; showing large hole through head of upper common rafter

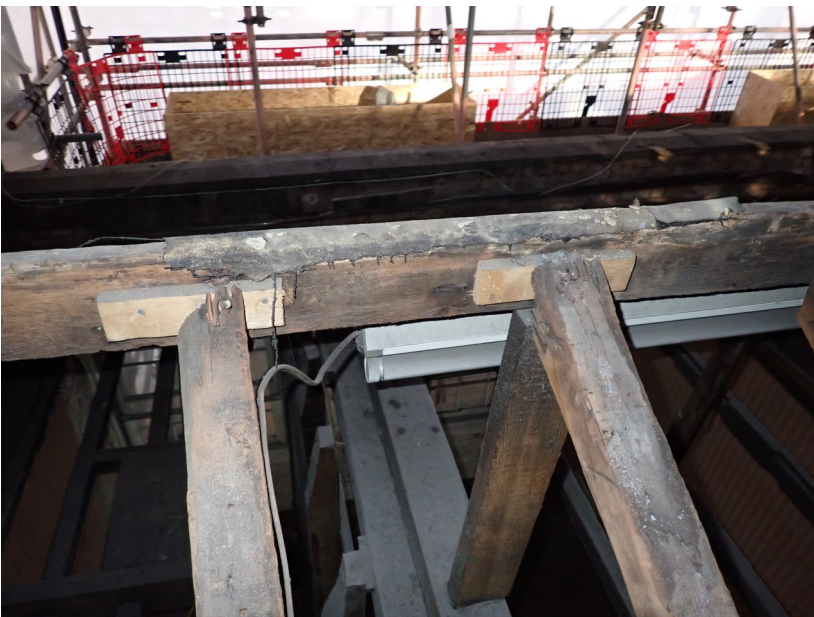
**Fig 12:**

Roof 5, west pitch, north end; showing upper common rafters packed between ridge board and plumb cut suggesting lengthening of space between upper rafter and ridge board further confirming racking and structural movement

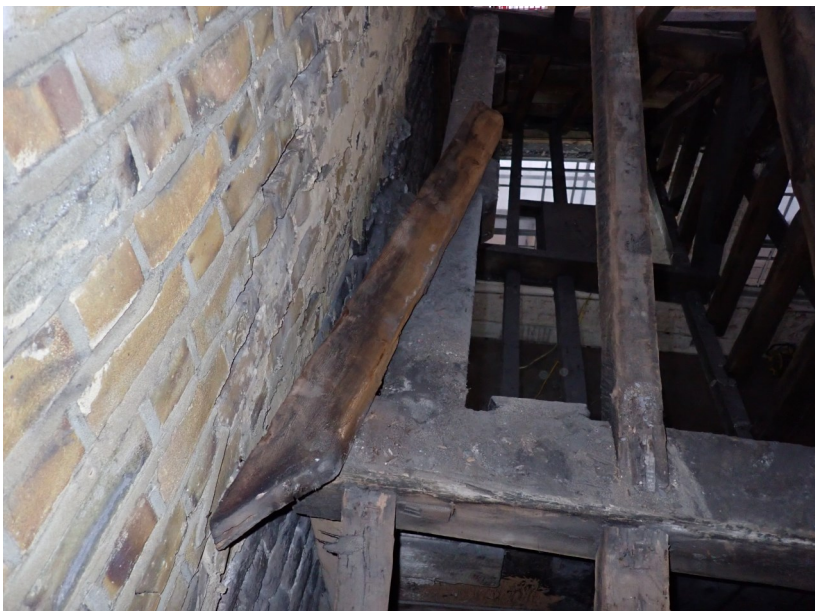
**Fig 13:**

Roof 5, west pitch, north end; showing complete detachment of upper common rafter at extreme north end

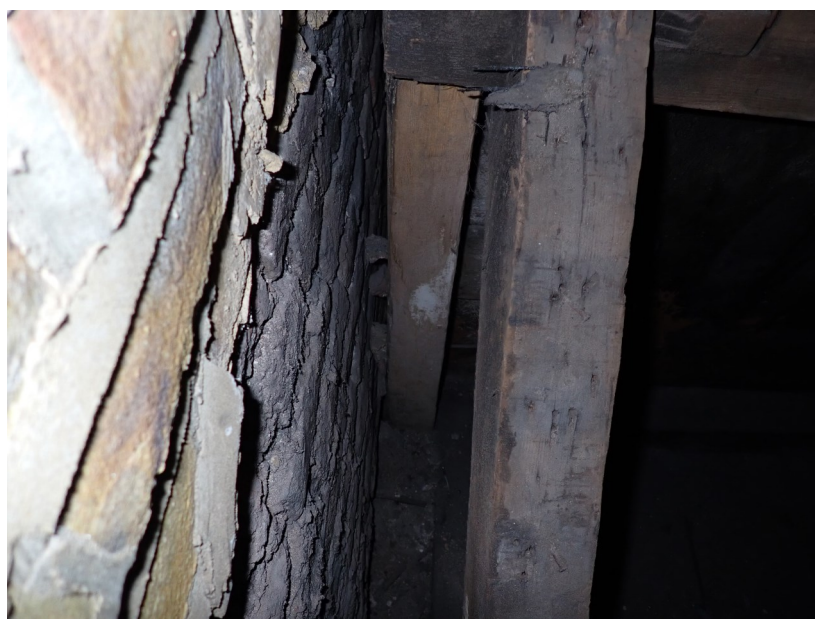
**Fig 14:**

- Structural defects: The general sagging of the purlins in roof 5 was likely to be a result of removal of intermediate supports during previous rounds of refurbishment works, indeed it would be unusual for a purlin of this length to be structurally unsupported via struts/bracing onto internal walls along the length. Likewise, and depending on the view of the Structural Engineer, the general racking of roof 5 towards the north was likely a combination of both the lack of intermediate support for the purlins and of any form of diagonal bracing

Roof 5, west pitch; showing outward movement of purlin support post at extreme north end suggesting dropping at purlin connection point

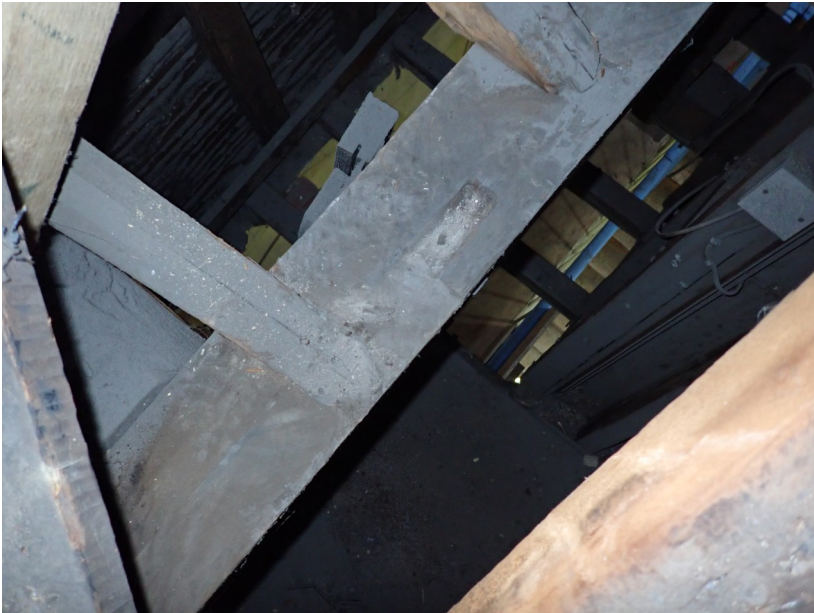
**Fig 15:**

Roof 5, west pitch; showing purlin connection approximately 2m back from north wall pegged Essex scarf joint
