Project Hays Mews
Client Confidential
Address 41-43 Hays Mews London W1J 5QA
Drawing Title Existing Pitched roof 5 sheet 1
Scale 1:5 & 1:10 @ A1
Status PY

Drawing No 2101-URA-DR-02240

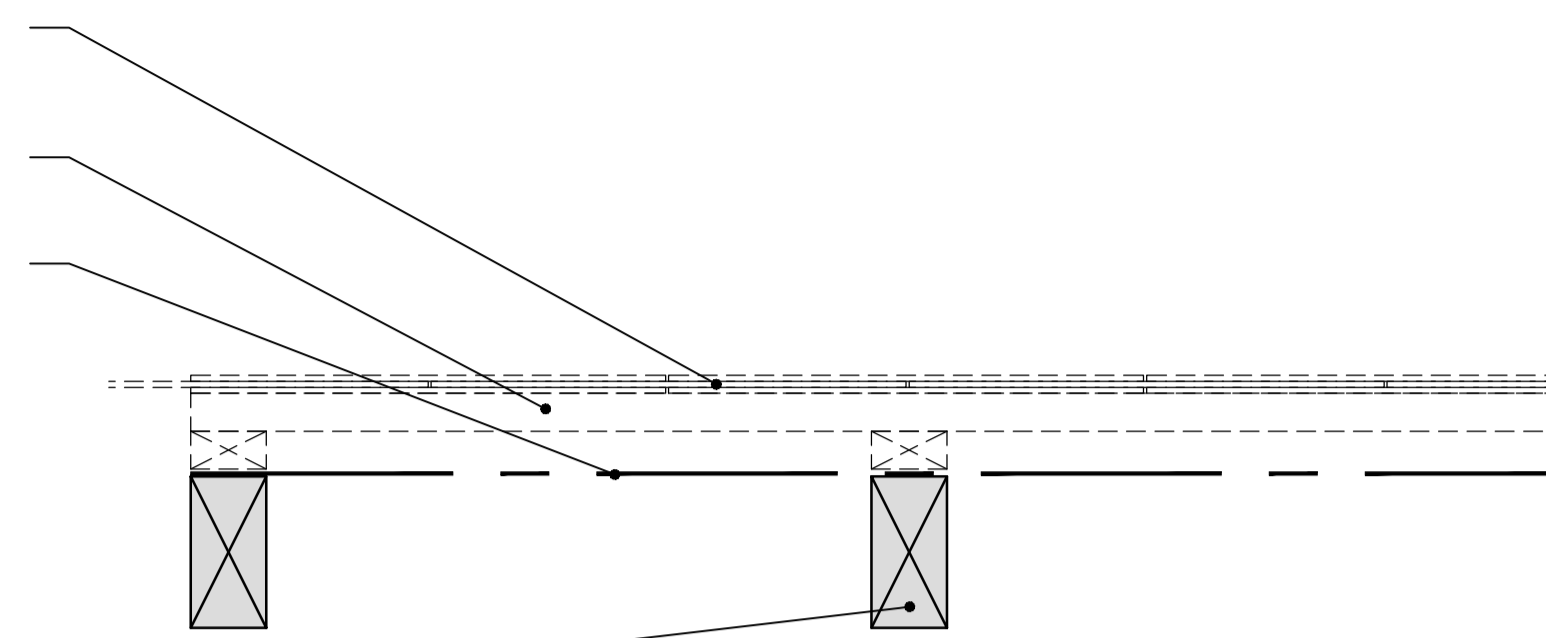
01 As Existing typical cross section of upper rafters
Scale 1:5 @ A1

Existing Pinus Sylvestris rafters, rotting, with significant section loss from wood boring beetles. Unfixed from main structure.

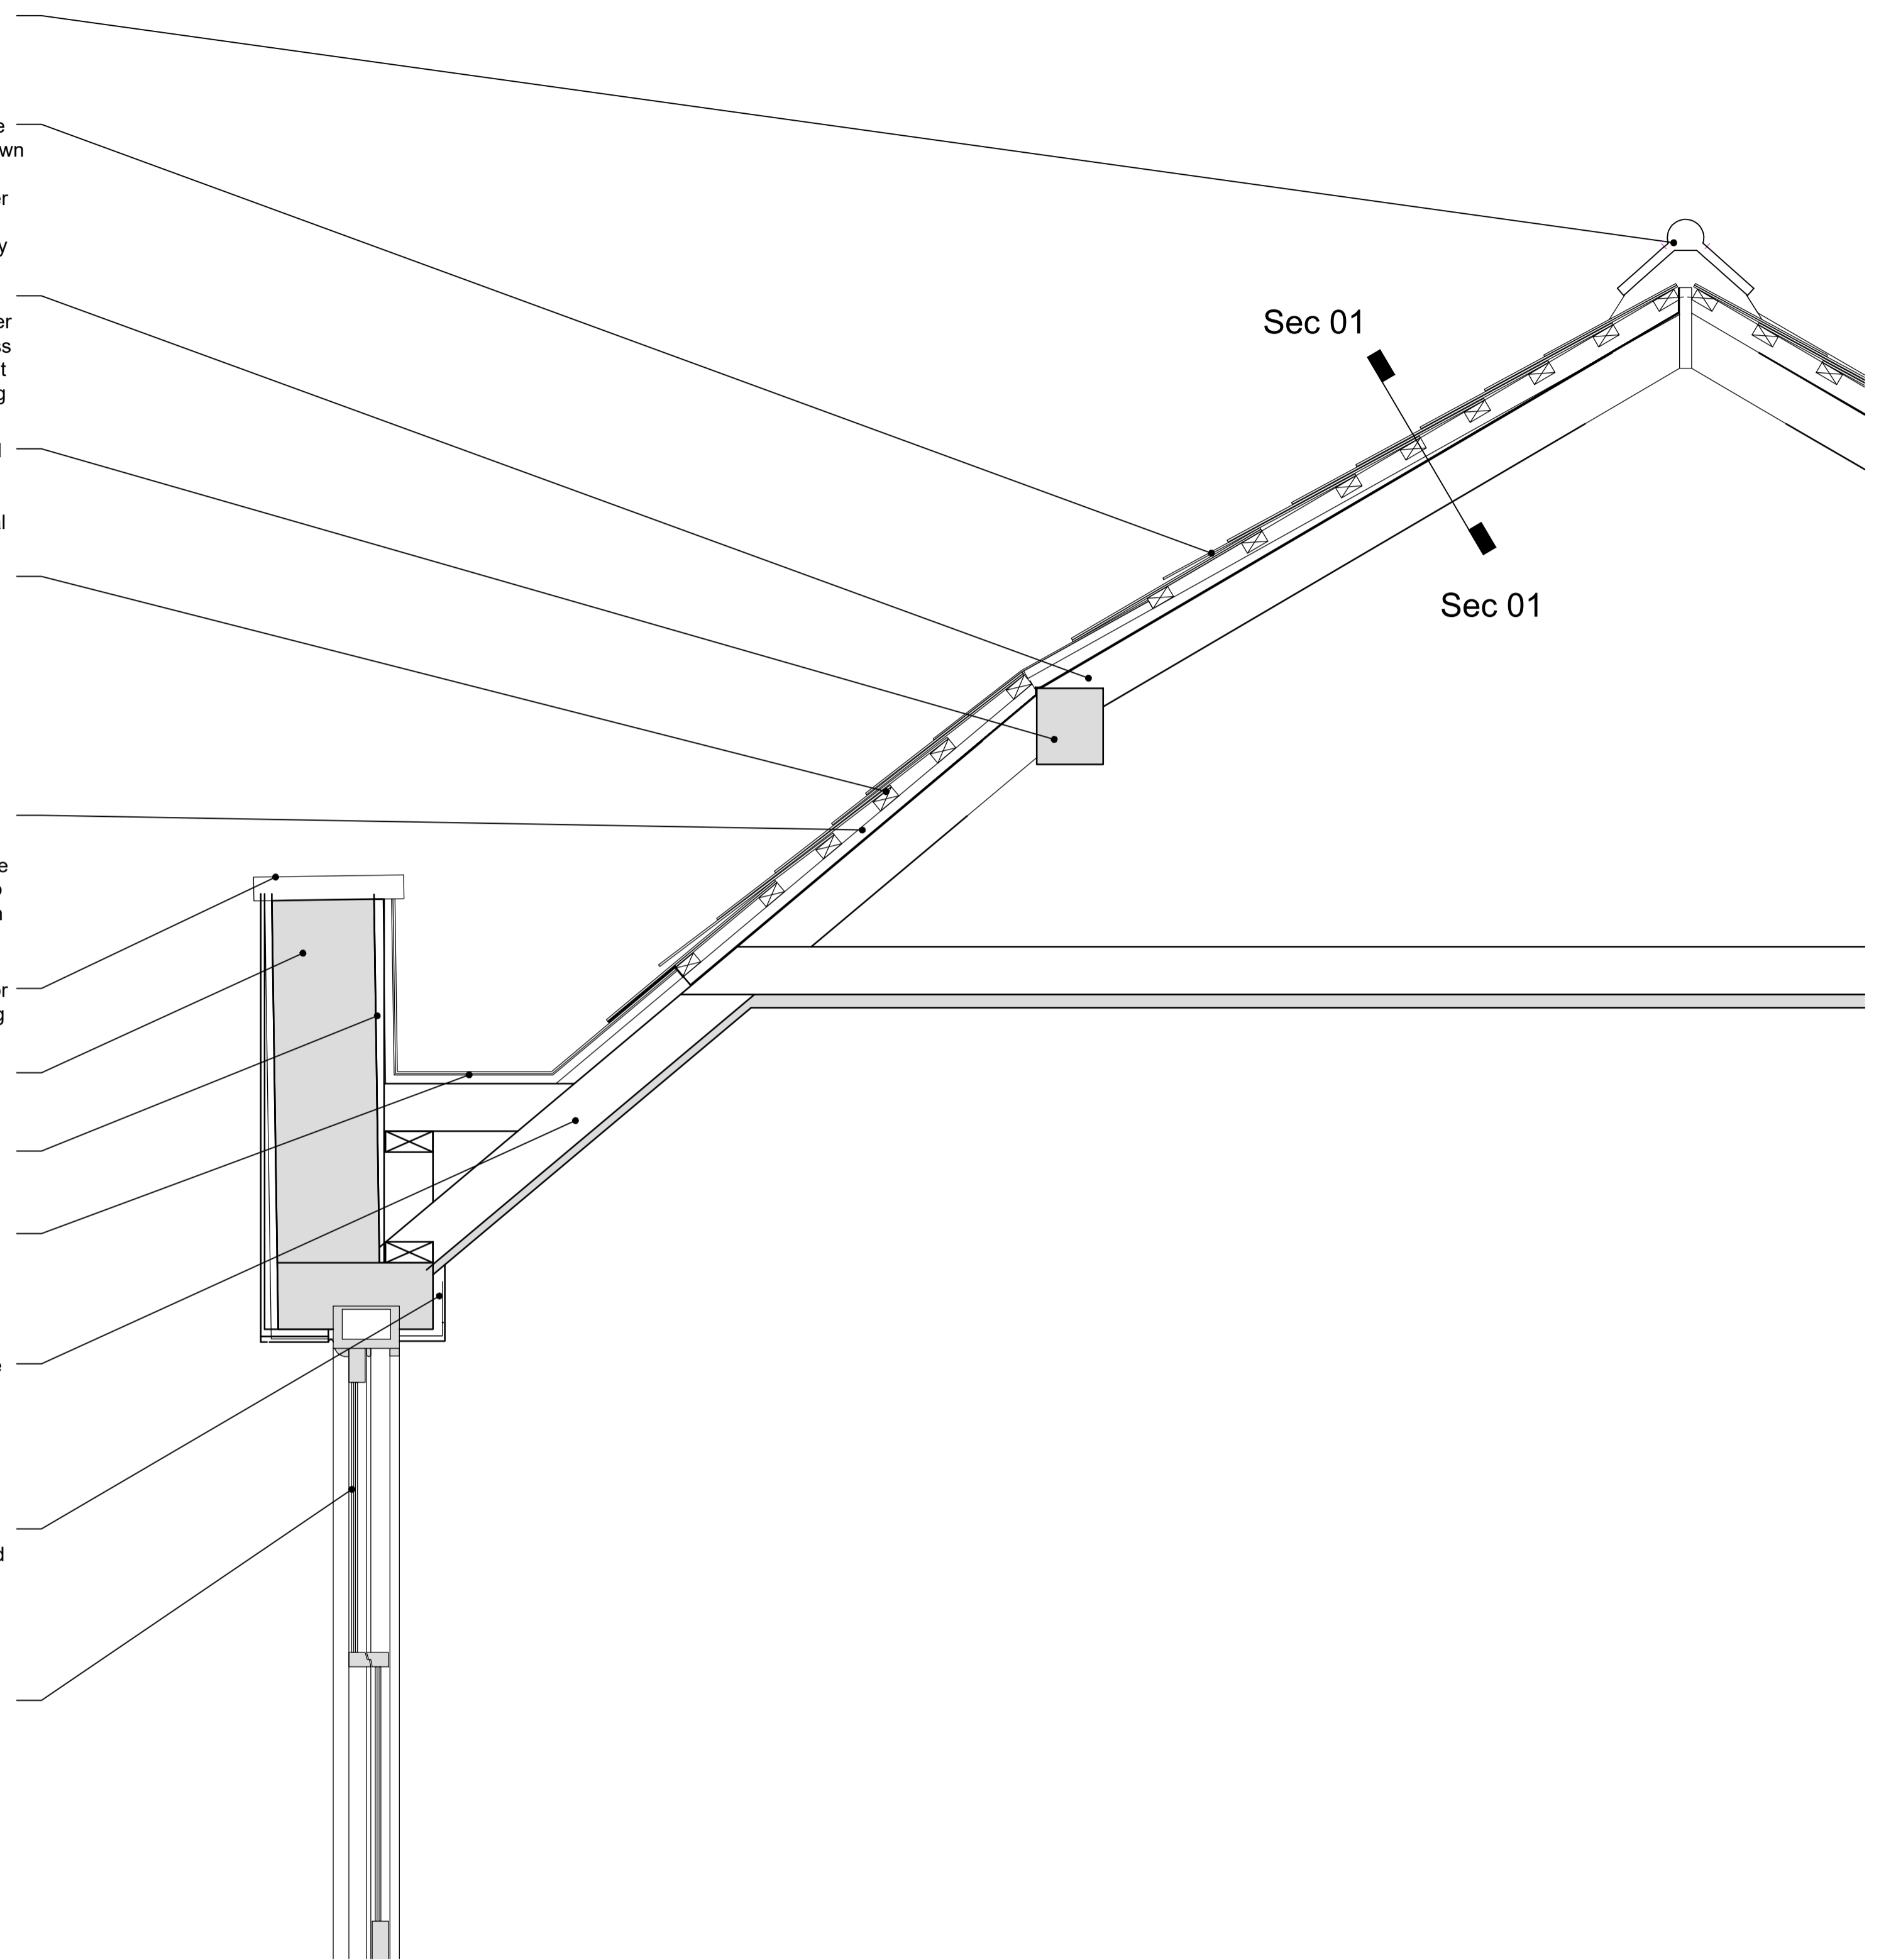
02 As existing part section of Roof 5. Repairs proposed the same for Roof 6
Scale 1:10 @ A1

Existing ridge uneven. Ridge board warped, undersized, with large splits and poorly spliced. Replacement required.

Existing reused Penryhn Heather Blue Welsh slates 4mm thick with 20% brown Spanish slates from refurbishments. Slates are delaminating and have over 4No. nail holes per slate. These cannot be reused again as they will break on nailing. Many rafters are not fixed and have slipped from their positions. The timber at the fixing has significant section loss due to racking and moisture ingress at corroded fixings. Timber needs cutting back to sound and splicing.

Purlins are not supported at party wall and sagging dangerously due to poor renovations removing mid supports and internal structural walls. Structural reinforcement required underneath.

Existing battens are undersized with poor fixings and ventilation zone contributing to moisture in timbers. Unspported high resistance bitumen felt below: this is causing water to pond on timbers and is not ventilated below. This is causing condensation on the roof timbers to the extent the timber is wet and needs drying out.

Existing Pinus Sylvestris rafters with some previous partner repairs. 50% section loss of timbers due to moisture levels allowing wood boring beetles to thrive. Significant splits and twisting in rafters. Replacement and partnering required to timbers.

Existing copings, 1980's concrete poor quality with little overhang contributing to water ingress in masonry.

1980's engineered brick parapet with cement mortar, leaning 1° due to lack of wind posts.

Existing cement render up to 40 mm thickness cracking and preventing moisture leaving masonry.

Existing Code 3/4 lead gutter corroding to underside. Uninsulated and ventilated and contributing to condensation on support timbers.

Lower rafters poorly fixed to wall plate and wedged to purlins. Rafters are loose and require fixing.

Existing gypsum and cement plaster from 1980's refurbishment, rotting and debonding in places. Impermeable plaster is contributing to the moisture building up in the masonry.

Existing sashes fitted in the 1980s. Existing sash timbers undersized, corners, meeting rails, sill and bottom corners are distorted, patched together and rotting. Windows require replacement. Poor roof and parapet detailing has lead to the box frame rotting.
