**41-43 Hayes Mews, Roof**  
Roof timber condition investigation - revisit  
November/December 2023

Hutton + Rostron Environmental Investigations Ltd  
Netley House, Gomshall, Surrey, GU5 9QA Tel: 01483 203221  
159-31 Site Note 9 -Not to scale- © Copyright Hutton+Rostron 2023

**41-43 Hayes Mews, Roof**  
 Roof timber condition investigation  
 July 2023 (initial visit)

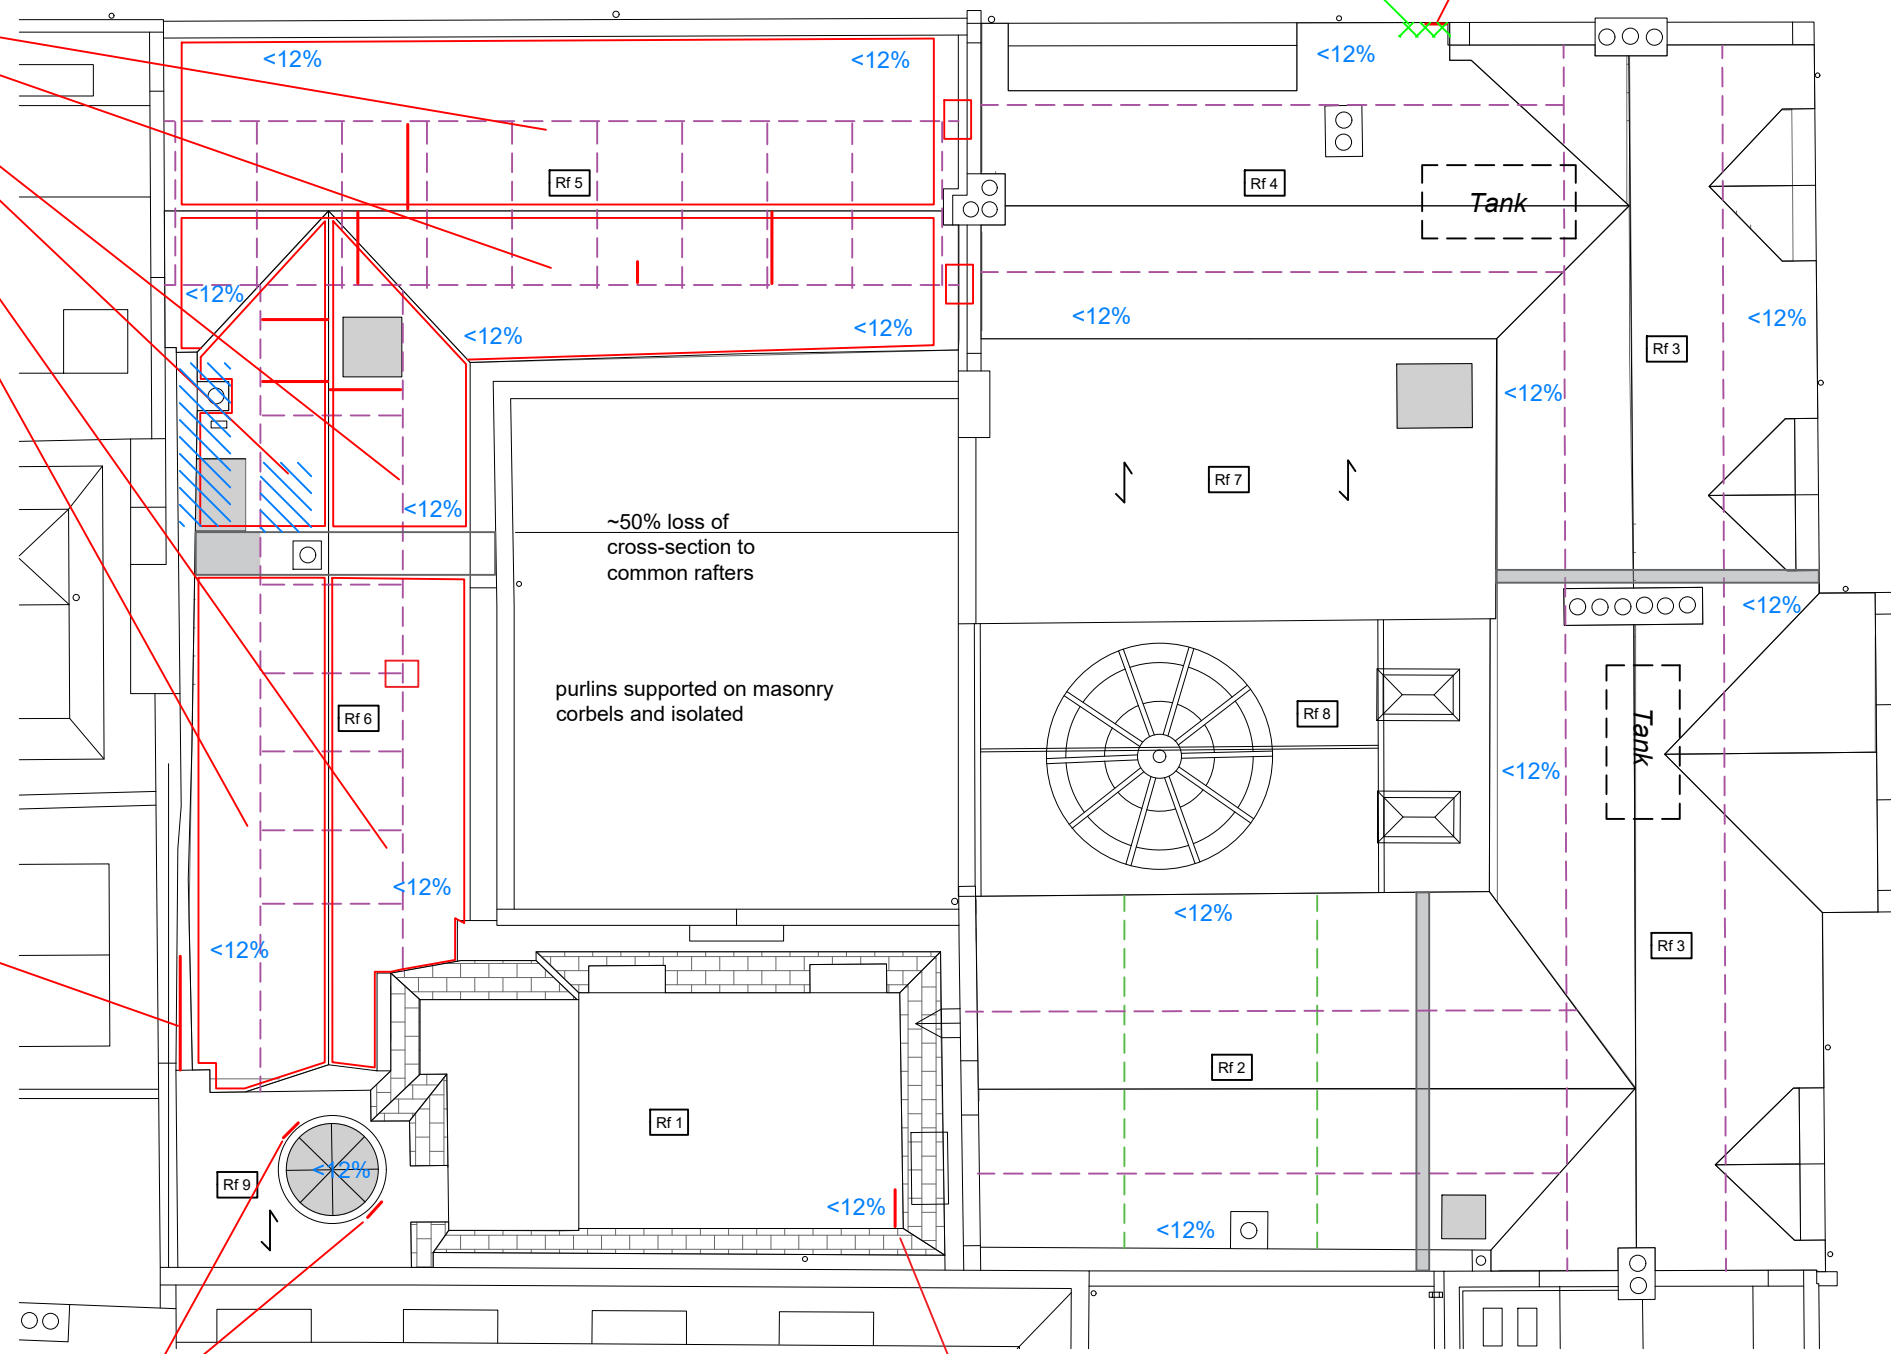
Multiple defects identified to upper and lower common rafters of both pitches. See attached schedule for further details

Mycelial growth over masonry and section of rafter plate

Section of rafter plate decayed for ~400mm. See drawings in Attachment A for further details

Rafter plate partially decayed along external edge for ~1m. See attached schedule for further details

2 no. noggings decayed ~150/200mm. See attached schedule for further details

1 no. flat roof joist decayed

~50% loss of cross-section to common rafters  
purlins supported on masonry corbels and isolated
