Arboricultural Report

Tree Condition Survey and Hazard Report:

Address: Queenshill Lodge, London Road, Ascot, SL5 7EQ

Reference: RCG-TCQL-2024/201

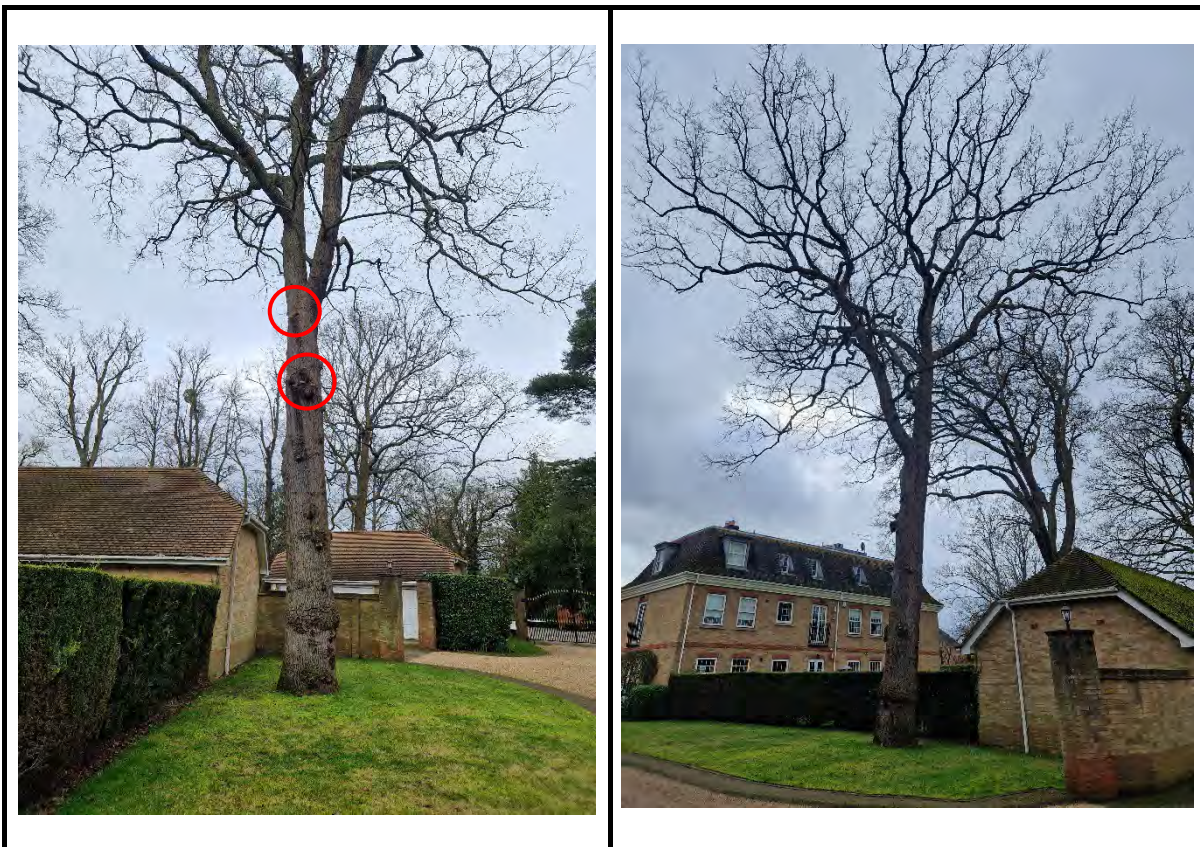
Above Left: Showing the location of the two cavities on South Side
 Above Right: Showing general crown density

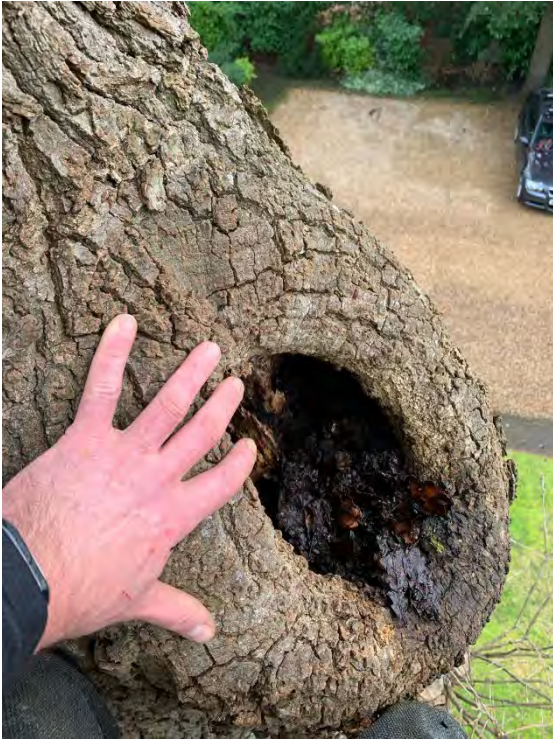
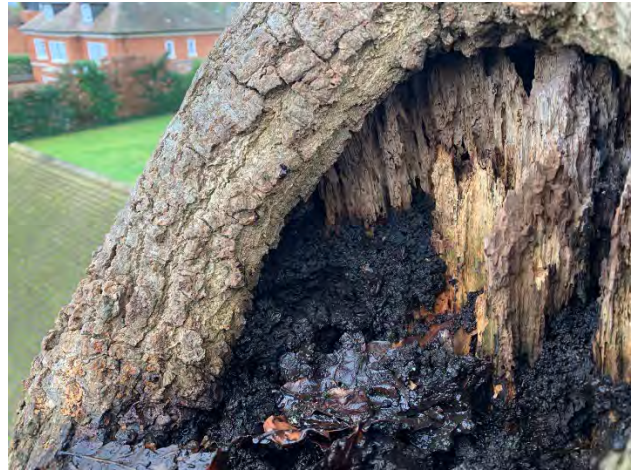
Above Left & Right: Cavity 1 (upper at 7m)

Length – 250mm | Width – 70mm | Probe Depth – 150mm | Callus growth – 120mm | Stem diameter 700mm

Both the upper and lower cavities are slowly but successfully occluding. Upper cavity is collecting detritus and forming a sludgy pocket but the tree appears to have compartmentalised the wounds with limited wood degradation and decay.

No remedial works required.

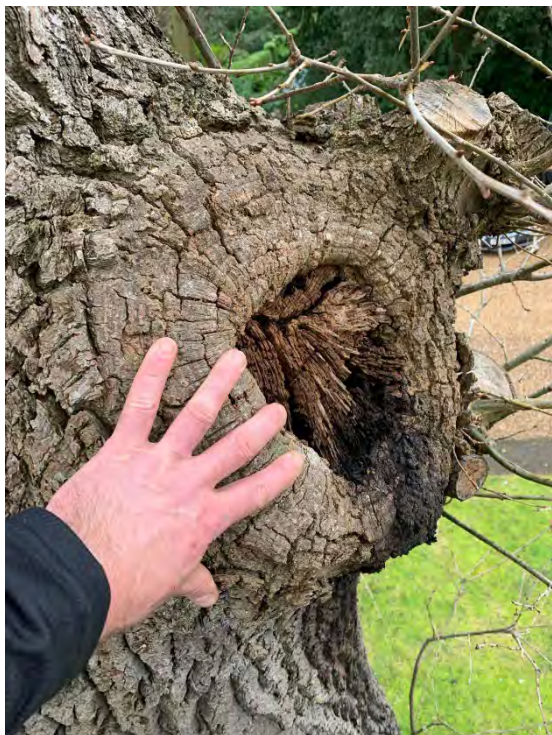
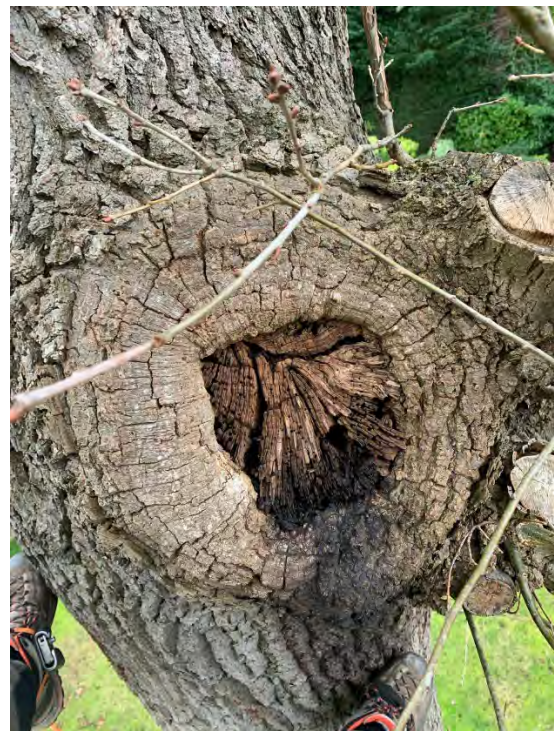
Below Left & Right: Cavity 2 (Lower at 6m)

Length – 180mm | Width – 160mm | Probe Depth – 90 /100mm | Callus growth – 110-130mm | Stem diameter 700mm

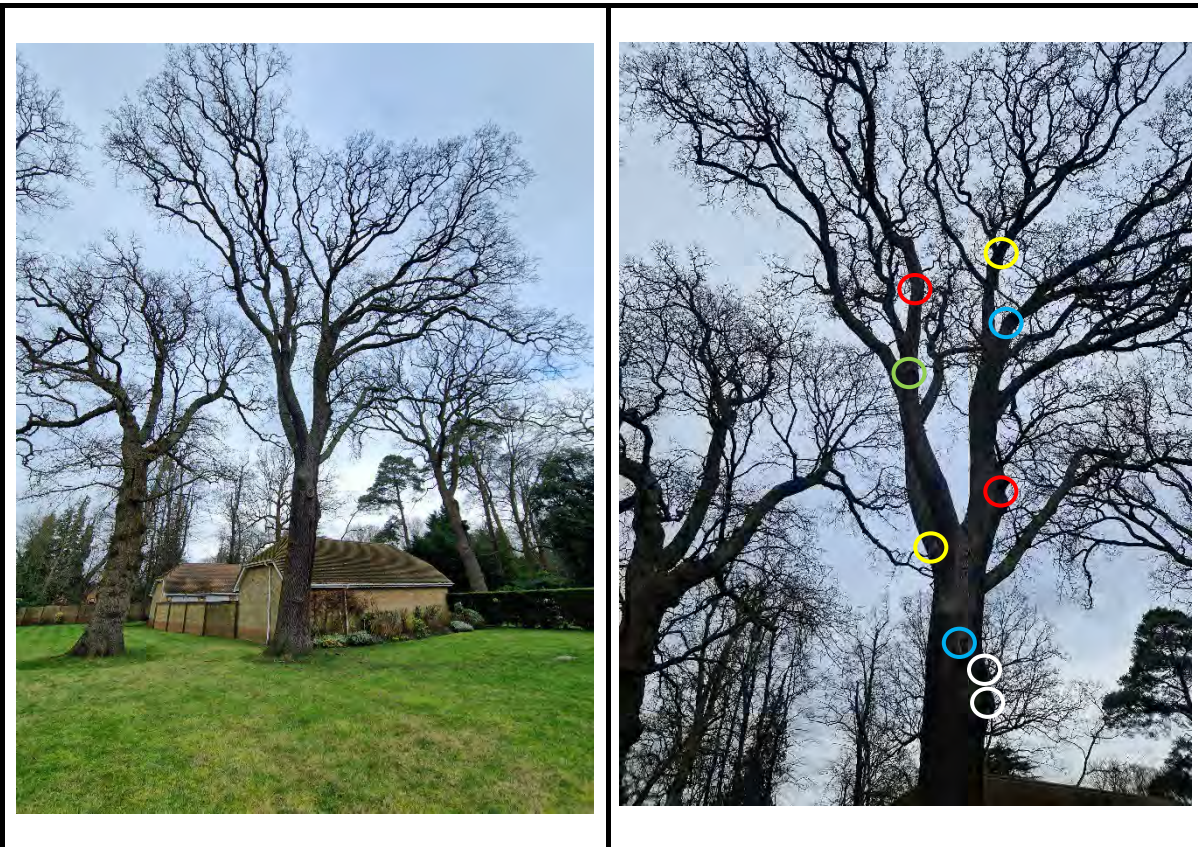
Above Left: Showing setting and general vitality
 Above Right: Showing locations of cavities and defects inspected

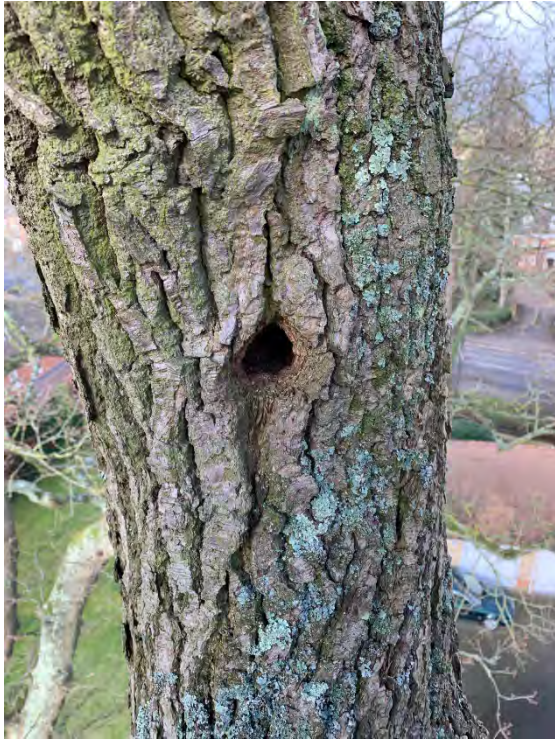
Above Left Cavity 1 Suspected Nesting Hole (Upper Red Circle)

Length – 30mm | Width – 30mm | Probe Depth – 50mm | Callus growth – N/A | Stem diameter 350mm

The associated reactive growth from a suspected old tear out above cavity 1 has resulted in a defect which will require some crown reduction remedial work to reduce the loading on the weakness.

| Tree Work Recommendations | |
|---|---|
| <p>T13 – Oak: Crown reduce the two identified limbs by up to 3m back to suitable growth points.</p> <p>2m crown reduction of remaining sections where necessary to balance the crown and prevent the shading out of the lower limbs.</p> <p>Reasons: To reduce the risk of limb failures from identified structural weaknesses.</p> | <p>3 months</p> |

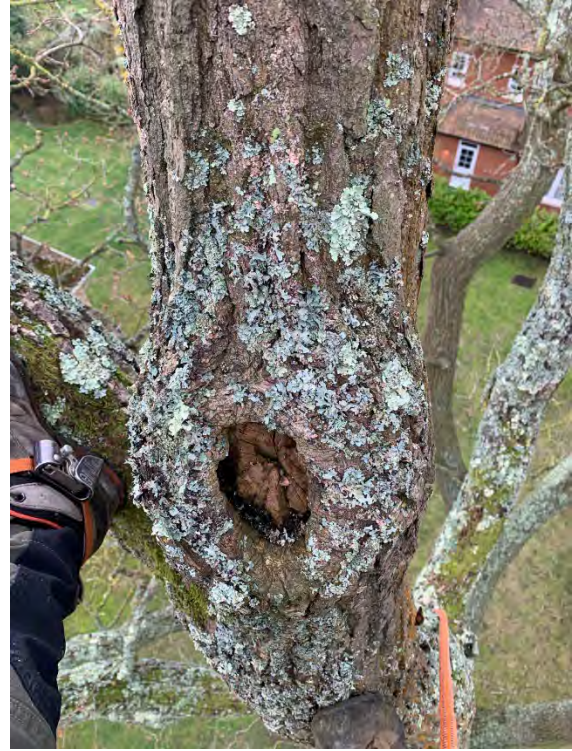
Above Right: Cavity 2 (Upper Yellow Circle)

Length – 70mm | Width – 40mm | Probe Depth – 60mm | Callus growth – 40mm | Stem diameter 300mm

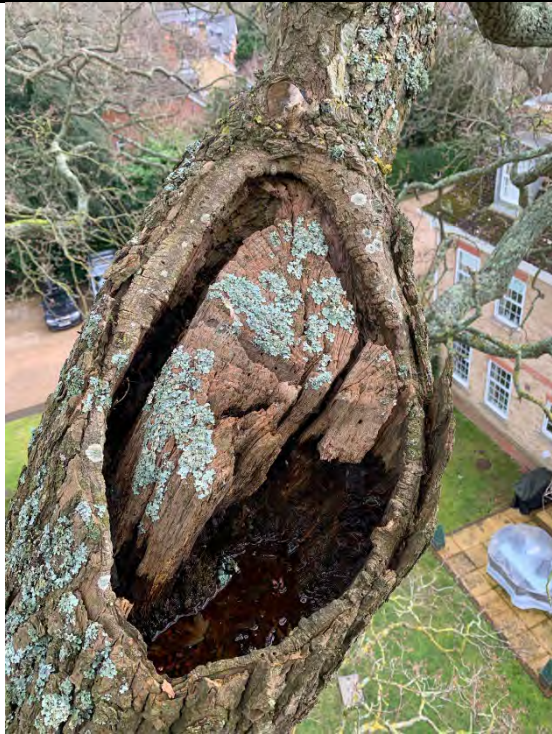
Below Left: Cavity 3 (Upper Light Blue)

Length – 450mm | Width – 250mm | Probe Depth – 50mm | Callus growth – 5-50mm |

Cavity 3 from a suspected lost old leader has produced a slight dog leg but with the cavity on the tension upper side of the main limb growing towards the main building. This limb will need to be crown reduced to lessen the loading and weight put through the branch at the structural weakness.

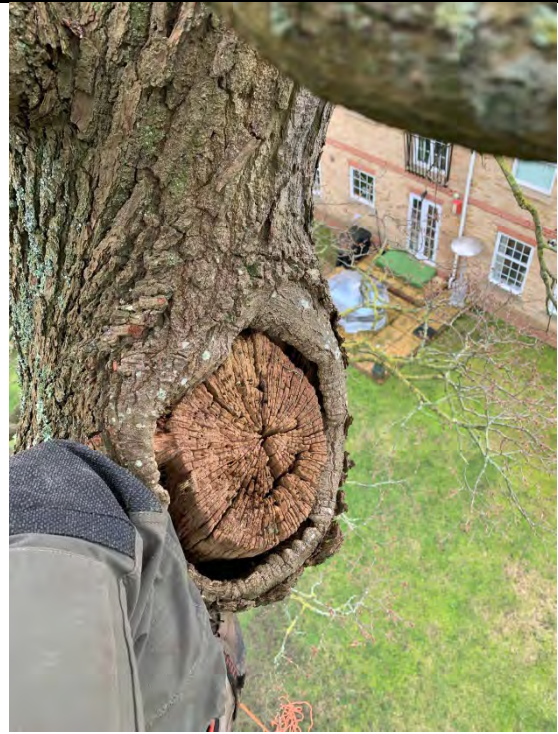
Below Right: Cavity 4 (Green Circle)

Length – 260mm | Width – 220mm | Probe Depth – 40mm | Callus growth – 20-70mm | Stem diameter 430mm

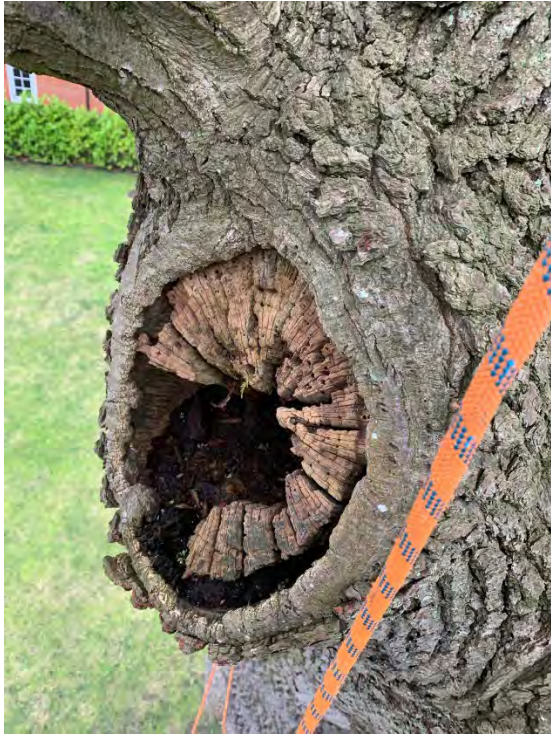
Above Left Cavity 5 Suspected Nesting Hole (Lower Red Circle)

Length – 280mm | Width – 230mm | Probe Depth – 240mm | Callus growth – 20-70mm | Stem diameter 780mm

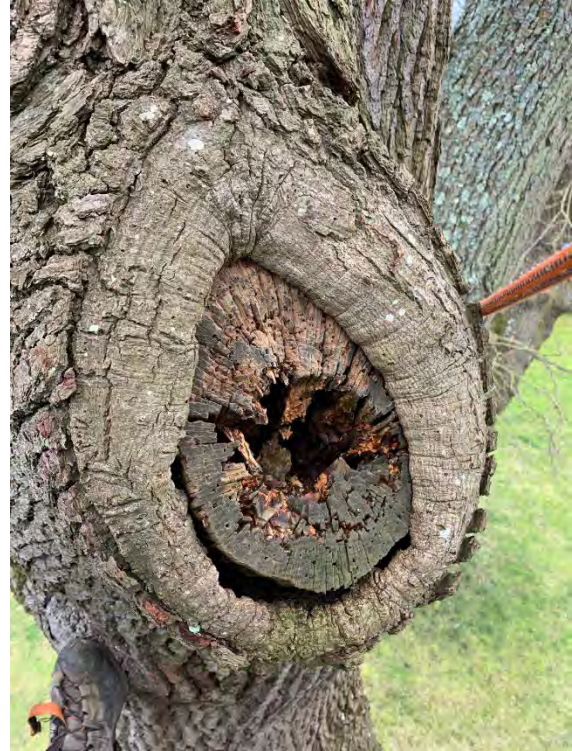
Above Right: Cavity 6 (Lower Red Circle)

Length – 270mm | Width – 180mm | Probe Depth – 150mm | Callus growth – 40-80mm | Stem diameter 750mm

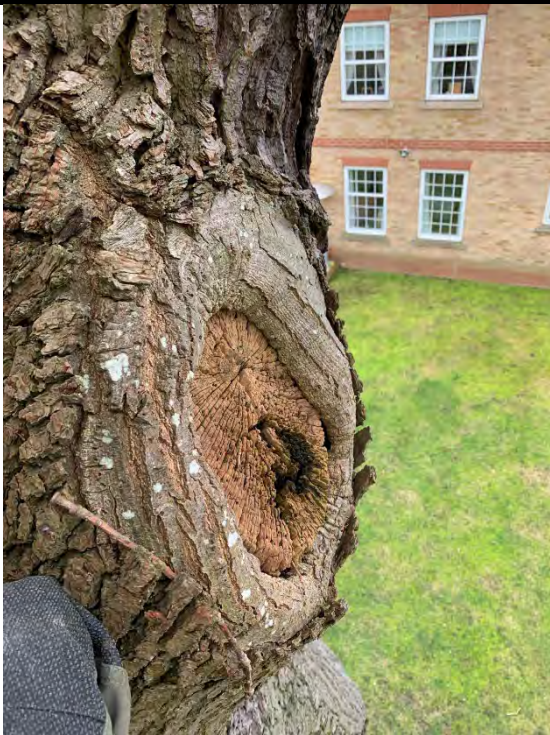
Below Left: Cavity 7 (Lower Yellow Circle)

Length – 260mm | Width – 170mm | Probe Depth – 0mm | Callus growth – 40-90mm |

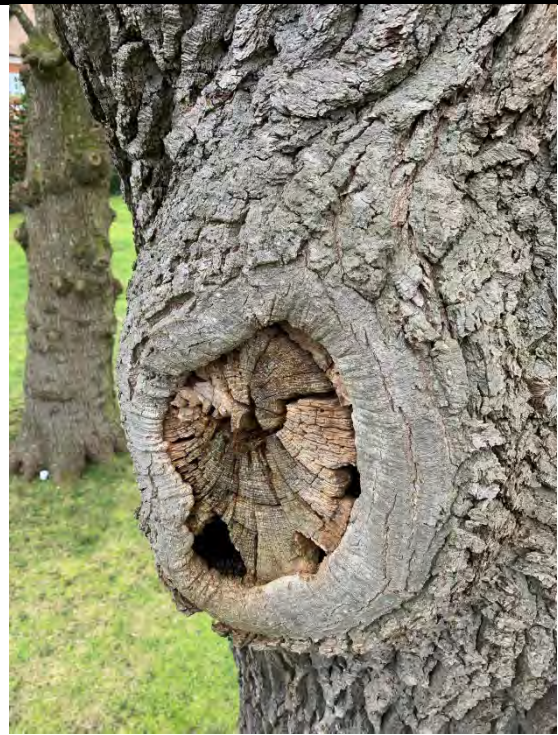
Below Right: Cavity 8 (Upper White Circle)

Length – 300mm | Width – 190mm | Probe Depth – 130mm | Callus growth – 50-80mm | Stem diameter 1200mm+

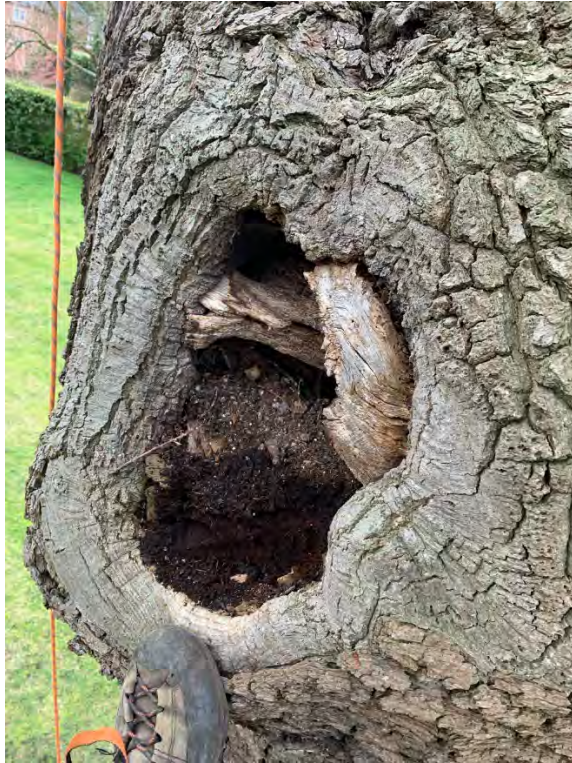
Above Left Cavity 9 (Lower White Circle)

Length – 400mm | Width – 280mm | Probe Depth – 350mm | Callus growth – 50-130mm | Stem diameter 1250mm+
