Tree Survey Report

The Rectory, Church Street, Staveley,
Chesterfield, S43, 3TN

3rd March 2024

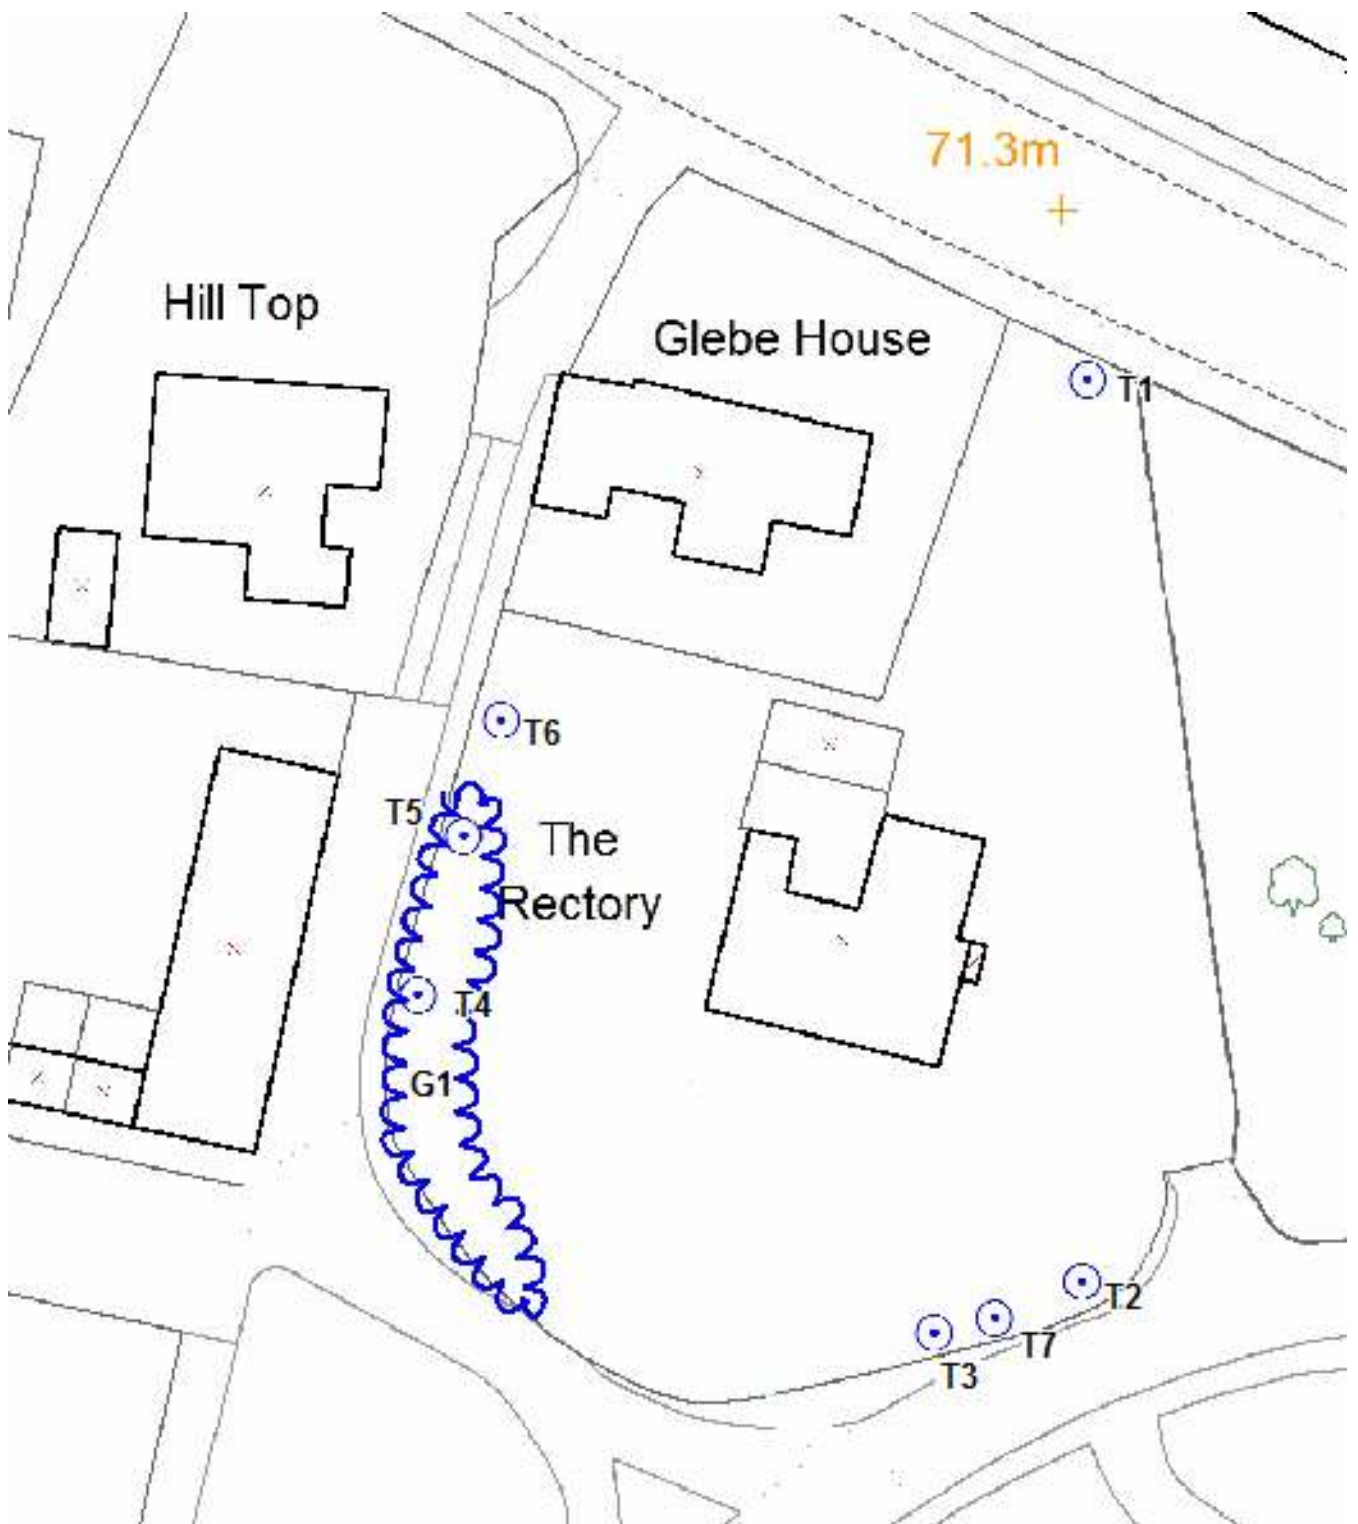
SCHEDULE 2

Trees and groups of trees marked on the plan in **Green** may be retained without work at the present time.

Trees and groups of trees marked on the plan in **Blue** may be retained following the completion of the work detailed in Schedule 1.

Trees and groups of trees marked on the plan in **Red** are to be removed and the resultant stumps are to be treated as detailed in Schedule
