Engineers Report

Risk Address Helios House
Clarkes Lane
Barsham
NR34 8HN

360 Reference LIV-SN-22-006091
Insurer Reference 610-11-000307
Policy Holder Mrs. Ann Gaskin

Date Notified 11th November 2022
Date of Assessment 16th January 2023
Report Date 16th January 2023

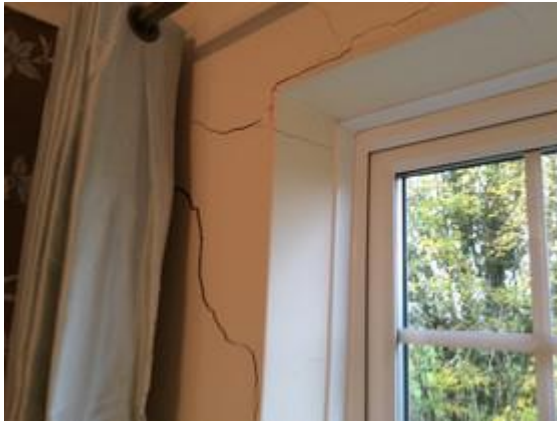
Tapering cracking above and below windows up to 10mm wide.

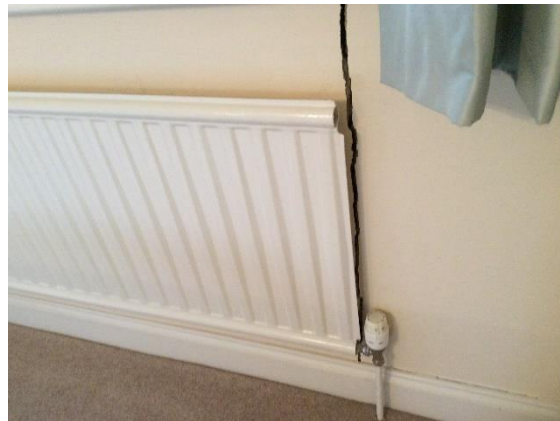
Tapering cracking above and below windows up to 10mm wide.

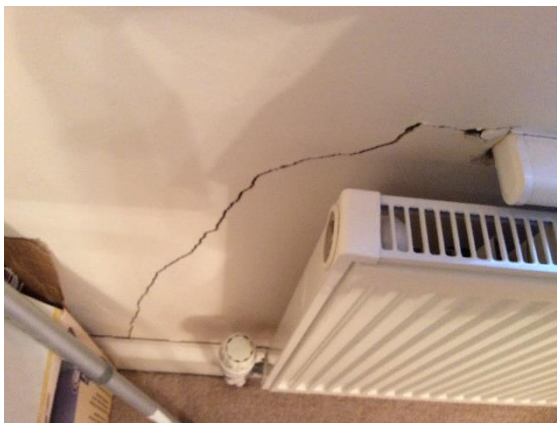
Tapering cracking above and below windows up to 10mm wide.

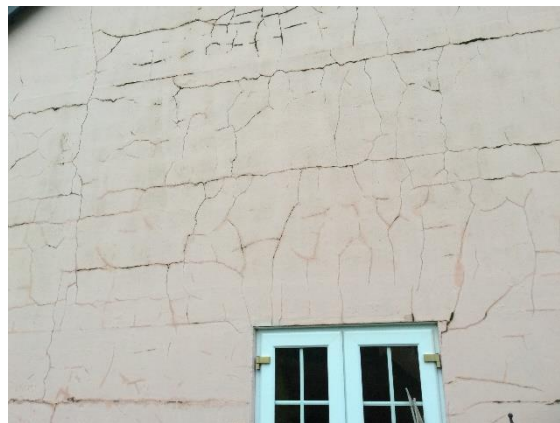
Render in a poor state of repair on gable wall.

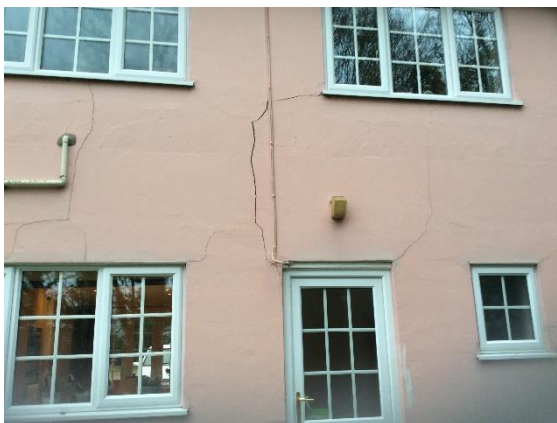
Tapering cracking above and below windows up to 10mm wide.
