CCTV REPORT FOR: HELIOS HOUSE
CLARKES LANE
BARSHAM
NR34 8HN

Insured: Mrs. Ann Gaskin
Reference: LIV-SN-22-006091 Ins Ref: 610-11-000307

Site Visit: 03-Apr-23
Report Date: 12-May-23

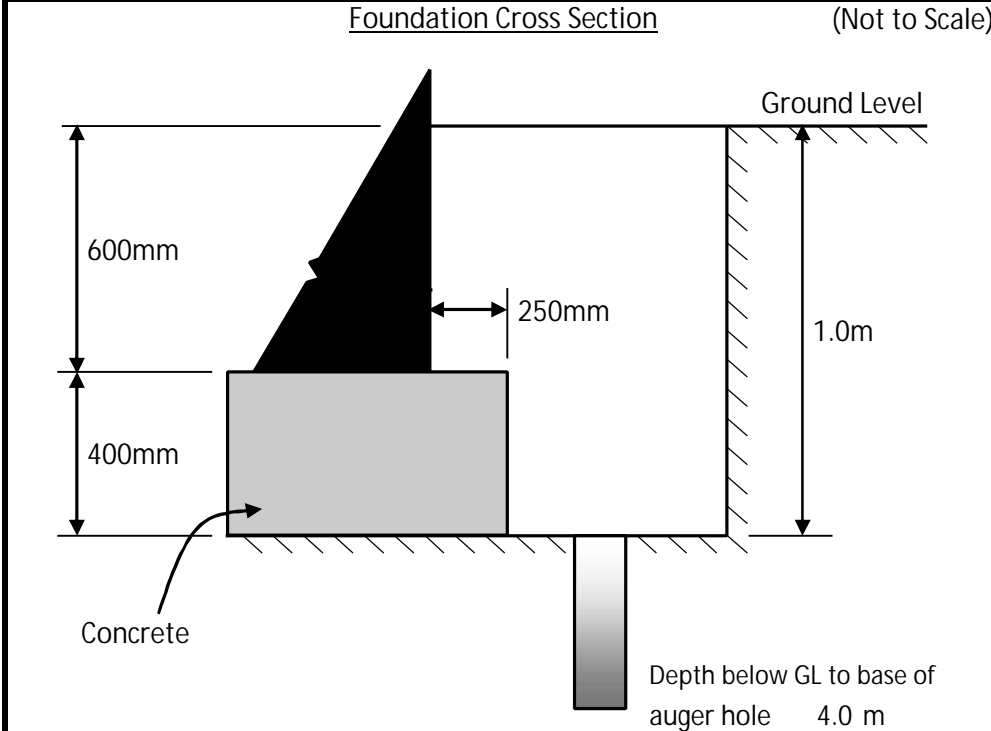
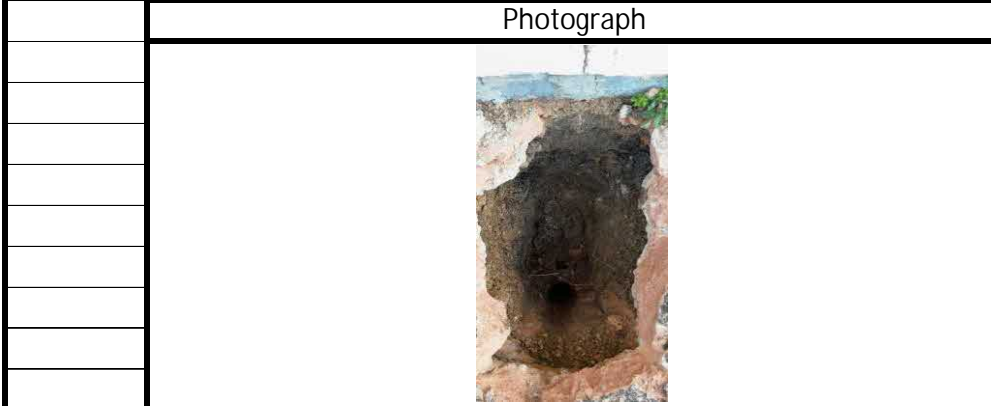
Location: Front Elevation	T/H No. 1
Ground Surface: Dry	Weather: Dry
	Date: 03-Apr-23

Roots Depth & Diameter:
From 1.0m
Down to 1.5m
up to 2mm diameter
Water Depth Hit & Rise:
None observed on site
Reason for Termination:
Encountered obstruction
Bedrock (chalk)

Depth (m)	Soil Descriptions (NB: Field crew description only)	Test Type	Depth (m)	
			From	To
G.L.				
1.00	Firm brown CLAY	V(n) 44	1.000	
1.50	Firm/stiff brown CLAY with some chalk	V(n) 52	1.500	
4.00	End of Borehole	V(n) 55	2.000	
		V(n) 56	2.500	
		V(n) 54	3.000	
		V(n) 57	3.500	
		Mac 50+	4.000	4.075

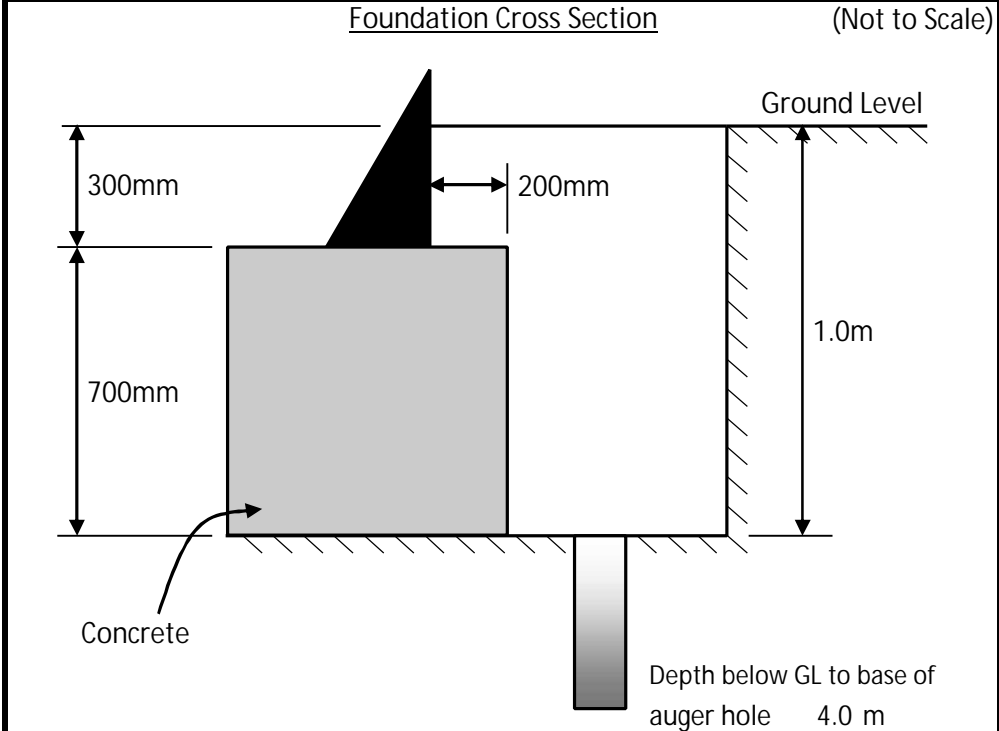
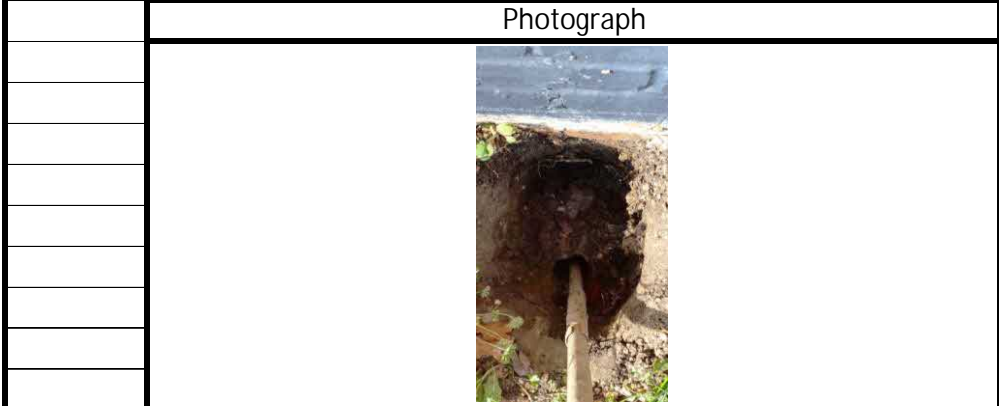
Location: Rear Elevation	T/H No. 2
Ground Surface: Dry	Weather: Dry
	Date: 03-Apr-23

Roots Depth & Diameter:
None observed on site

Water Depth Hit & Rise:
None observed on site

Reason for Termination:
Encountered obstruction
Bedrock (chalk)

Depth (m)	Soil Descriptions (NB: Field crew description only)	Test Type	Depth (m)	
			From	To
G.L.				
1.00	Firm brown CLAY	V(n) 42	1.000	
1.50	Firm/stiff brown CLAY with some chalk	V(n) 51	1.500	
4.00	End of Borehole	V(n) 53	2.000	
		V(n) 53	2.500	
		V(n) 54	3.000	
		V(n) 53	3.500	
		Mac 50+	4.000	4.075

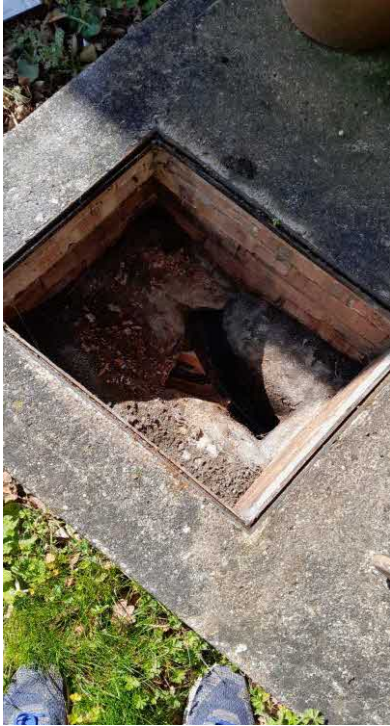
0.00			At I/C1		
3.00	No Visible Defects		At rest bend to SVP1		
			End of survey		
<u>RUN:</u> 2	Pipe Dia. (mm): 100	System: Foul Water	Made of: Glazed Clay		
From: I/C1	Inv (m): 0.50	Upstream	To: FWG1	Inv (m): -	
Metres	Faults / Defects		Remarks

0.00			At I/C1		
0.60			Material changes to plastic		
0.90	No Visible Defects		At FWG1		
			End of survey		
<u>RUN:</u> 3	Pipe Dia. (mm): 100	System: Foul Water	Made of: Glazed Clay		
From: I/C1	Inv (m): 0.50	Downstream	To: I/C3	Inv (m): 1.00	
Metres	Faults / Defects		Remarks

0.00			At I/C1		
2.30			At I/C2		
5.10			Inlet at 10 o'clock to WC		
11.50	No Visible Defects		At I/C3		
			End of survey		
<u>RUN:</u> 4	Pipe Dia. (mm): 100	System: Foul Water	Made of: Plastic		
From: I/C4	Inv (m): 0.80	Upstream	To: SVP2	Inv (m): -	
Metres	Faults / Defects		Remarks

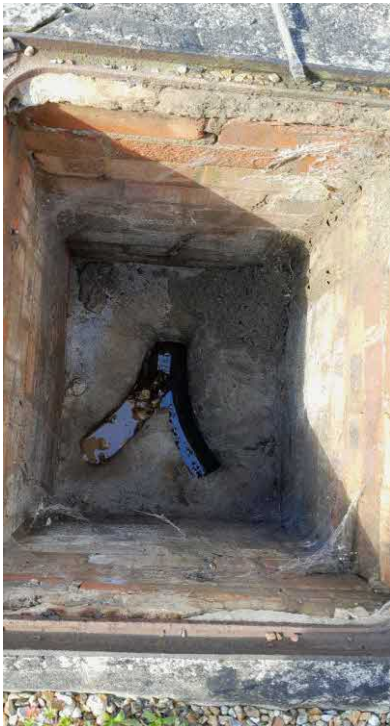
Metres	Faults / Defects	Remarks
0.00		At I/C3
5.00	No Visible Defects	Past area of concern
		End of survey

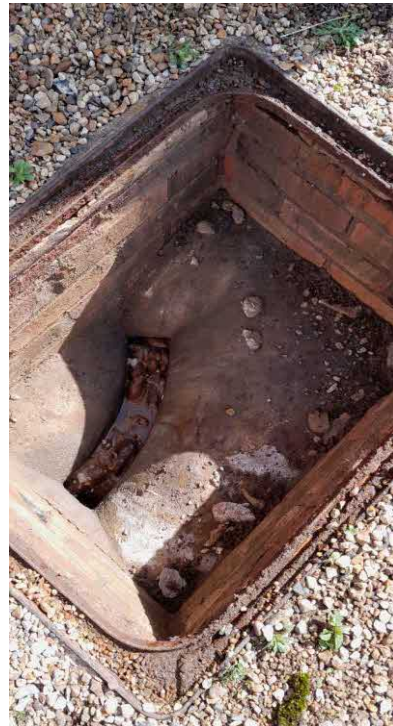
0.00			At I/C4		
1.60			Pipe bends left		
2.00	No Visible Defects		At rest bend to SVP2		
			End of survey		
<u>RUN:</u> 5	Pipe Dia. (mm): 100	System: Foul Water	Made of: Plastic		
From: I/C4	Inv (m): 0.80	Downstream	To: I/C3	Inv (m): 1.00	
Metres	Faults / Defects		Remarks

0.00			At I/C4		
5.00	No Visible Defects		At I/C3		
			End of survey		
Address: HELIOS HOUSE, CLARKES LANE, BARSHAM, NR34 8HN

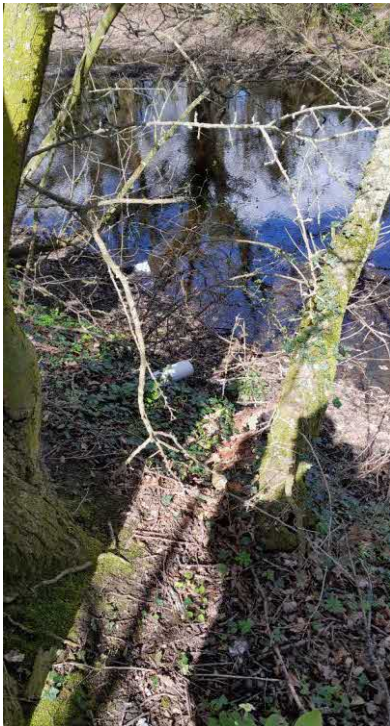
Metres	Faults / Defects	Remarks
0.00		At RWP1
4.00	No Visible Defects	At soakaway
		End of survey

RWP1 discharge to pond at rear

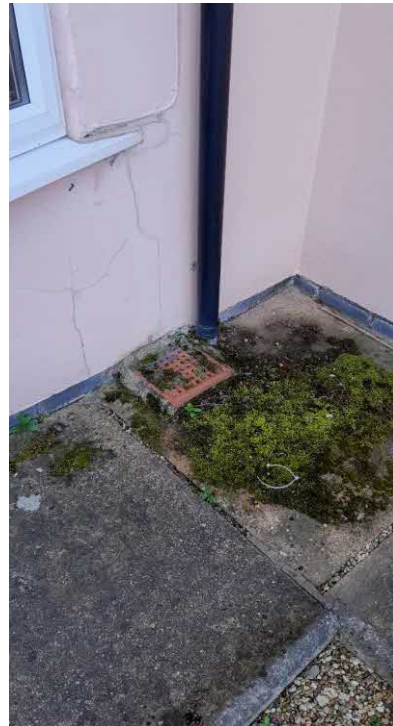
Metres	Faults / Defects	Remarks
0.00		At RWP2
10.00	No Visible Defects	At outfall to pond
		End of survey

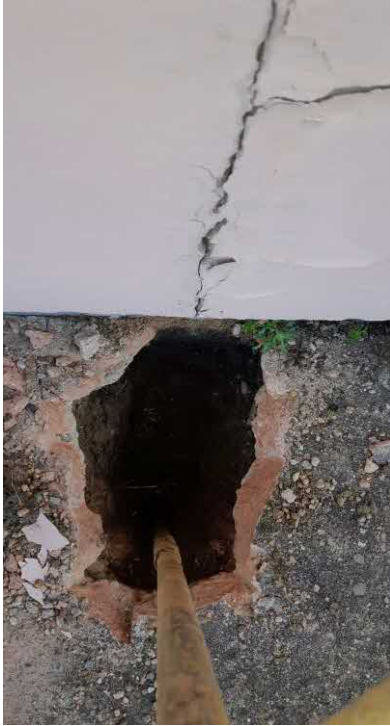
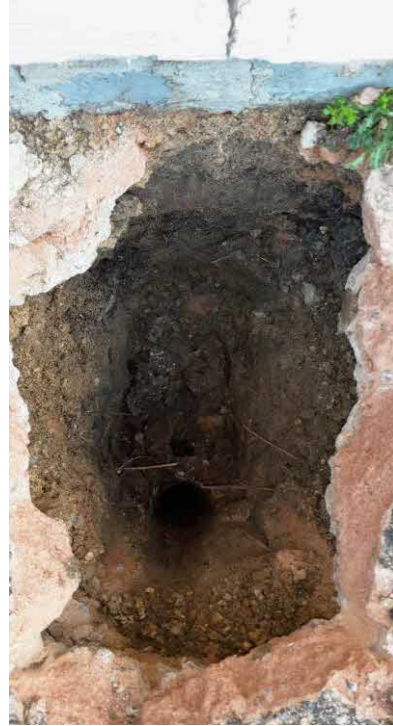
T/H1

TP/BH1, 1.0-1.5m		
5 no.	Examined root: similar in many ways to the family Rosaceae, subfamily ROSOIDEAE (shrubs including Roses, Brambles, Raspberries, Kerria and Potentilla). Slightly tentative - this sample was in POOR condition; it also had NO BARK.	Very decayed*.
