# Arboricultural Appraisal Report

## Subsidence Damage Investigation at:

Helios House  
 Clarkes Lane  
 Barsham  
 NR34 8HN

CLIENT: 360Globalnet  
 CLIENT REF: LIV-SN-22-006091  
 MWA REF: SUB230530-13217  
 MWA CONSULTANT: Andy Clark  
 REPORT DATE: 03/07/2023

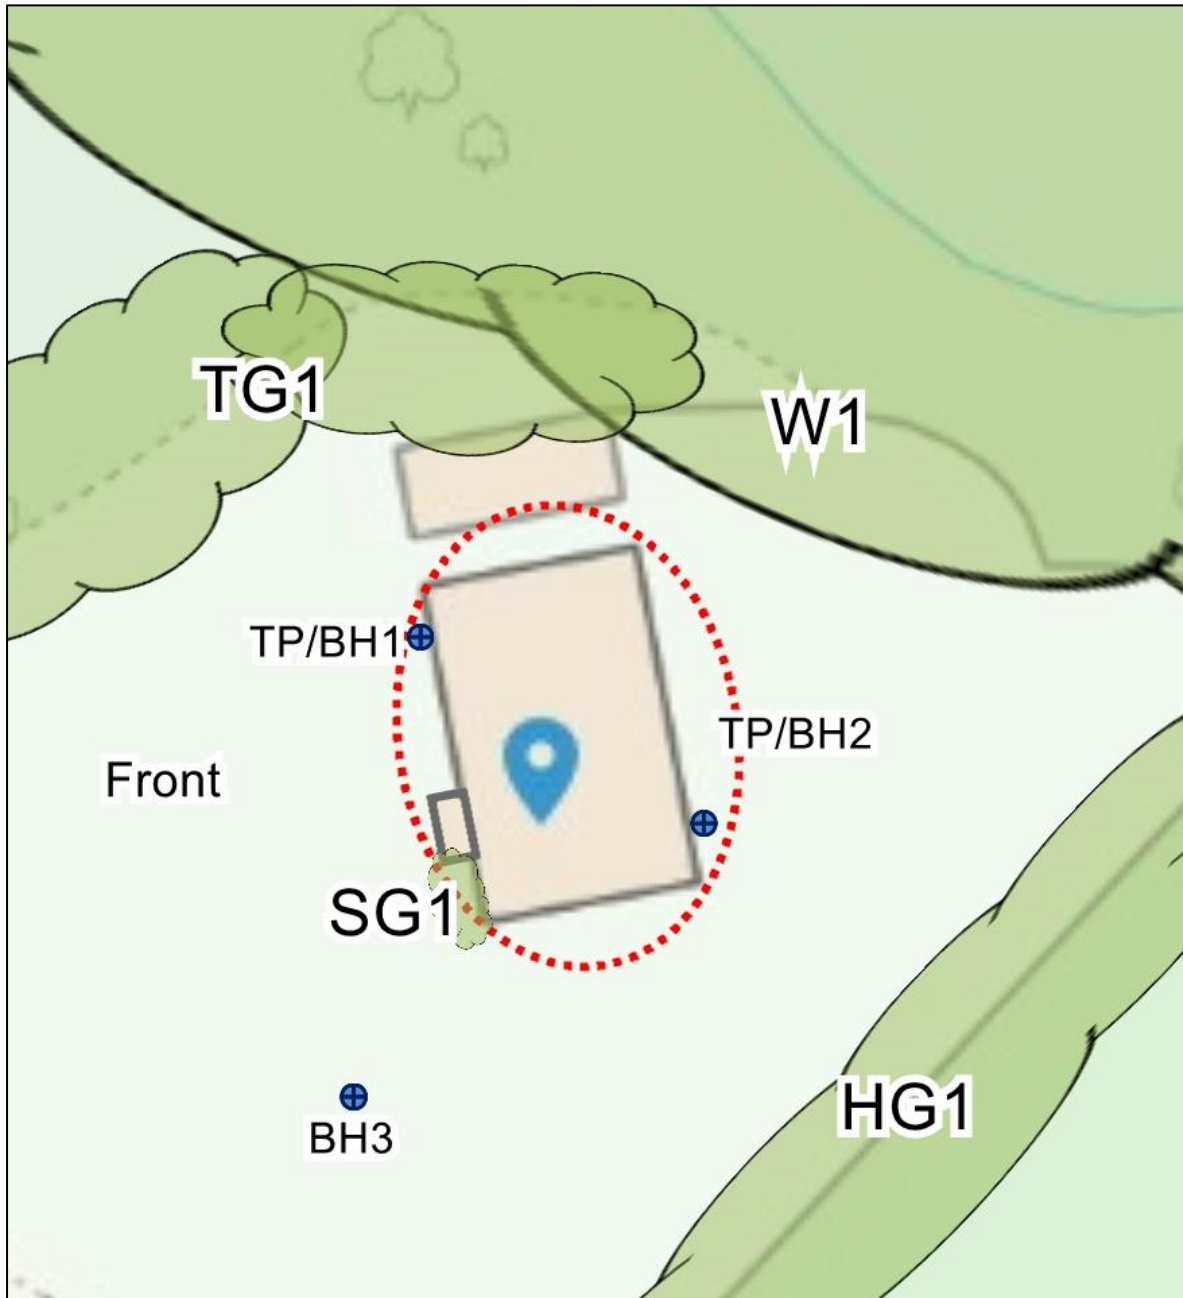
Site Plan

Approximate areas of damage

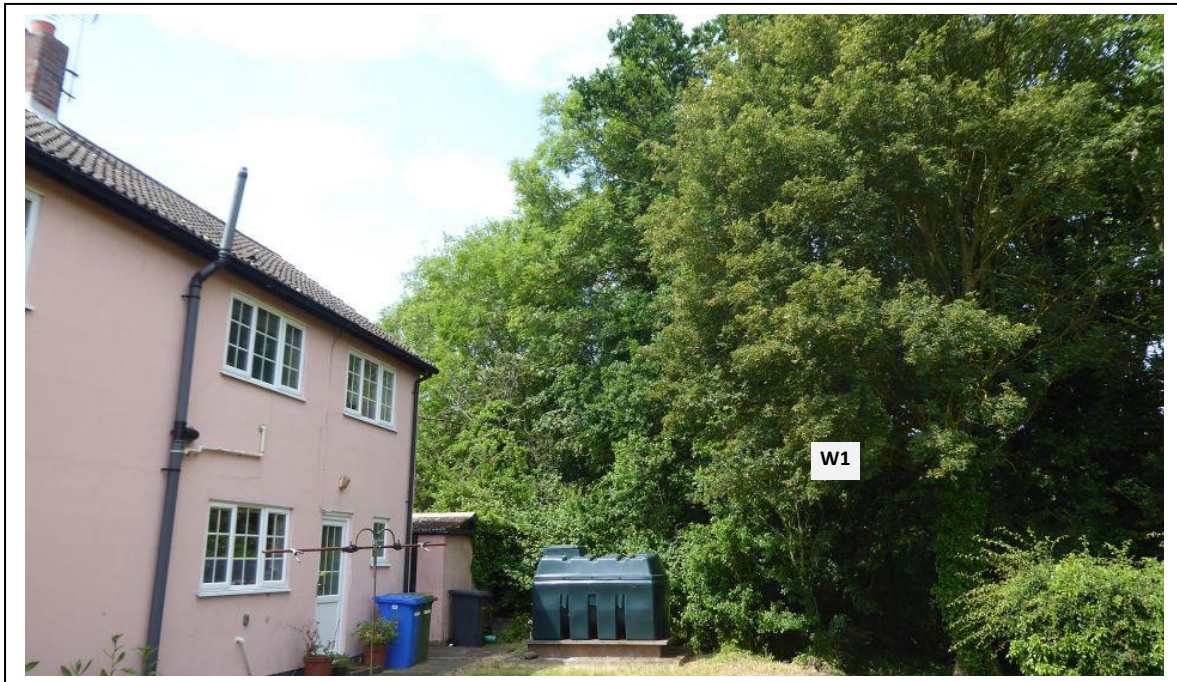
Irrespective of the identification of recovered root samples, our survey has identified vegetation within influencing distance of the building with a current potential to influence soil volumes below foundation level; the most significant of which in relation to the current damage are the large nearby trees within the W1 mixed spp. woodland. The smaller vegetation of TG1 group and HG1 mixed spp. hedgerow will also likely have a contributory influence, albeit to a much lesser degree than the mature trees in W1.

View from rear of adjacent sections of W1 mixed spp. woodland

Recommendations at this stage comprise removal of the larger nearby trees within the W1 mixed spp. woodland, along with removal of the proximal scrub growth of TG1 and management of the HG1 mixed spp. hedgerow. The small nearby shrubs of SG1 group should also be removed in order to negate any localised influence.

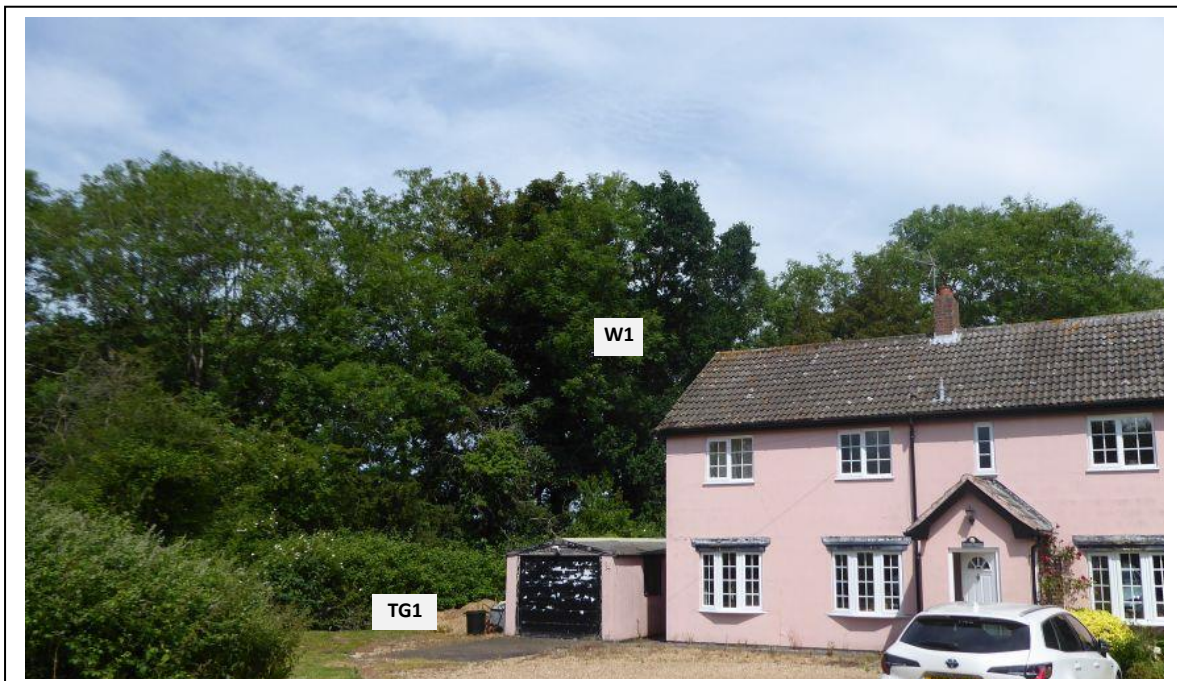
Roots were observed to a depth of 1.5m bgl in TP/BH1 and recovered samples have been positively identified (using anatomical analysis) as very decayed Rosoideae gp. [shrubs such as Roses, Brambles, Raspberries, Kerria and Potentilla]; the origins of which will mostly likely be the bramble growth of TG1 group.

Overview from frontage of W1 mixed spp. woodland with TG1 to left of garage

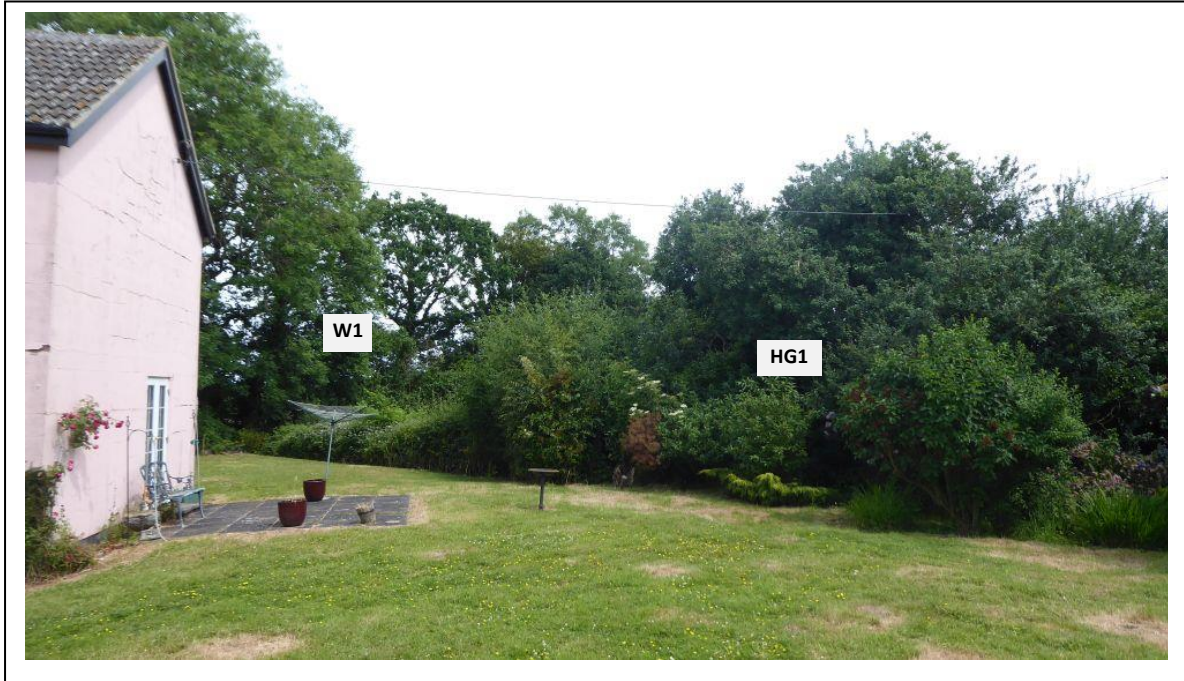
View of HG1 hedgerow to right of building with continuation of W1 mixed spp. woodland beyond

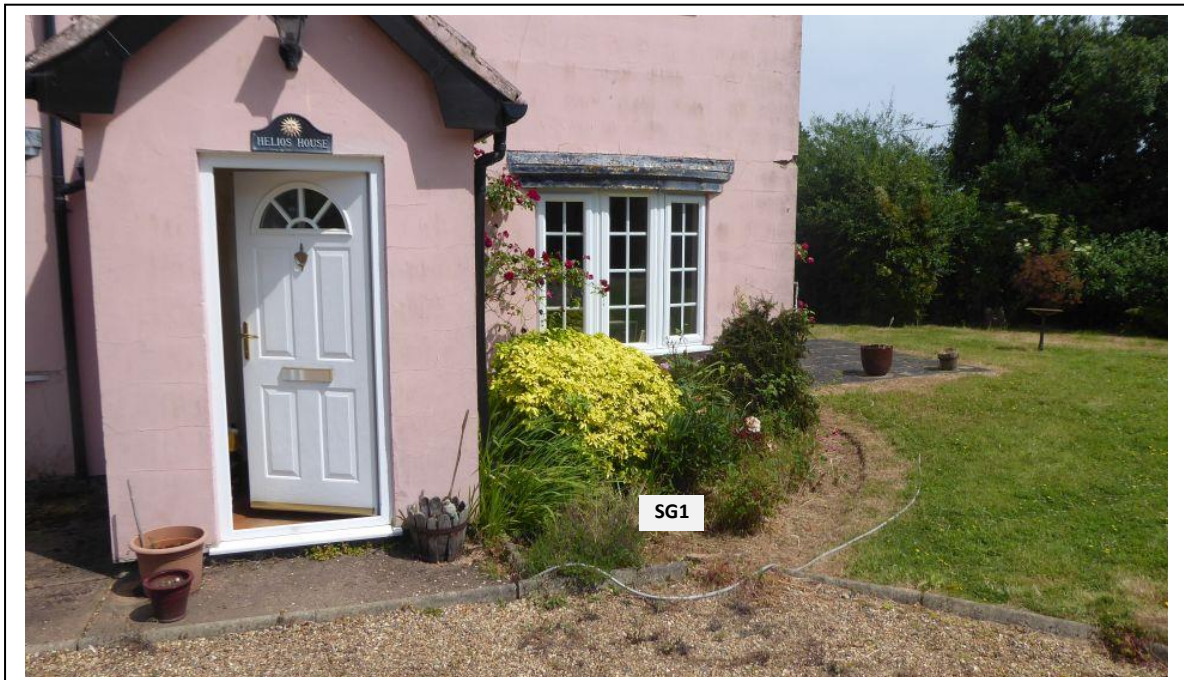
View of SG1 mixed spp. shrub group
