Tree Preservation/Conservation Order Application

St Aidan's Catholic Academy

Description of works –

These works have been identified on the Tree Survey carried out by Amenity Tree with the works and TPO application carried out by ATW Tree and Landscaping Specialists LTD.

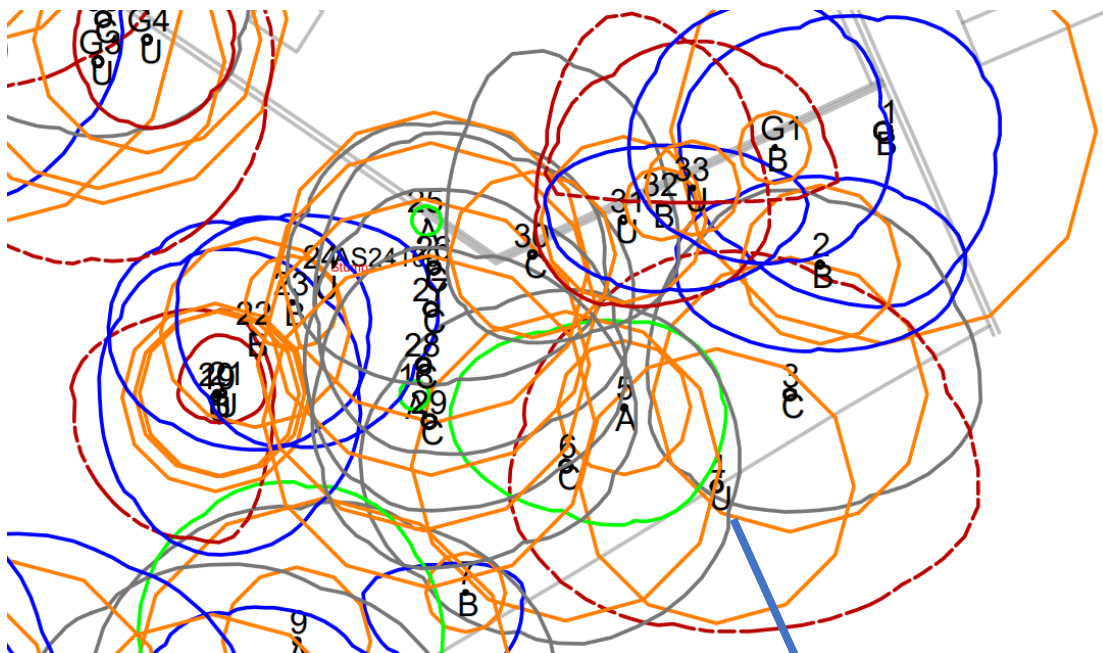
T4 - Large cavity at base of tree up to approximately 1m in height, tree has lean towards school premises, recommend for removal.

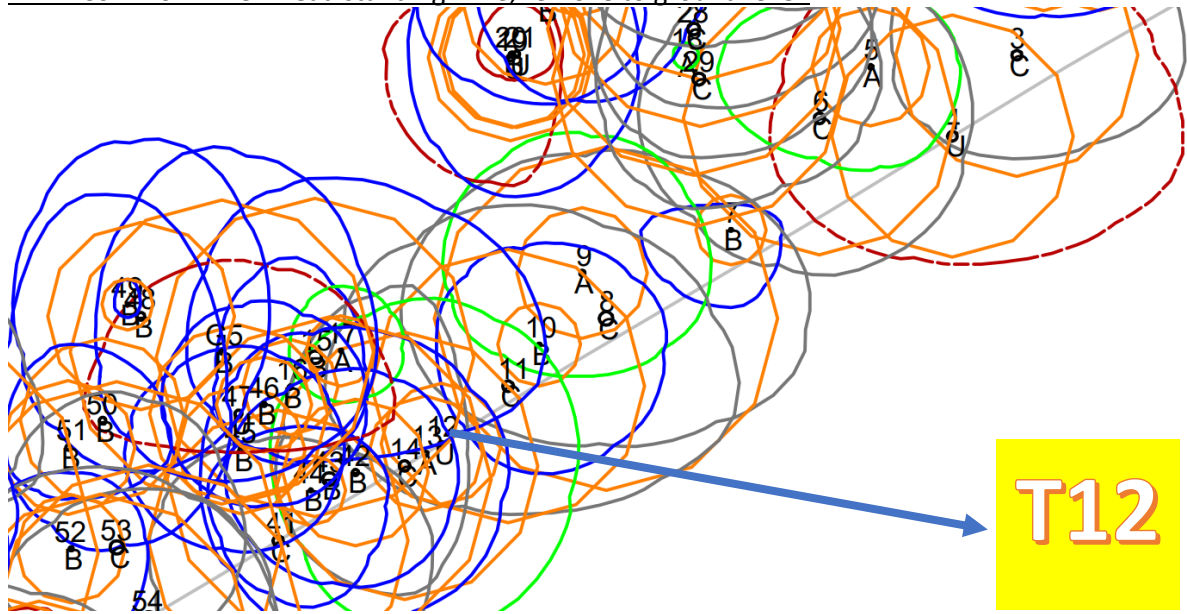
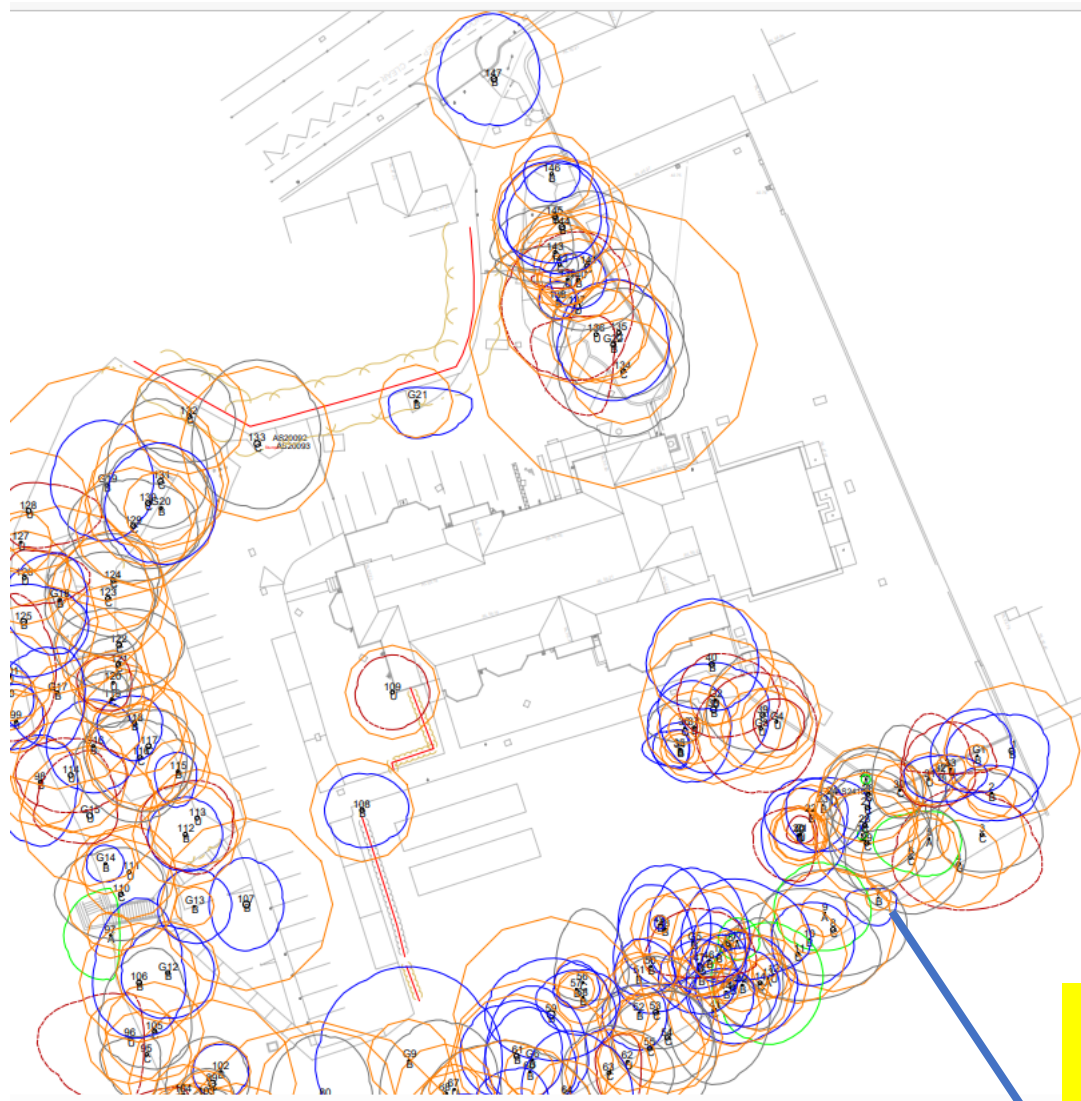
T12 – Common Lime - Dead standing Lime, remove to ground level.

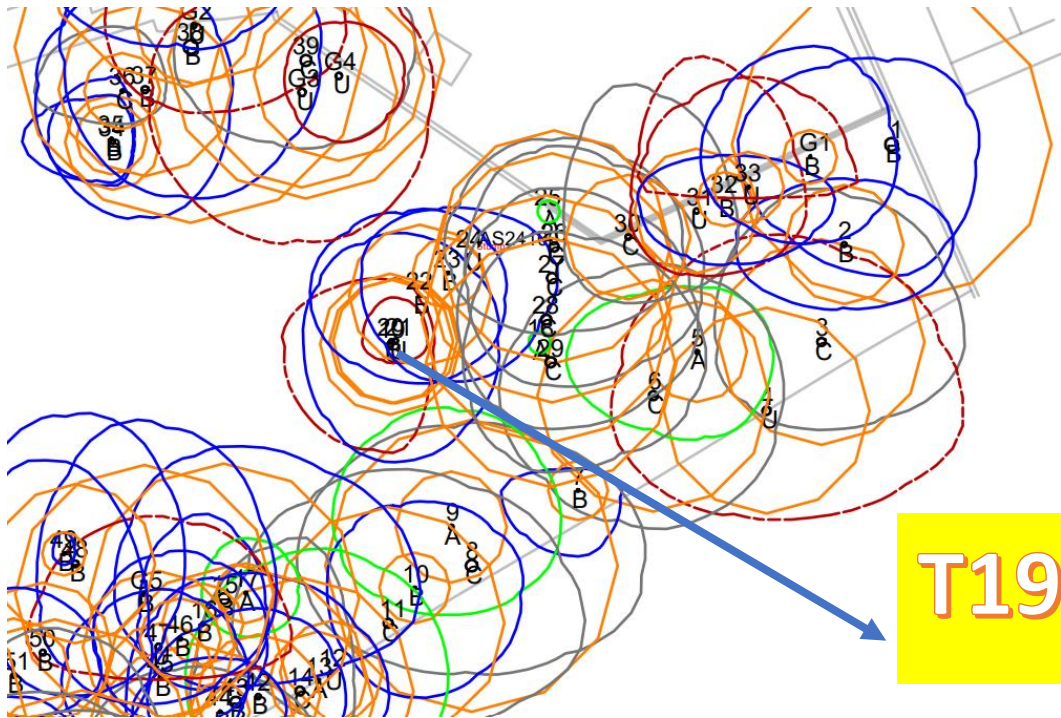
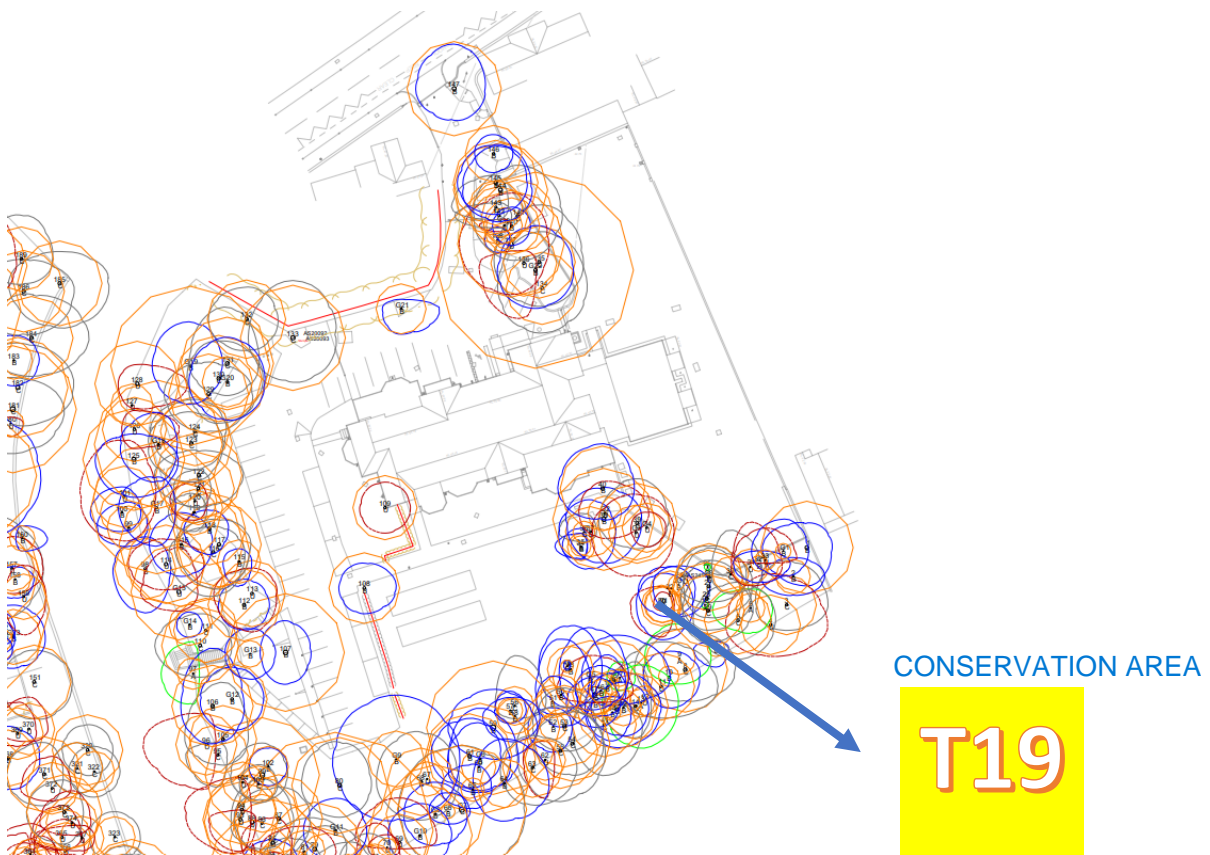
T19 – Common Black Elder - Elder in decline, signs of dead throughout tree, cavity at 1m up stem, saprophytic fungi (Jews Ear) common on Elder but large amount of dead evident throughout crown, bad specimen close to playing field, remove to eliminate risk.

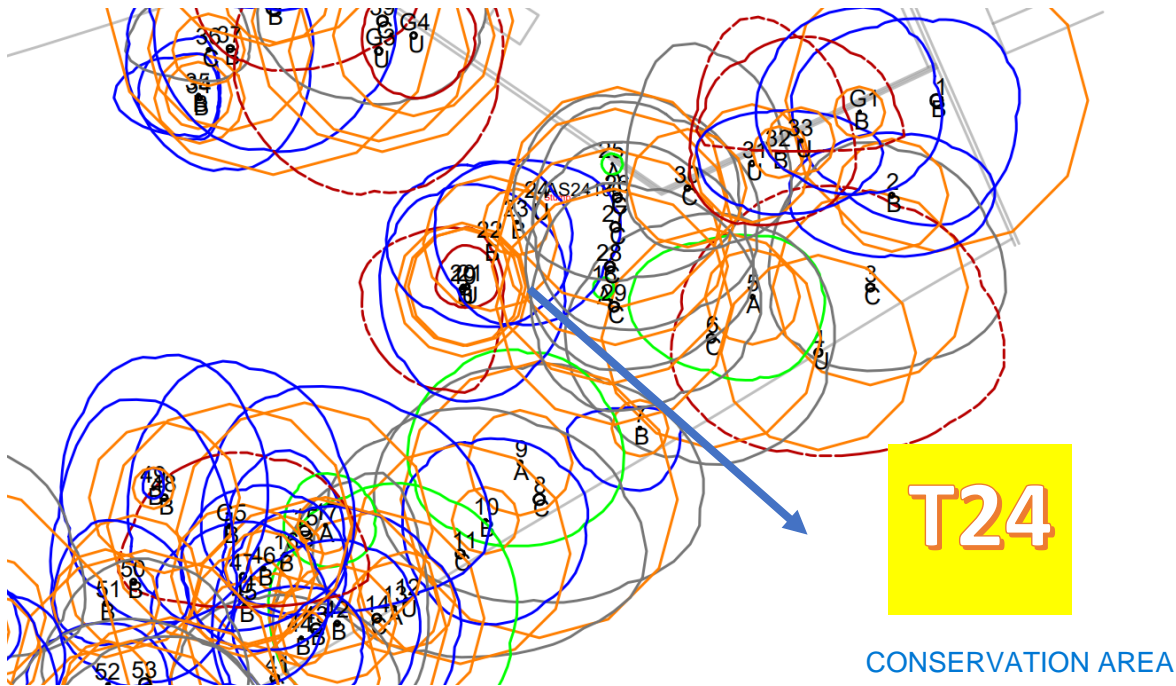
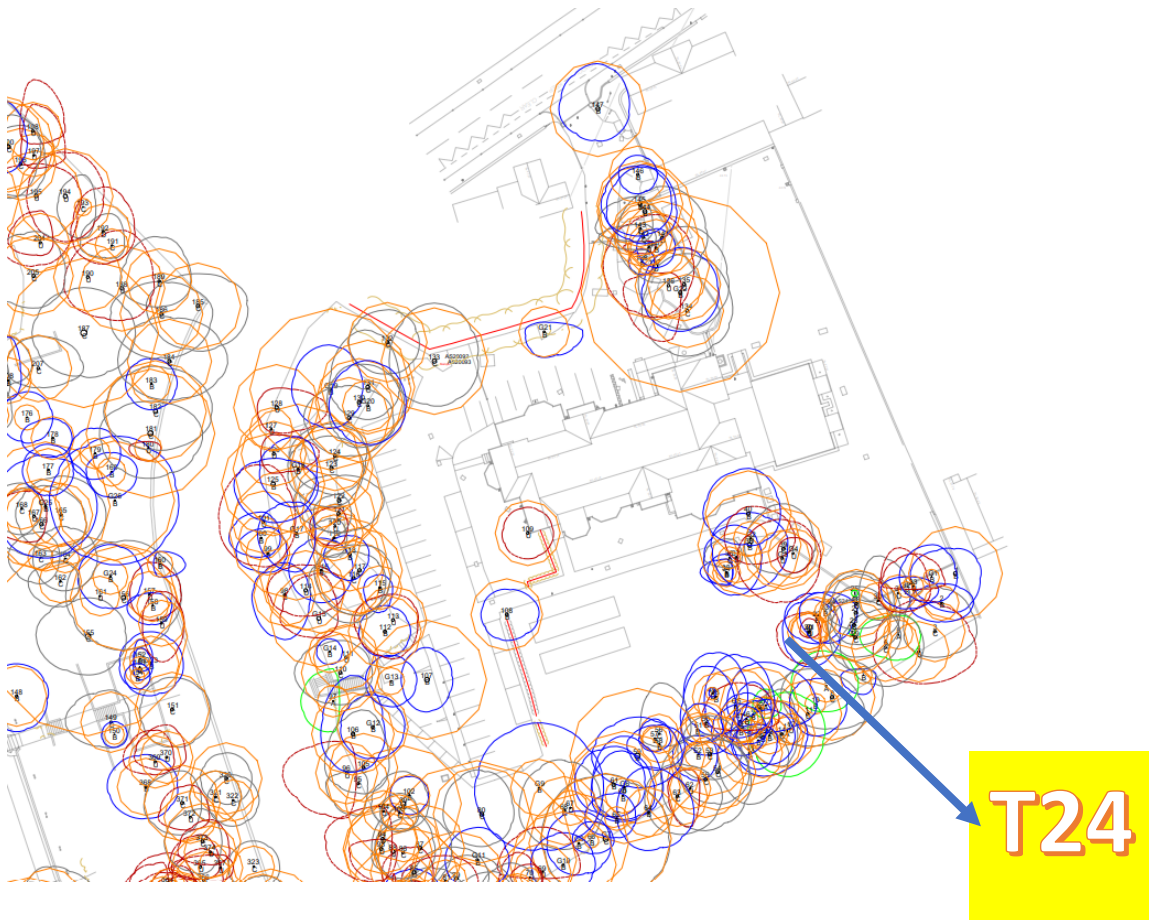
T24 – Common horse chestnut - Horse Chestnut stump at 0.5M, cut down to ground level to remove trip hazard.

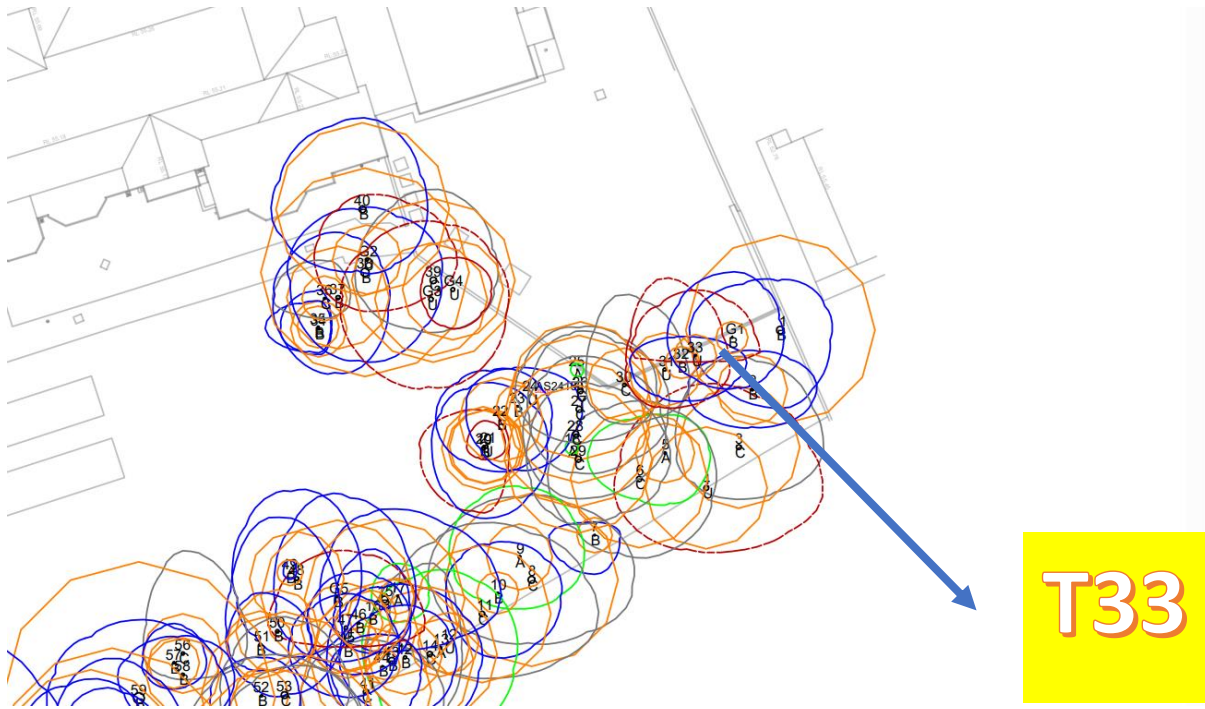
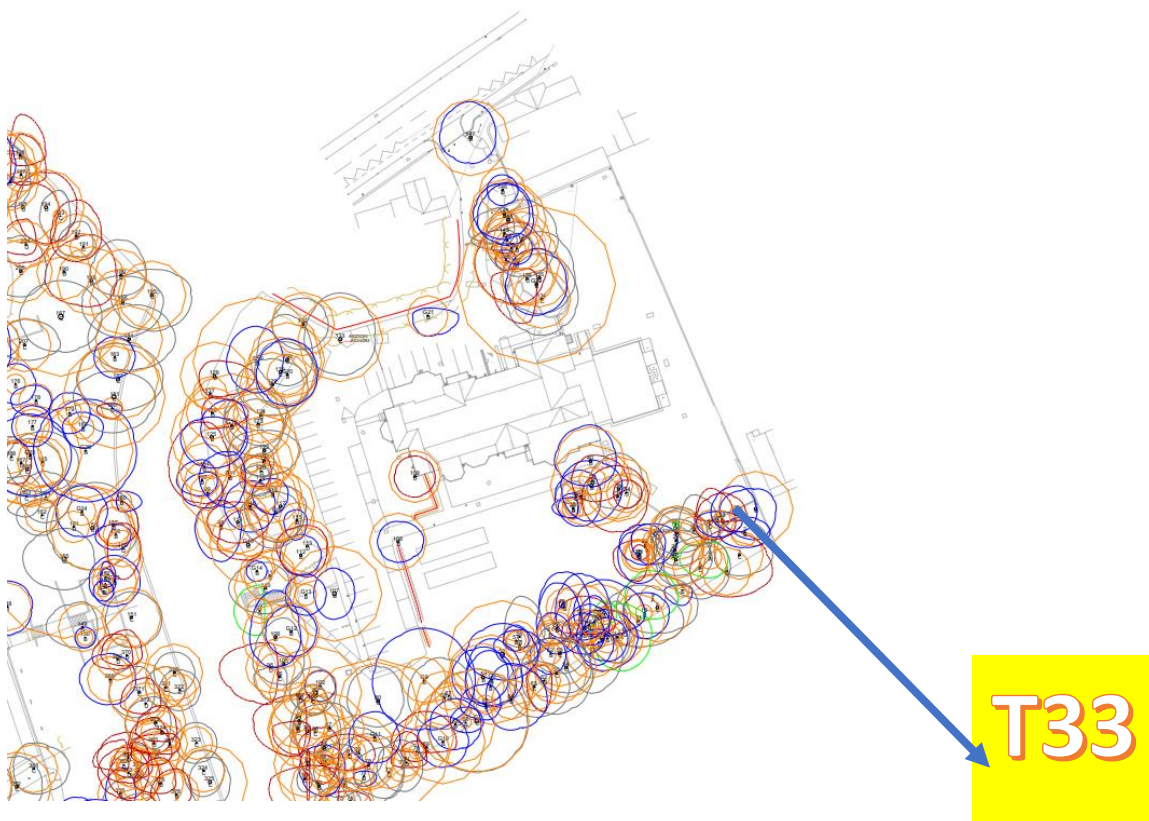
T33 – Common Ash - Inonutus hispidus evident on stem @ approximately 1.5m, unclear if Ash has developed die back at this stage due to time of year. Ash is leaning over playground remove to eliminate risk.

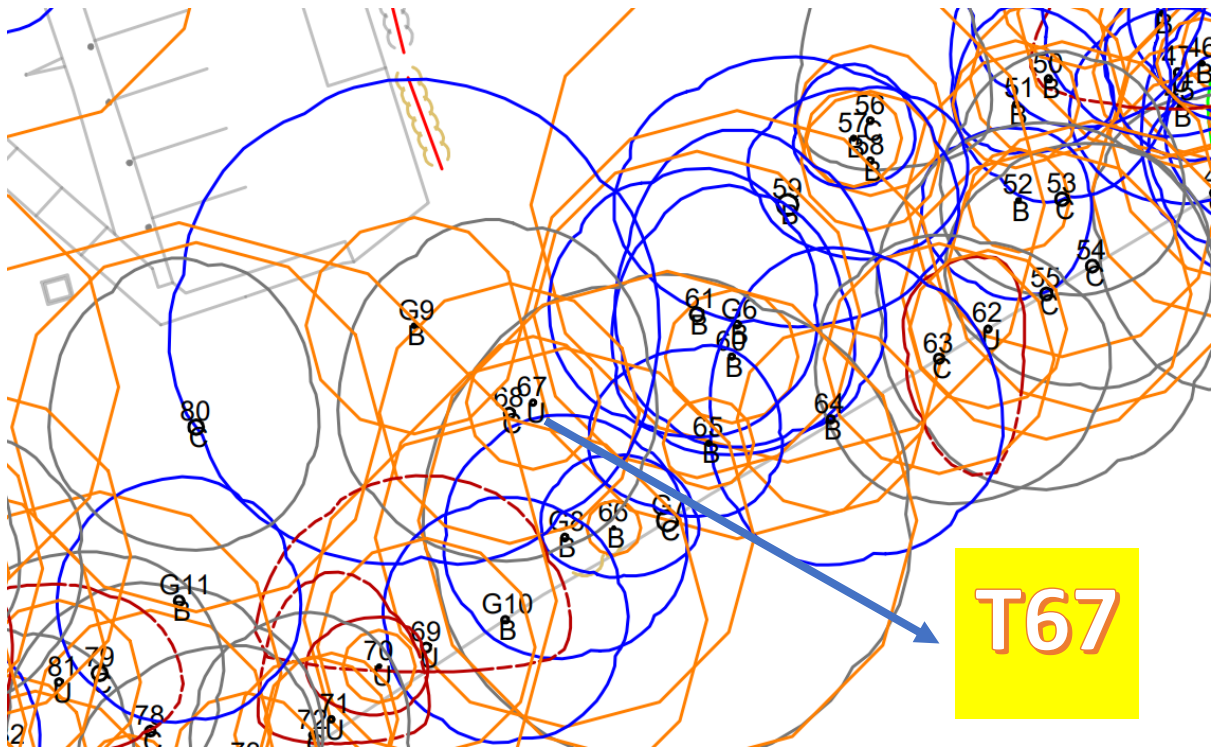
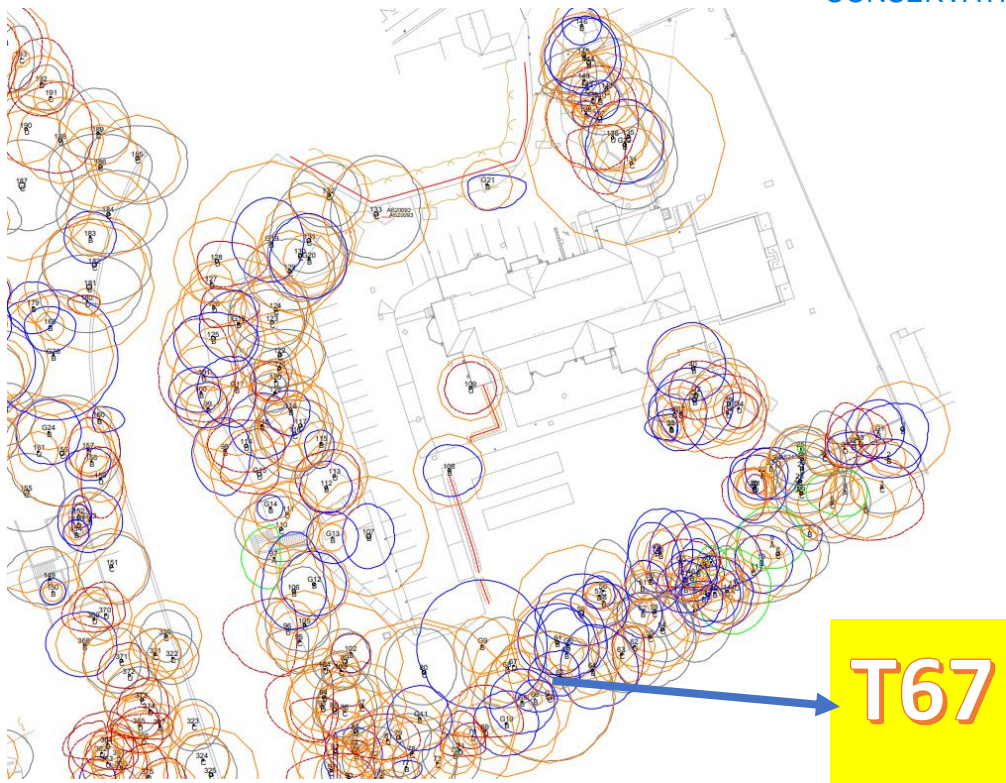
T67 – Common Ash - Windblown Ash already processed prior to survey, leave in length for habitat, saprophytic Jews Ear evident, no works required.

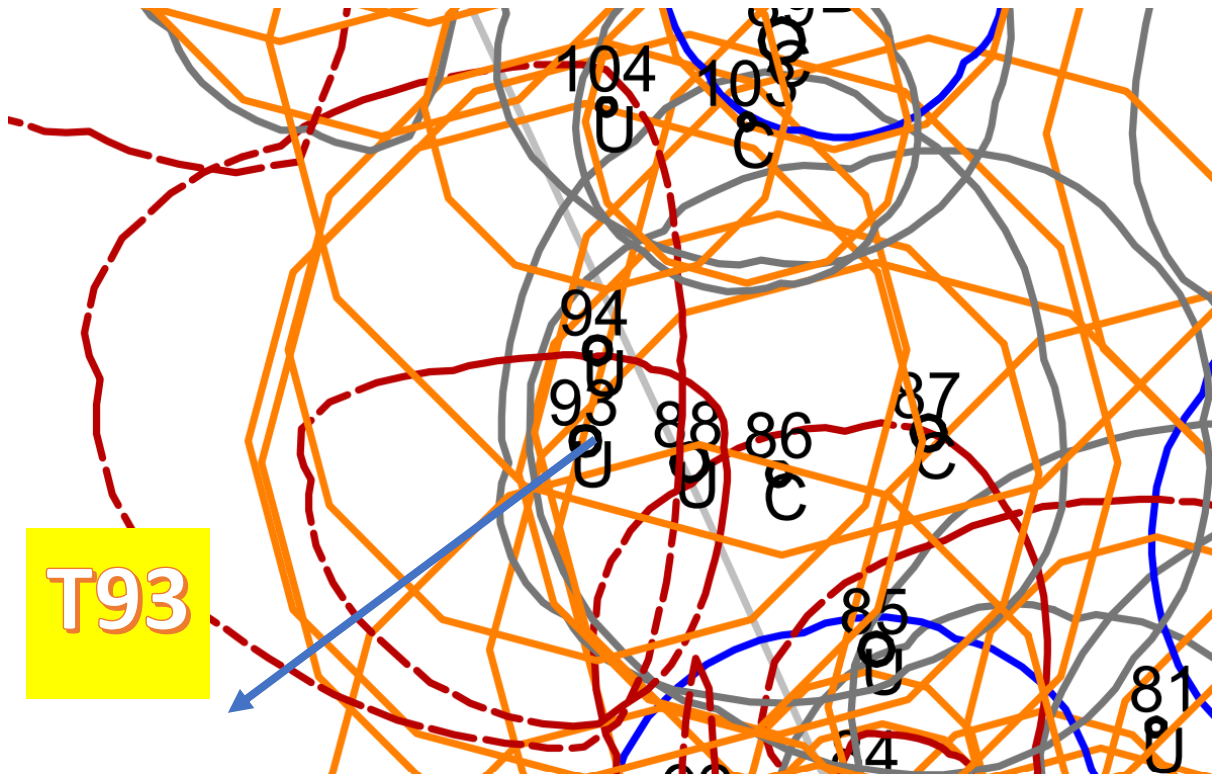
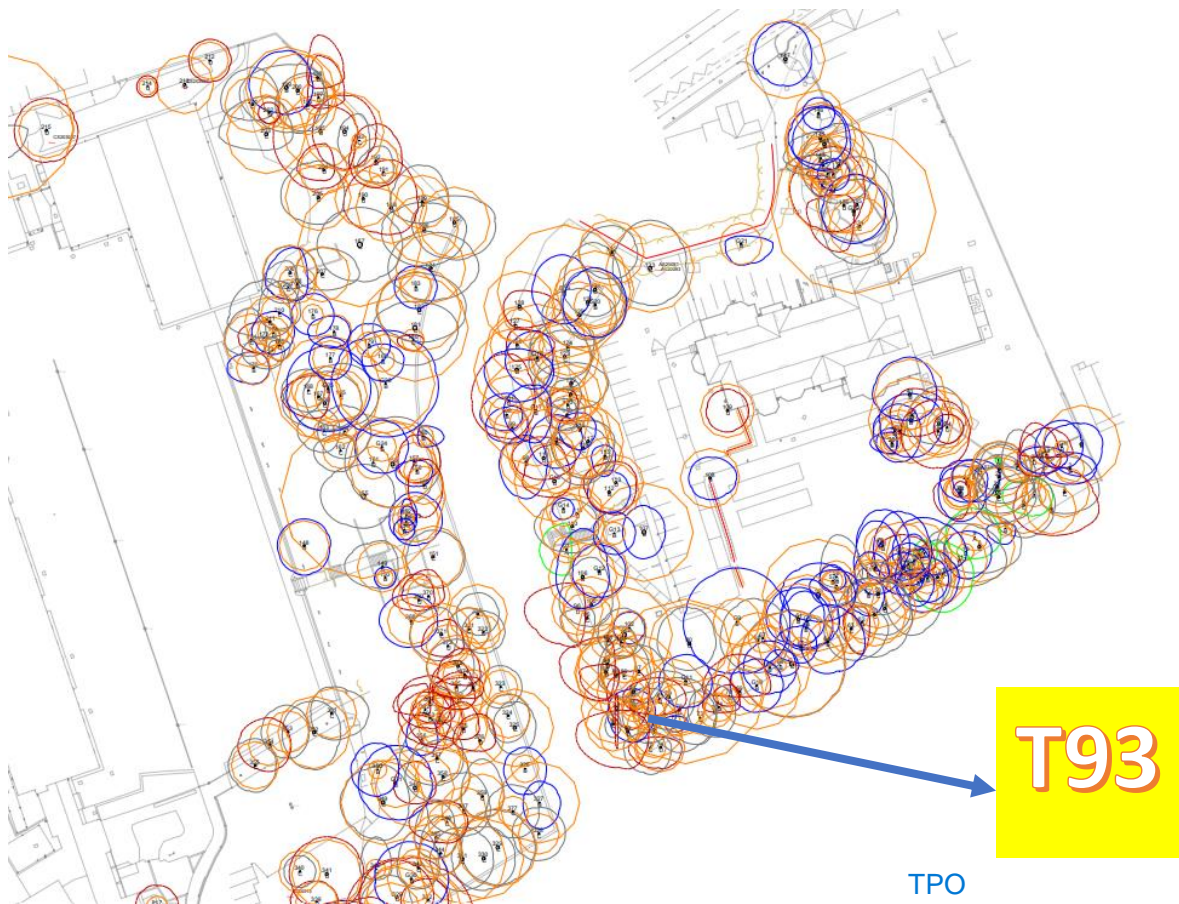
T93 – Sycamore - Difficult to determine trees health due to Ivy engulfing stem and crown, remove Ivy to reinspect.

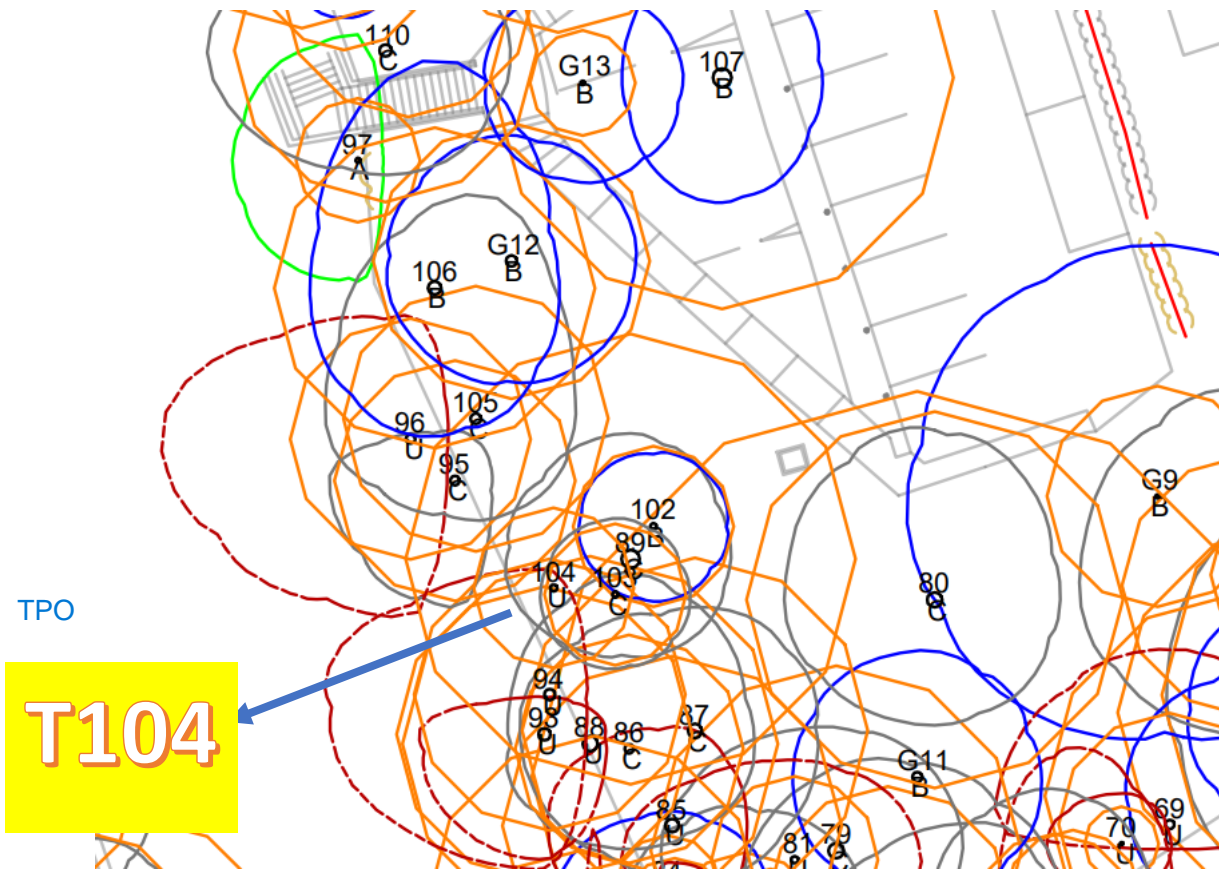
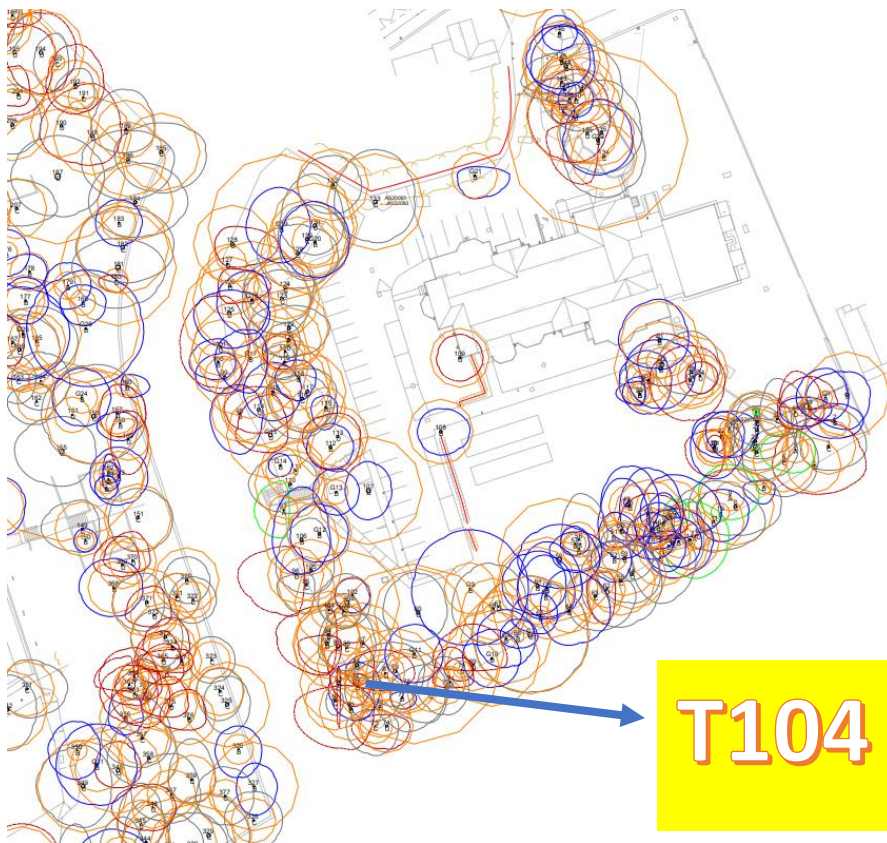
T104 – Swedish Whitebeam - Windblown tree, process and stack for habitat piles.

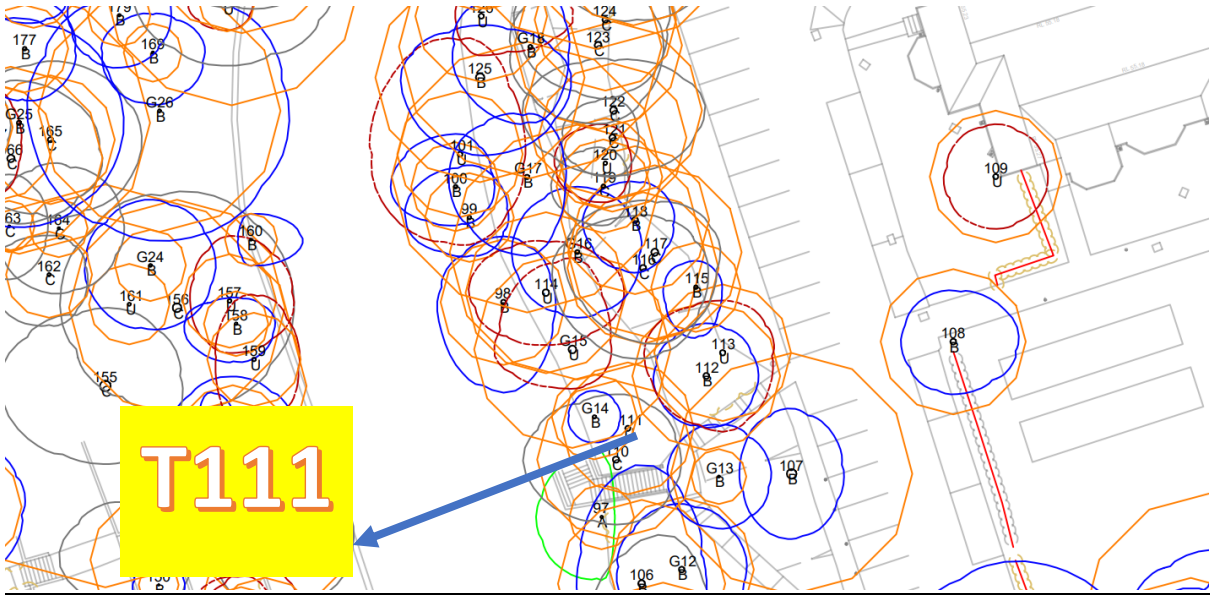
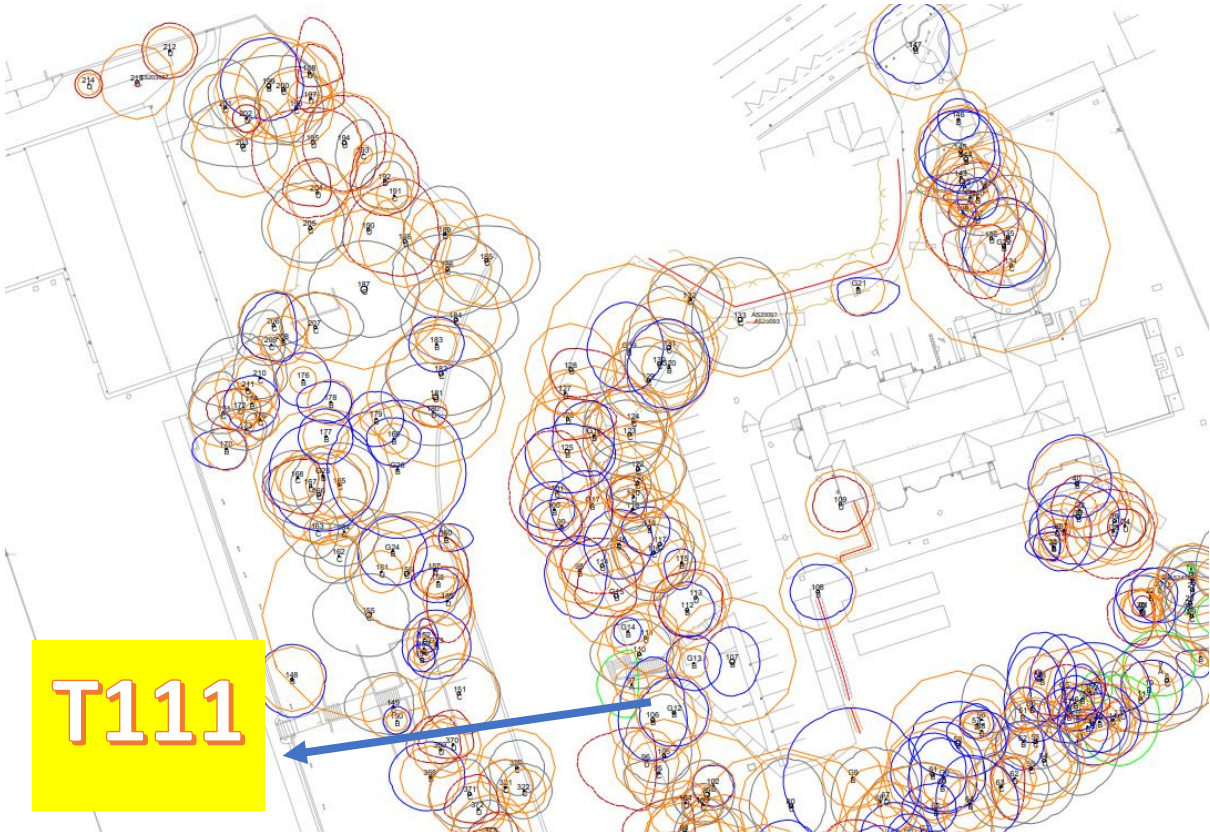
T111 -Swedish Sycamore - Crown has been removed and left as standing stem, no work required.

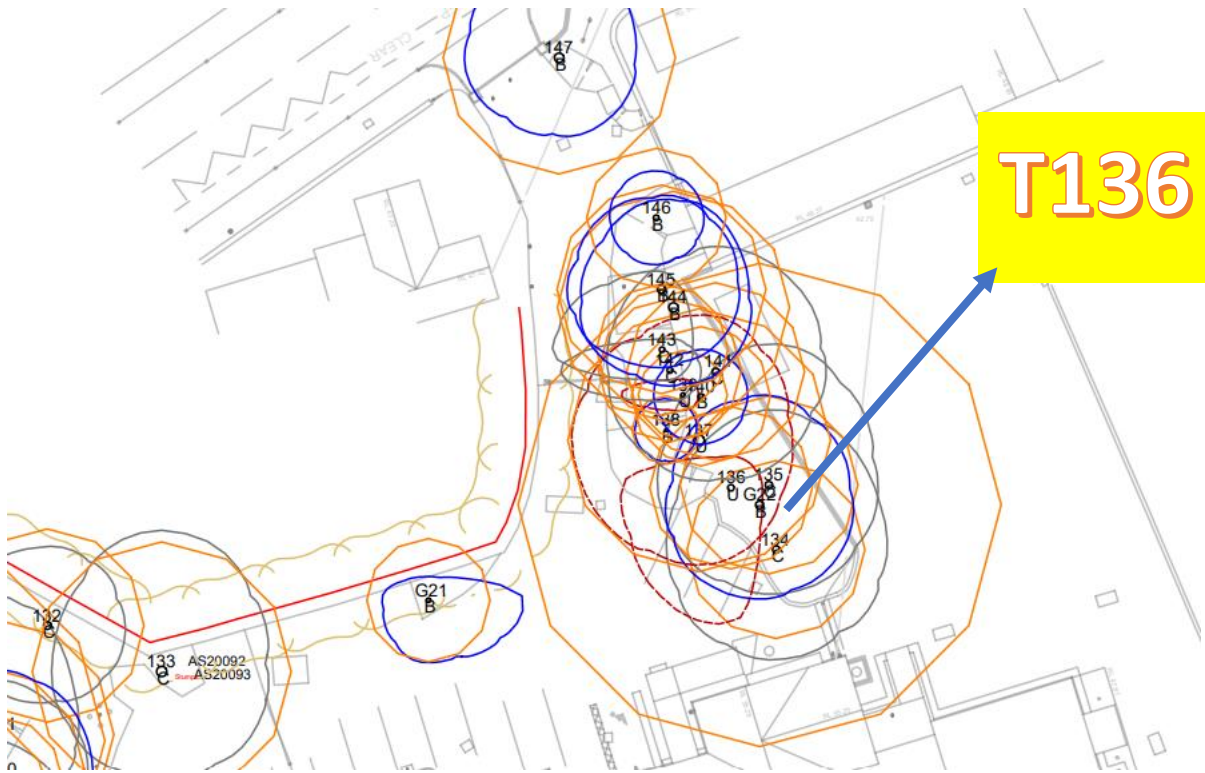
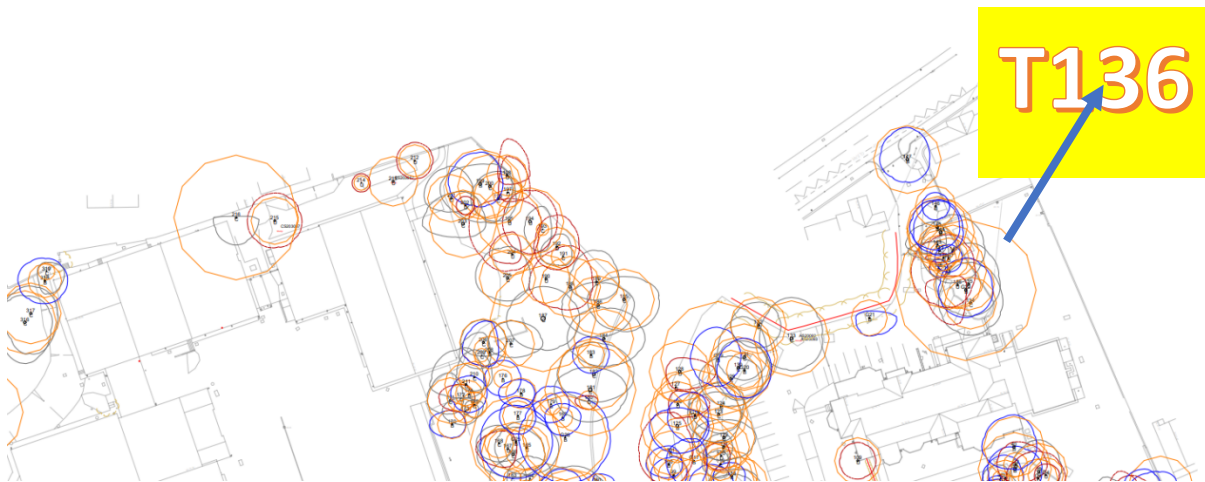
T136 – Common Lime - Massive lean southward to school building, poor specimen, suggest removal.

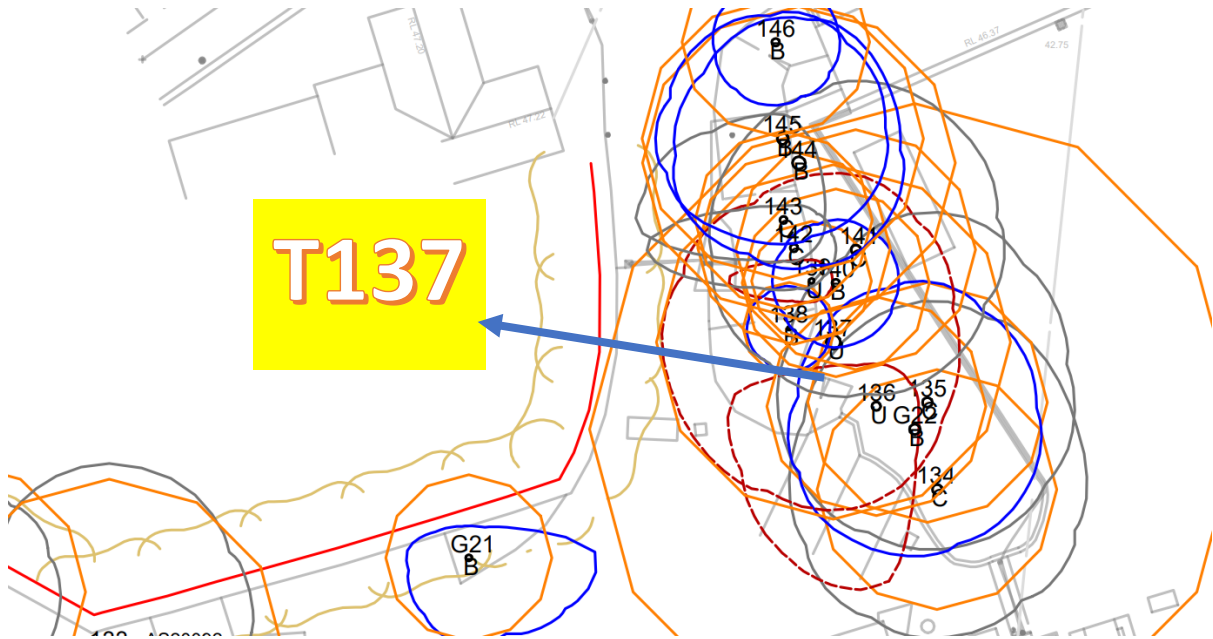
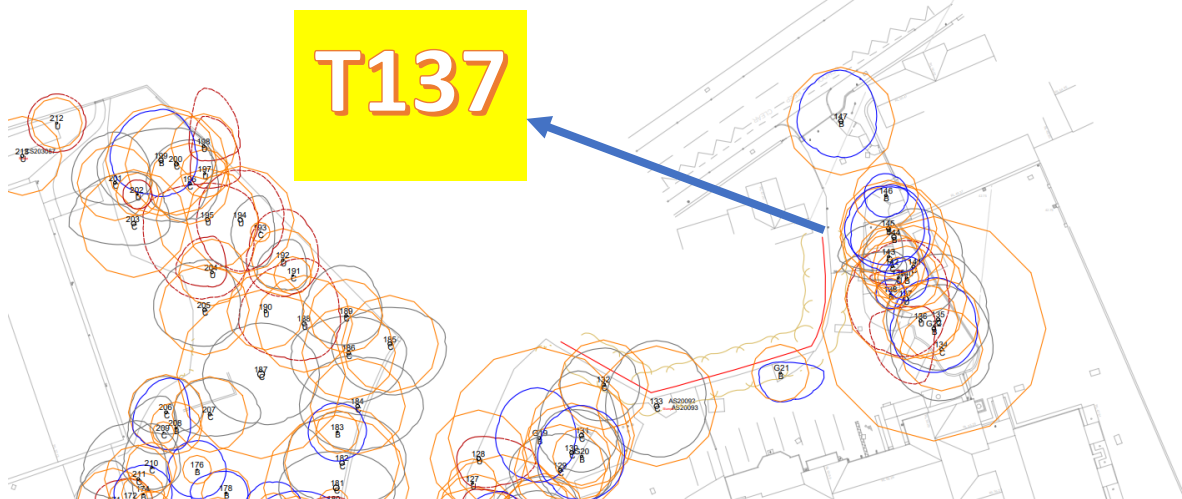
T137 - Common Ash - Major deadwood in the majority of crown, overhang on entrance road to Sixth Form, has all the characteristics of dieback, recommend removal or pollard at the very least.

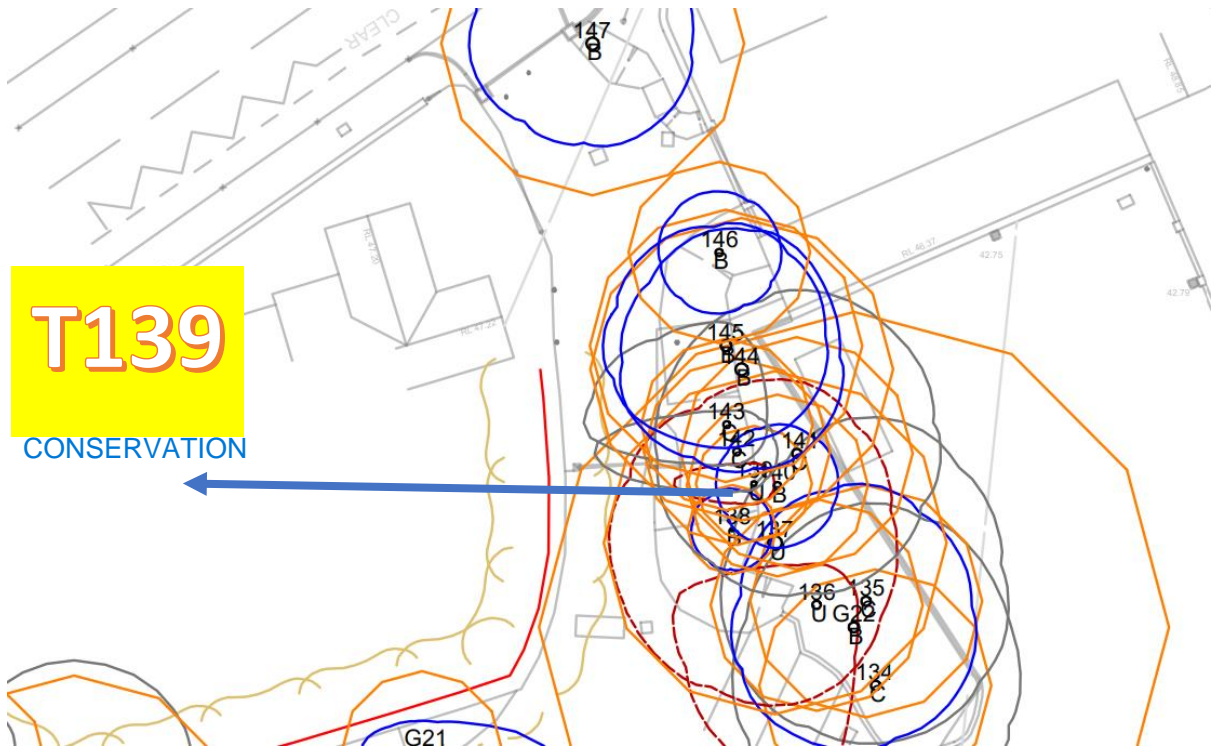
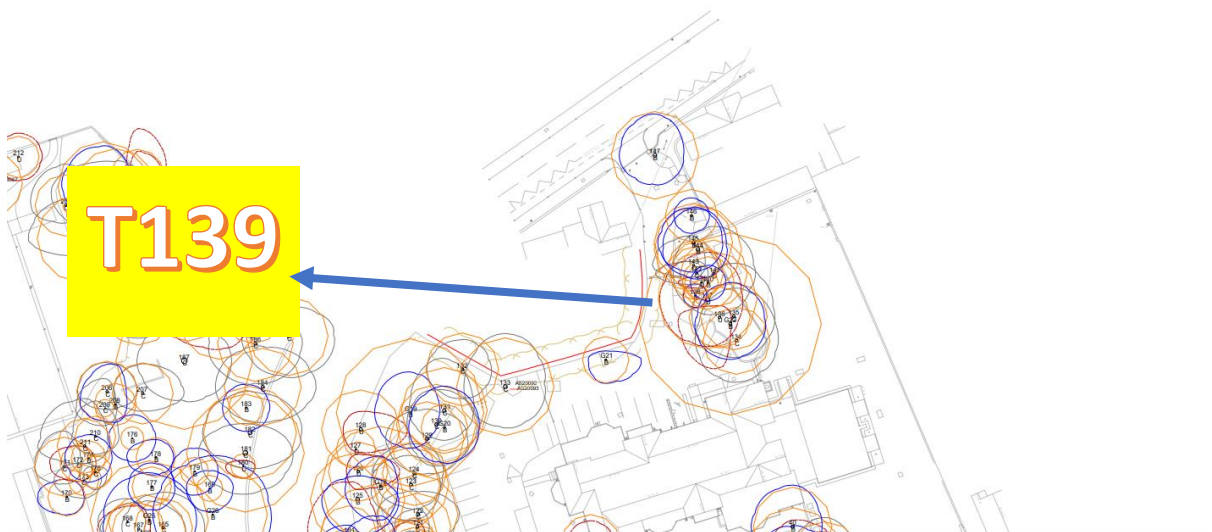
T139 – Common Lime - Large tear/cavity @ 4m on main stem, heartwood visible. Affecting crown of adjacent Yew, Lime is a poor specimen, removal recommended.

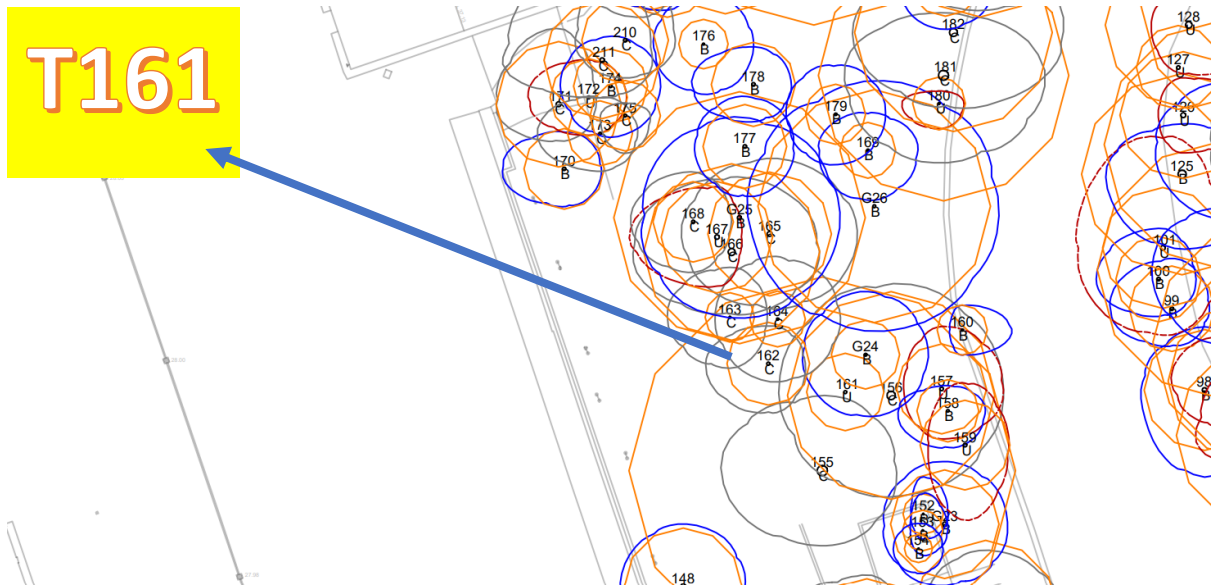
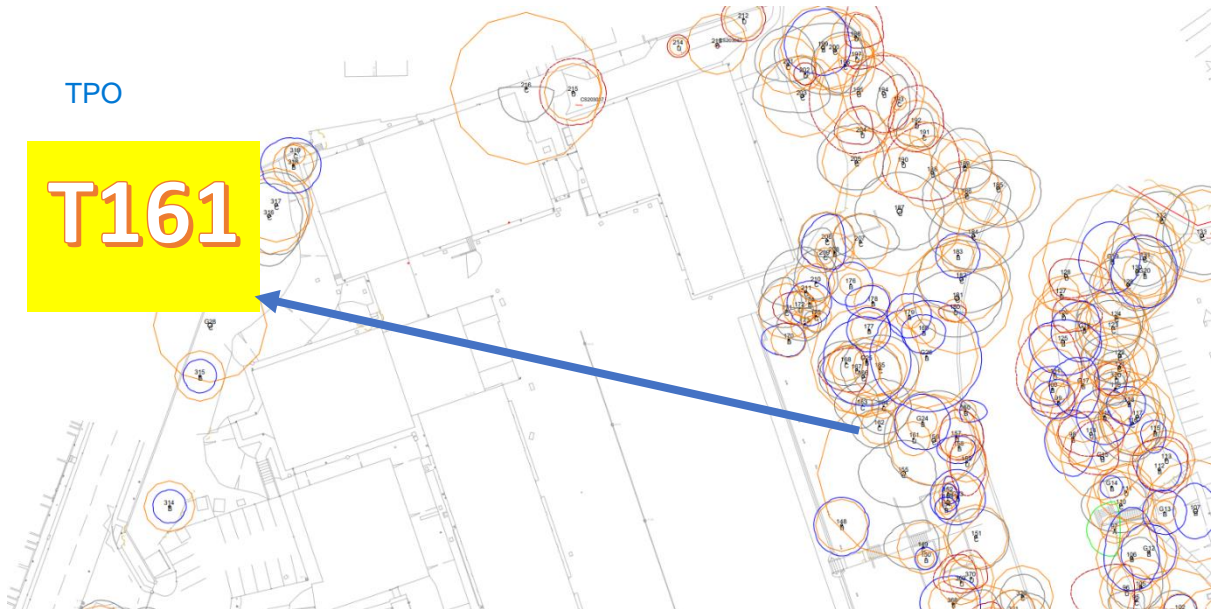
T161 – Common Ash - Windblown Ash, tips of crown touching wall, process and leave in piles for habitat.

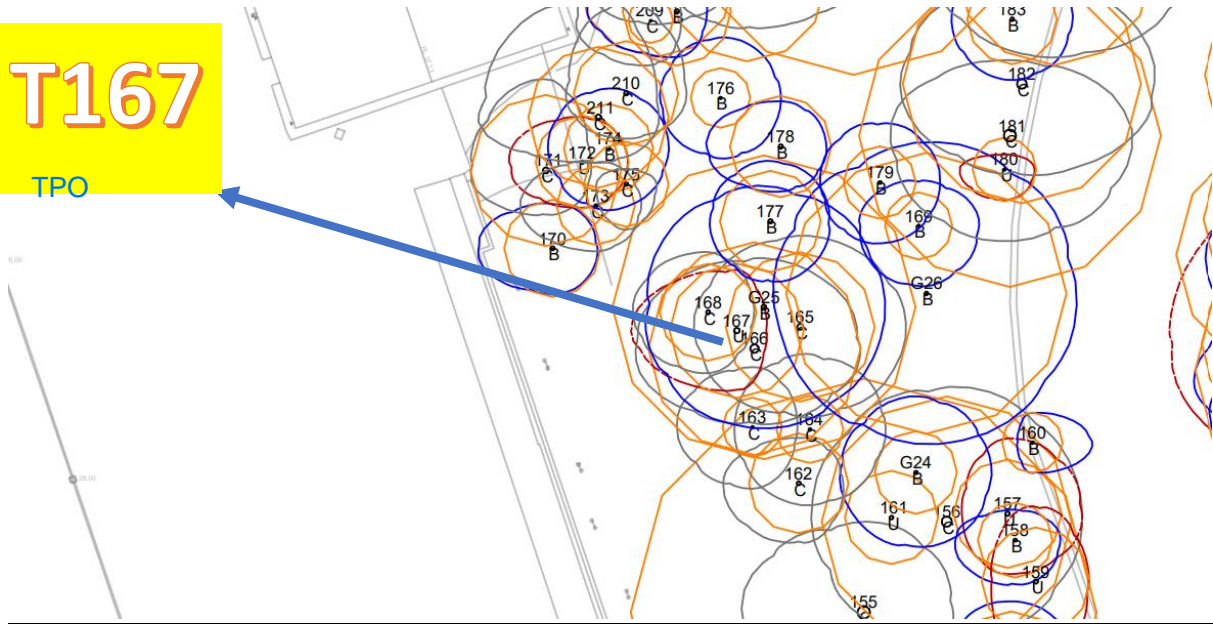
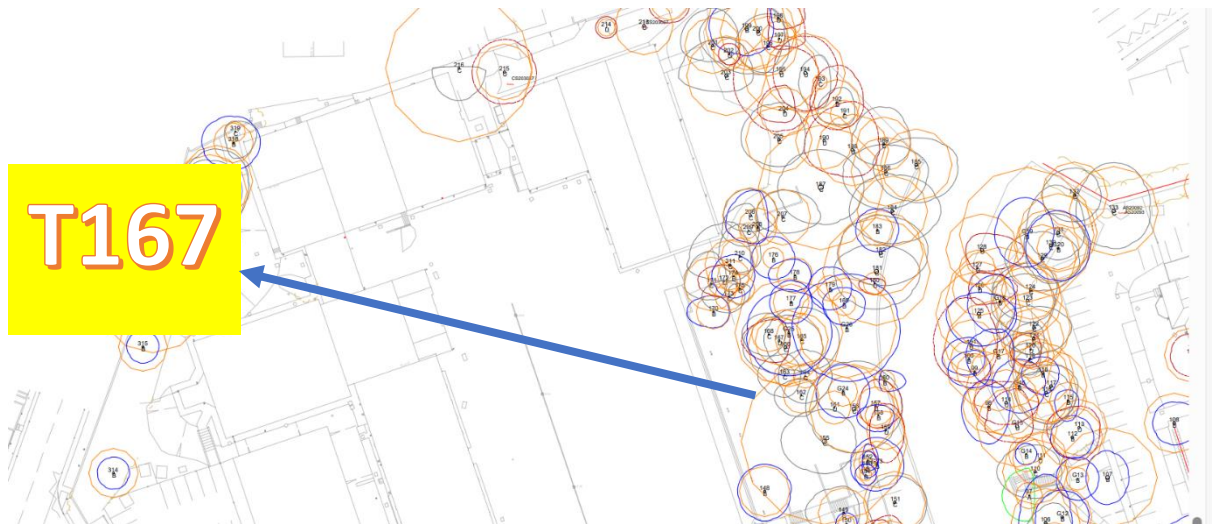
T167
TPO

T167 – Sycamore - Severe westerly lean within falling distance of playground, Sycamore is a poor specimen which may have had scaffold branch failure @ 6m easterly side, hard to determine due to Ivy, recommend fell to eliminate risk.
